**Structural Appraisal Report**  
**on**  
**Existing Barn at Home Farm,**  
**West Street, Walsham Le Willows**

**for**  
**Mr Tim Gudgeon**

Project No : **J198**

Date : **2<sup>nd</sup> JUNE 2023**

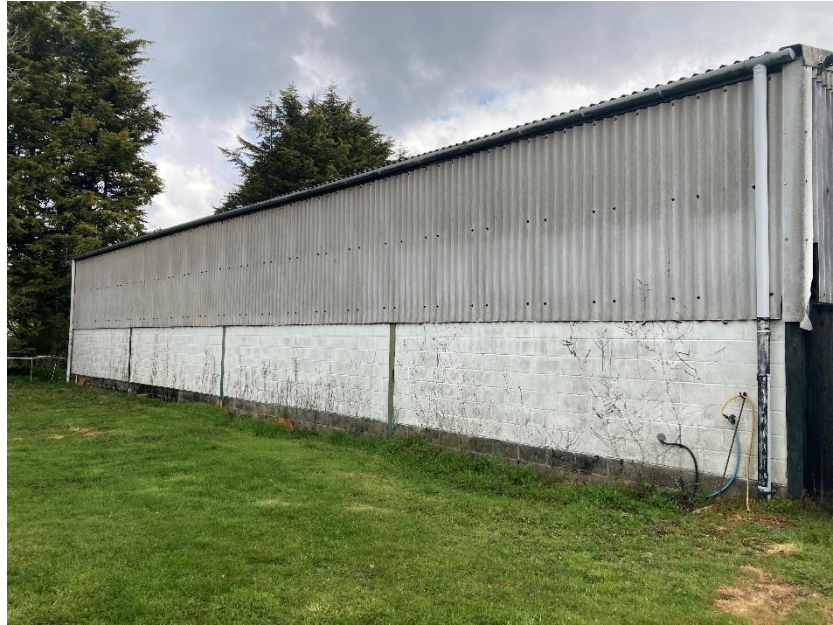
Fig 1 – West Elevation – Side elevation of existing barn, viewed from Home Farm Garden.

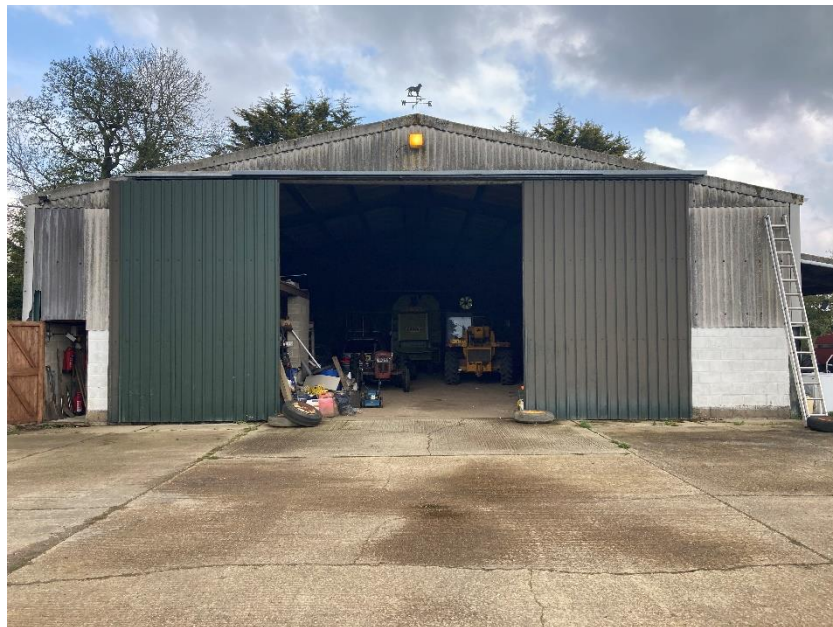
Fig 2 – South Elevation – Front elevation of existing barn, viewed from entrance hardstanding.

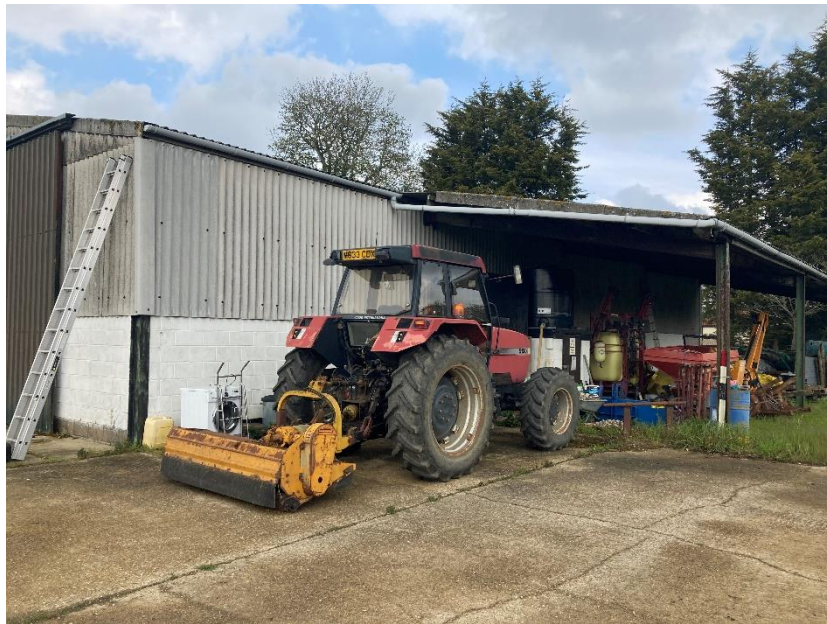
**Fig 3 –East Elevation – Side elevation of existing barn, viewed from rear eastern boundary.**

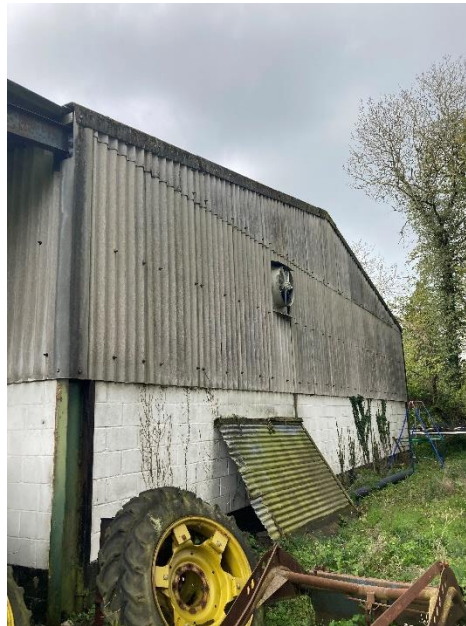
**Fig 4 – North Elevation – Rear gable end of existing barn, viewed from northern boundary.**

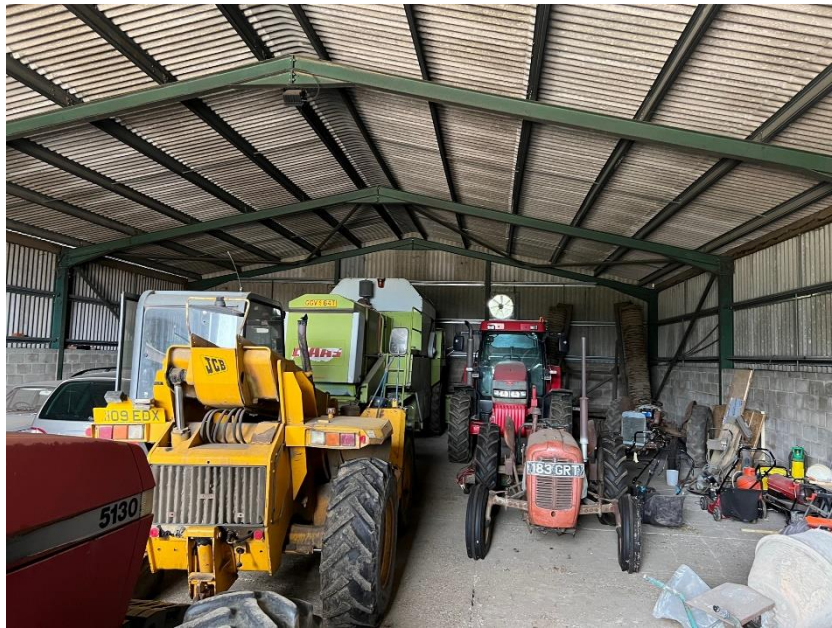
The roof pitches east to west and is covered by corrugated asbestos cement ‘big Six’ sheeting, supported by a system of regularly spaced cold rolled Z purlins. The Z purlins are in turn supported by a series of 5No duo-pitch structural steel portal frames. The structural steel portal frames comprise universal beam section (UB) rafters and universal beam section (UB) stanchions, with eaves and apex haunches. The rafters and columns are braced with diagonal steel circular hollow sections between the 4<sup>th</sup> & 5<sup>th</sup> rear portal frames.

**Fig 5 – Internal view of North gable, showing roof structure and supporting portal frames.**

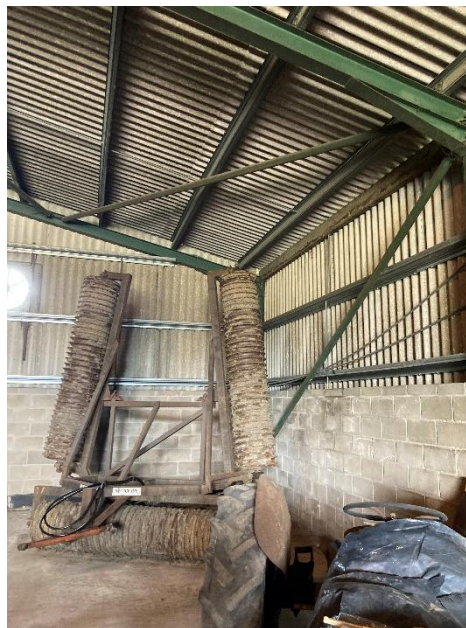
**Fig 6 – Internal View of braced portal frame rafters & columns.**

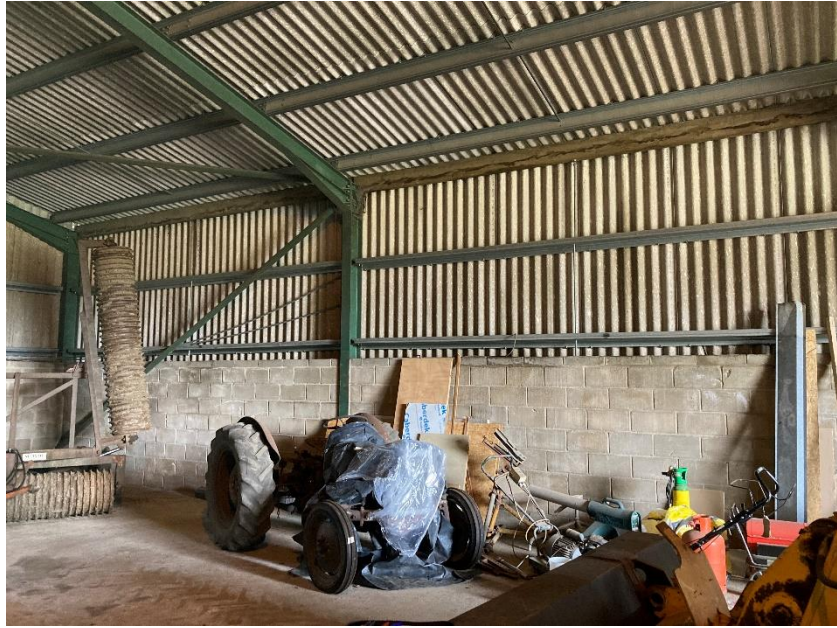
The top portions of the walls are generally formed by corrugated asbestos cement 'big Six' sheeting, supported by a timber eaves beam & 2 rows of cold rolled Z purlins cladding rails, with a 1900mm high 215mm thick blockwork built up to the first cladding rail on the inside of the cladding.

**Fig 7 – Internal view of portal frame column & masonry plinth.**

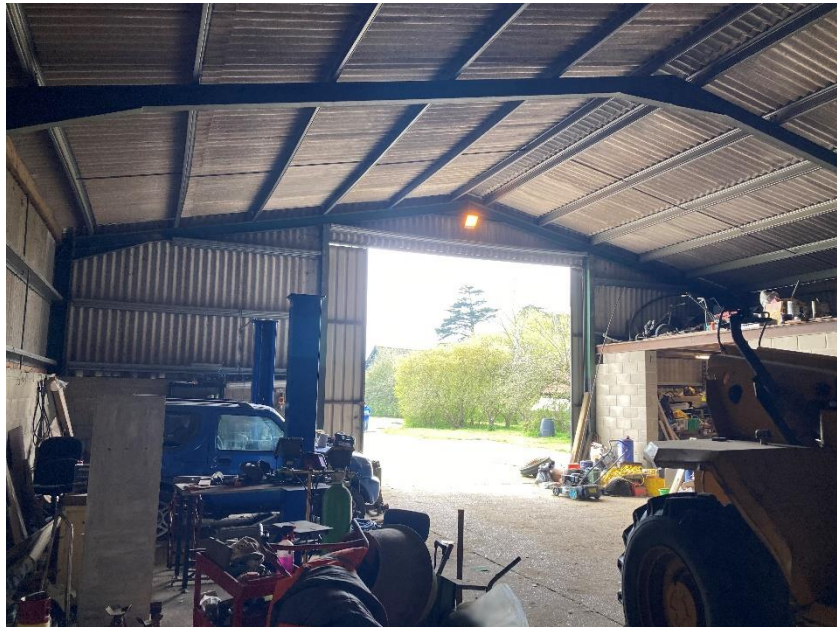
The concrete ground bearing floor slab is in good condition.

**Fig 8 – Internal view of ground bearing concrete floor slab.**
