BJW/ESH/18/185  
18<sup>th</sup> October 2018

**Barns at Progress Farm, Base Green Road, Wetherden, Suffolk, IP14 3LR**  
**Report on Building Condition**

Barns at Progress Farm, Base Green Road, Wetherden, Suffolk, IP14 3LR  
Report on Building Condition

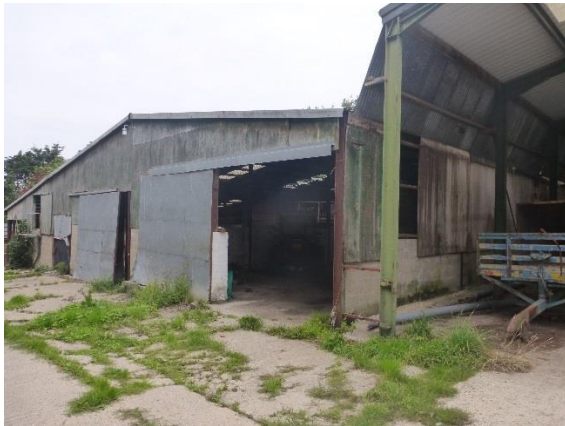
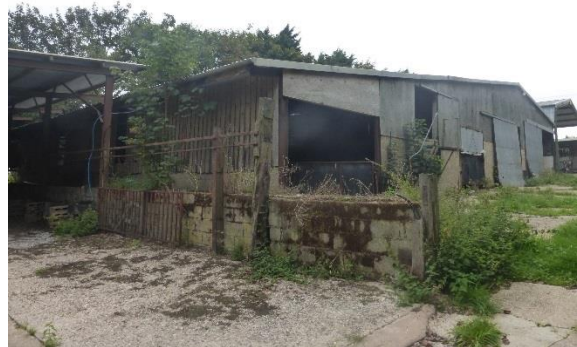
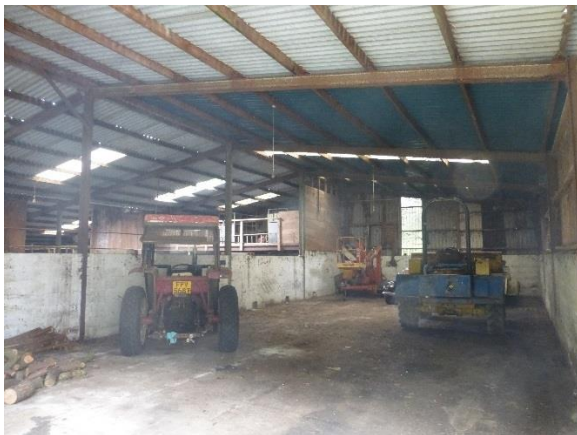
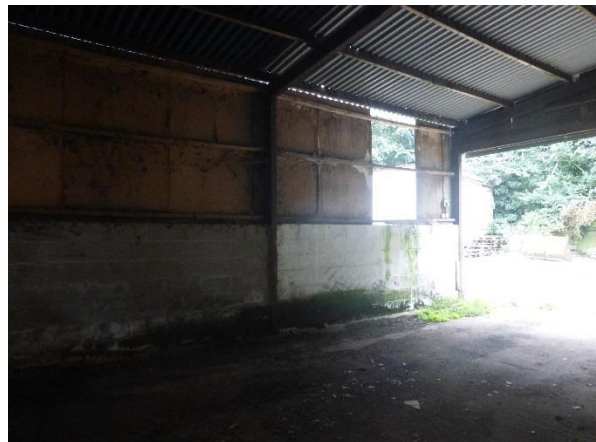
BARN 2

- 2.6 The roof covering is supported on timber purlins running between the portal frame rafters. There is evidence of some sheeting having been replaced over time and evident damage to others including a missing translucent sheet. This will allow significant water ingress and there was evidence of decay to some timber purlins.

- 2.8 Although the steel framework is in reasonable condition there is some delamination of steelwork columns particularly at low level. This may require some treatment or provision of strengthening plates as part of the conversion works subject to further advice from Structural Engineer or the Building Control Authority.

- 2.10 The concrete block plinth walls are in a reasonable condition for the most part or there are some areas of damaged blockwork and missing mortar which will need to be repaired.

- 2.11 There is significant weathering and erosion of blockwork to the attached lean-to section to the left hand flank wall and rear wall which may necessitate some of the infill block panels being reconstructed.

- 2.12 The timber and plywood cladding to the exterior walls is severely weathered and in generally poor condition and we would expect this to be renewed with new insulated cladding as part of the conversion works in compliance with Building Regulations requirements.

- 2.13 For the most part rainwater gutters and downpipes are defective or missing and require complete renewal.

- 4.1 This is clearly the more modern and substantial of the two buildings inspected and is in reasonable condition commensurate with its age and method of construction. It would be suitable for conversion to residential accommodation without wholesale demolition although some isolated repairs will be required as identified together with replacement roof and wall cladding.

- 4.4 As mentioned in the report it is expected that in providing a new insulated roof covering new purlins will also be provided. As part of this process we expect that the design Structural Engineer will check the design of the existing steel rafters and columns and recommend any strengthening, bracing etc. that may be required.

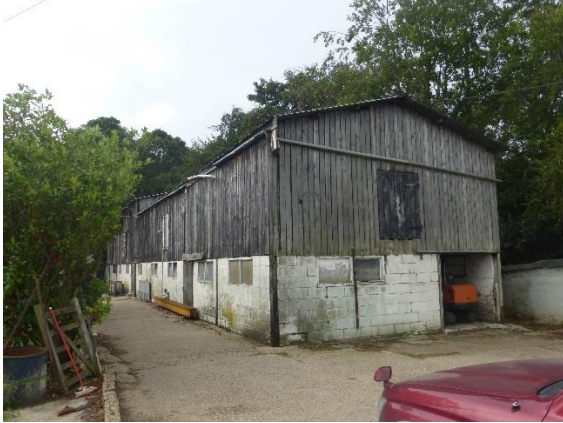
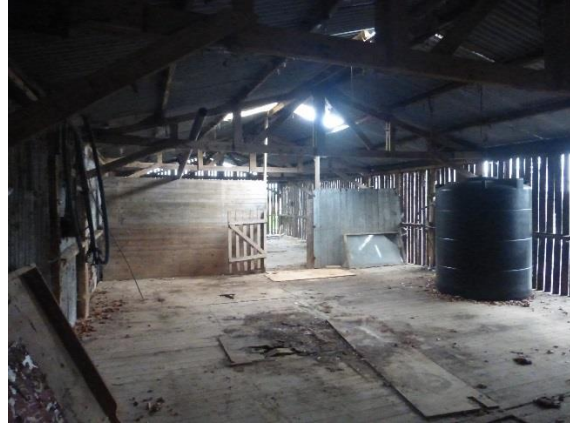
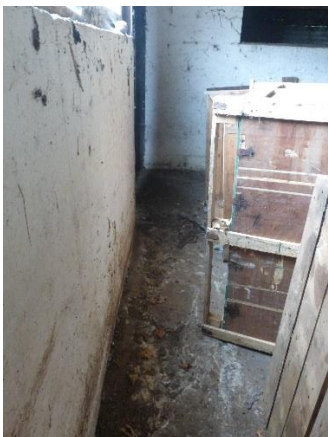
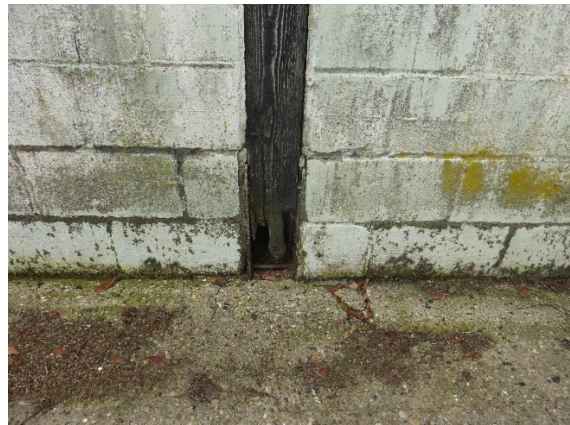
BARN 7

- 3.6 The roof covering is a mix of corrugated steel sheeting, some galvanised, some not. Consequently, there are a number of corroded sheets and trims.

- 3.8 The timber roof trusses appear to be at the limit of their ability as there is evidence of distortion and deflection of the bottom cords. It is our expectation that these elements will require some strengthening to support the new insulated roof covering required to meet Building Regulations requirements in conversion.

- 3.9 The timber purlins also show signs of decay and infestation by wood boring insect and again we would anticipate these will be renewed with any new roof covering.

- 3.10 The vertical timber cladding at first floor level is in generally moderate to poor condition with a number of missing boards and boards showing signs of timber infestation and decay. As this is vertical Yorkshire boarding we would anticipate that new insulated wall cladding will be required as part of any conversion works.

- 3.12 The concrete blockwork at ground floor level is in reasonable condition although there are areas of eroded blocks and mortar joints and some cracked blockwork which will require localised repair as part of the conversion works.

- 3.13 The intermediate timber posts forming the structural support for the building are of modest section size and all exhibiting severe timber decay at lower level with corrosion and delamination of steelwork at ground level to a greater or lesser degree. Although not compromised at this time these will require splice timber repairs, treatment and strengthening plates as part of any conversion works.

- 3.14 The first floor structure has timber boarding over the timber joists. There are signs of infestation by wood boring insects and timber decay which will require treatment as part of the conversion works and may also necessitate some repair or

- 4.6 This building is in a less satisfactory condition being what appears to be an older building and of less substantial construction. However, we are of the opinion that subject to some repair and strengthening of the existing columns, roof and floor elements the building can be converted into residential accommodation without wholesale demolition.
- 4.7 The roof and roof trusses will need some strengthening and additional support to carry the new roof loads and cladding.
- 4.8 The external wall storey posts will need splice repairs near ground level where they are currently decayed and refixed to the steel shoe supports.
- 4.9 Damaged and defective blockwork will need to be repaired.
- 4.10 All rotten and decayed timbers to the first floor roof and lintels etc. will need to be replaced with remaining timbers treated to eradicate insect and fungal infestation.

- 4.11 The exterior wall cladding we anticipate will be replaced with new insulated wall cladding as part of the conversion works.
- 4.12 The existing concrete floor will be suitable as a base although a new insulated floor will be required as part of the conversion works complete with damp-proof membrane to comply with Building Regulations requirements.
