JP Chick & Partners Ltd
Consulting Civil & Structural Engineers

Newtown Meadow Worlingworth

Structural Inspection Report

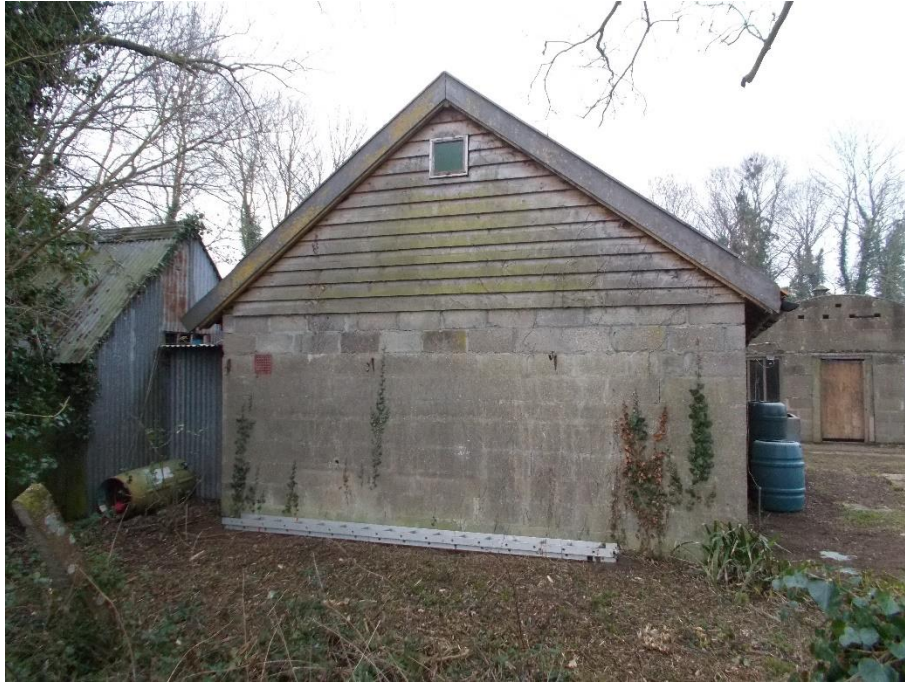
- 4.1 The north elevation presents a gable end comprising timber weatherboarded clad gable over a solid blockwork wall beneath. The wall is in good alignment and good verticality.

Photograph 1: North gable end

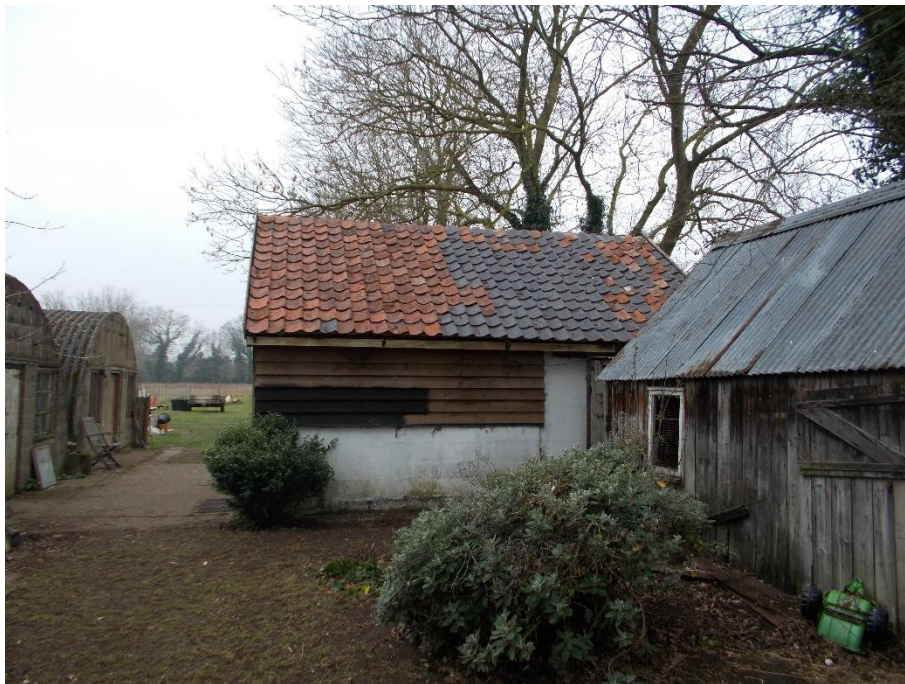
- 4.5 The ridgeline of the roof presents as level. The roof plane presents as uniform with no obvious dipping or sagging. The roof currently discharges rainwater on this side directly to ground level, with the guttering missing at the time of the inspection.
- 4.6 The wall to the east elevation is a combination of timber featheredge boards over timber framing supported on painted concrete blockwork.
- 4.7 The blockwork presents in good alignment and verticality. There is a vertical construction joint approximately two thirds along the elevation representing different phases of construction.

Photograph 2: East elevation

- Add guttering to the eastern facing roof slope with a positive outlet.
 - Repoint the minor cracking recorded to ensure that the external walling remains watertight. Reapply the painted finish as appropriate.

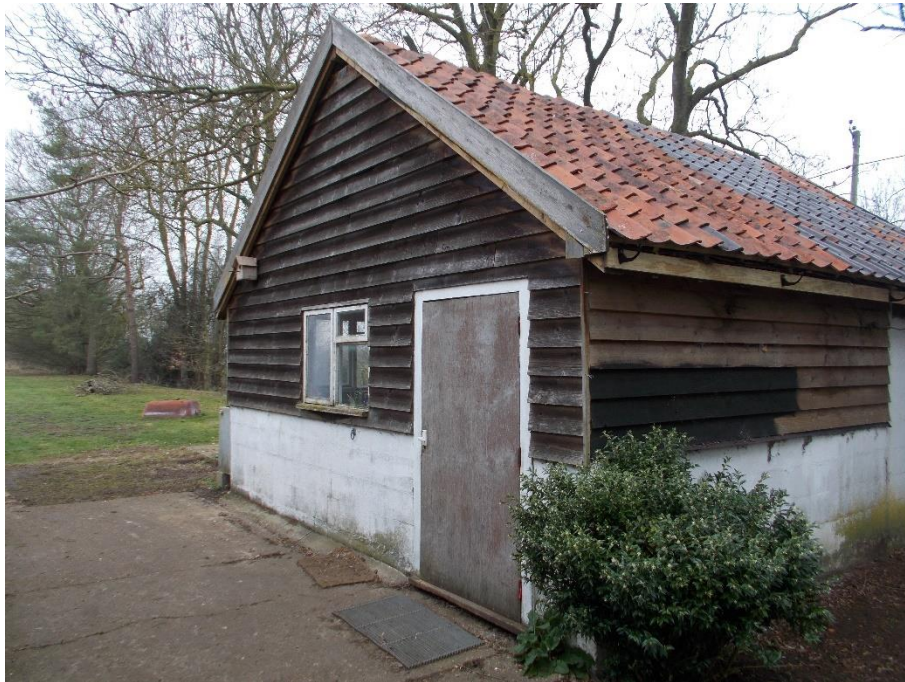
- 4.8 The south elevation presents a gable end predominantly clad in timber featheredge boards over a small plinth comprising five courses of painted concrete block.
- 4.9 The wall is in good alignment and verticality.
- 4.10 There are two relatively minor stepped fractures in the blockwork plinth, one located beneath the window, and the other towards the western end. The fracturing generally follows mortar joints, however, has cracked through two to three of the blocks. The fracturing is open to hairline beneath the windowsill and increases in width towards ground level, open to a maximum of 2mm to 3mm

width. The western crack is smaller at the base, open to approximately 1.5mm at ground level, and increasing in width at sole plate level to approximately 3mm to 4mm.

Photograph 3: South elevation

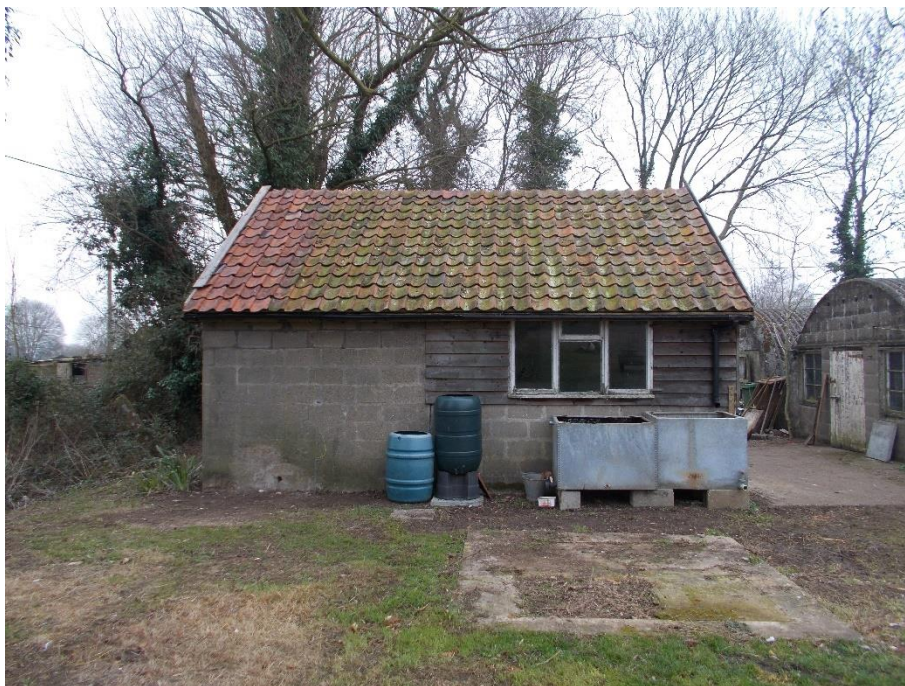
- 4.11 As recorded previously, the ridgeline presents as level and the roof plane uniform with no obvious dipping or sagging.
- 4.12 The roof discharges rainwater to a positive rainwater system comprising uPVC guttering out letting via a rainwater downpipe into large galvanised tanks.

- 4.13 The wall construction supporting the roof is a combination of timber featheredged boarding on timber frame supported on the concrete blocks. The concrete blocks appear to be of the hollow type and measure approximately 150mm in thickness. The construction joint noted on the east elevation is also present on this elevation representing phases of development.

Photograph 4: West elevation

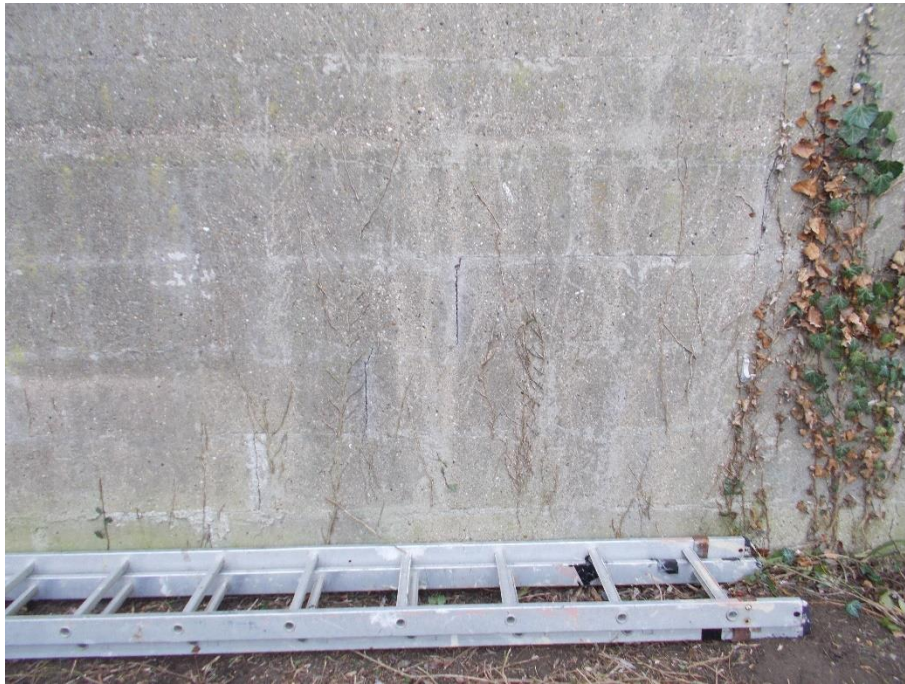
- 4.2 There is evidence of minor movement in the blockwork with a stepped fracture occurring approximately in the middle of the elevation, and tracking diagonally upwards and to the west, where it is open to approximately 3mm width.
- 4.3 Of note at the west corner of the building a mature deciduous tree, believed to be Ash, is present, approximately 3.5m distance.
- 4.4 At the opposite corner of the elevation, at the east end a mature Willow tree is located approximately 2.5m distant.

- 6.2 There has been a series of additional phases of development at the building in the last twenty to thirty years, which are recorded in the body of the report. A few, small magnitude fractures were recorded to the external blockwork, which are commonly found when using this brittle building material and frequently occurs as a result of shrinkage of the mortar joints and of the concrete blocks themselves.

Photograph 5: Minor cracking to north blockwork

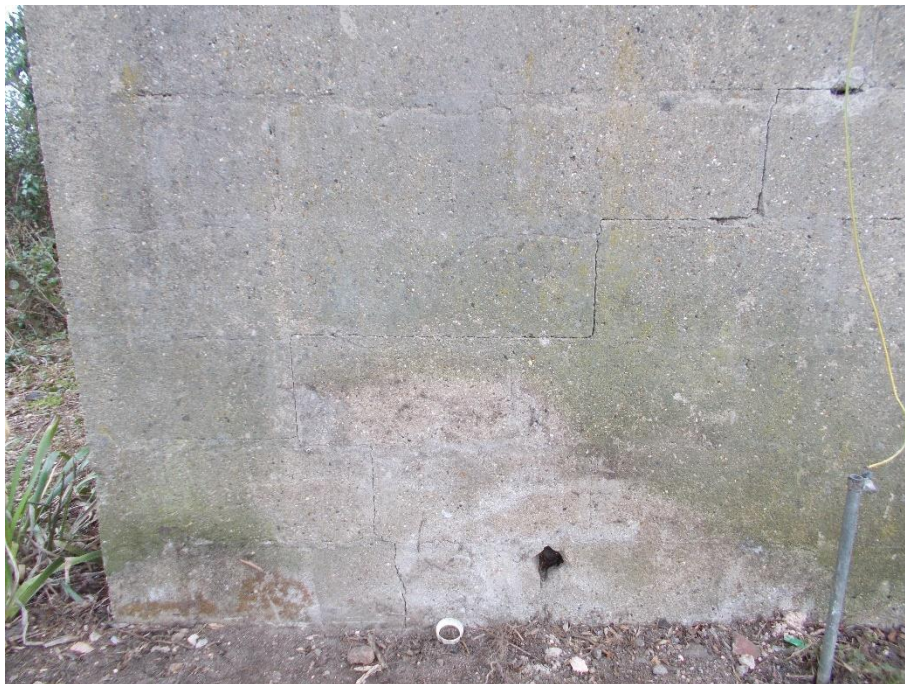
- 4.14 There are a few fractures present across the elevation with a pattern of stepped fractures being visible towards the northern end, with the cracking open to approximately 1mm width at ground level, generally stepping and following perpendicular joints and bed joints, where it opens to approximately 2mm width two courses below the eaves level.

Photograph 6: Minor cracking to west elevation blockwork

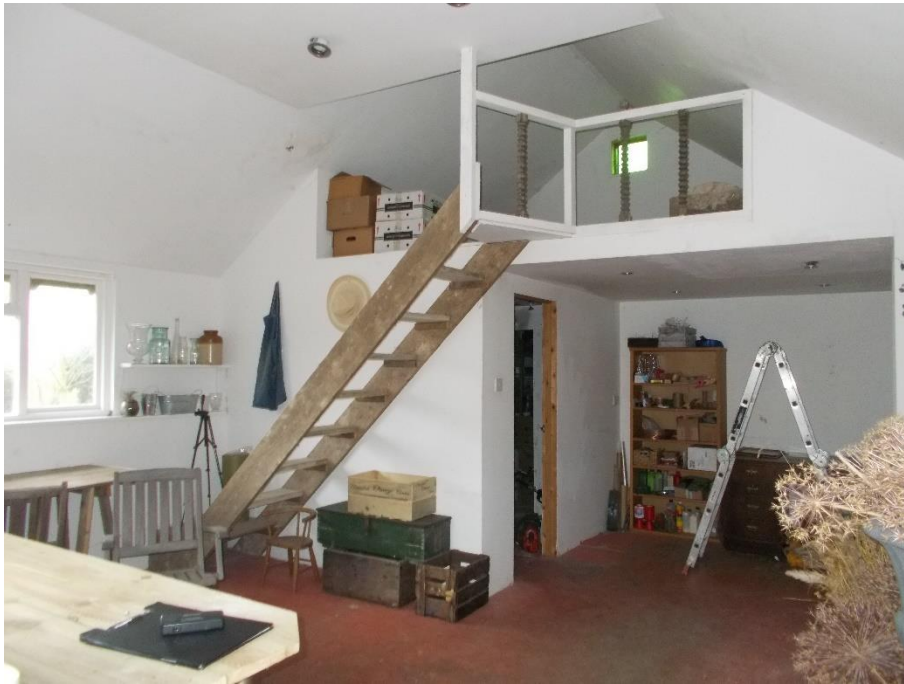
- 5.2 The walls of the main open space have been finished with plasterboard and painted, drylined off the supporting structure. There are a few minor shrinkage fractures in the finishes around the space, however, these are considered to be of a minor nature and are commonly found with this format of finishing.

- 5.3 Within the main space the roof is vaulted and the plasterboard finish continues up on the underside of the rafters and up to the ceiling collars. The finishes are generally in fair to good condition, aside from minor shrinkage cracking.

Photograph 7: General view of interior

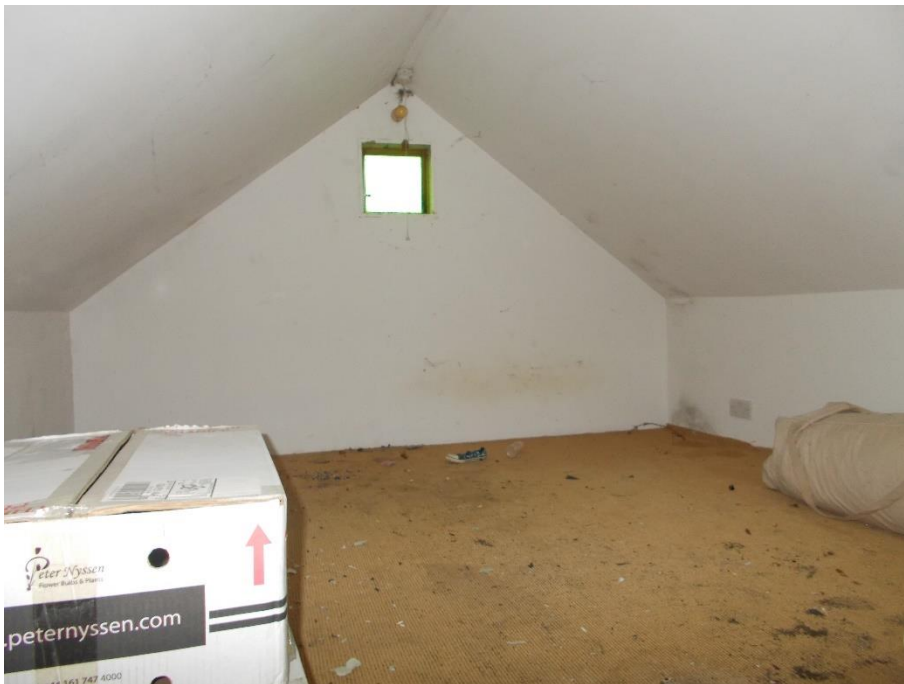
- 5.6 At the northern end of the building, a mezzanine / attic level is present providing accommodation within the roof space. The plaster finishes to the underside of the rafters present in good condition with no obvious signs of sagging or significant fracturing. The plastered wall finishes present in a similar condition.
- 5.7 The floor of the attic / mezzanine is level and does not yield to heel drop test.

Photograph 8: Mezzanine / attic level
