# **Curtis Farm, Kersey, Suffolk**

## **Heritage Asset Assessment**

**Leigh Alston MA (Oxon), Architectural Historian**

**August 2020**

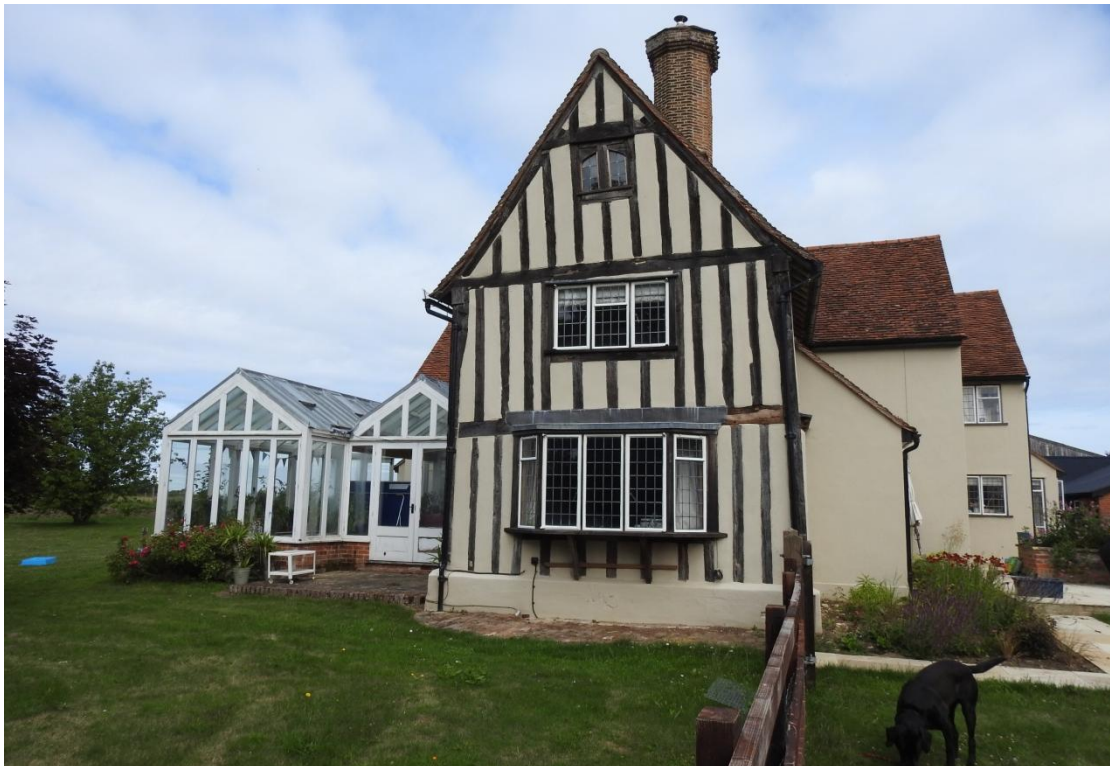
**Illus. 2.** The south-eastern gable, facing the Kersey road, with the remains of the medieval Wicker Street Green on the left. Until the 1960s the house consisted only of two wings adjoining at right-angles: the conservatory on the left and the projections to the right are modern additions. The gable windows are also modern (compare figure 11), and many of the associated timbers have been renewed. The chimney appears to survive from the 17<sup>th</sup> century but has been heavily repointed.

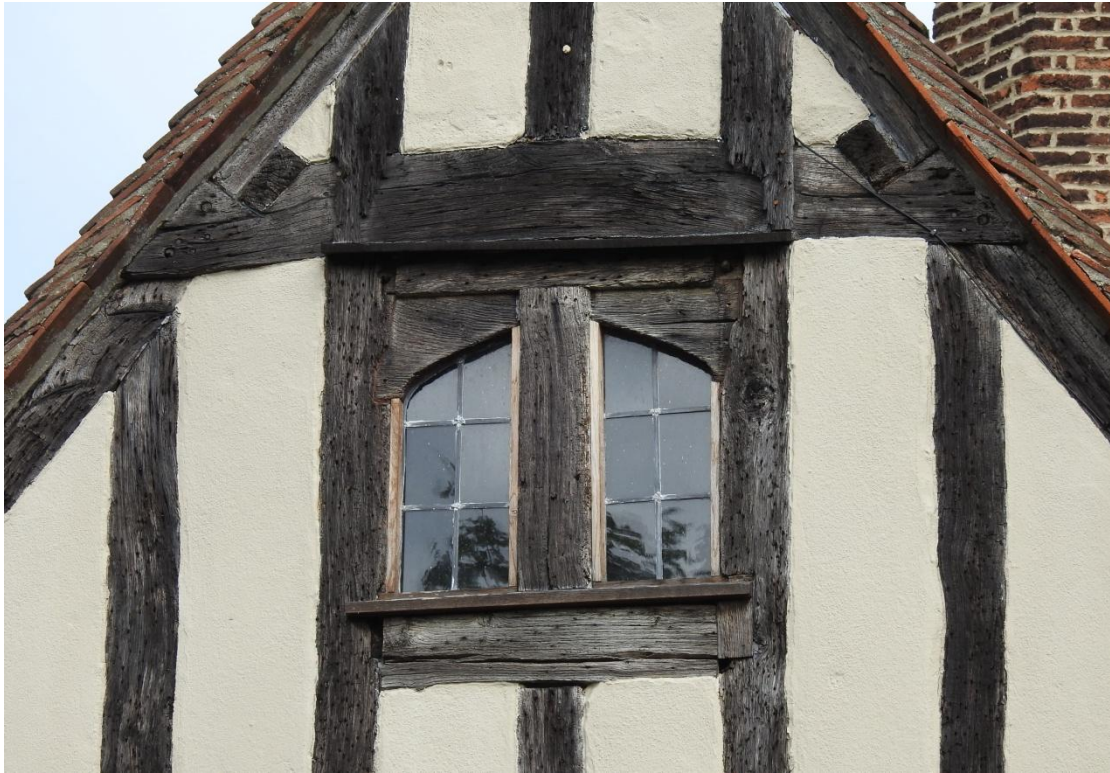
**Illus. 3.** A detail of the original arched attic-storey window in the south-eastern gable. The central stud is a later insertion. Arched 16<sup>th</sup> century windows are usually found only in shop facades and examples at this height are rare. A close parallel of the same late-16<sup>th</sup> century date can be seen nearby at 4 Nayland Road in Bures (figure 10).

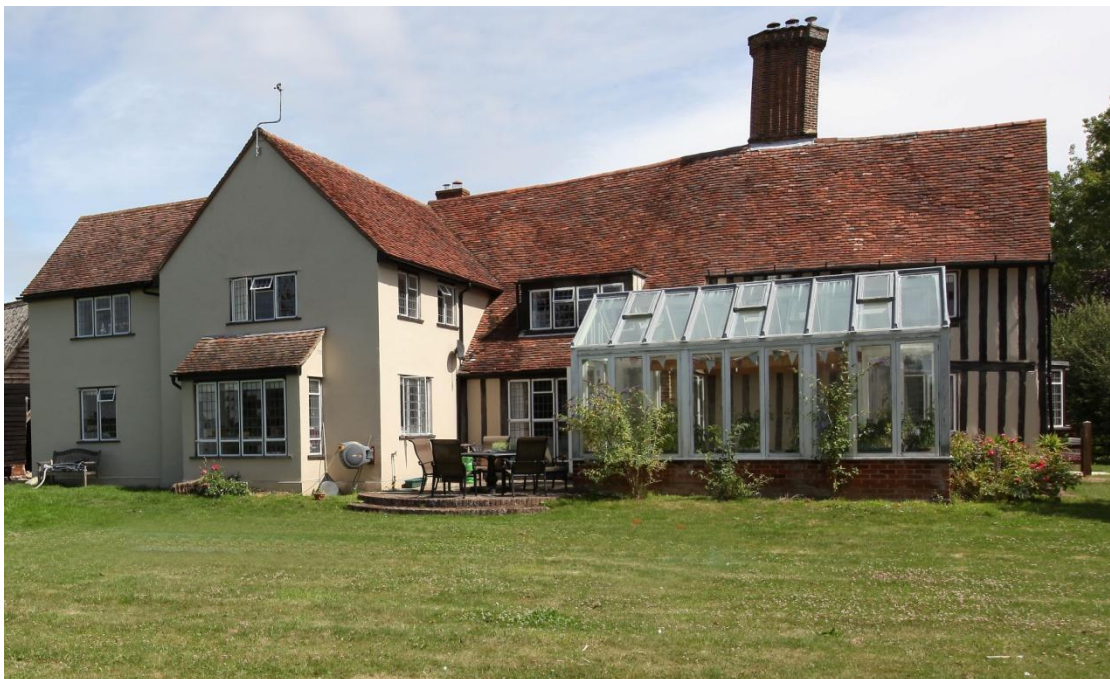
**Illus. 4.** The original south-western facade, seen from the medieval green. Compare the photograph of the same elevation in 1959 (figure 11). The red-brick fabric of the left-hand wing has been disguised with cement render. The lean-to in the angle of the two historic wings was added in or about the 1960s while the glazed conservatory and the two-storied projection on the left date from 1992 and 1994 respectively. The original first-floor window with moulded mullions in illus. 18 is hidden behind the conservatory.

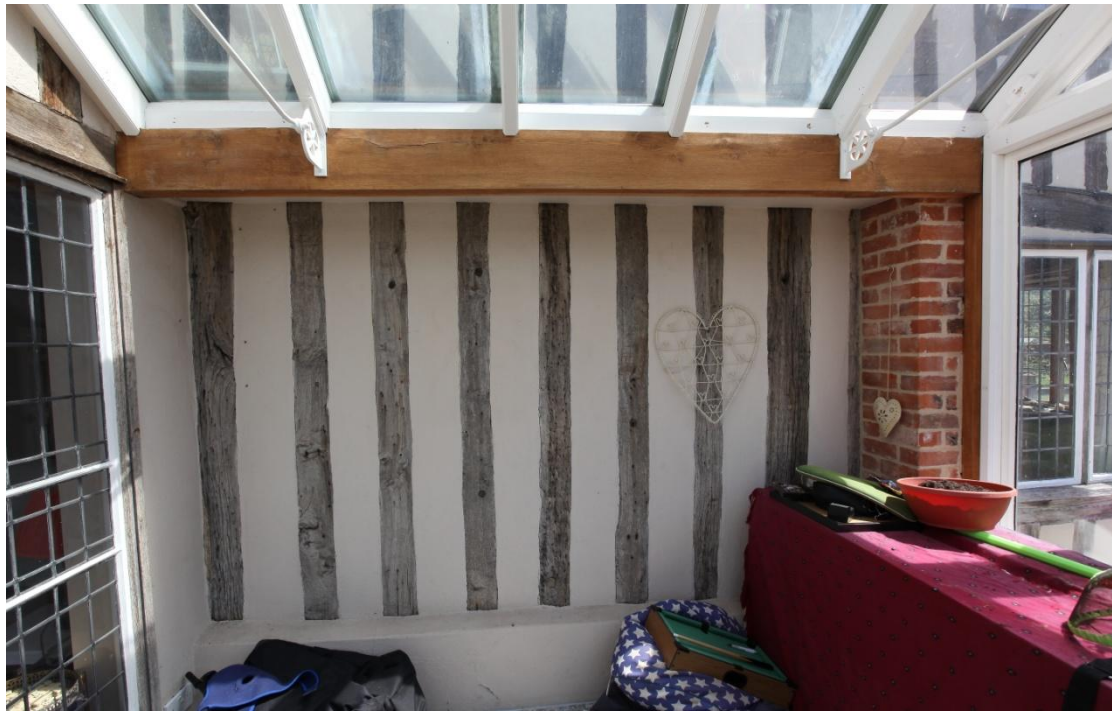
**Illus. 5. The studs of the south-western facade from the conservatory which was initially added in 1992. The 1959 photograph shows a ‘lobby entrance’ door in this position, and the central two studs are insertions that are not pegged to the mid-rail – suggesting the door was either an original feature or more probably occupied the position of an original window. The weathered storey posts of the chimney bay are visible to left and right but all six central studs lack weathering and are recent replacements.**

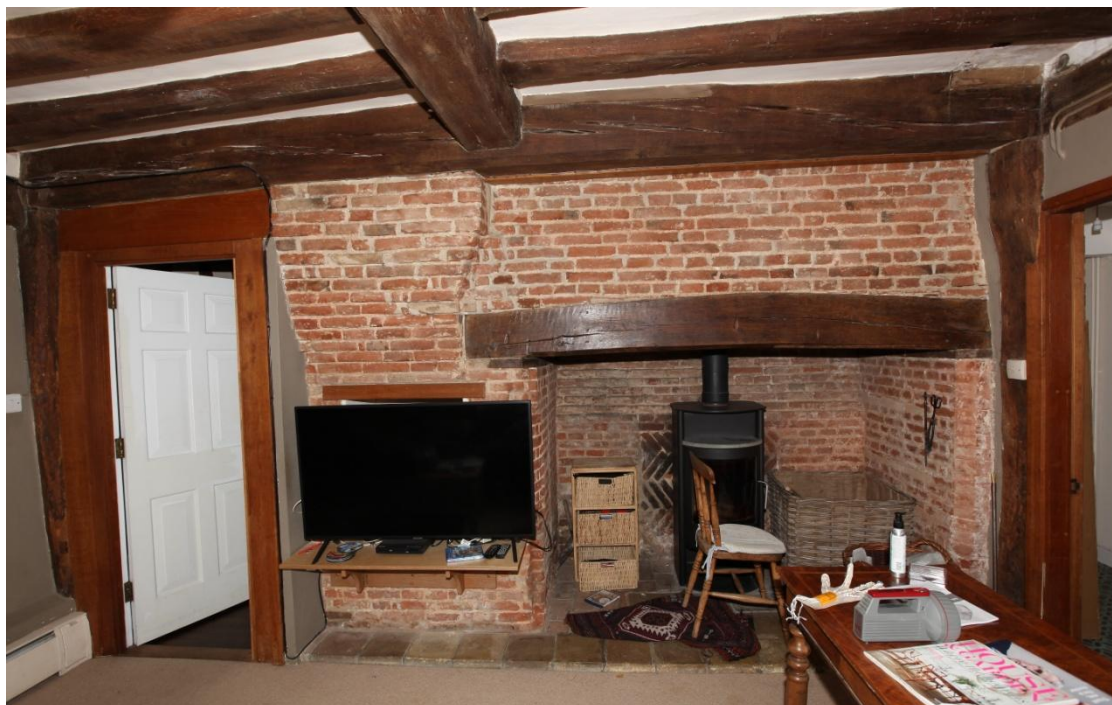
**Illus. 6. The good 17<sup>th</sup> century fireplace in the heavily timbered late-16<sup>th</sup> century parlour with the projection of the integral staircase to the left of the lintel. Although the brickwork occupies a dedicated narrow chimney bay it projects through the original external wall on the right and is clearly a replacement of the narrower stack for which the frame was designed. A number of ‘taper’ burns are visible on the lintel.**

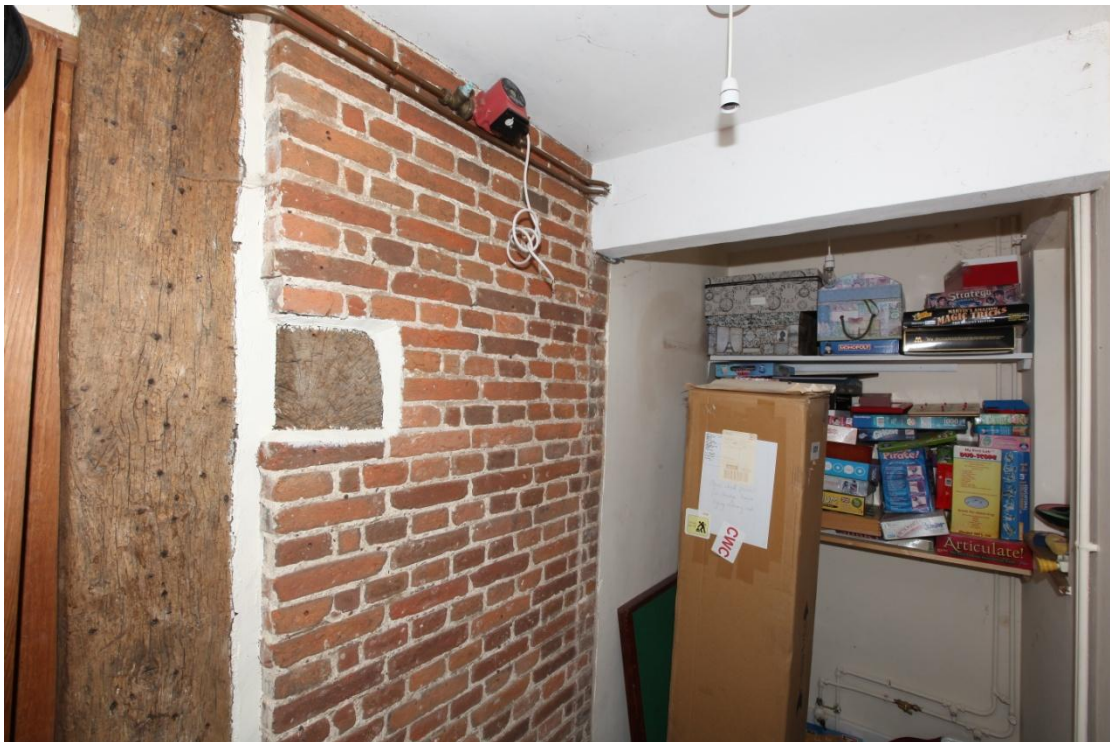
**Illus. 8.** The north-eastern side of the brick chimney with the corner-post of the parlour on the left. The lintel and brickwork project through the timber-framed wall and are weathered, having been exposed to the elements until the addition of the lean-to in the 1960s. This unusual feature demonstrates that the present chimney post-dates the frame.

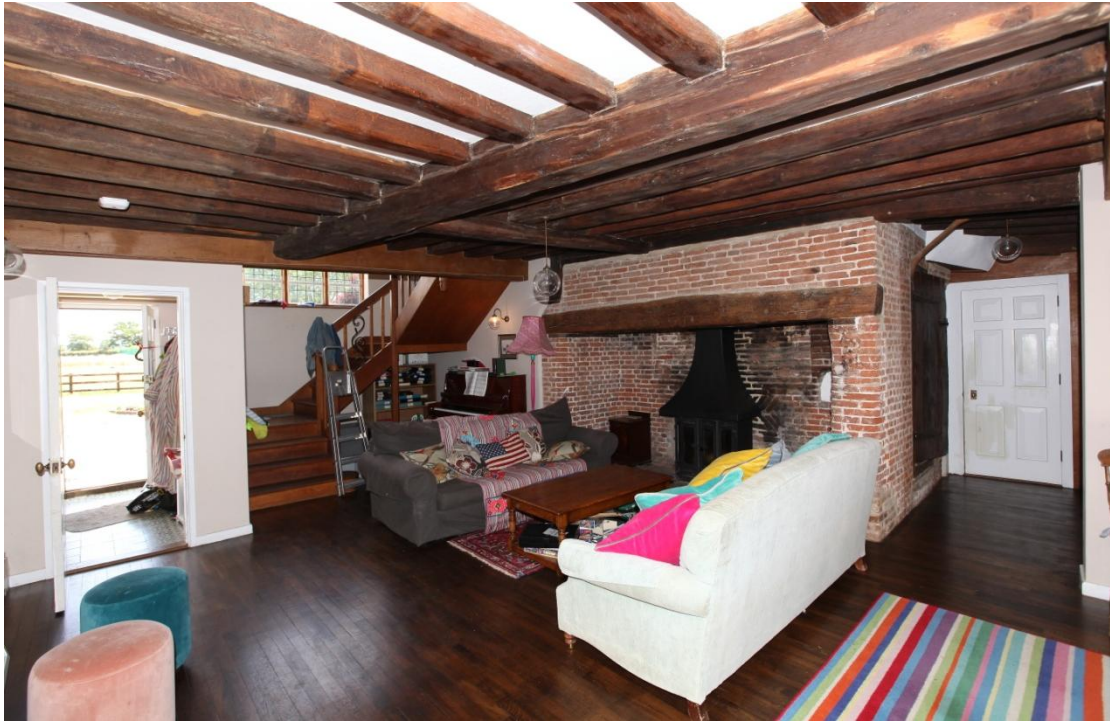
**Illus. 9.** The central hall from its western corner, showing the door to the parlour on the right. The north-eastern wall on the left was completely removed in the 1960s when the gabled extension containing the modern staircase was added. The ostensibly original boarded door to the 17<sup>th</sup> century stair is visible in the side of the chimney (to the left of the parlour door). Note the scar of a missing partition on the ceiling joists at top left that may relate to a former cross-passage screen.

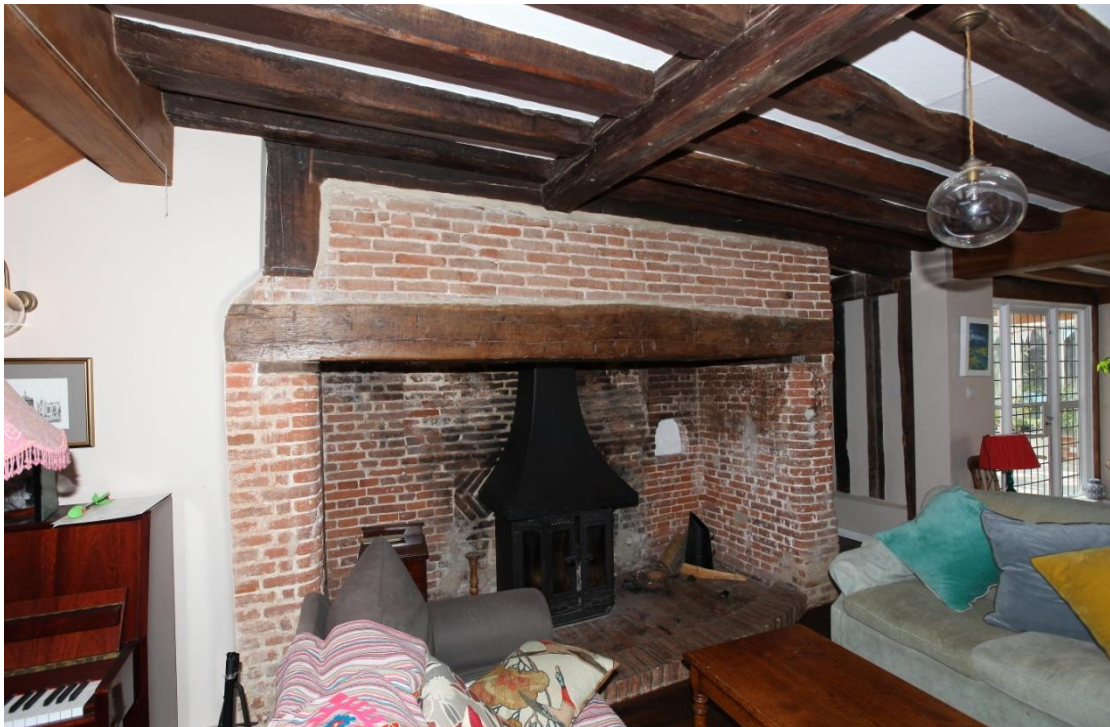
**Illus. 10.** Like its counterpart in the parlour the hall fireplace survives largely unaltered from the 17<sup>th</sup> century but the timber frame was built for a smaller, earlier chimney and the fireplace cuts the corner post on the left. Note that the axial joist of the ceiling is central to the wider hall and not the binding joist above the chimney.

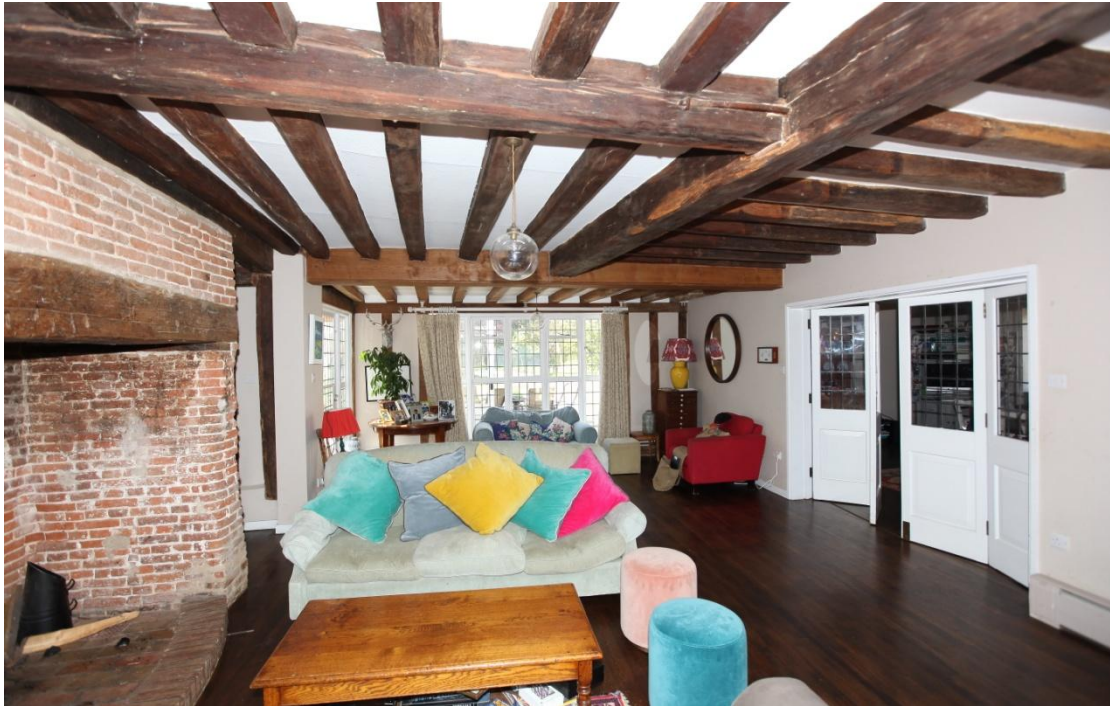
**Illus. 11. The central hall from the north-east, with the 20<sup>th</sup> century folding doors to the brick service wing on the right. The original front wall facing the green lay beneath the light-coloured modern ceiling beam in the background but was entirely removed on the ground floor when the lean-to extension was added beyond. The joists and wall studs of this extension are modern.**

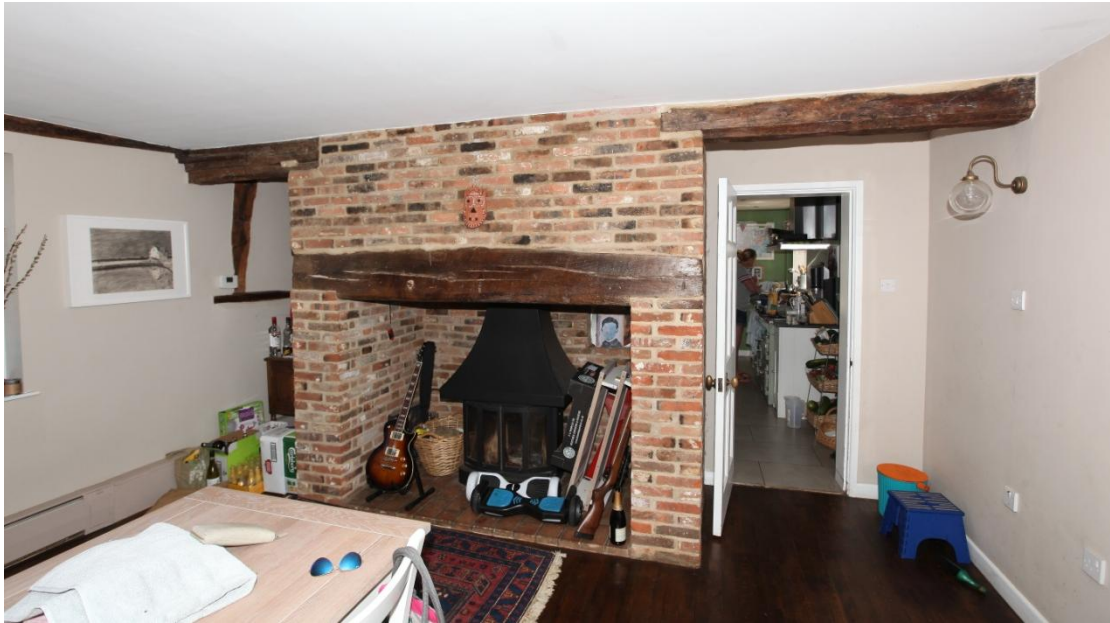
**Illus. 13.** The fireplace against the rear (north-eastern) gable of the original service wing. The modern kitchen beyond is an extension of the 1960s. The 19<sup>th</sup> century Ordnance Surveys show what appears to be an external chimney projecting from this gable but the present fireplace is a 20<sup>th</sup> century reconstruction that re-uses an early lintel. Some of the adjoining timber may be *in situ* but most has also been re-used. The rest of the wall fabric in the wing is hidden by modern render but appears to be of brick.

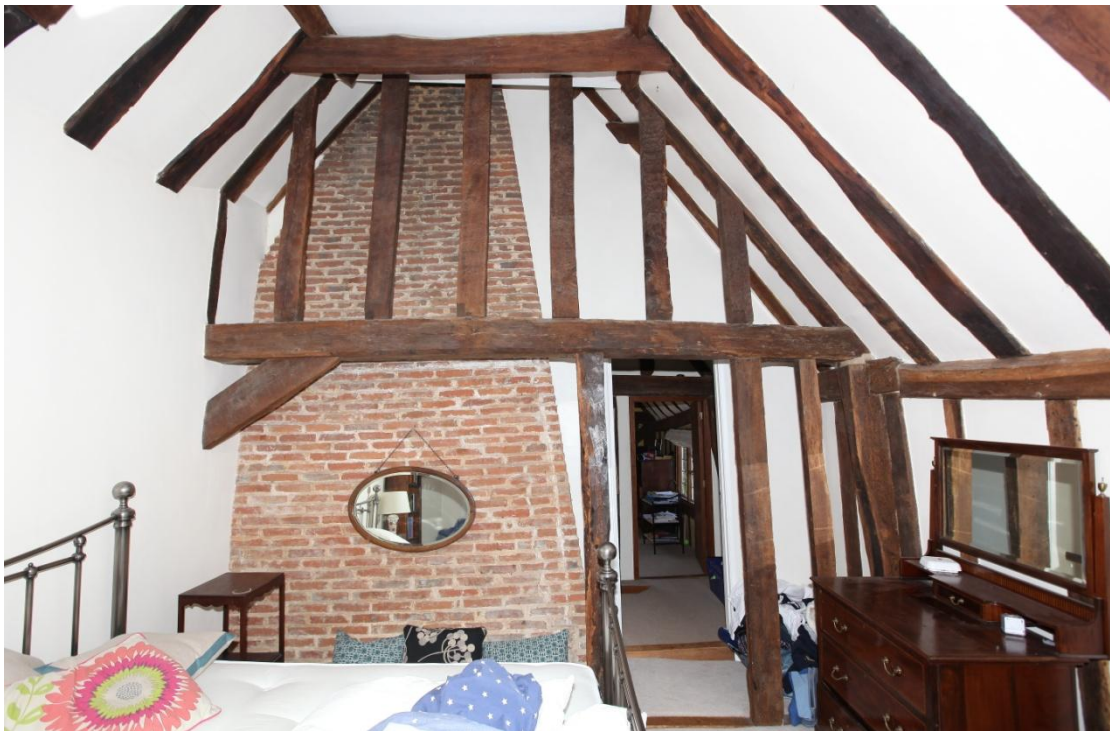
**Illus. 14.** The first-floor chamber above the central hall looking towards the chimney bay with the parlour chamber beyond. The studs to the right bear the diagonal weathering scar of the lower hall against which the chimney bay and parlour were originally built (illus 15). The diagonal timber to the left is an integral arch-brace rising from the truncated corner post shown in illus. 10 but the rest of the studs appear to be original despite the fact that they are nailed rather than tenoned to the frame. The clasped-purlin roof of the hall chamber lacks wind-braces but re-uses sooted rafters.

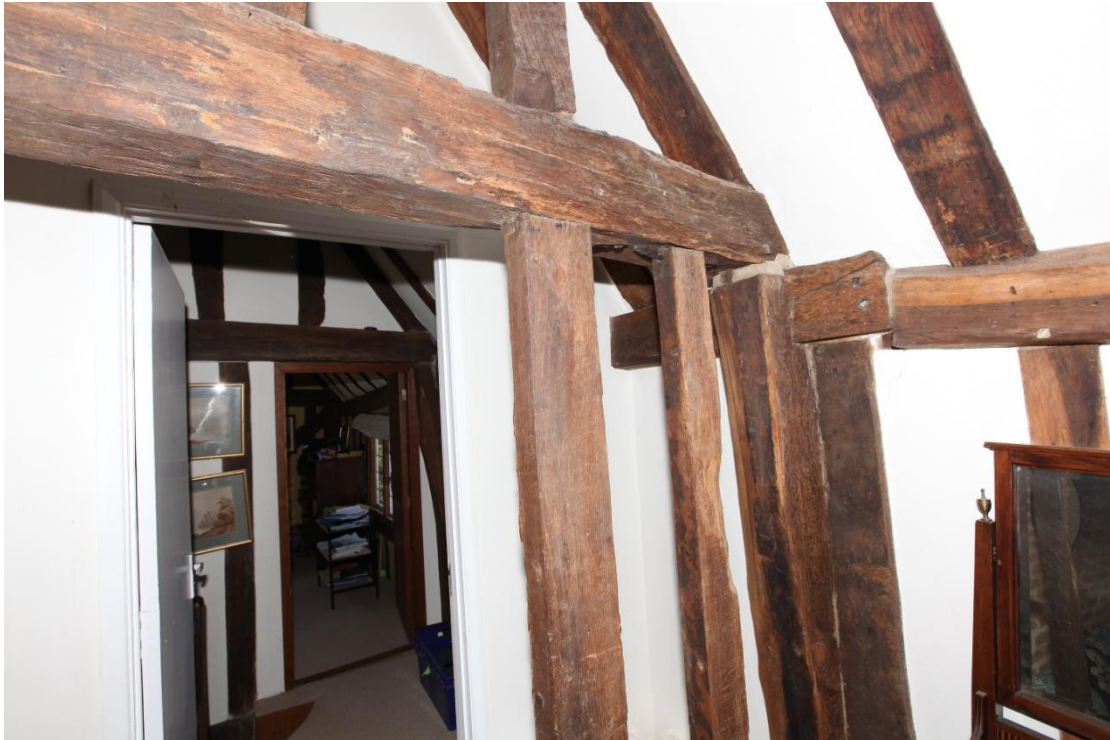
**Illus. 15.** A detail of the framing to the right in illus. 14. The frame of the hall chamber is a 17<sup>th</sup> century replacement of a lower predecessor that almost certainly represented a medieval open hall. Its roof-plate at top right is lapped and pegged to the end of the late-16<sup>th</sup> century parlour roof-plate which is clearly weathered where it once projected above the medieval roof. The angle of this medieval roof is reflected by a diagonal weathering scar to the tie-beam and wall studs, with those at top-right once exposed while the area to the left was protected with the missing roof and remains unweathered.

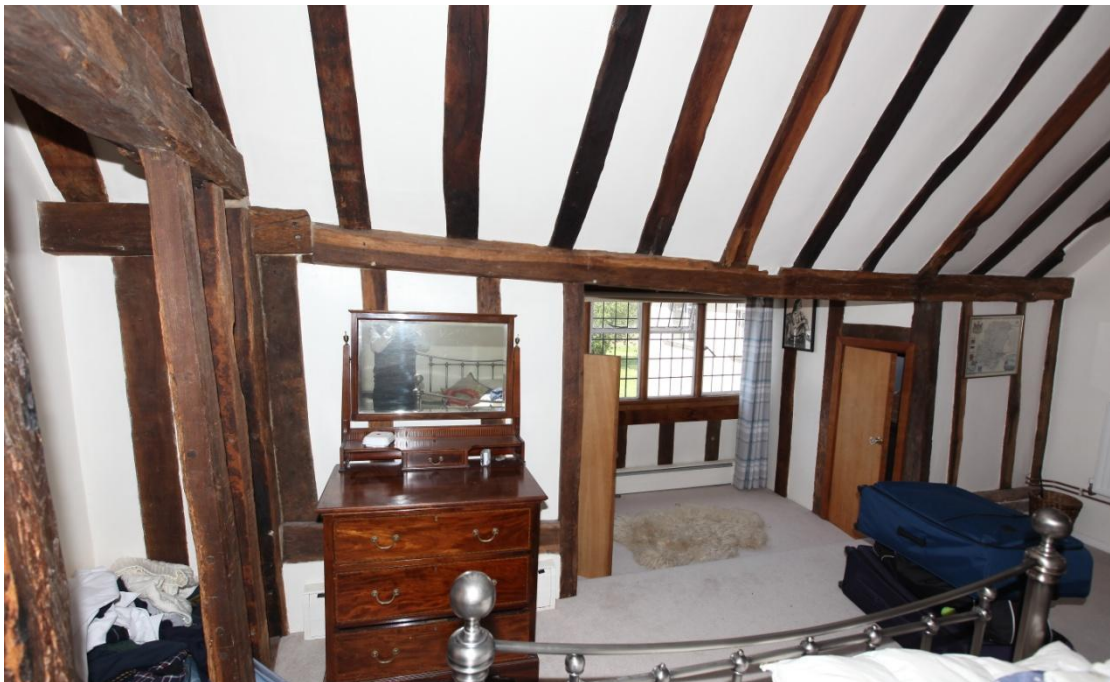
Much of the rebuilt hall was removed during the heavy restoration of the 1960s but part of its front wall is still visible on the first floor (illus. 16). Its timbers are narrow and widely spaced compared to the older parlour, but are weathered externally and were still exposed inside and out. This weathering can now be seen from the cupboards in the roof-space of the 20<sup>th</sup> century lean-to extension (illus. 17). Accurate dating is impossible given the limited evidence,

**Illus. 16.** The front (south-western) wall of the hall chamber showing its intact roof-plate with original studs and mid-rails on each side of a central aperture cut to link the chamber with the lean-to extension of the 1960s. These studs are widely spaced relative to those of the parlour but are weathered externally and were evidently exposed.

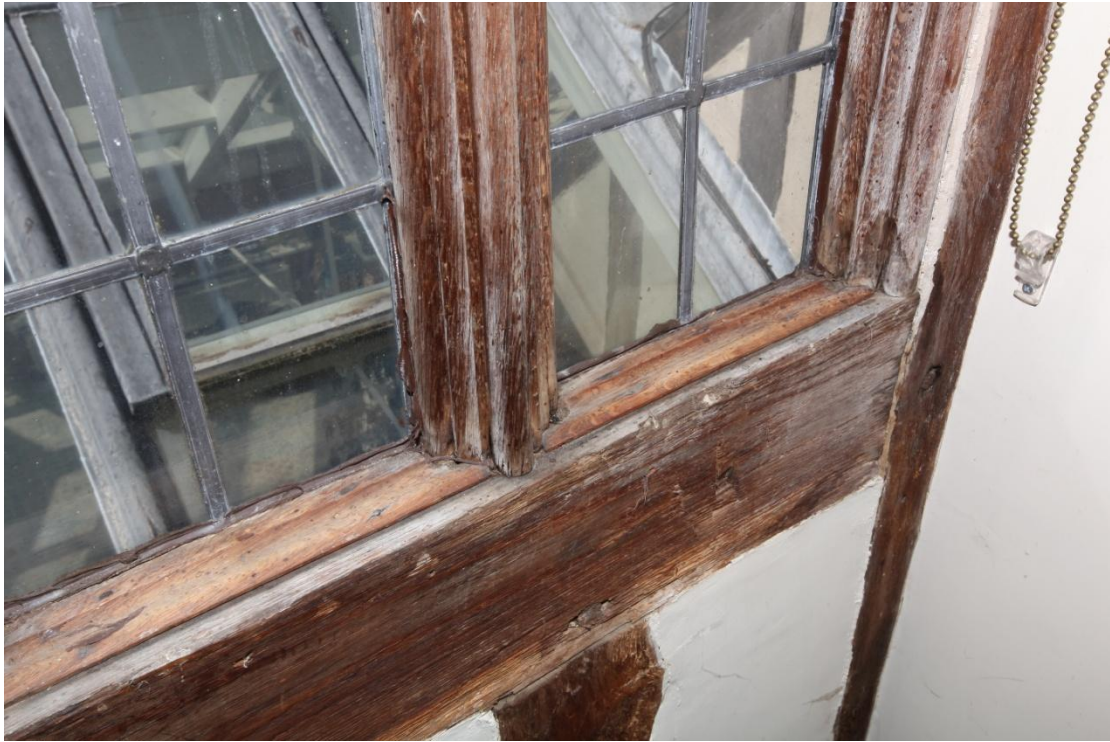
**Illus. 19.** A detail of the mullions in illus. 18. High-quality roll-moulded examples of this kind were fashionable in high-status buildings throughout the 16<sup>th</sup> century but were quickly superseded by quarter-round ovolo mouldings at the turn of the 17<sup>th</sup>. The later beading on the sill conceals small circular holes for saddle bars in the centre of each light to which leaded panels of glass would have been tied initially. These holes are still visible in the underside of the roof-plate above.

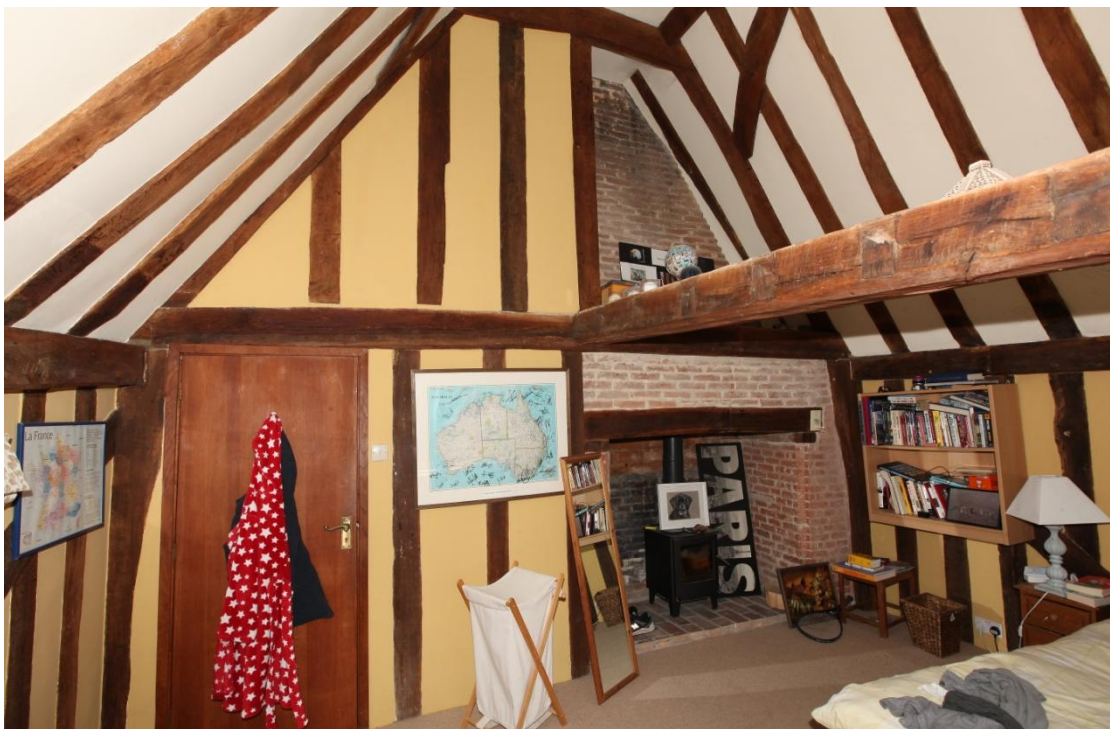
**Illus. 22.** The parlour chamber from its south-eastern gable showing the well preserved 17<sup>th</sup> century fireplace above the ground-floor example in illus. 6. This too retains its original reddled finish. Note the empty mortices in the axial joist for the large, flat-sectioned common joists of a missing original ceiling. The principal rafter above the fireplace contains a pegged mortice for another curved wind-brace that projected into the chimney bay and was cut by the later brickwork of the present chimney.

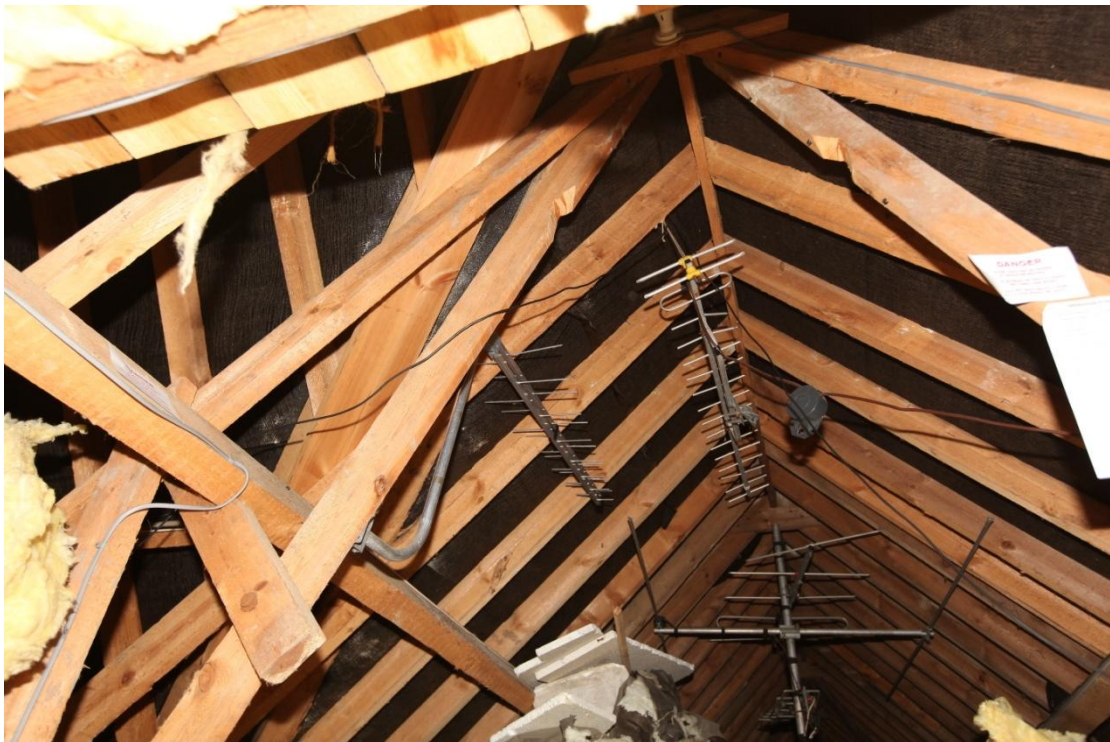
**Illus. 26.** The softwood roof of the brick service wing, rebuilt either as part of the 1960s restoration or when the wing was extended in the early 1990s. Re-used sooted rafters that were probably salvaged from the medieval open hall on the site are visible in the roof of the hall range to the left.
