CEC 1697760
Scope of Works Document
Georgia Piggott BSc
9th March 2023

SCOPE OF WORKS DOCUMENT

Project Title: Ipswich

Site Address: Curtis Farm, Cox Hill, Wicker Street Green, Ipswich, IP7 6EY

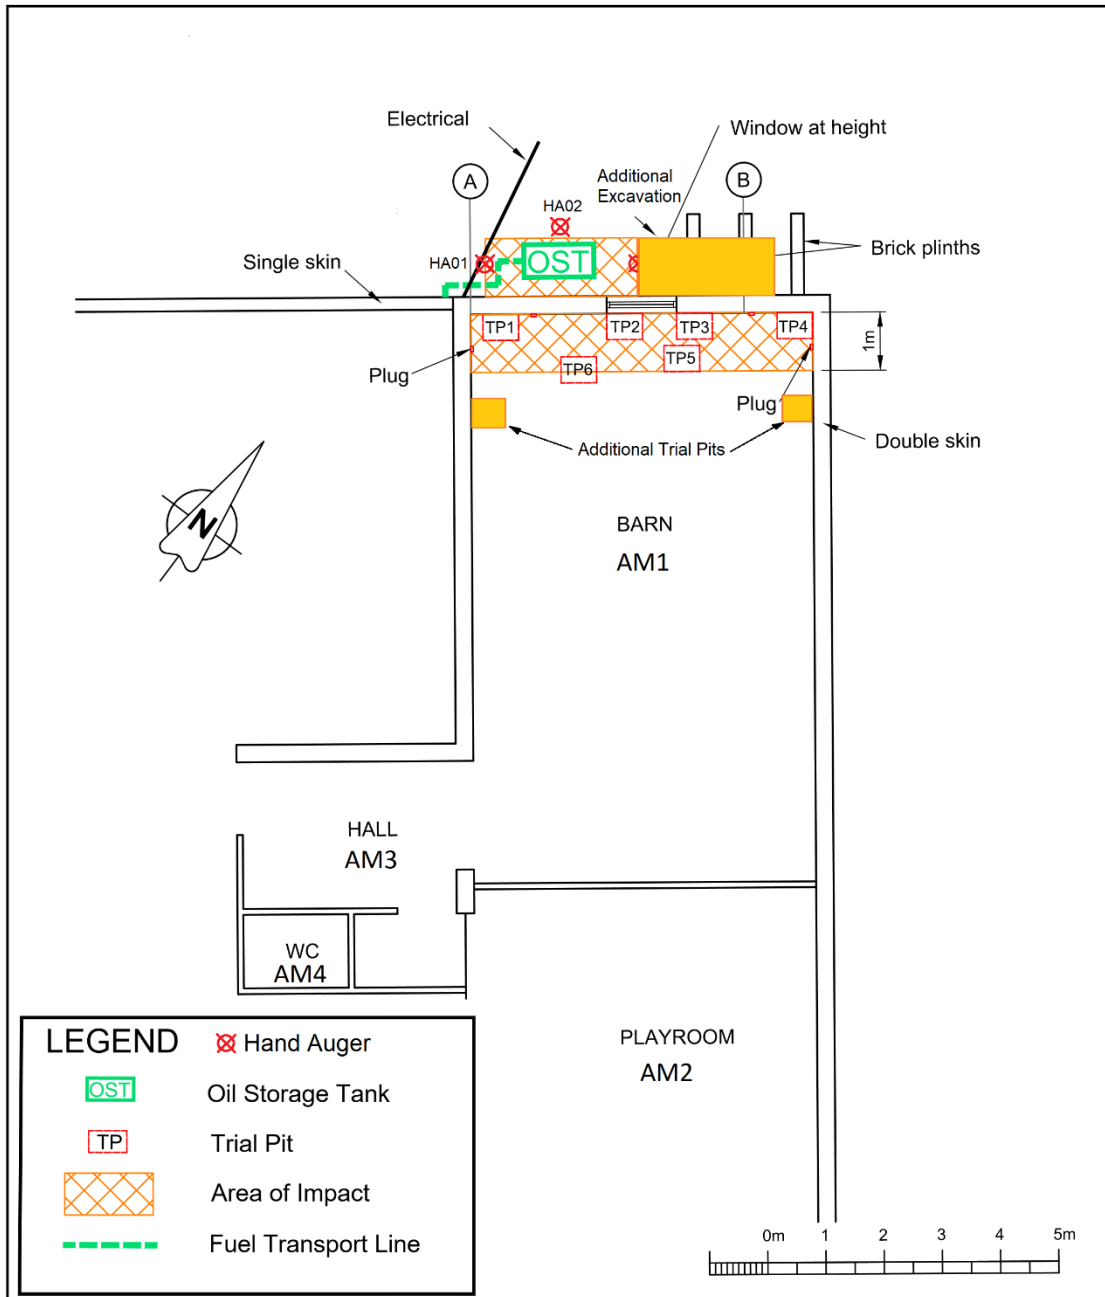
Drawing number	CEC-1697760-01		Revision	00

Additional excavation and trial pits in block orange

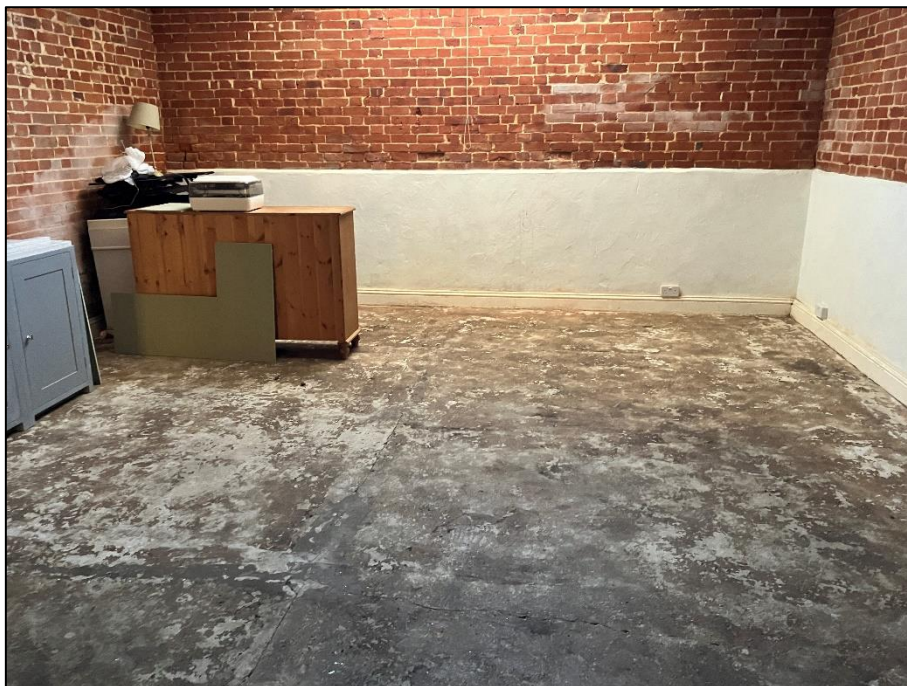
Photograph 6 – View of internal works area

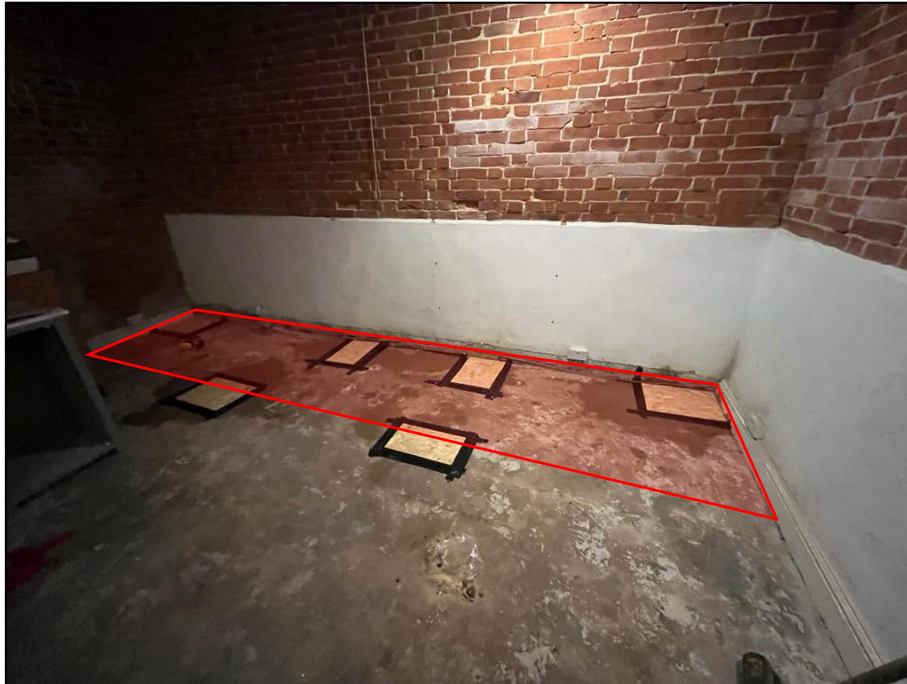
Photograph 7 – Trial pitting locations

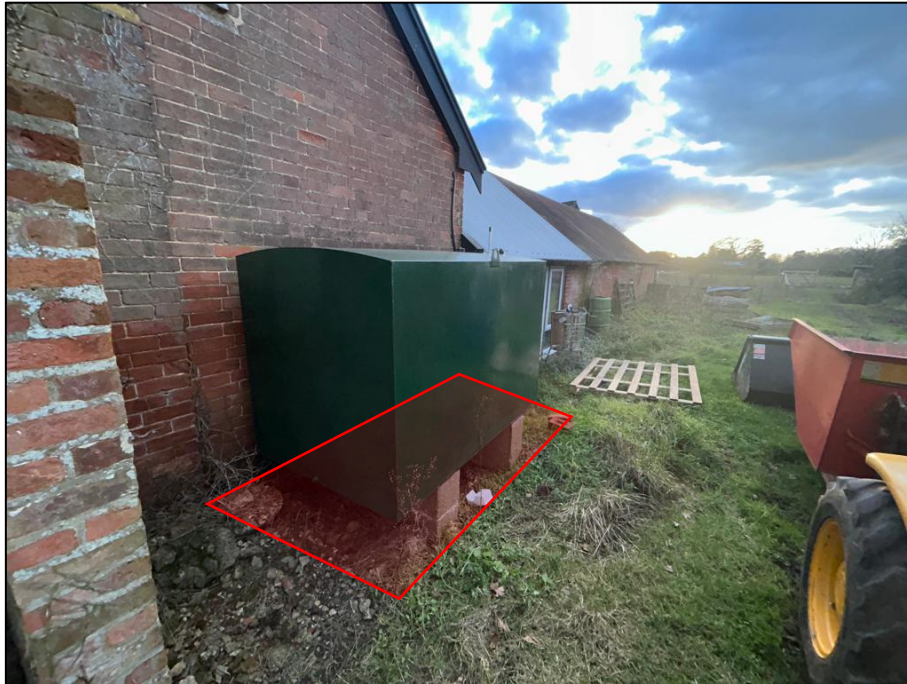
Photograph 9 –View of tank location

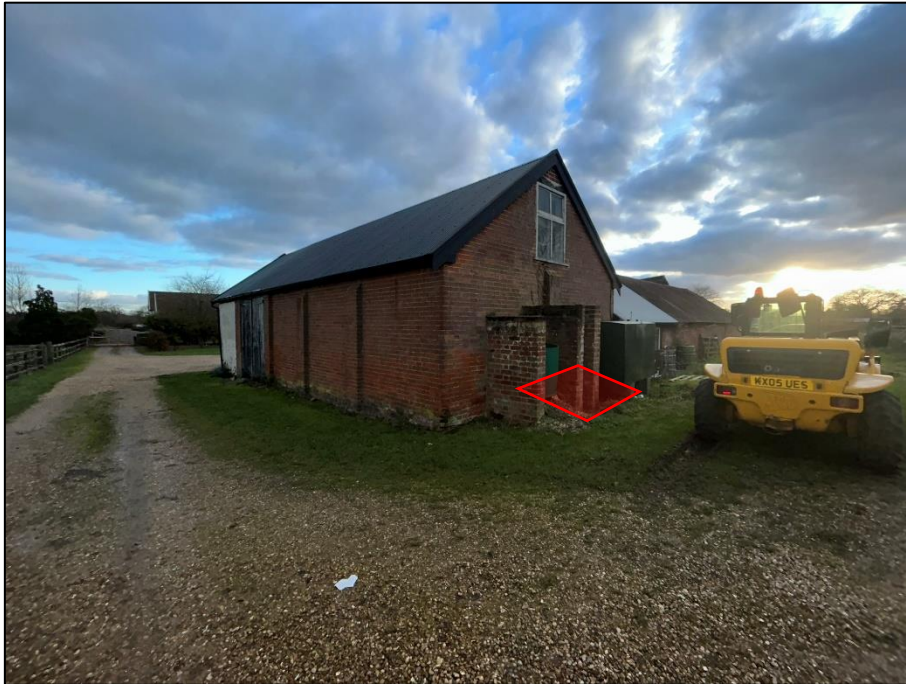
Photograph 11 – Extension of external excavation

No.	Description
1	Extension of external excavation according to site plan, measuring approximately 2.5 m X 1.5 m to footing level. NB two brick plinths to be dismantled. See Photograph 11.
2	Up to 4 no. additional trial pits within the barn to assess migration along the side walls. CEC to advise extension of internal excavation based on findings.
3	Removal of internal brickwork skin (maximum extents 1.6 m X 6.0 m) as per Photograph 12 in line with structural engineers' method statement to facilitate screening of outer skin from internal side.
4	Pause and allow CEC to screen brickwork, trial pits and excavation.

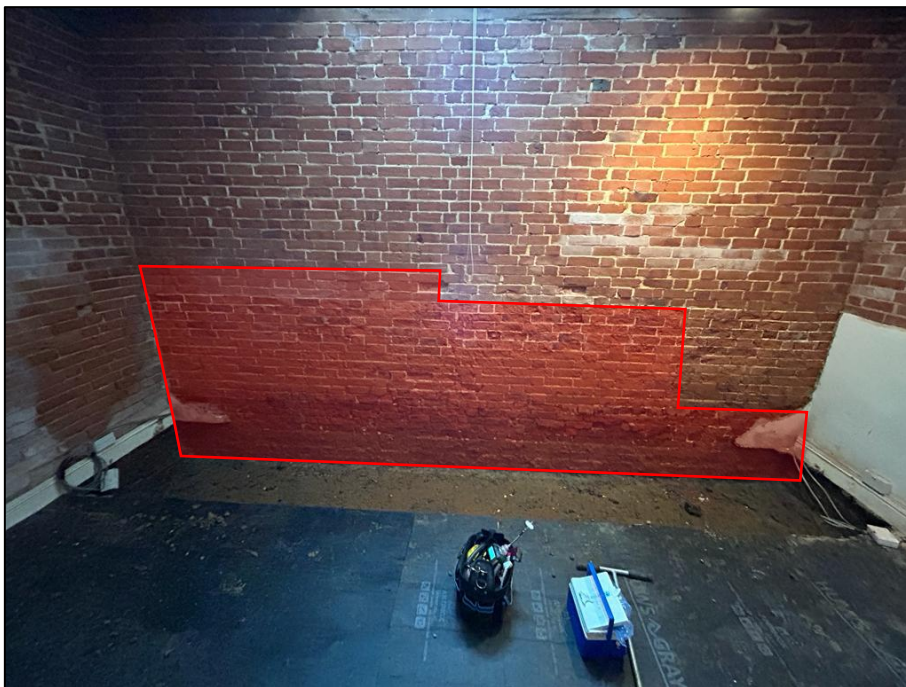
Photograph 12 – Internal brickwork replacement

No.	Description
1	Replace brickwork as per structural engineer's method. Known extents requiring replacement measure 1.6 m X 6.0 m. Installation of pipework into cavity at 4 no. locations across wall to facilitate passive venting.
2	Provision of bentonite pellet layer to base of excavation.
3	Excavated areas to be suitably backfilled in line with industry standards, with installation of vapour membrane internally and 4 no. perforated pipes beneath, to be threaded through wall, to facilitate later connection if necessary.
4	Reinstate concrete flooring on like for like basis internally in line with industry standards, reinstate electrics and skirting board on a like for like basis.
5	Tank base and supporting plinths to be replaced on a like for like basis to allow reinstatement of OST.
