223012.100

STRUCTURAL ASSESSMENT

CONVERSION OF EXISTING OUTBUILDINGS

**THE WILLOWS
EYNHAM ROAD
CASSINGTON
OX29 4DF**

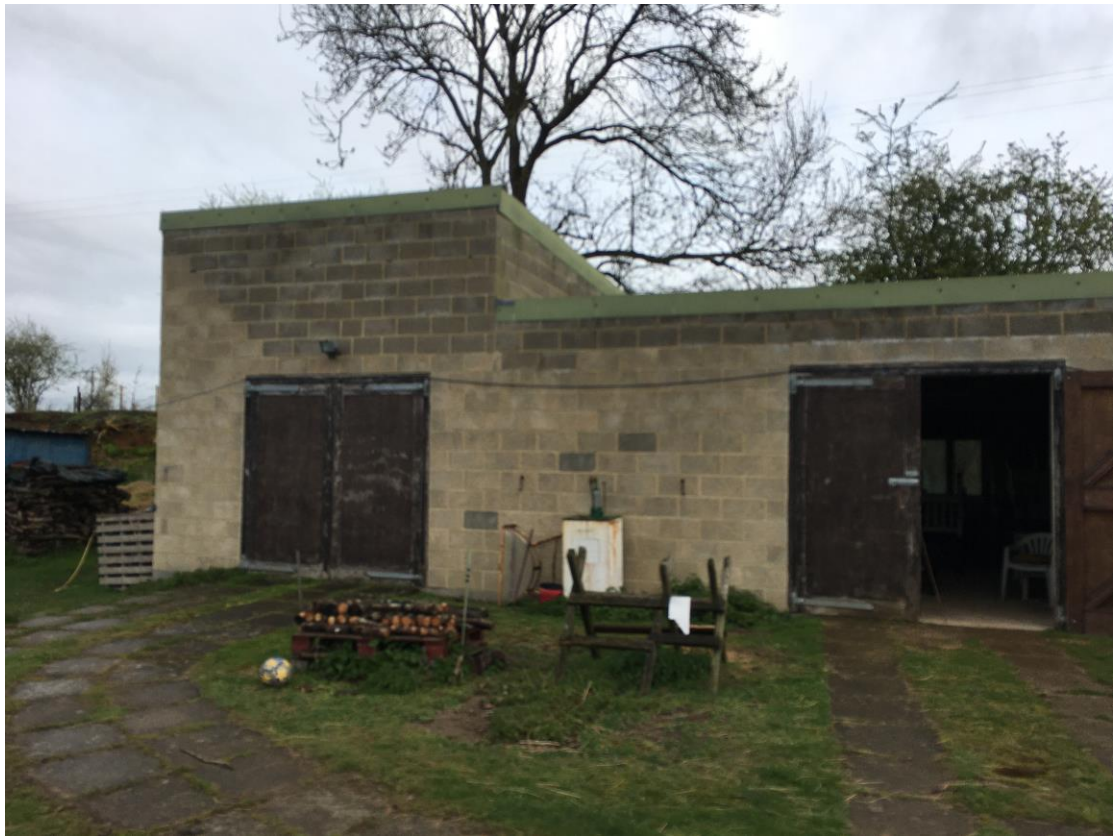
Photograph 1 Workshop Front elevation

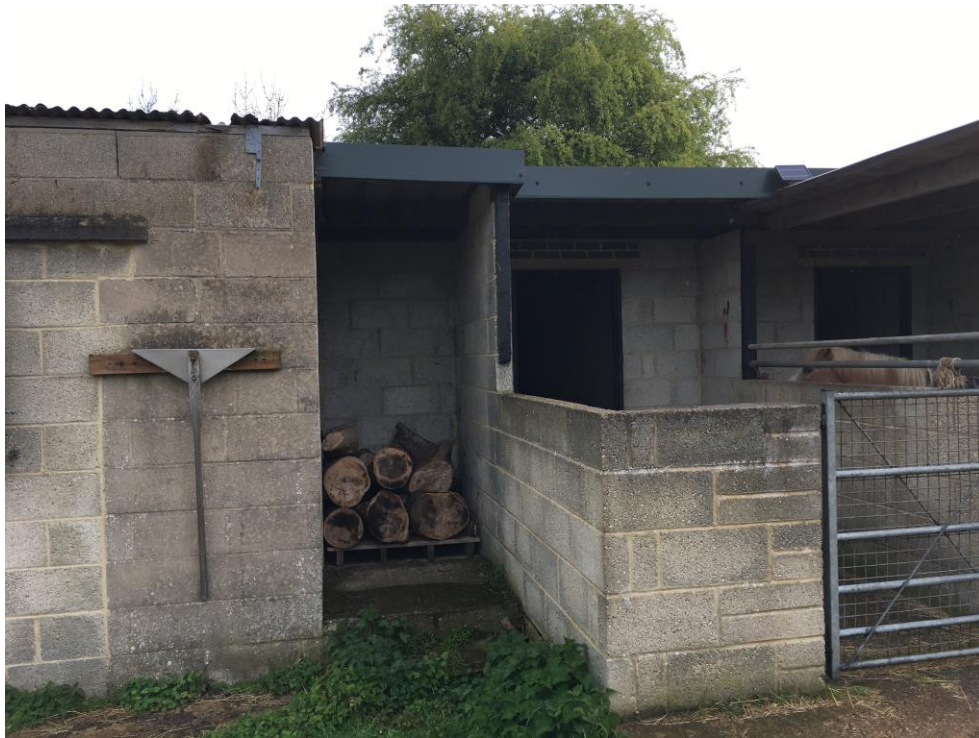
- 4.2.5** Small cracks were observed at the top RHS corner of the front elevation externally, and at this corner on the side wall internally. The cracks developed under a hole in the corrugated roof sheet and were likely caused by water ingress. The stepped cracks are less than 5mm wide and follow the horizontal and vertical line of the mortar joints between the blocks. Some repair works will be required to these walls locally but overall, the walls should be fully capable of retention with no visible areas of bulging.

Photograph 5 Stables – External cracking at top RHS corner

- 5.4** Local repairs will be needed to the walls of the Stables and Workshop where slight cracking was observed in the blockwork, but overall, the walls are capable of full retention with no requirement to dismantle and rebuild.

- 6.3** Minor masonry repairs will be needed to the walls of the Stables and Workshop locally where slight cracking was observed in the blockwork. Overall, however, it can be concluded that the walls are capable of full retention with no requirement to dismantle and rebuild.

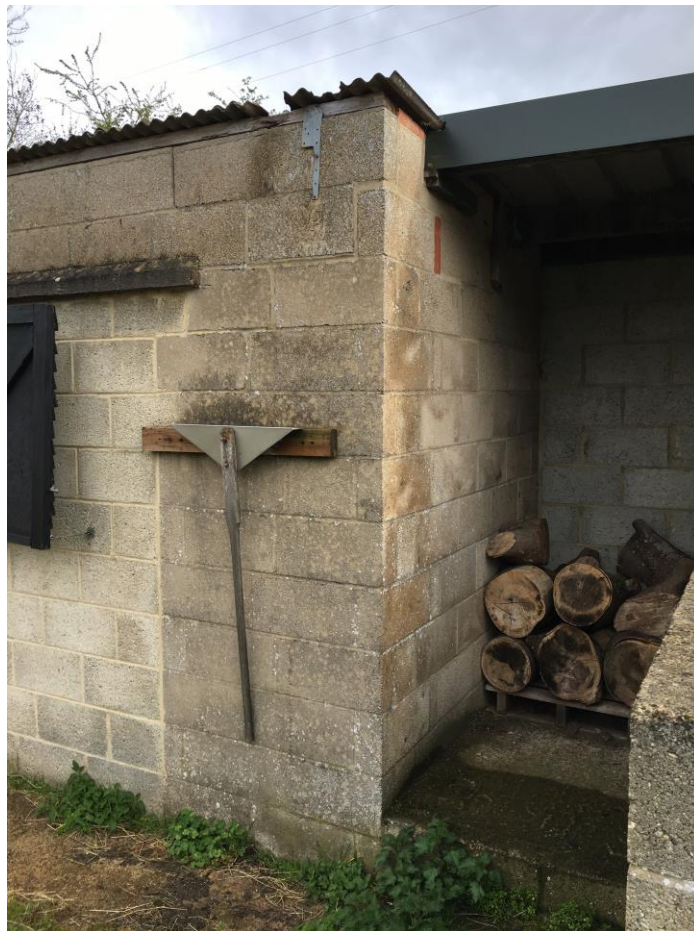
Photograph 6 Stables – External cracking and discontinuity of roof

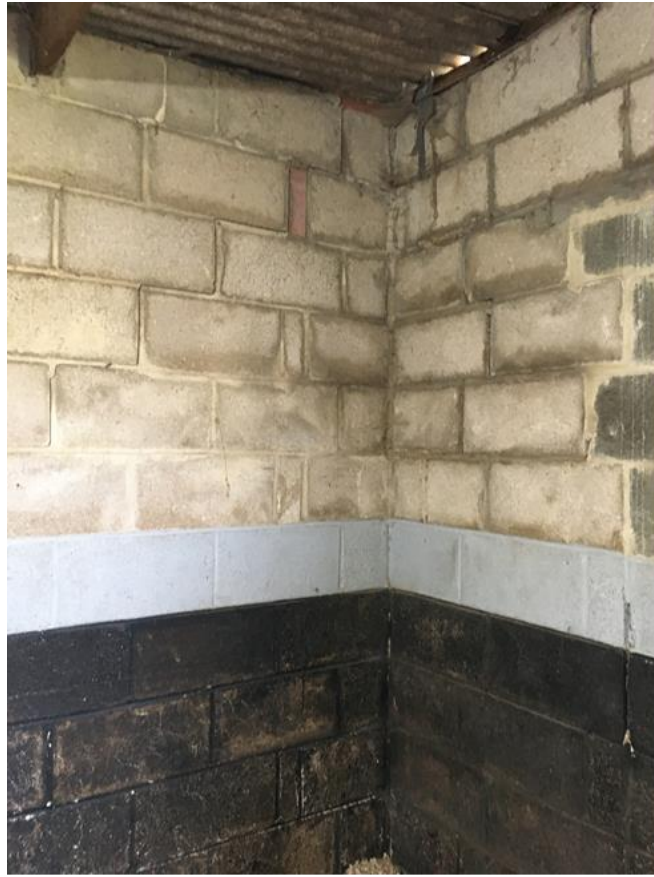
Photograph 7 Stables – Cracking internally

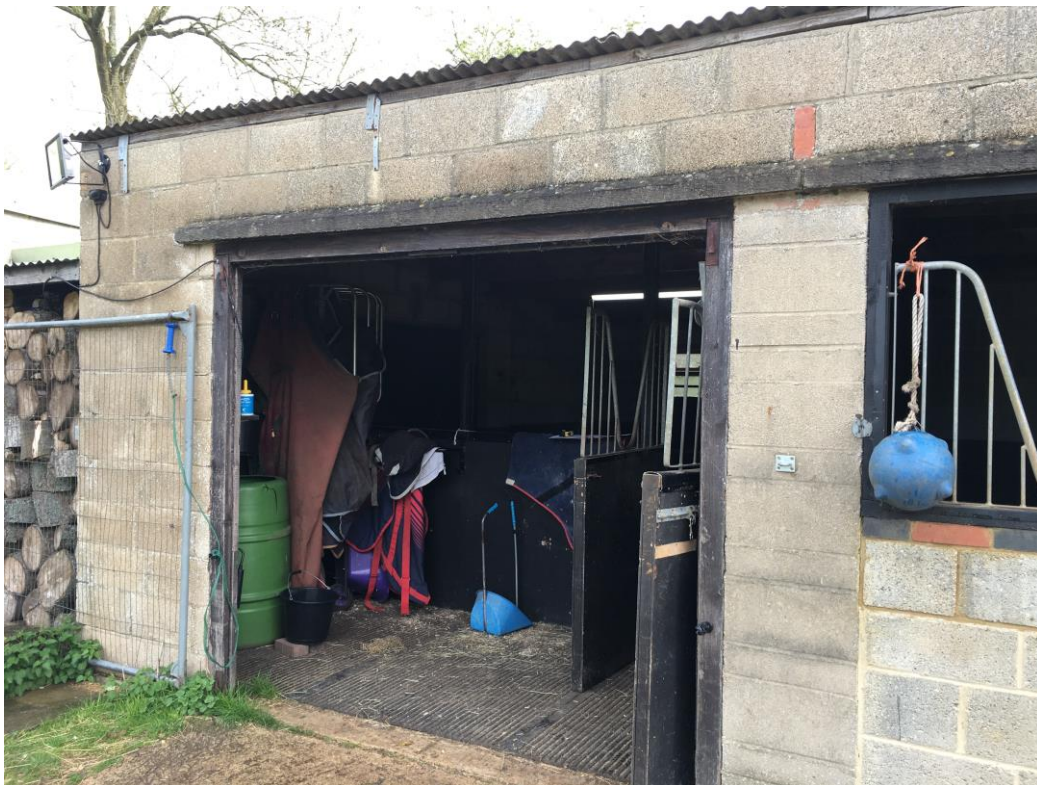
- 4.2.6** Precast concrete lintels were used to bridge over window and door openings.

Photograph 8 Stables – Precast concrete lintel over door

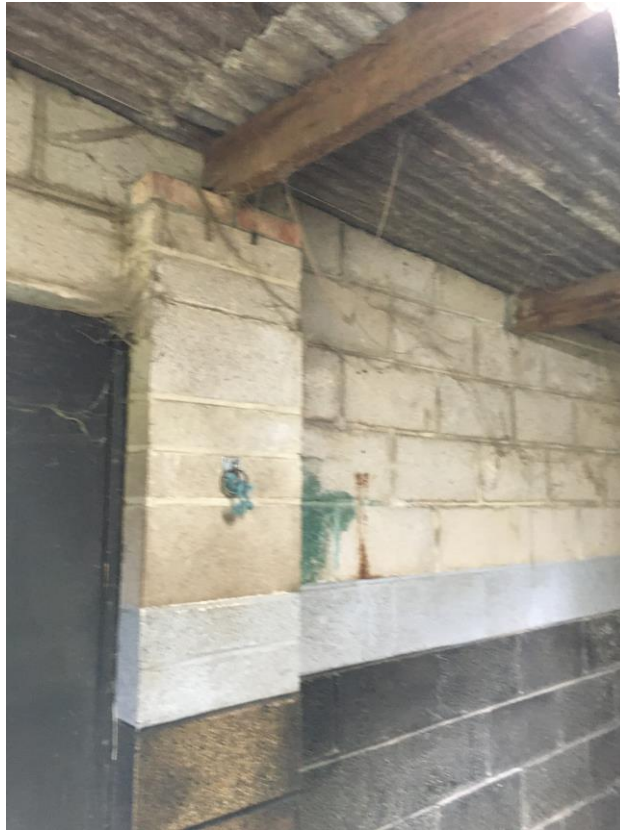
- 4.2.3** Walls are formed with a single leaf of blockwork which is stiffened by block piers enhancing wall stability.
- 4.2.4** Elevations are generally plumb and exhibit no signs of significant movement or extensive damage which would be indicative of stability or foundation problems.

Photograph 9 Stables – Stiffening pier

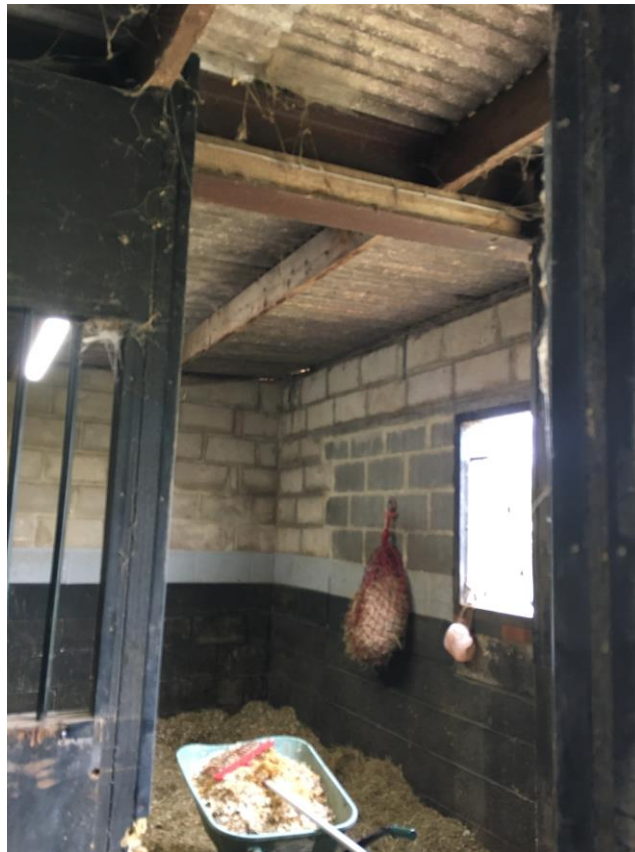
- 4.2.2** The corrugated sheet roof is supported on six rectangular 50x150mm deep timber purlins, which are in turn held in place by the walls and a front to back spanning steel beam in the middle of the building, splitting the span into two equal lengths. The steel beam is 280mm deep. There was no evidence of structural shortcomings observed in the roof.

Photograph 10 Stables – Steel beam supporting timber roof joists

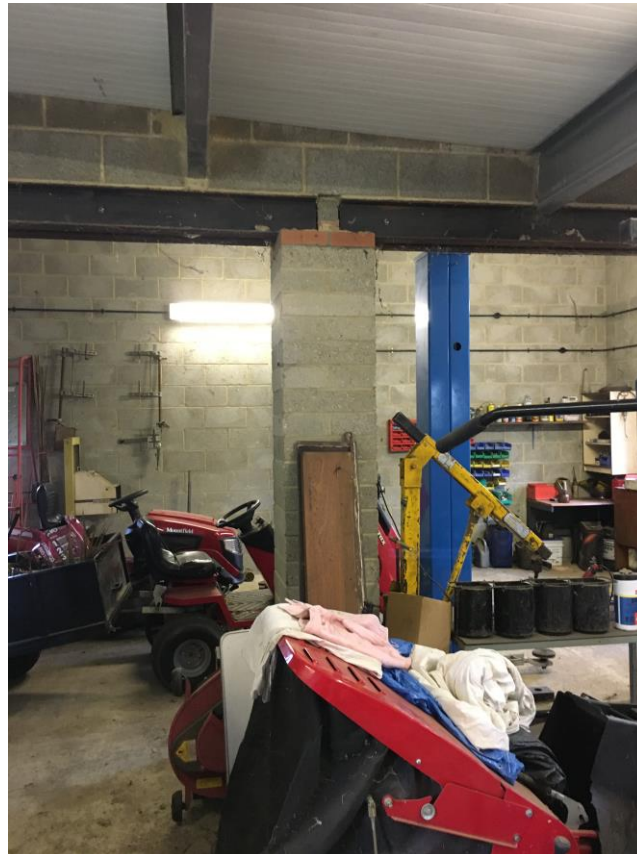
4.4.2 Steel twin beams span front to back between the two sections supporting the cavity wall above which in turn supports the raised roof. The beams are 178x102x19 UB sections resting on the external walls and on an internal blockwork pier at midspan. The pier is 440mm wide and 440mm long constructed of concrete blocks laid flat.

Photograph 12 Workshop – Block pier

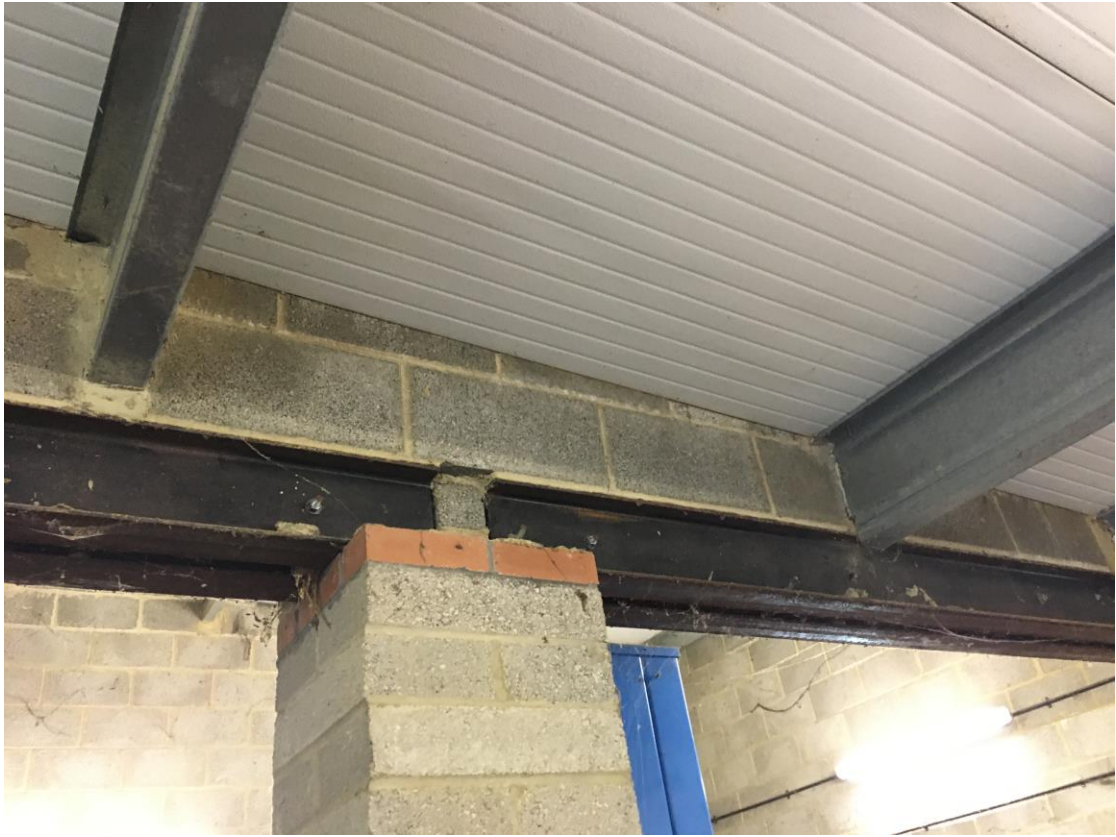
Photograph 13

4.4.3 The composite roof panels are supported on 290mm deep cold formed Z purlins, which are in turn held in place by the walls and the above mentioned hot rolled steel beams.

Workshop – Z purlins and steel beams supported on block pier

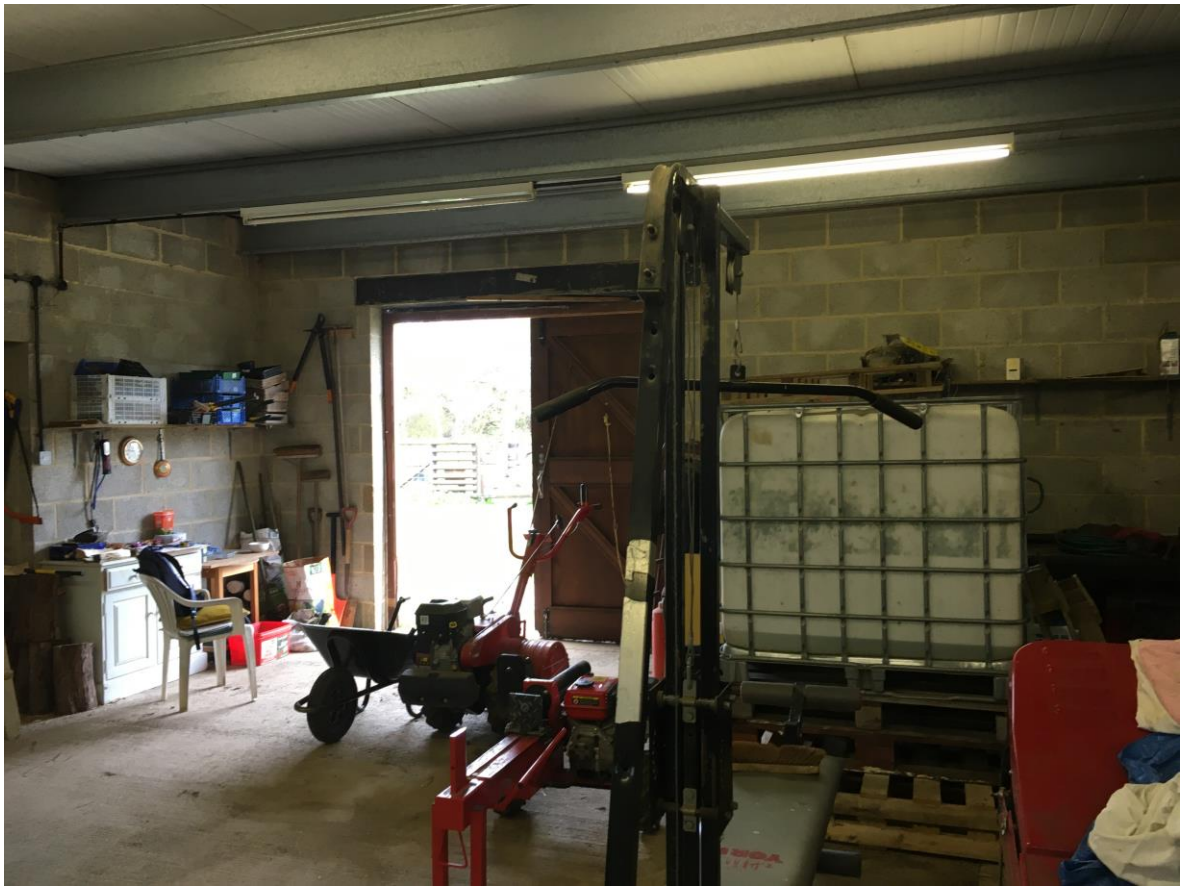
4.4.7 The floor is cast concrete and has been laid level. The inspection of the slab was limited slightly by a quantity of farm equipment, but overall, the floor structure appeared in a sound condition.

Photograph 16 Workshop – Concrete floor
