# **Church Lane Cottage, Aldham, Suffolk**

## **Heritage Asset Assessment**

**Leigh Alston MA (Oxon), Architectural Historian**

**October 2021**

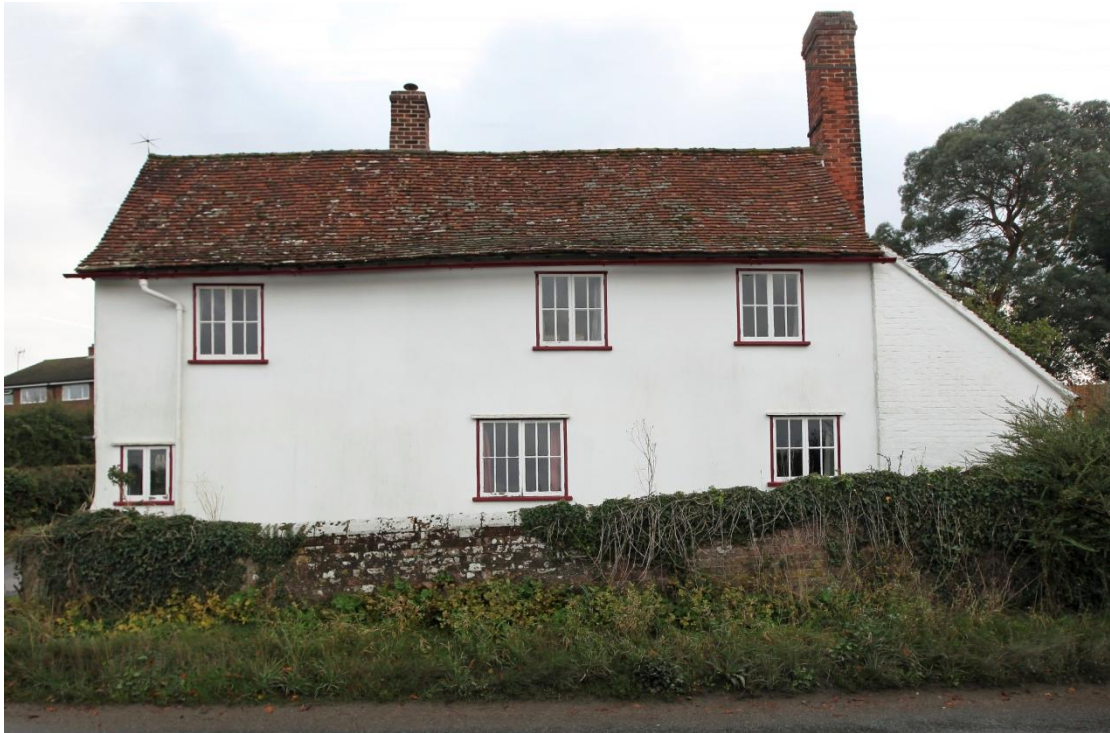
**Illus. 1.** The north-western facade with the substantial mid-19<sup>th</sup> century brick lean-to on the right and the uniform late-20<sup>th</sup> century casement windows with narrow lights that differ from those shown in the 1960s photographs (figures 8-9). The present windows were inserted as part of an extensive renovation in or about the 1980s, with only the ground-floor window to the right replicating its predecessor of 1961.

*It is proposed to rebuild the large brick lean-to against the south-western gable as shown to the right in illustration 1 and from the interior in illustrations 19-20.*

The substantial brick lean-to was added as part of a major refurbishment in the mid-19<sup>th</sup> century that included the construction of the rear lean-to and was outlined on the Ordnance Survey of 1884 but not the tithe map of 1839. It may slightly post-date the gable chimney to which it offers a straight joint (illus. 19). While its brickwork and ostensibly 19<sup>th</sup> century gable window are of considerable historic character a like-for-like reconstruction may be necessary if (as suggested) the present fabric is impossible to repair viably. A small crack to the right of the window in illustration 20 demonstrates a degree of movement, but whether or not the present fabric can be saved is a question for a competent structural engineer.

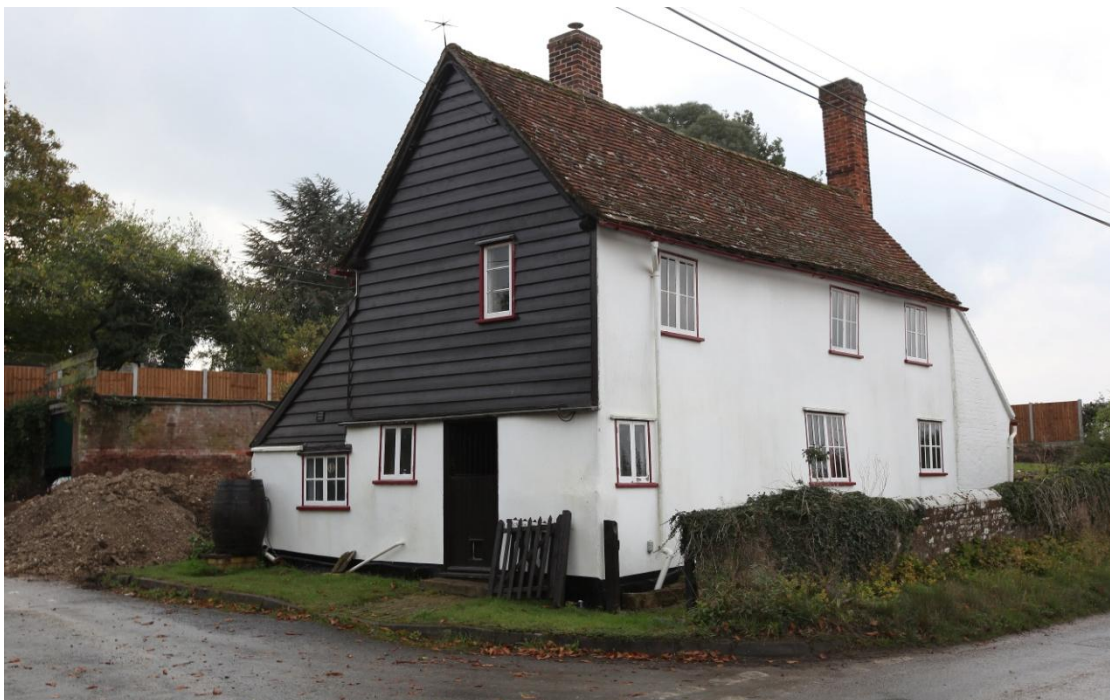
**Illus. 2.** The weatherboarding of the north-eastern gable facing Church Lane is a recent replacement of that shown in 1967 although the early-20<sup>th</sup> century window to the first-floor bedroom survived the subsequent refurbishment along with that of the lean-to.

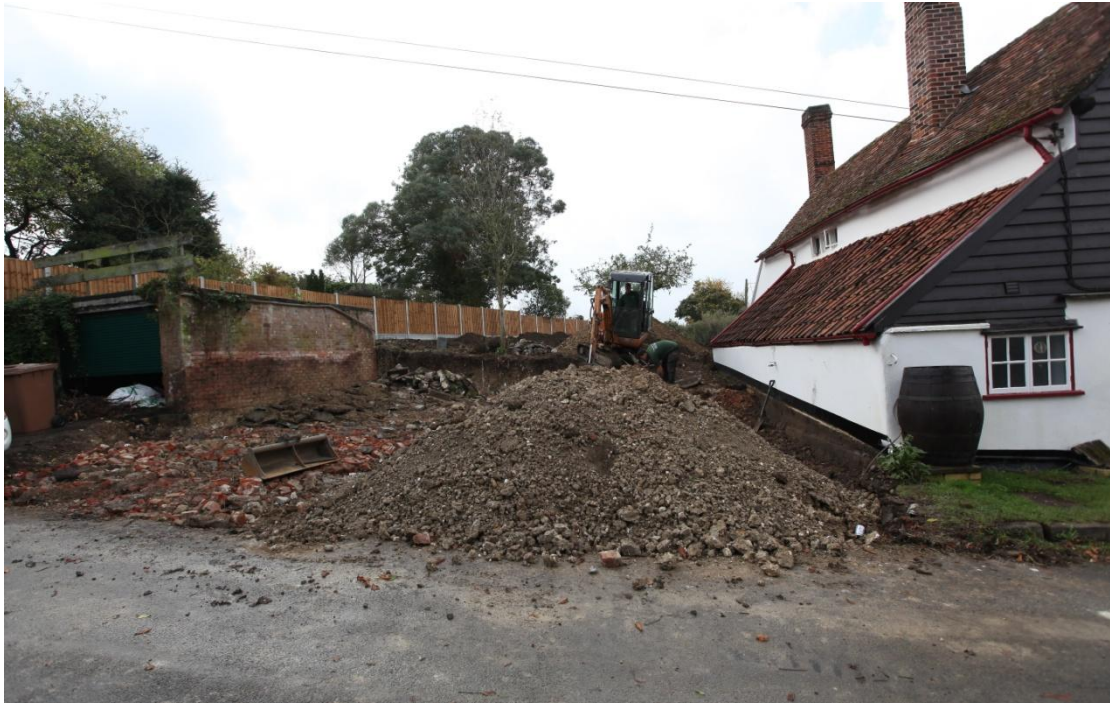
**Illus. 3.** The higher ground to the rear of the house reflects the slope of the hill into which the Fletton brick garage on the left was inserted at some point after 1970 (figure 7). The cement-rendered rear wall of the ostensibly brick lean-to on the right is straight rather than angled as depicted in figure 10.

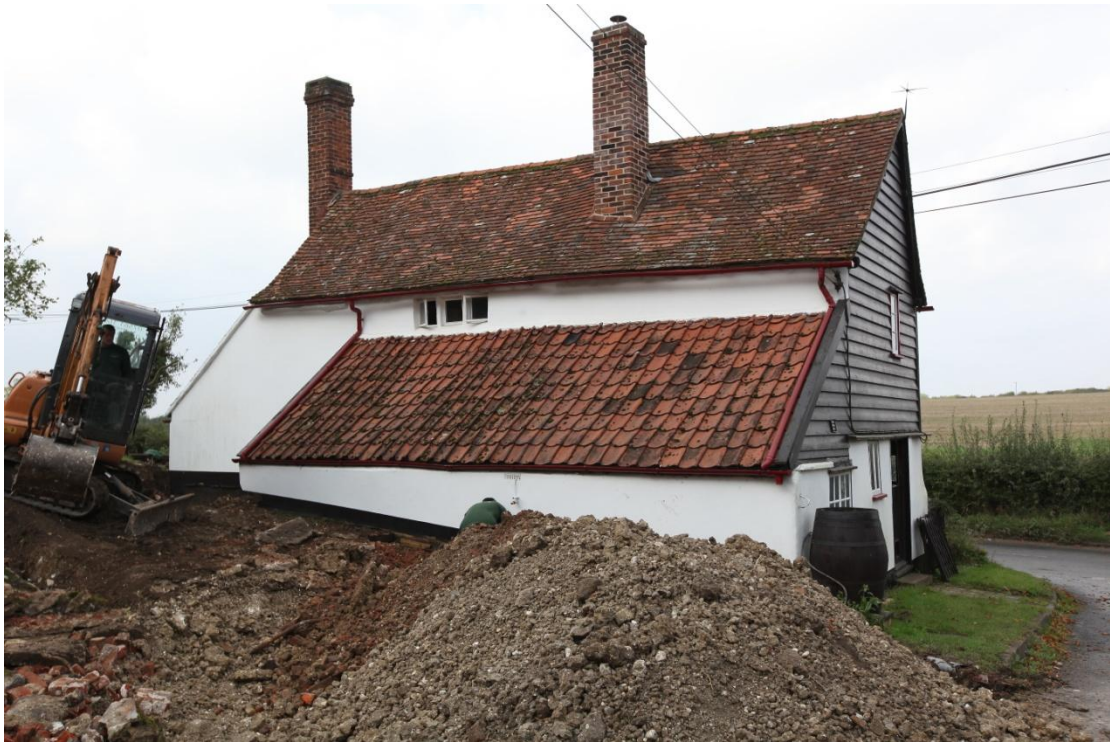
**Illus. 4.** If the Ordnance Surveys are accurate, the pantiled rear lean-to originally extended to the left-hand gable of the timber-framed building to leave only the brick lean-to projecting to the south-west. Although first shown on the Ordnance Survey of 1884 its walls are concealed by cement render and the extent of any subsequent rebuilding is unclear. It would be interesting to establish whether more of the earlier external weatherboarding is preserved within its roof than that shown in illus. 11.

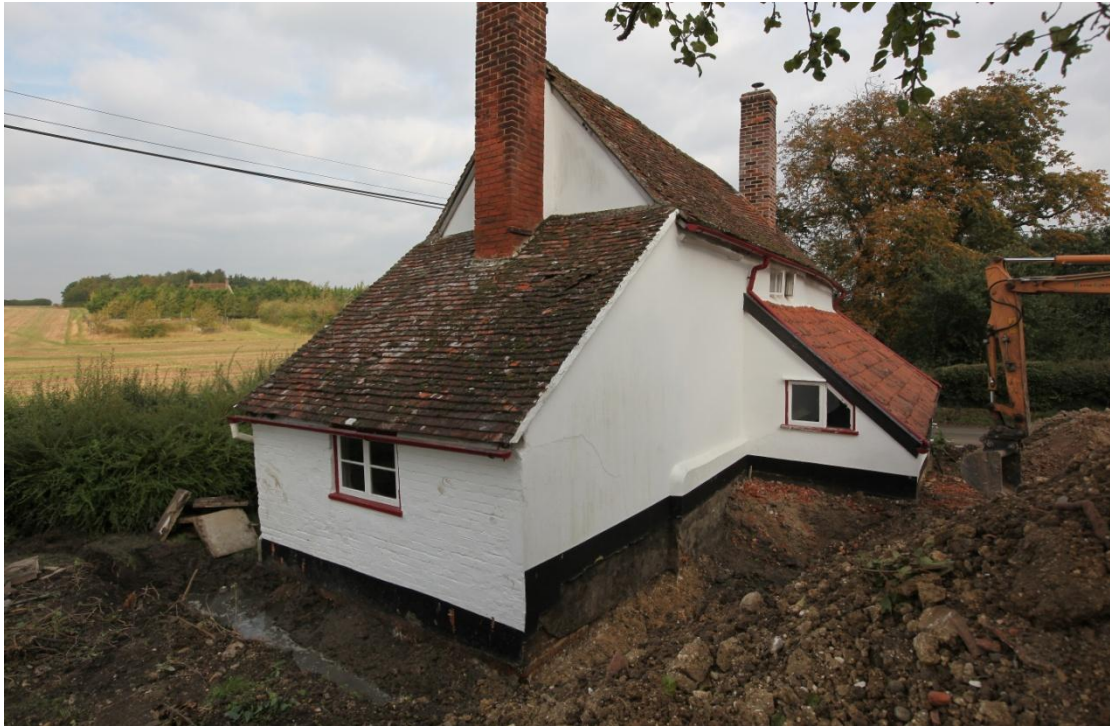
**Illus. 5.** The brick lean-to against the south-western gable was added as part of the mid-19<sup>th</sup> century refurbishment and the historic maps suggest the pantiled lean-to once continued to its right-hand corner. The late-20<sup>th</sup> century window in the latter's present gable is consistent with a recent truncation or reconstruction, as is the absence of a rear window in the service bay (i.e. the 'lounge' in figure 10).

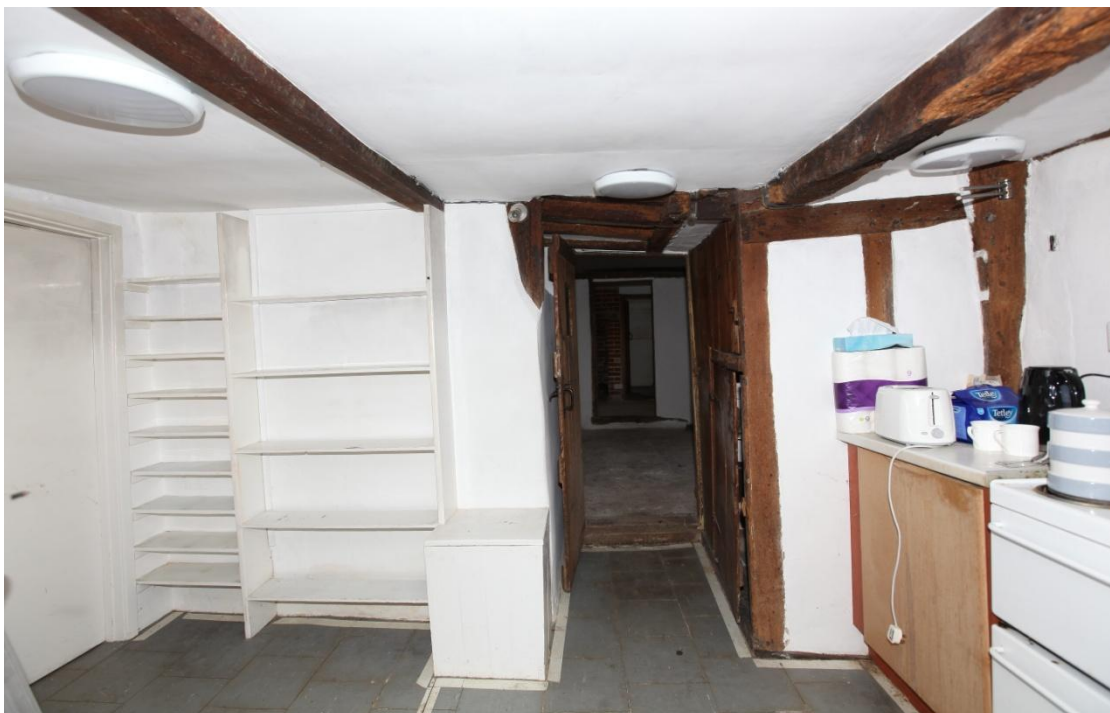
**Illus. 6.** The kitchen from the present entrance door in the north-eastern gable with the stair on the right and the 20<sup>th</sup> century shelving attached to the back of the dining room fireplace on the left. The two axial joists differ in character and suggest the common joists have been altered or consist of re-used timber. Figure 9 shows the outline of a 19<sup>th</sup> century cottage door in the front wall to the right.

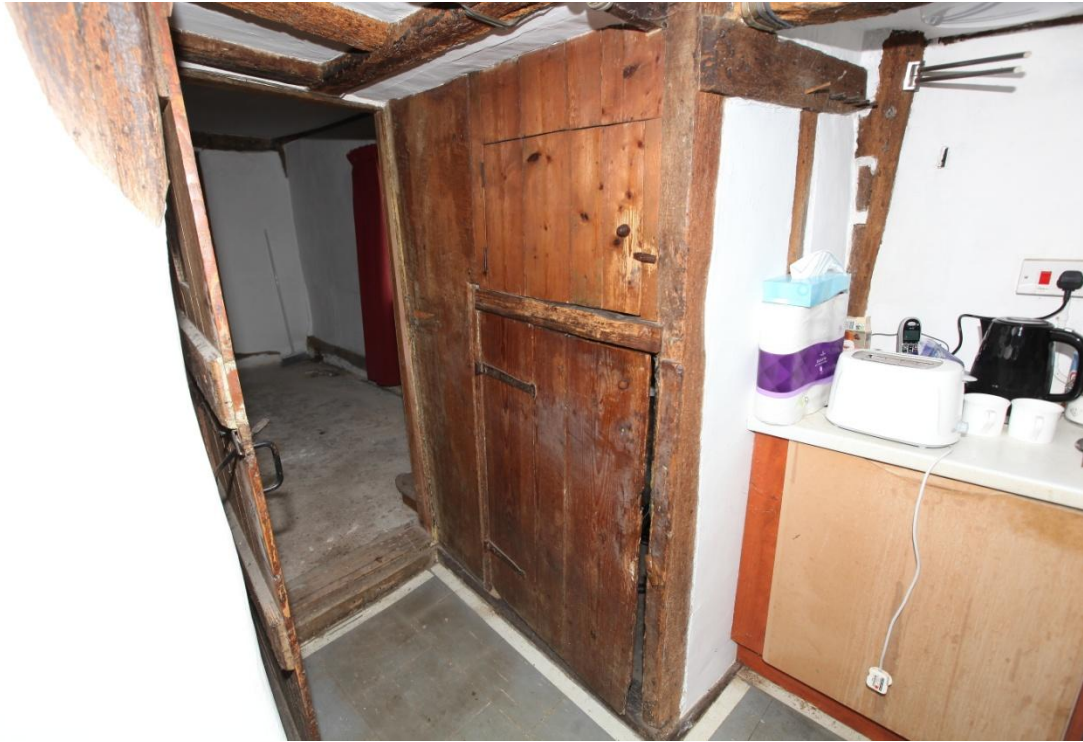
**Illus. 7. The mid-19<sup>th</sup> century pine boarding to the stair in the corner of the kitchen which is respected by a trap in the ceiling joists. These timbers date from the 17<sup>th</sup> century or earlier but are not pegged and have been re-used.**

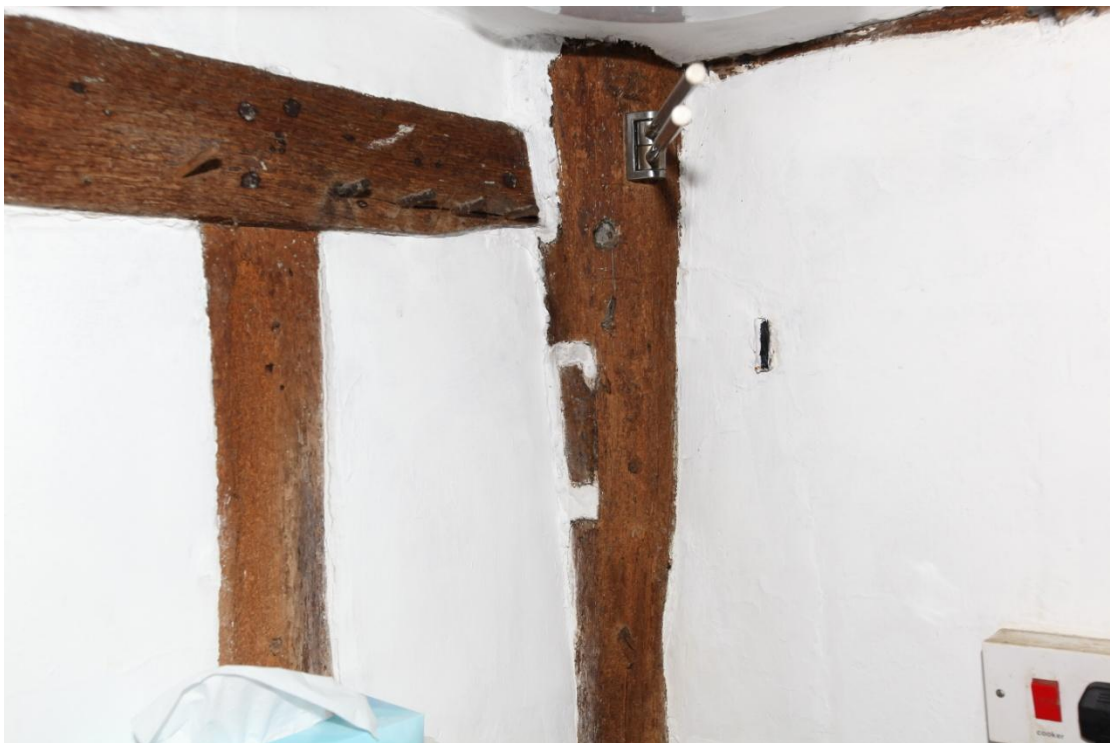
**Illus. 8. A detail of the jowled storey post in the corner of the kitchen (illus. 7). This contains a pegged mortice for a missing lateral brace or mid-rail but is not respected by the present mid-rail which preserves a single pegged stud. These timbers all date from the 17<sup>th</sup> century or before, but the extent to which the rest of the wall fabric is hidden by plaster makes it impossible to establish whether they remain *in situ* or have been re-used. The exposed timber at top-right is a rail supporting the ceiling joists.**

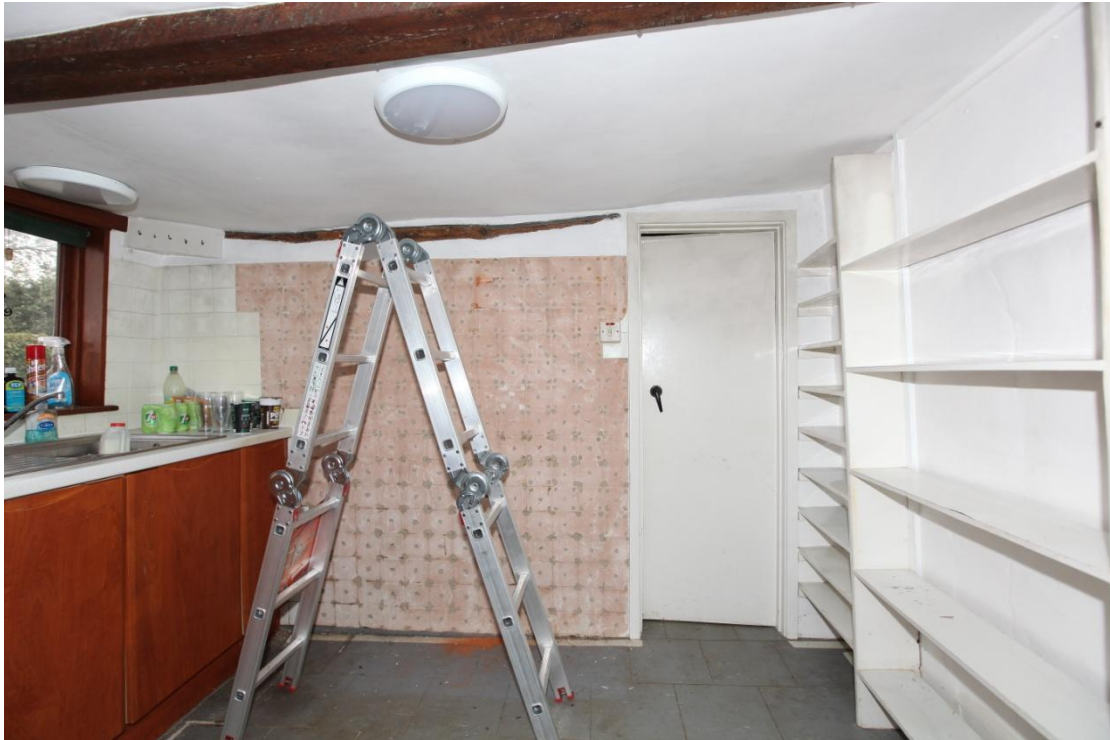
**Illus. 9. The back wall of the kitchen with the entrance to the bathroom in the lean-to extension on the right. The exposed horizontal rail supporting the ceiling joists consists of 19<sup>th</sup> century pine but the exact nature of the wall fabric beneath is unclear (see illustrations 10 and 11).**

*It is proposed to remove the present wall between the kitchen and bathroom as shown in illustrations 9-11.*

This wall occupies the position of the original external wall prior to the addition of the lean-to extension which contains the bathroom. A section of formerly external weatherboarding survives in the bathroom (illus. 10-11), but this lies above the height of the kitchen ceiling and has been removed beneath in order to enlarge the bathroom and create a recess for the bath. The weatherboarding probably continues above the connecting door between the two rooms on the left in illustration 10 but is hidden by plasterboard. This boarding illustrates the appearance of the building in the 19<sup>th</sup> century and possibly the 18<sup>th</sup> and is of historic significance as a result. As the position of the majority of the original timber-framed wall is now occupied by the recess the exact nature of the present partition is unclear, although it retains what appears to be the original rail or clamp which supports the joists of the kitchen ceiling (illus. 9). It is therefore possible that some part of the original wall survives below the level of this ceiling, but also that it was entirely replaced as part of the late-20<sup>th</sup> century refurbishment. The exact nature of its fabric cannot be established without removing sections of the plaster with which it is currently concealed.

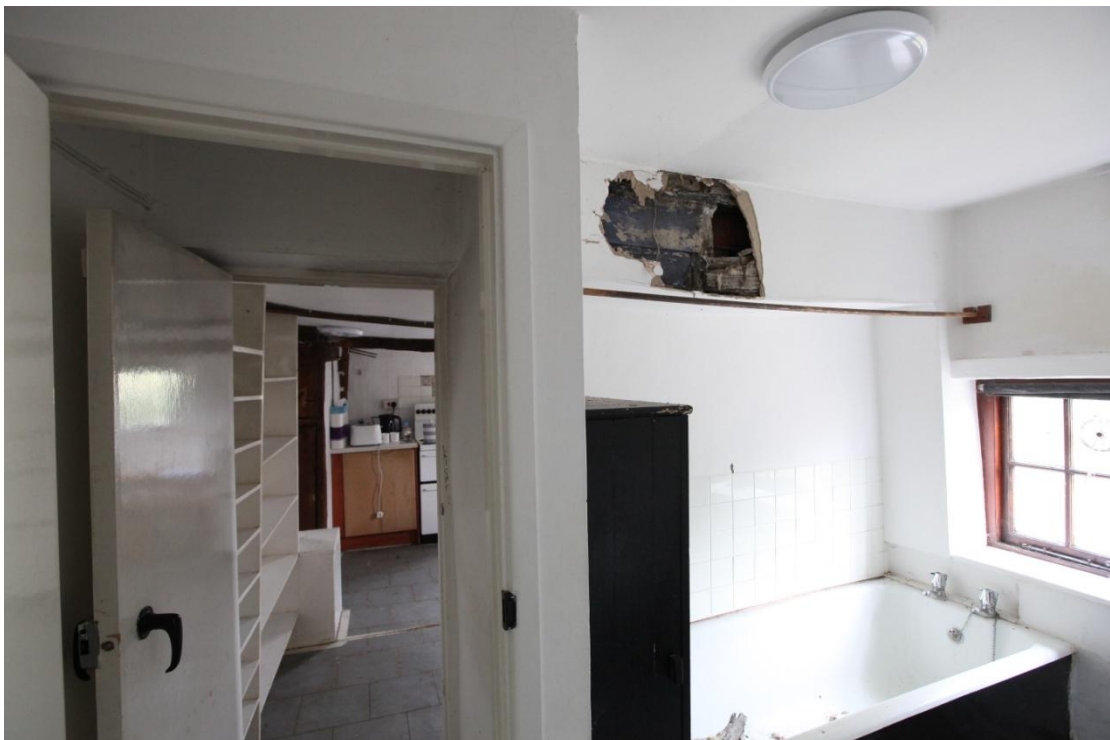
**Illus. 10. The bathroom in the rear lean-to looking north-west towards the kitchen with part of the original weatherboarded external wall exposed on the right (see illustration 11). The lower section of this wall has been at least partly removed to create the recess that now accommodates the bath and the exact nature of what survives in the partition against the kitchen is unclear. It may represent only a late-20<sup>th</sup> century replacement.**

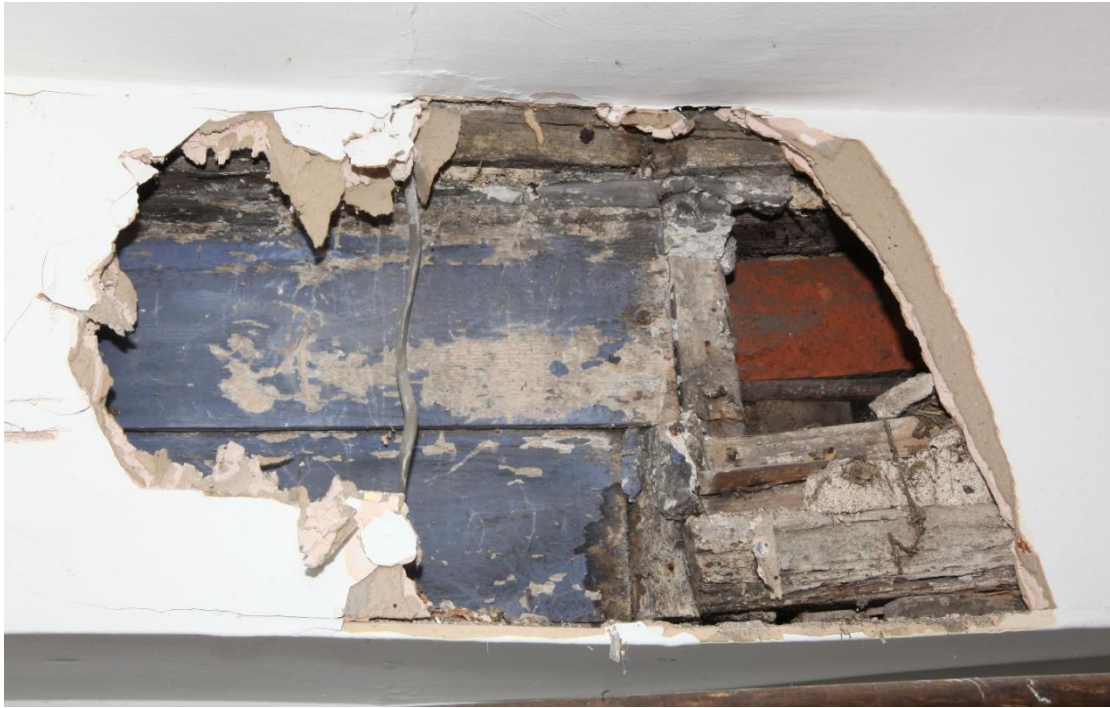
**Illus. 11.** A detail of the exposed external weatherboarding in the bathroom (illus. 10). The blue paint behind the modern plasterboard would have decorated the internal walls of the lean-to but the whitewash beneath may indicate the original external appearance of the building. The horizontal timber above is the original roof-plate visible internally (illus. 23) and the boarding respects the jamb and projecting lintel of a former door or window adjoining the corner to the right. This fragment suggests the entire house was weatherboarded initially and investigation above the lean-to ceiling may reveal whether it was confined to the lower storey.

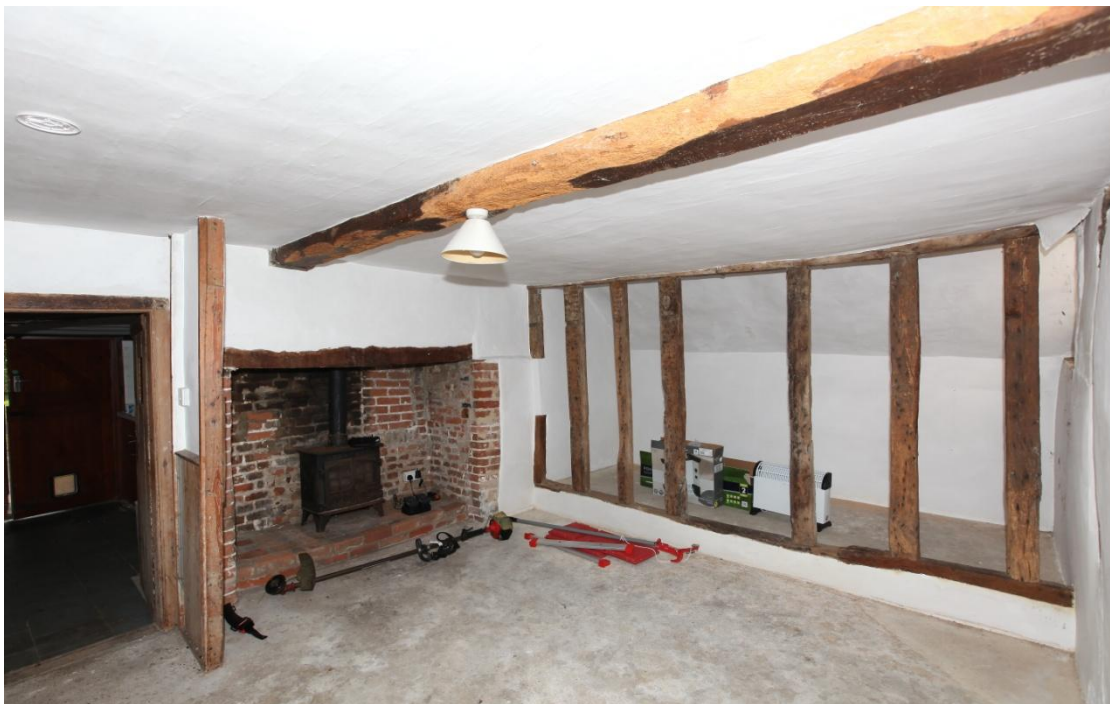
**Illus. 12.** The hall ('dining room') from its western corner showing the rear lean-to on the right and the door to the kitchen on the left. The original back wall adjoined the fireplace but has been moved into the lean-to by approximately 2 feet.

*It is proposed to remove the studs which divide the dining room from the rear lean-to as shown in illustrations 12, 13 and 16.*

The original wall between the central hall and the lean-to has already been removed to widen the dining room and the studwork in question lies within the ostensibly mid-19<sup>th</sup> century lean-to. The exact date of this alteration is unclear and it may have occurred as early as the 19<sup>th</sup> century. The substantial individual studs date at least from the 17<sup>th</sup> century and the four to the left in illustration 13 are uniform, but it is also unclear whether they belonged to the original back wall or were imported from elsewhere. The lower of the two roof-plates exposed on the upper storey contains pegged mortices for 7 studs which correspond with the remaining 6 timbers (given that one has been removed to create a connecting doorway). However, the studs to the right of the central aperture differ in character and the horizontal ceiling timber to which they are nailed has been renewed. Although not *in situ* there is a distinct possibility the left-hand studs represent part of the original back wall while those to the right are more likely to have been imported from elsewhere.

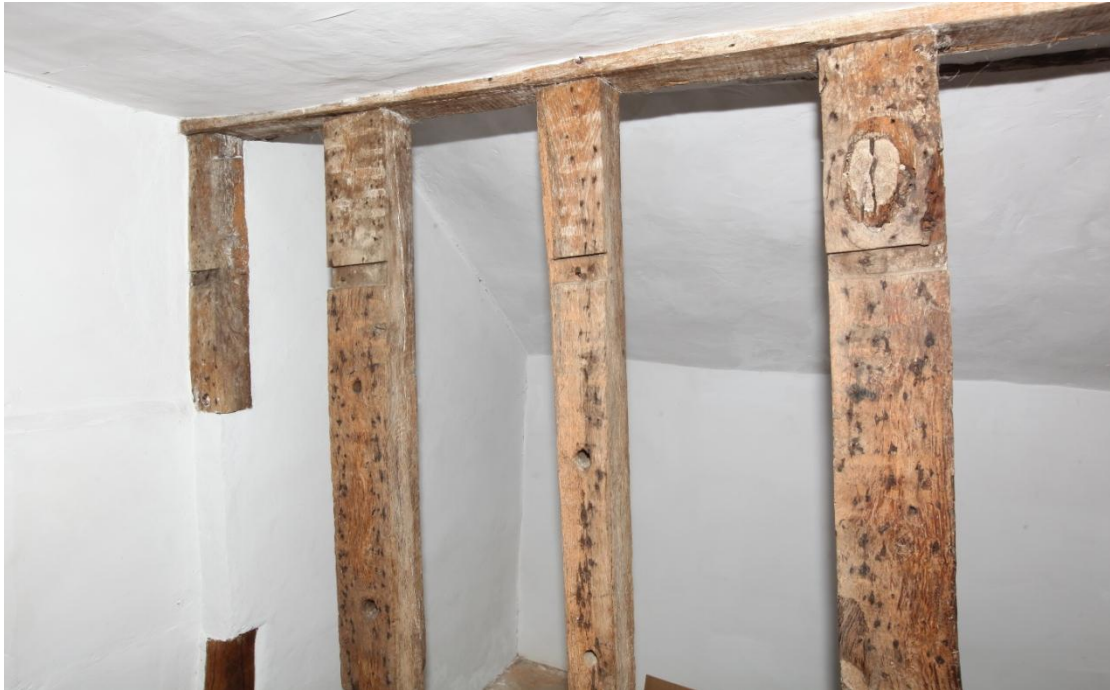
**Illus. 13.** A detail of the studs in the back wall of the ‘dining room’ (illus 13). In addition to the scars of lath-and-plaster these 17<sup>th</sup> century timbers contain grooves that were normally cut into the external surfaces of contemporary walls to secure external wattle-and-daub, indicating they have been re-used. Their upper ends are now nailed and tenoned to a rail which lies beneath the roof of the lean-to, but the attachments are not modern and they may have occupied their present positions since the 19<sup>th</sup> century.

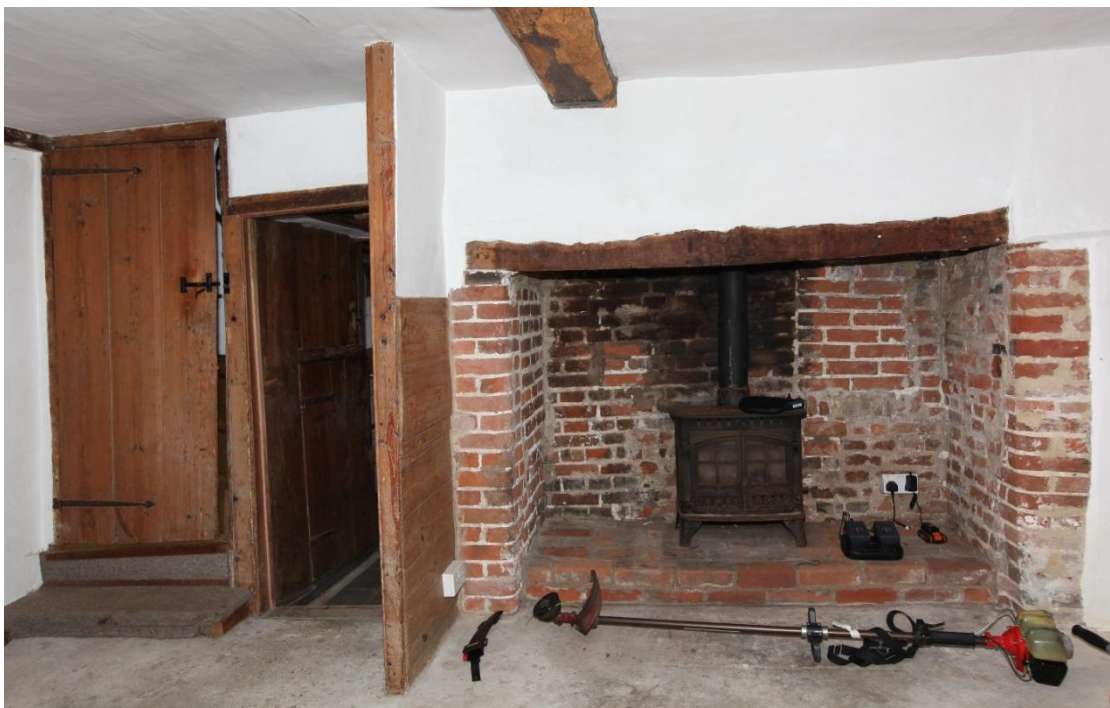
**Illus. 14.** The ‘dining room’ fireplace is impossible to date closely but is more typical of the 18<sup>th</sup> century than either the late-17<sup>th</sup> or early-19<sup>th</sup> centuries. The pine boarding of the stair relates to the mid-19<sup>th</sup> century remodelling as does the screen to the left of the fireplace which is intended to shield the occupants of the fireside from draughts and represents a rare survival.

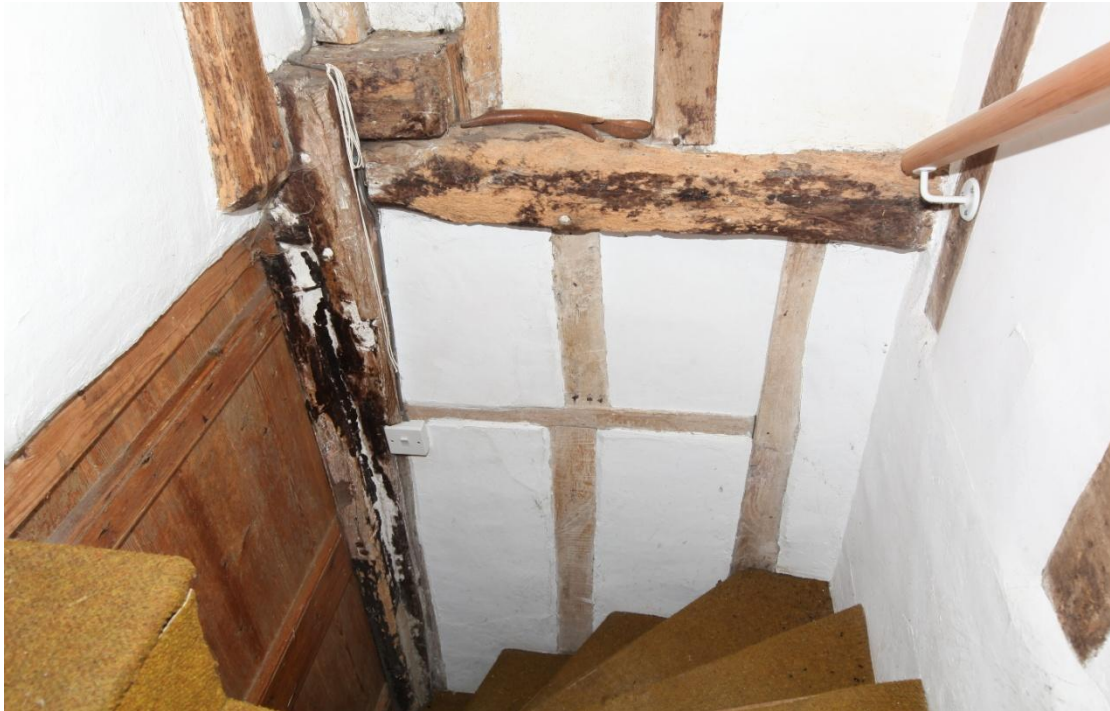
**Illus. 15.** The front wall adjoining the stair with clear evidence of a blocked lobby entrance door: the horizontal lintel corresponds with a rebate in the jowled post on the left. The post contains mortices for a mid-rail and wall brace similar to those in the corner of the kitchen which is hidden to the right (illus. 8), and these two posts appear to have formed a narrow bay for the chimney in a manner often seen elsewhere. The crude manner in which the roof-plates overlap suggests either that one was added as an extension to the other or they were re-used in the original single-storied structure. The ostensibly *in situ* narrow wall studs are typical of the 18<sup>th</sup> century.

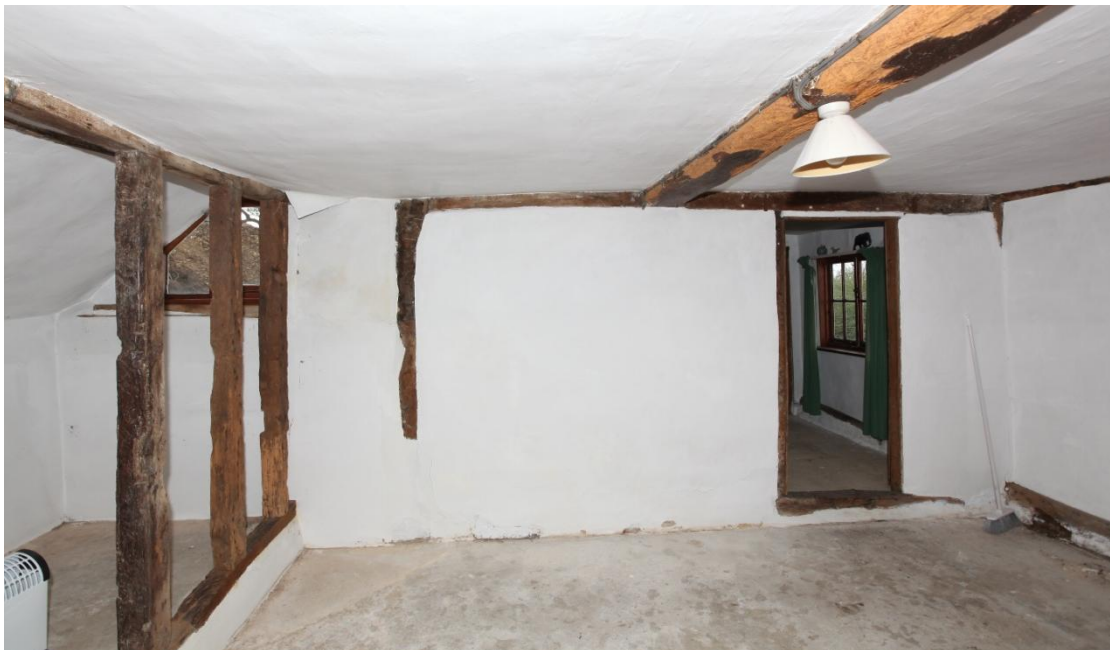
**Illus. 16.** The south-western wall of the dining room with the door to the 'lounge' on the right. The isolated jowled post to the left marks the position of the original back wall and the present studs lie within the lean-to. The axial joist is central to the present room, suggesting the ceiling may have been rebuilt when this room was widened.

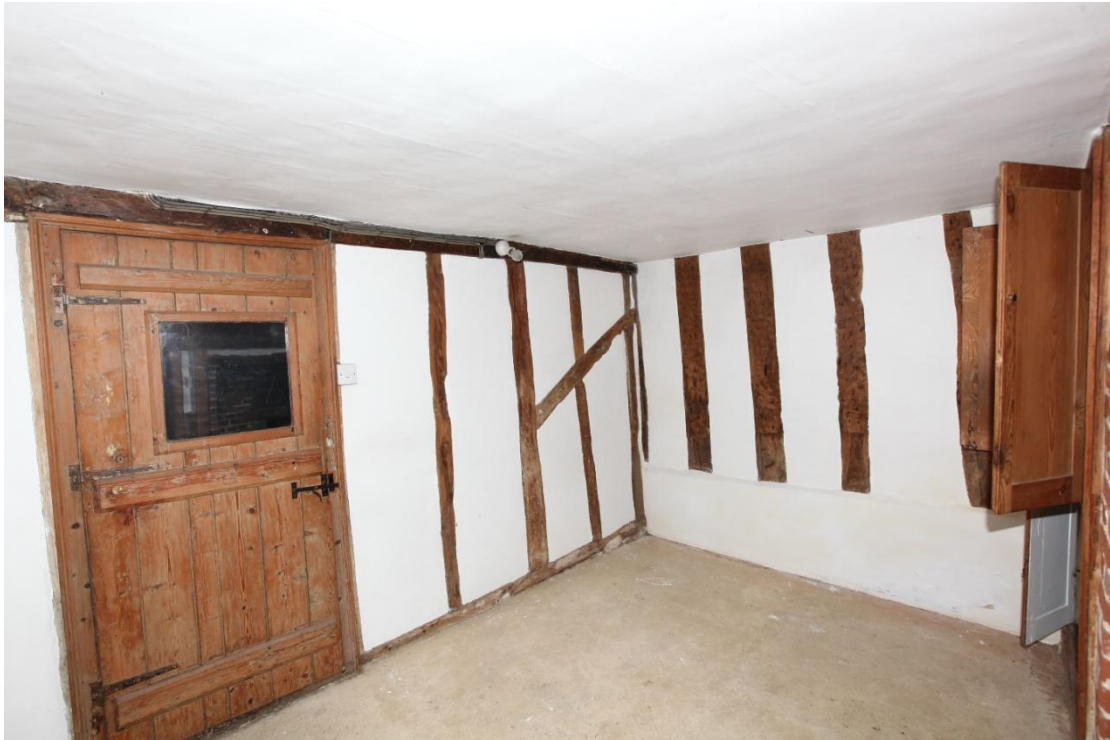
**Illus. 17.** The narrow service room ('lounge'), showing the chimney against its south-western gable on the right and the door to the hall ('dining room') on the left. The substantial studs in the back wall date from the 17<sup>th</sup> century or earlier but unlike their counterparts in the hall do not correspond with the pegged mortices in the exposed roof-plate on the upper storey. The narrow studs and diagonal brace of the internal partition are typical of the 18<sup>th</sup> century but the mid-rail above is in two sections linked by a splayed scarf joint in a manner that suggests the timbers have been re-used.

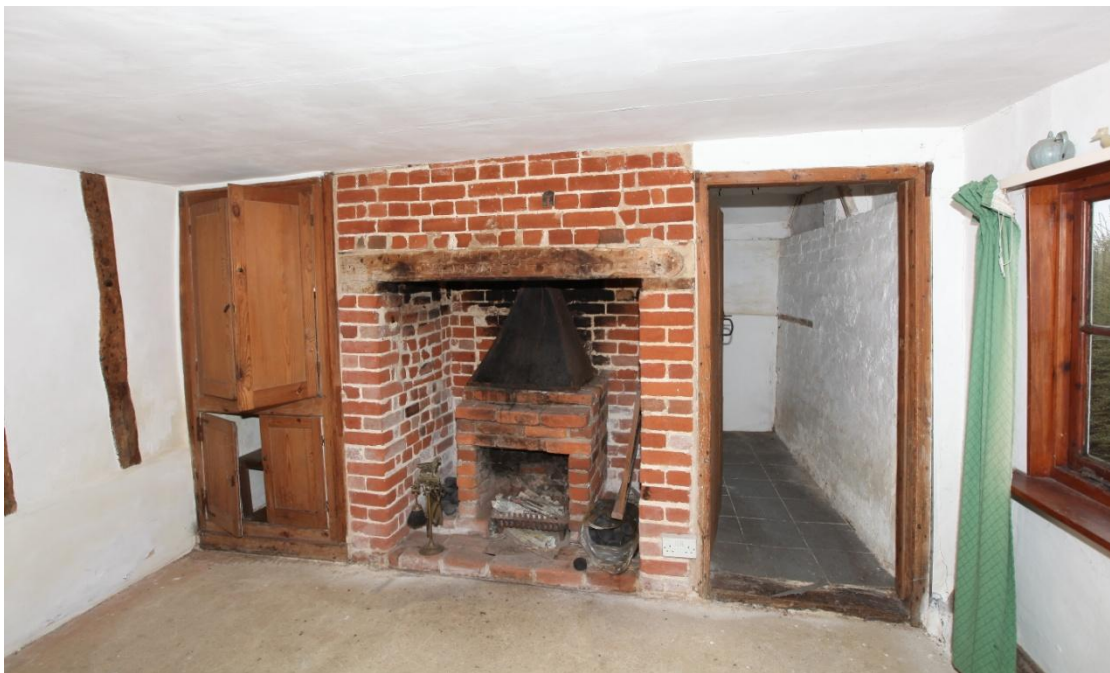
**Illus. 18.** The fireplace against the south-western 'lounge' gable with the lean-to beyond. The uniform nature of its soft red bricks indicates this fireplace post-dates that in the 'dining room' and was added when the house was divided in the early-19<sup>th</sup> century. The pine cupboard doors are likely to survive from the mid-19<sup>th</sup> century remodelling.

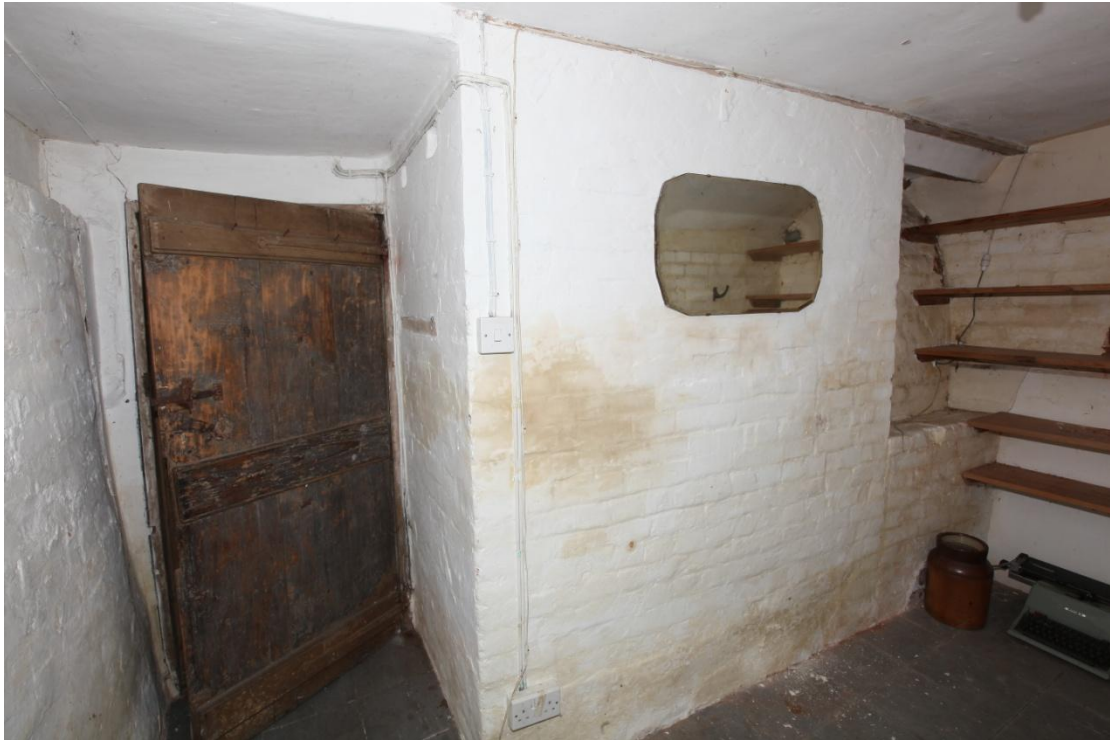
**Illus. 19.** The back of the 'lounge' chimney from the mid-19<sup>th</sup> century lean-to against the south-western gable. A straight vertical joint divides the chimney from the brickwork to its right, suggesting the lean-to may slightly post-date the chimney. The curious curved section above may survive from a former bread oven in the position of the present 'lounge' cupboard but there is no other evidence to support this.

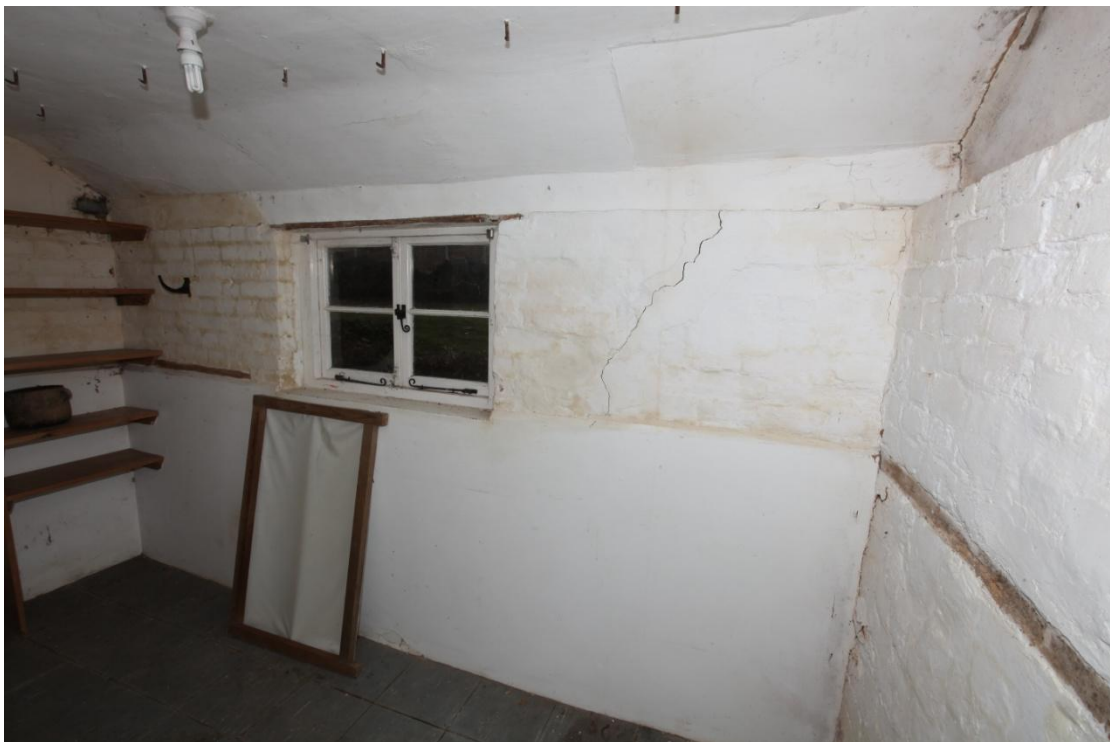
**Illus. 20.** The southern western internal wall of the gable lean-to which was shown for the first time on the Ordnance Survey of 1884. The 19<sup>th</sup> century casement window is similar to that of the present bathroom and is one of the few that survived the late-20<sup>th</sup> century refurbishment.

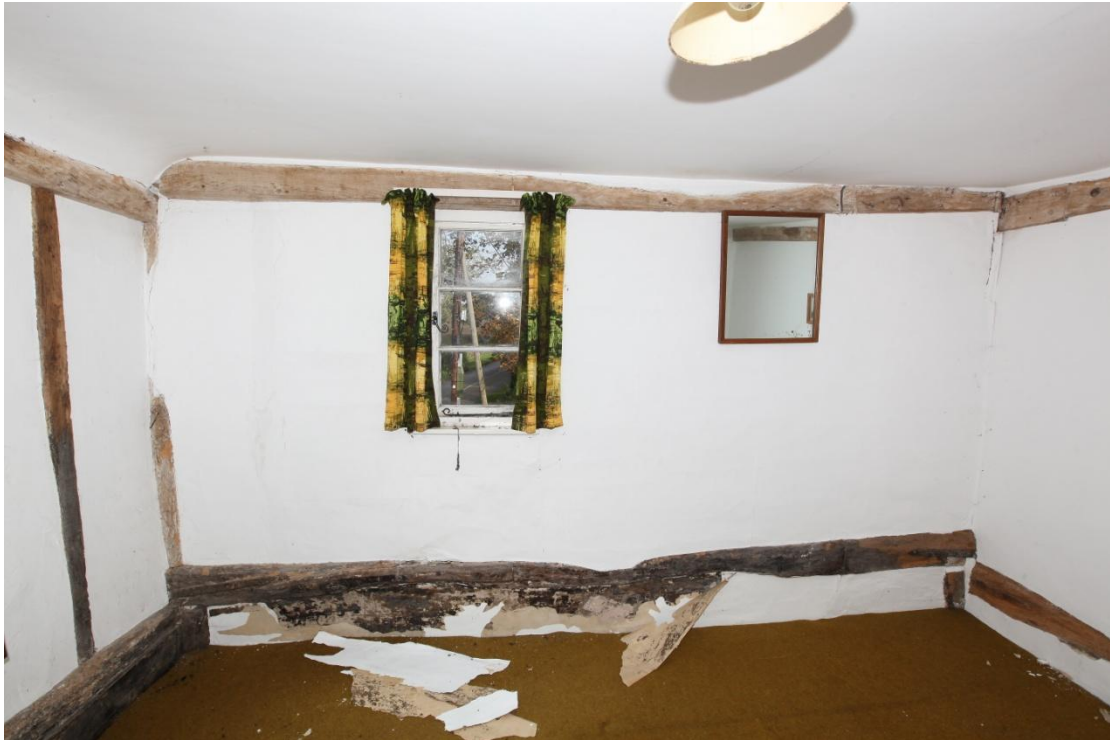
**Illus. 21. The interior of the north-eastern gable, facing Church Lane. The low tie-beam rests on jowled corner posts with corresponding roof-plates just above the floor and survives from an earlier single-storied building to which the present upper storey was added in the 18<sup>th</sup> century. A number of anomalies including a joint in the tie-beam (illus. 22) indicate that this earlier timber frame was either extensively rebuilt as part of the process or consisted of re-used material from the outset.**

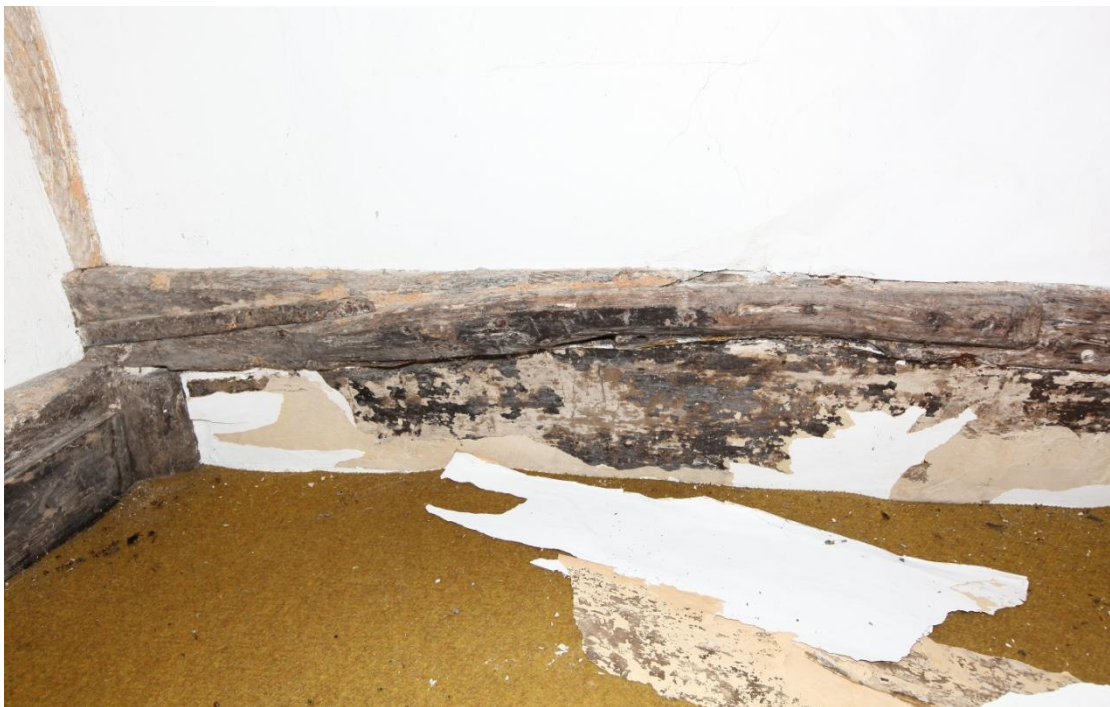
**Illus. 22. A detail of the low north-eastern tie-beam in illustration 21 (bedroom 1) showing a diagonally splayed joint secured by a nailed length of characterful roughwood. A tie-beam should not contain a joint of any kind and the presence of this feature indicates a significant degree of alteration or reconstruction.**

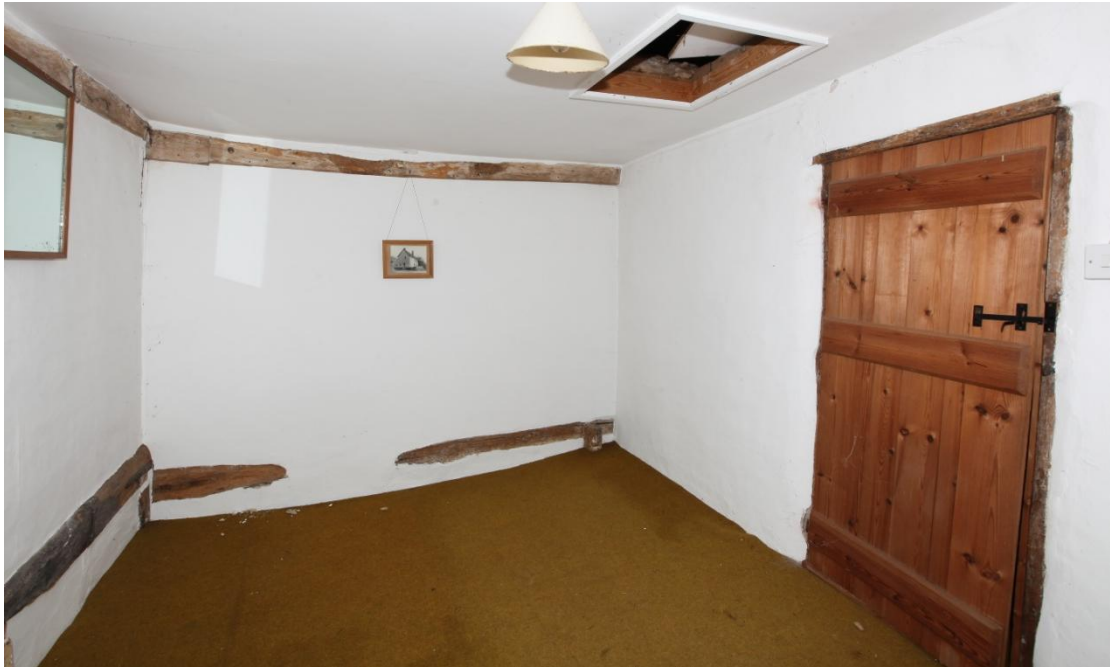
**Illus. 23.** The rear wall of the bedroom over the kitchen with the north-eastern gable to the left. A jowled post with an upstanding tenon for a missing tie-beam is visible in the right-hand corner, immediately opposite that shown in illustration 8. The roof-plate lies above the area of external weatherboarding in illustration 11 but is interrupted by a section of decay that would normally relate to a junction with another structure adjoining at right-angles. There is no evidence of any such structure on early maps.

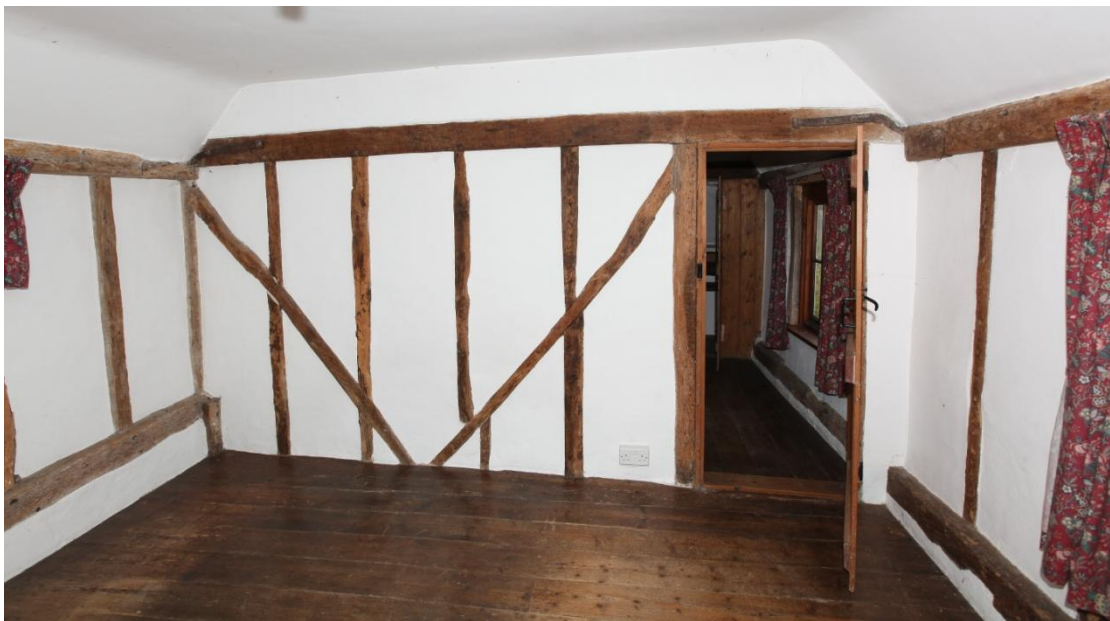
**Illus. 24.** The partition between the central bedroom (2) in the foreground and the south-western bedroom (3). Although the low roof-plates of the single-storied structure continue throughout, with a jowled post visible in the left-hand corner, the partition studs were replaced when the upper storey was added as there is no trace of the former roof. These studs are pegged to the upper tie-beam but their narrow proportions and straight diagonal primary braces respect the connecting door and are typical of the 18<sup>th</sup> century. The front roof-plate on the right appears to be a 17<sup>th</sup> century timber but its counterpart on the left contains pegs for studs above and beneath and was probably replaced when the upper storey was added.
