# **Church Lane Cottage, Aldham, Suffolk**

## **Heritage Asset Assessment**

**Leigh Alston MA (Oxon), Architectural Historian**

**October 2021**

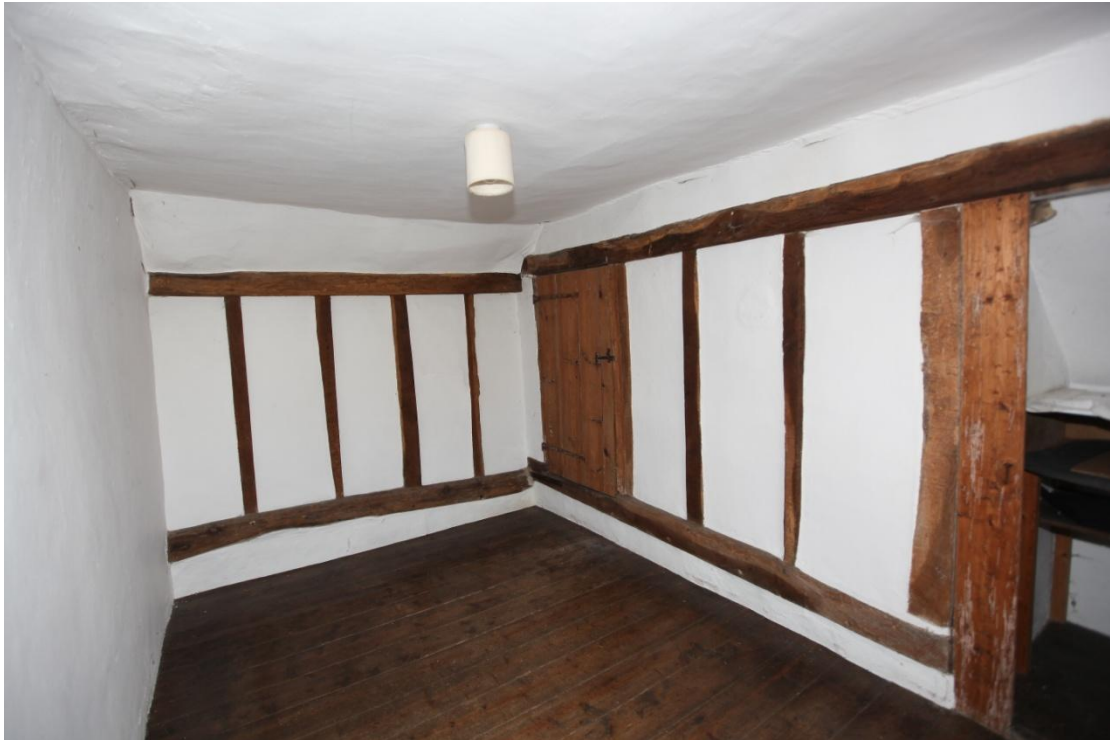
**Illus. 25.** The south-western bedroom (3) with no evidence of the single-storied roof in the gable on the right despite the presence of a lower tie-beam which also appears to have been renewed when the upper storey was added – as does the lower roof-plate of the back wall to the left. The good 19<sup>th</sup> century pine doors open into cupboards in the brick lean-to alongside the chimney.

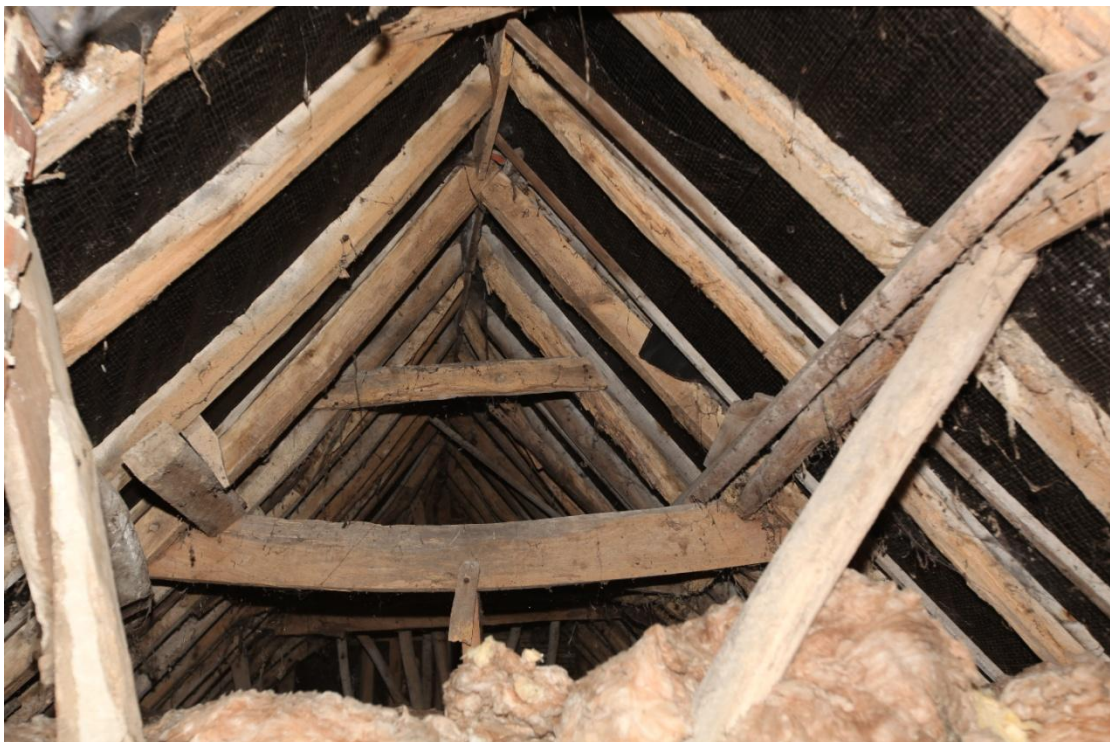
**Illus. 26.** The roof structure seen from the axial chimney to the north-east. The rafters consist of a variety of re-used timbers with pegged collars and clasped-purlins. The presence of a ridge-board indicates a degree of alteration in the mid-19<sup>th</sup> century.
