# The Morton Partnership

### STRUCTURAL ASSESSMENT REPORT OF CHURCH LANE COTTAGE, CHURCH LANE ALDHAM, IPSWICH SUFFOLK, IP7 6NP

**Date:** January 2023

**Reference:** SA/BBR/21268~srep

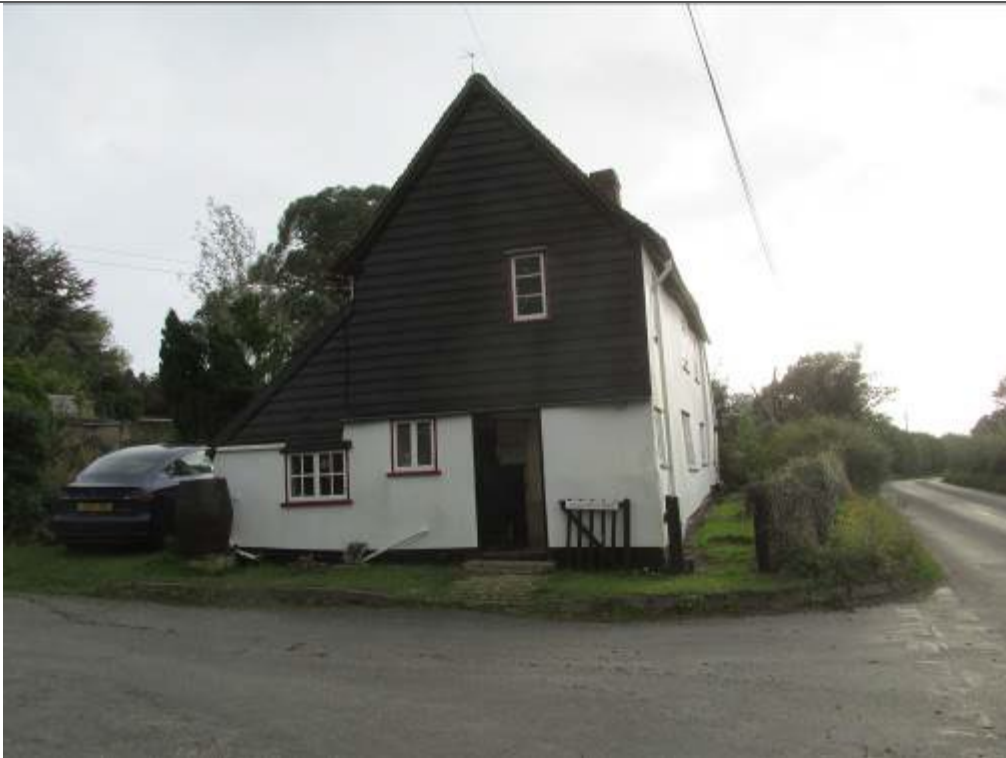
**Photograph 01 – Property viewed from Church Lane**

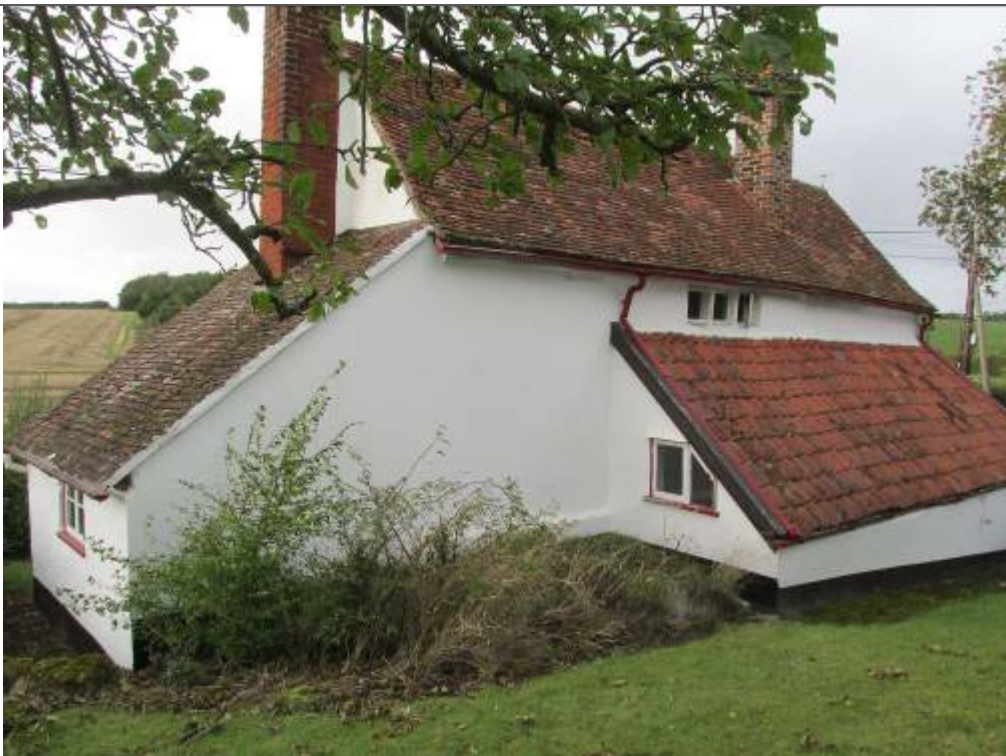
**Photograph 02 – Property viewed from rear, showing end and rear lean-to's**

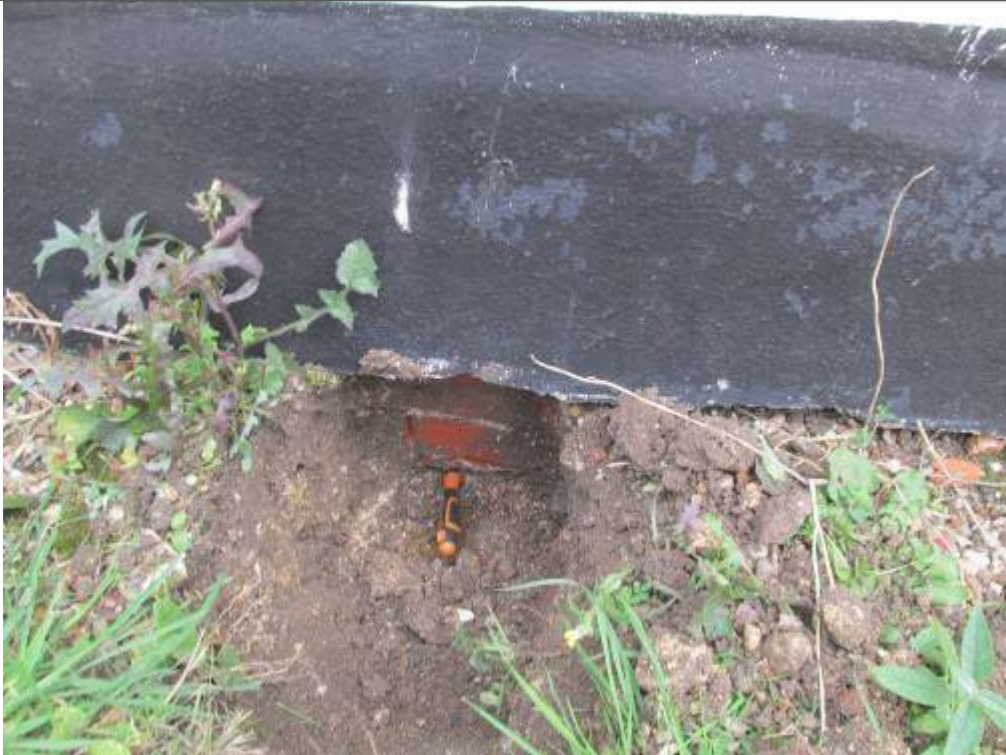
- 2.4 On the occasion of my first inspection, I was able to view small trial holes into the ground, which identified the foundation depth relative to the inside floor level and the outside ground level. Typically, the foundations were shallow, but especially so to the end lean-to, where the formation level was virtually at ground level.

**Photograph 03 – Trial pit typical, inspect walls/foundation shallow depth to plinth to timber frame walls (formation level identified at screw driver position)**

- 3.2 However, where the floor level is to be lowered, there is insufficient wall depth to allow this to be undertaken without disturbing the structure of the wall base and undermining the plinth. It is though, possible to overcome this issue by improving the wall footing, extending it to a deeper depth using a limecrete strip and rebuilding a plinth below the sole plate.

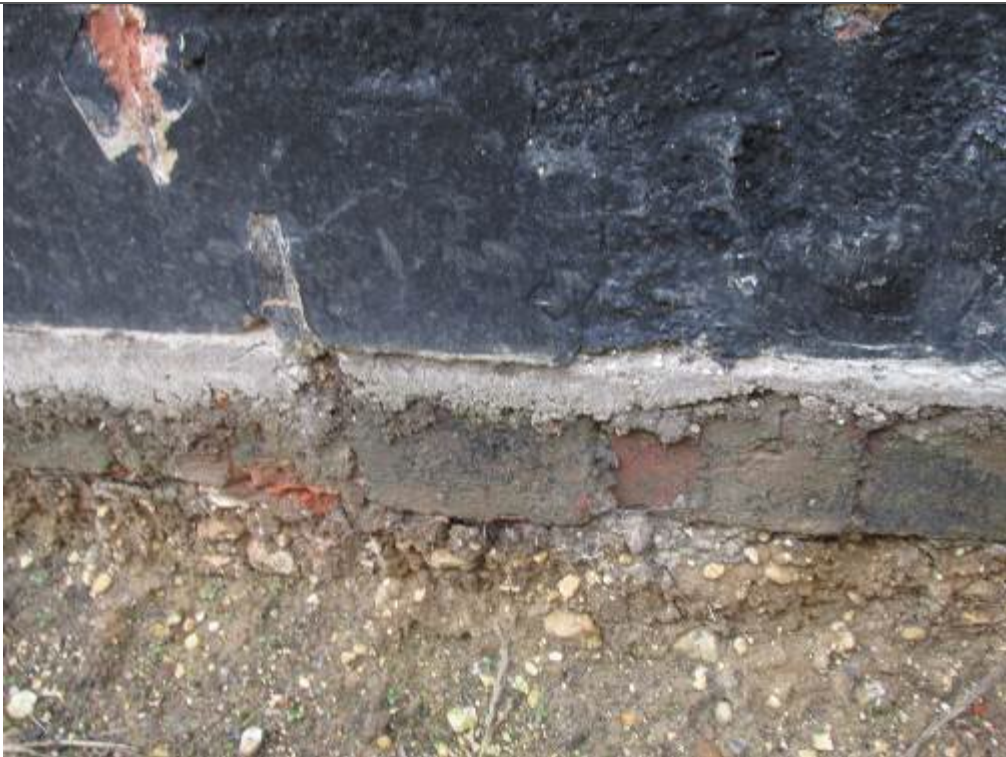
**Photograph 04 – Trial pit typical, end lean-to with single course of brick below ground level, directly onto earth**

- 3.8 At the far end of the property and to part of the rear lean-to to the existing bathroom where there has been movement, and the walls are of relatively short height (being single storey or less), it is proposed to rebuild these brick walls on new footings. The extent of rebuilding is shown on the proposed drawings. The condition of these existing low level walls is relatively poor, with aspects of rotation and settlement, as well as to the end lean-to, a foundation very close to ground surface level. There are a series of cracks to the walls of the end lean to, as well as a bellying out of the front wall. Whilst complex and costly works could perhaps be undertaken to underpin these walls and repair the cracks and restrict the rotation seen, given their more modern and modest nature and height, as well as the practical difficulty of safely carrying out the work, as stated, it is advised that reconstruction offers a more pragmatic approach.

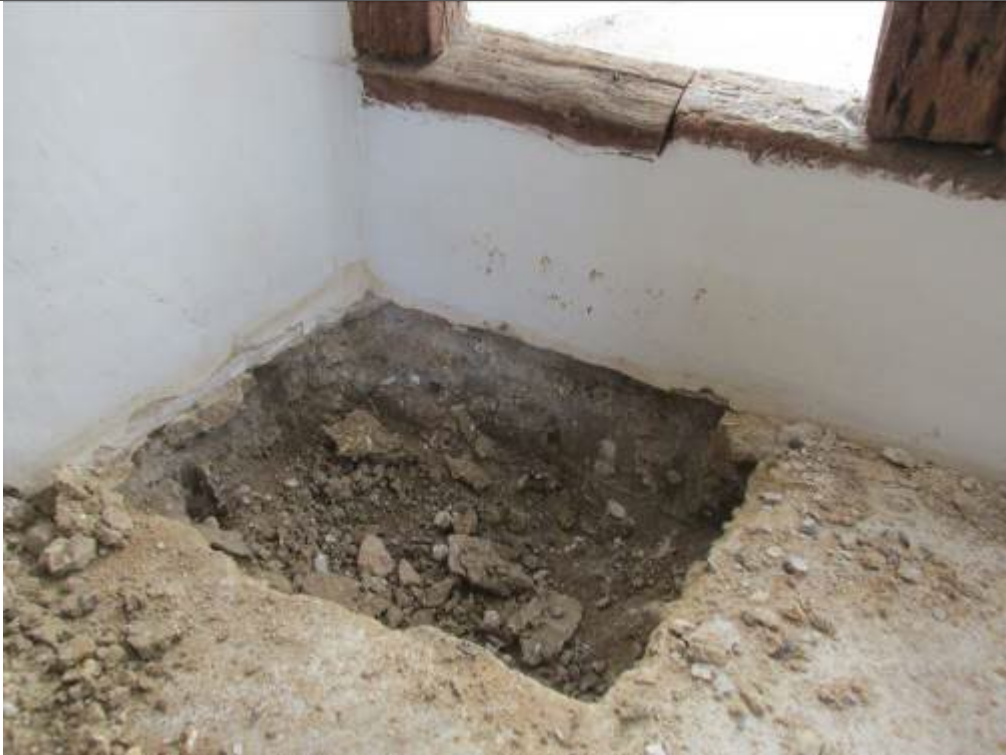
- 2.5 On my return visit, I inspected the depth of the footing to the rear lean-to and similarly found it was very shallow relative to the inside floor level in the existing bathroom.

**Photograph 05 – Trial pit typical against main chimney stack and rear lean-to internal, wall base at floor level directly onto earth**

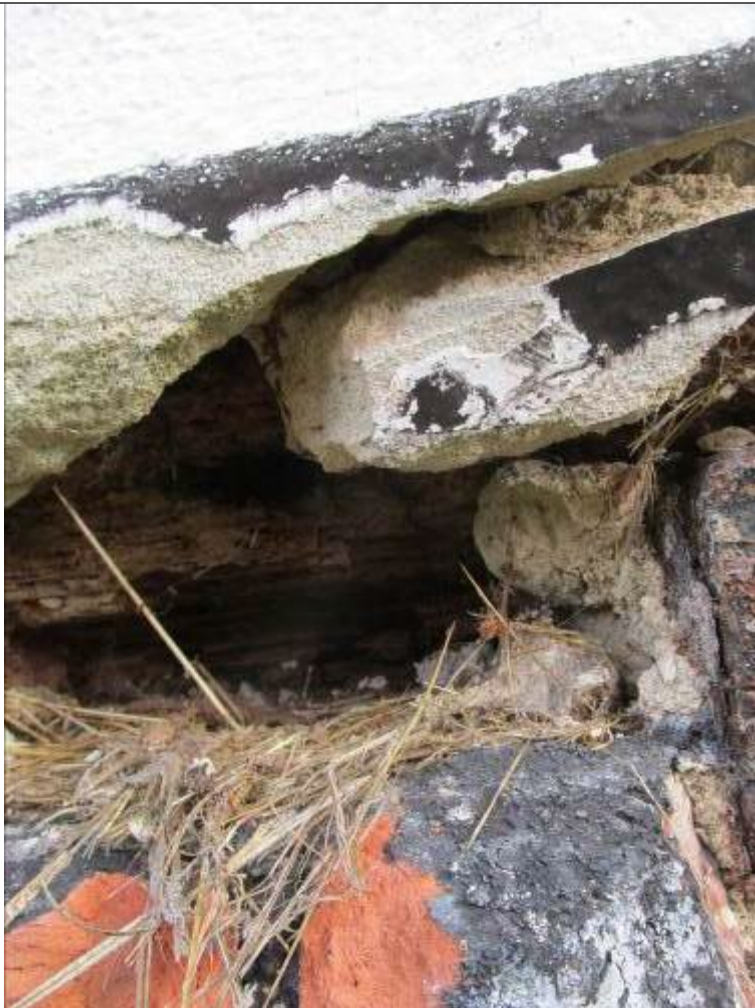
- 2.6 I was not able to inspect all the timber frame members in detail, other than to a number of small trial holes. At first floor, and where exposed internally at ground floor level, the condition appeared reasonable. However, there are indications that there are problems with sole plates, seen from the trial holes and by misalignments. This is of course not uncommon, and particularly to the kitchen end of the property, some replacement and rebuilding of brickwork has evidently been carried out in the past. The appearance of this work identified that it was undertaken some years ago.

- 3.3 The proposed scheme also involves removal of unsuitable cementitious render and replacement with lime render over the existing timber frame. In this process the frame will be exposed fully and traditional like for like repairs can then be undertaken as necessary. It is anticipated the sole plates will generally need to be replaced. Local trial investigations have indicated decay to the outer and under face of the sole plates.

**Photograph 06 – Trail investigation reveals poor condition of soleplate, expected to be typical, but will be uncovered as cement render is removed**

- 3.4 Conventionally, the replacement of sole plates is undertaken by removing a number of brick courses from the plinth below them, so that existing plate remains can be removed and new dry oak sole plates in lengths of, say 10 foot at a time, can be offered up and installed with temporary propping in place. Wherever possible this is to be done, retaining existing stud and post tenons, or where necessary carrying out bottom end repairs to these timbers. Where footings are to be deepened, plinths will need to be entirely rebuilt in red brick and lime mortar, a dampproof course will also be installed.

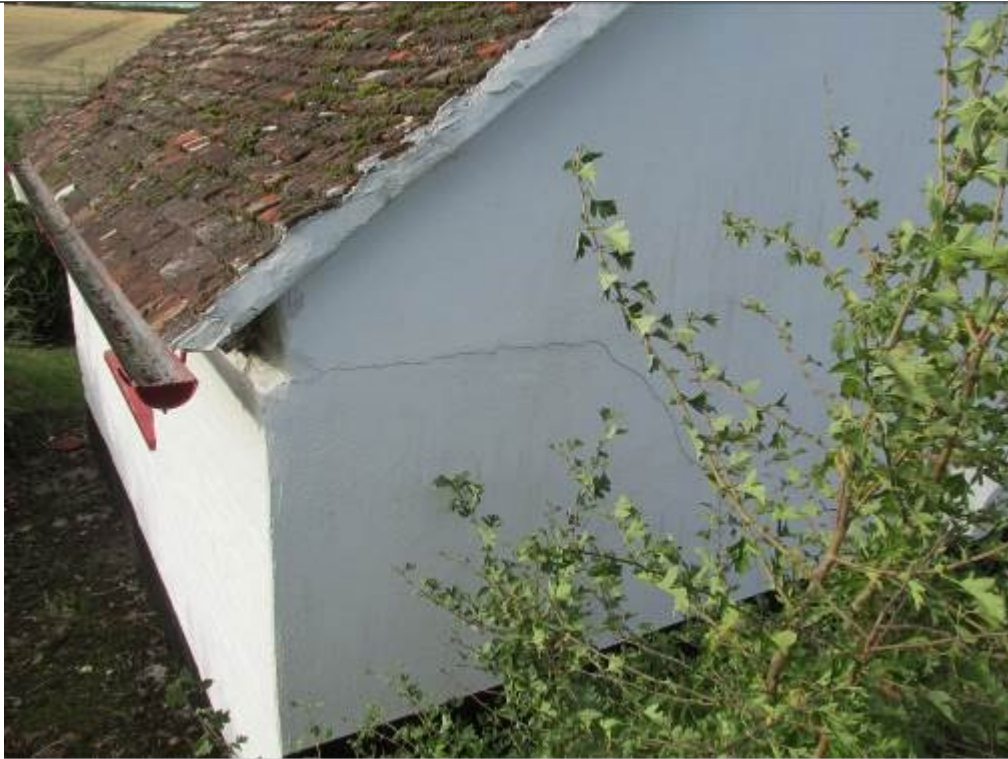
- 2.3 Whilst the main part of the property is timber framed and generally rendered, the lean-to's in both cases are of solid 9" brick construction. There has been some rotation of the rear wall, which supports the lean-to roof, and there has been some settlement of the end lean-to, particularly to the front and rear corners.

- 3.11 The structural movement that has occurred is likely to be related to the situation of shallow footings and possible rainwater drainage defects in the past. There may also be an influence related to clay moisture levels. Rainwater drainage will be improved as part of the scheme, to help limit the risk of any further movement.

**Photograph 07 – End lean-to settlement cracks to south corner**

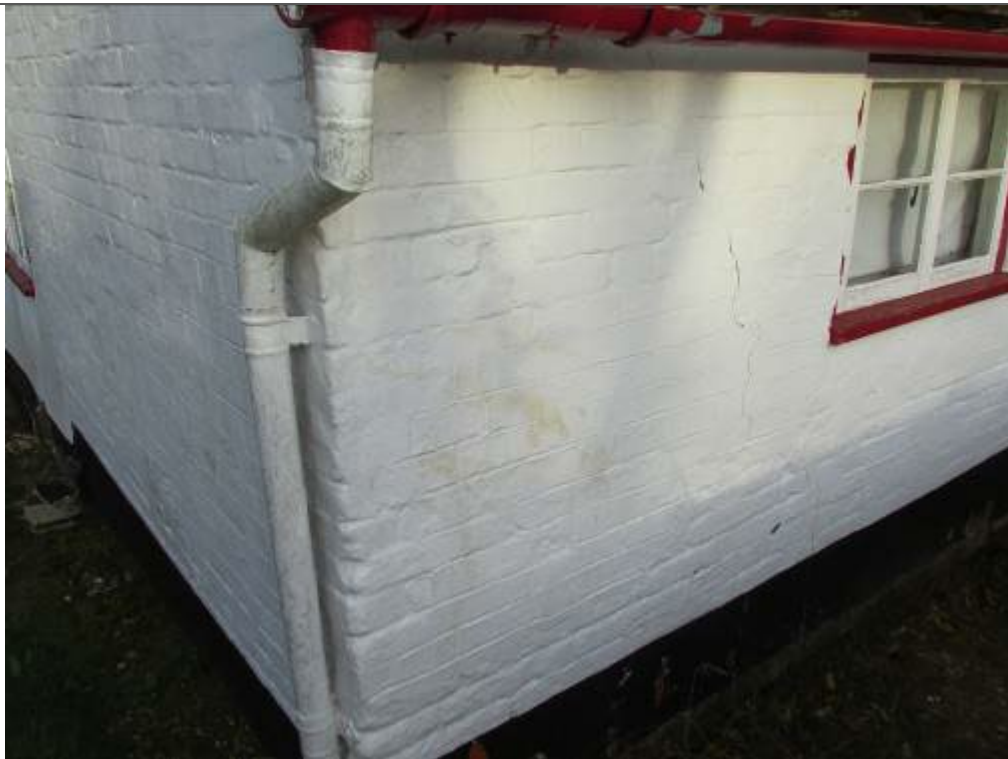
**Photograph 08 – End lean-to settlement cracks to west corner**

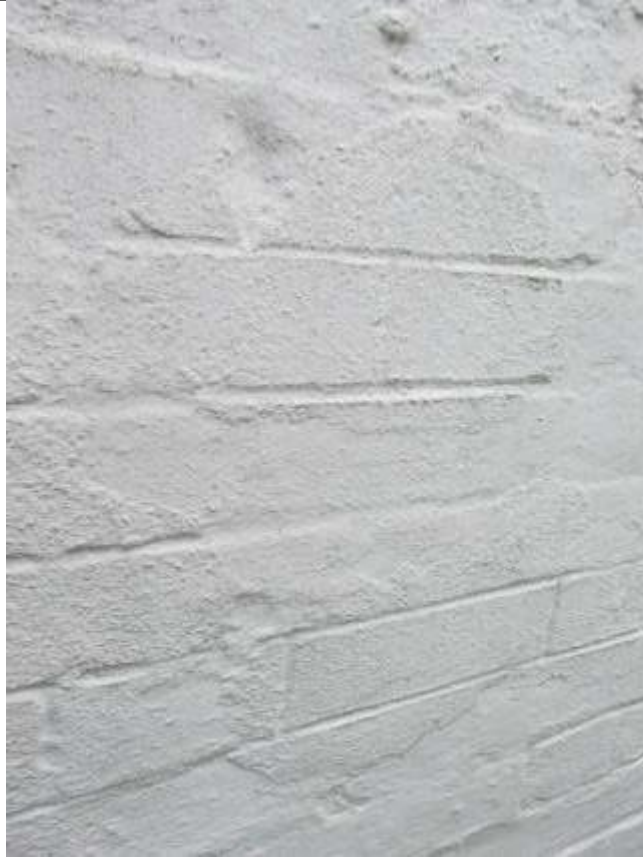
**Photograph 09 – End lean-to cementitious render repairs to damaged brickwork, typical**

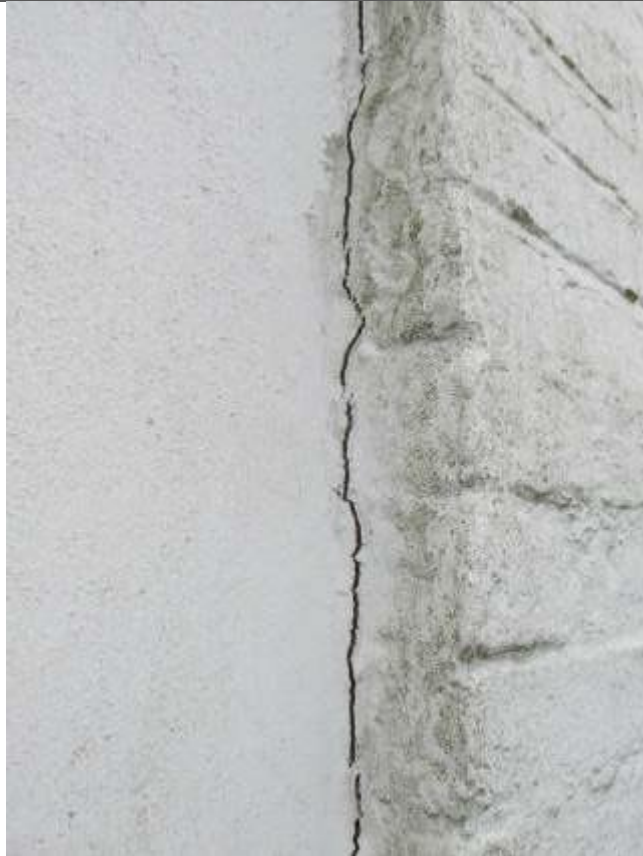
**Photograph 10 – End lean-to bulge to north face due to rotation**

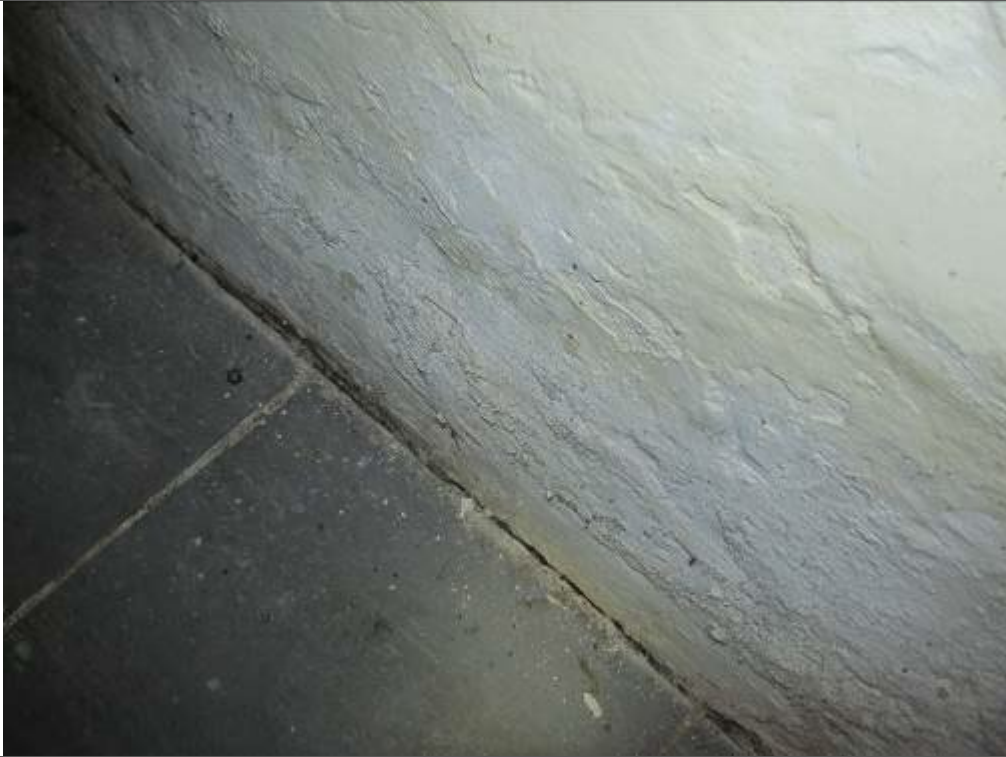
**Photograph 11 – End lean-to separation of north wall of floor due to rotation**

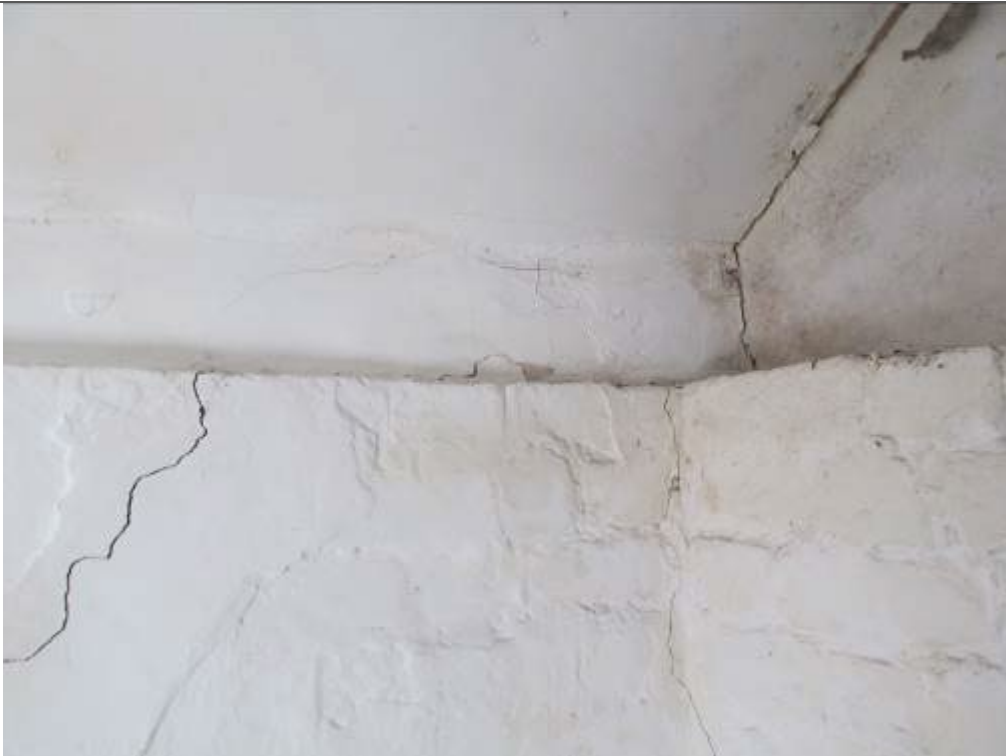
**Photograph 12 – End lean-to settlement cracks to west corner (internal), typical, similar seen to south corner**

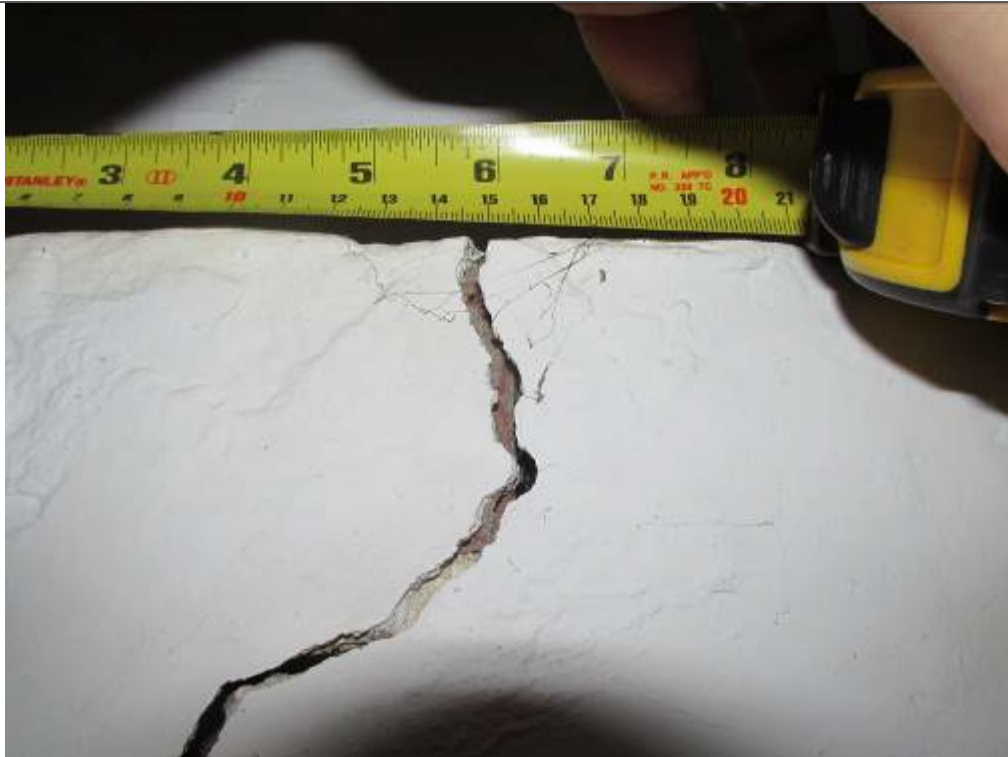
**Photograph 13 – End lean-to settlement cracks measured internally**

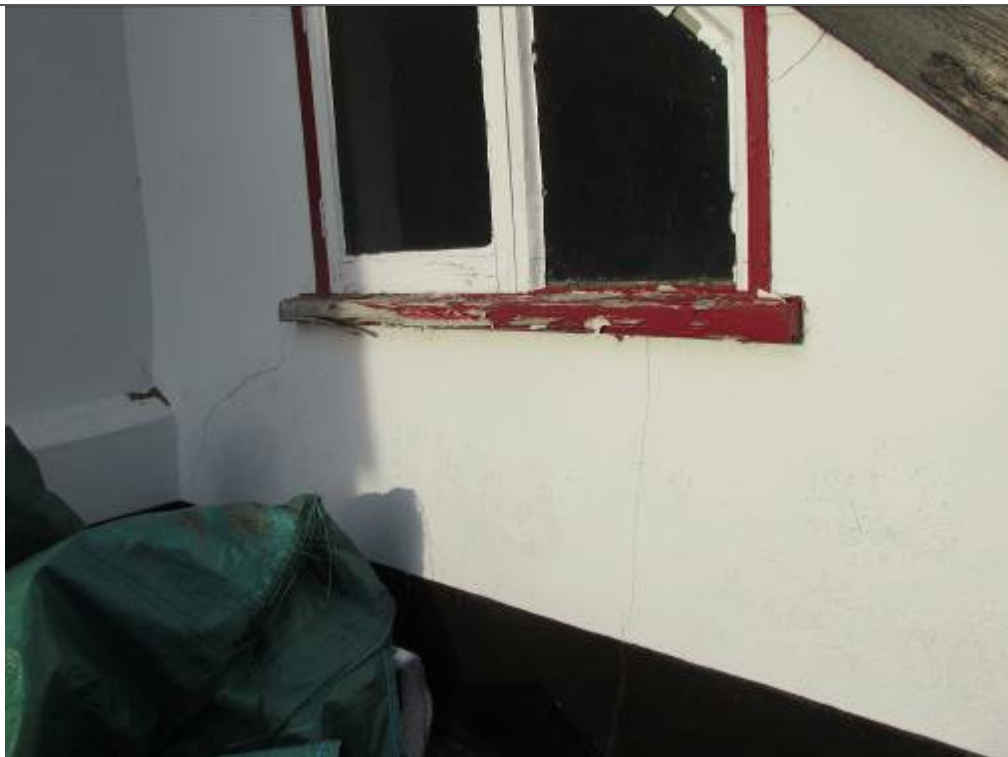
**Photograph 14 – Rear lean-to settlement cracks**

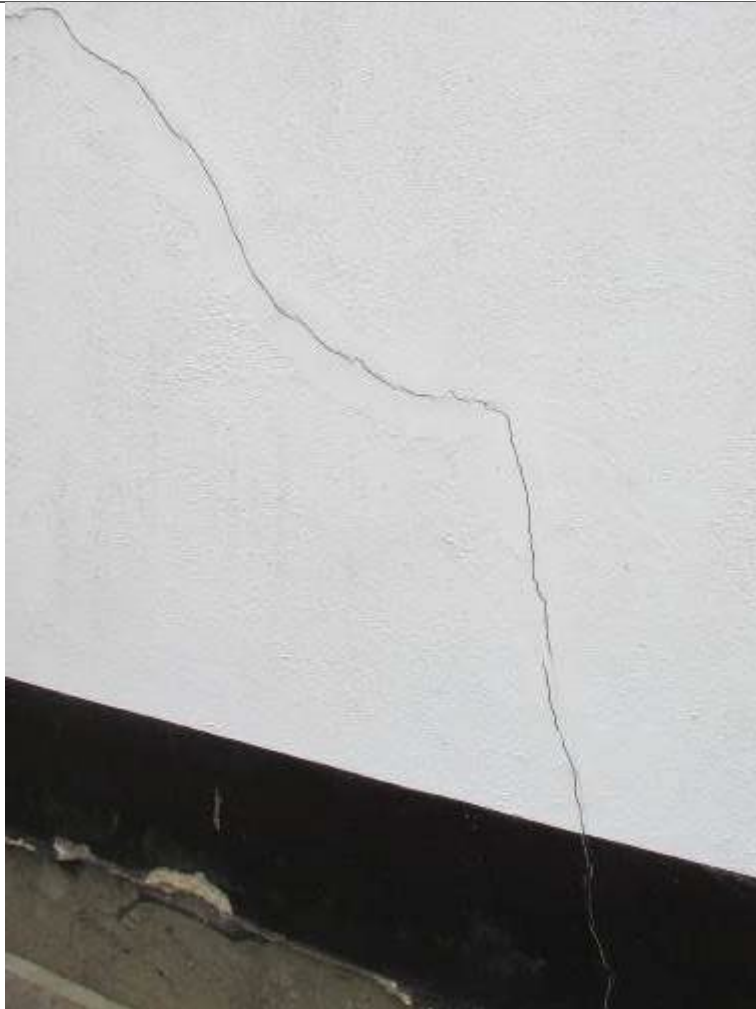
**Photograph 15 – Rear lean-to differential crack adjacent to bathroom**

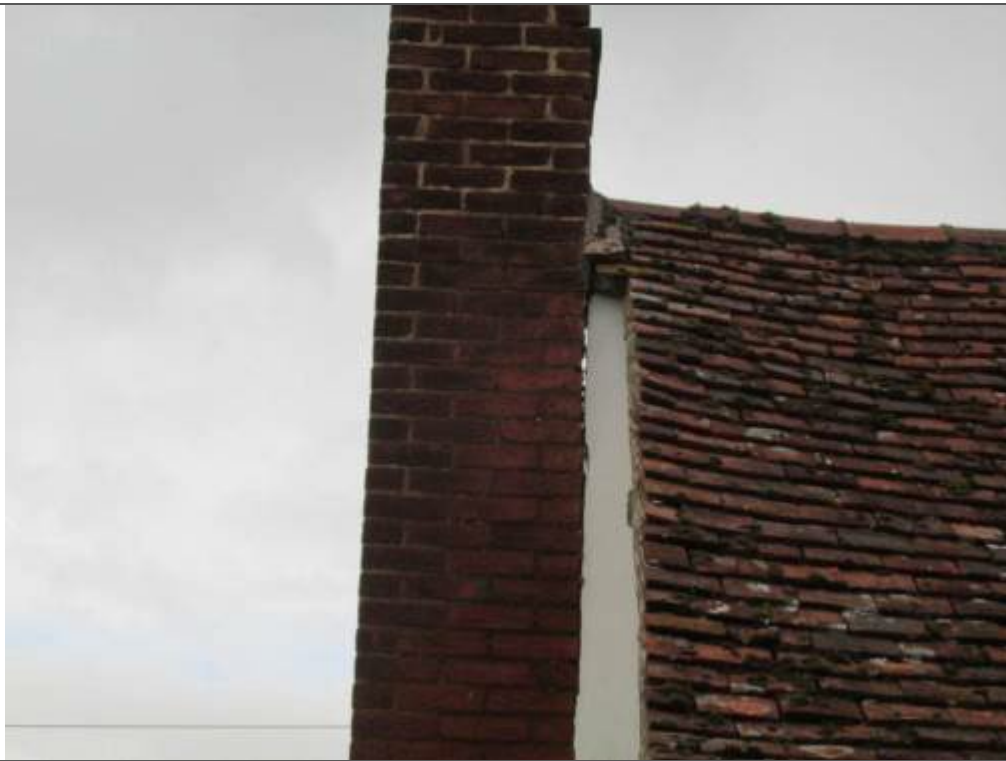
- 3.12 There has been a small degree of separation between the gable chimney stack and the end of the timber frame. It is not possible to determine whether this has been driven by stack movement or frame movement. The gable chimney stack appears relatively plumb, partly rebuilt, and it is possible the timber frame has moved away from it, driven by the decay of soleplates elsewhere. To avoid the frame pulling on the stack, rather than tying it in at high level, a lead protecting detail will be formed at the roof junction, which will accommodate a degree of movement without allowing water ingress. This is therefore a type of flexible interface.

**Photograph 16 – Slight separation between gable chimney stack and timber frame, where protective cover flashing is proposed to verge of tiles**

- 3.13 During the works, when forming a new footing/floor slab to the end room alongside, a sequenced installation is required to avoid any ground disturbance close to the base of the chimney stack.

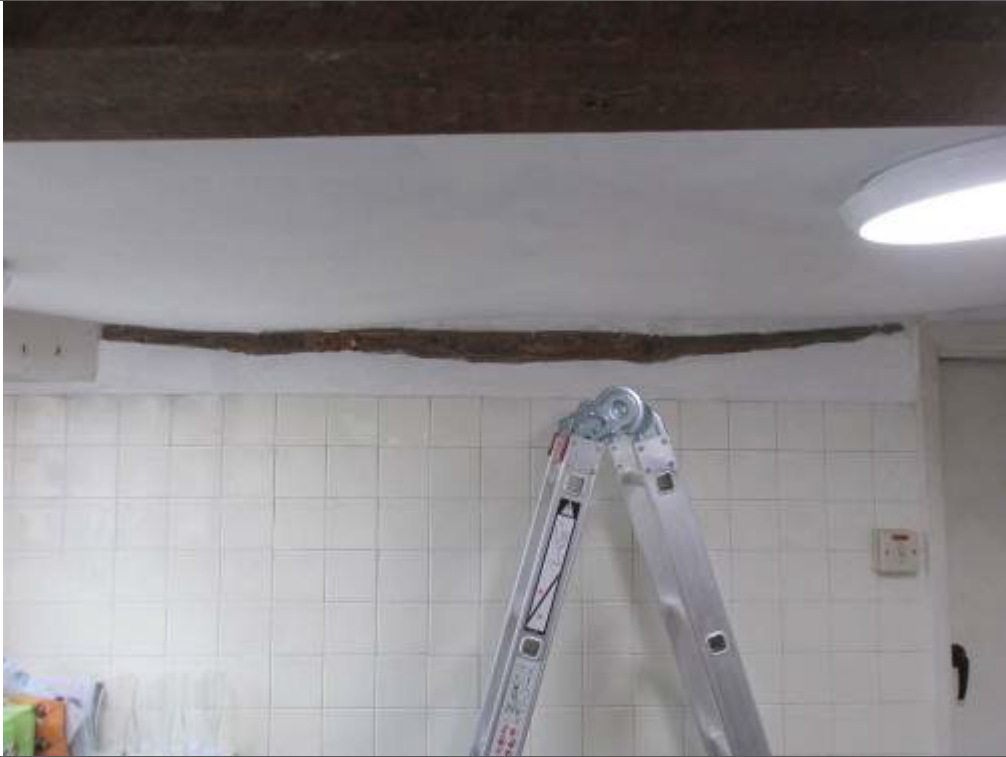
**Photograph 17 – Modern fletton brickwork partition to be removed (100mm thick)**

- 3.15 To remove the modern fletton internal brick wall between the kitchen and the rear lean-to, it will be required to strengthen the rail in the wall frame above. This can be achieved by strengthening the face of the frame with a new additional timber and carrying this at each end on to a new post. This arrangement is shown on the proposed drawing. The exact fixing configuration may need to be refined once the area is exposed during the works of refurbishment. The proposed detail carries the wall load above onto new footings.

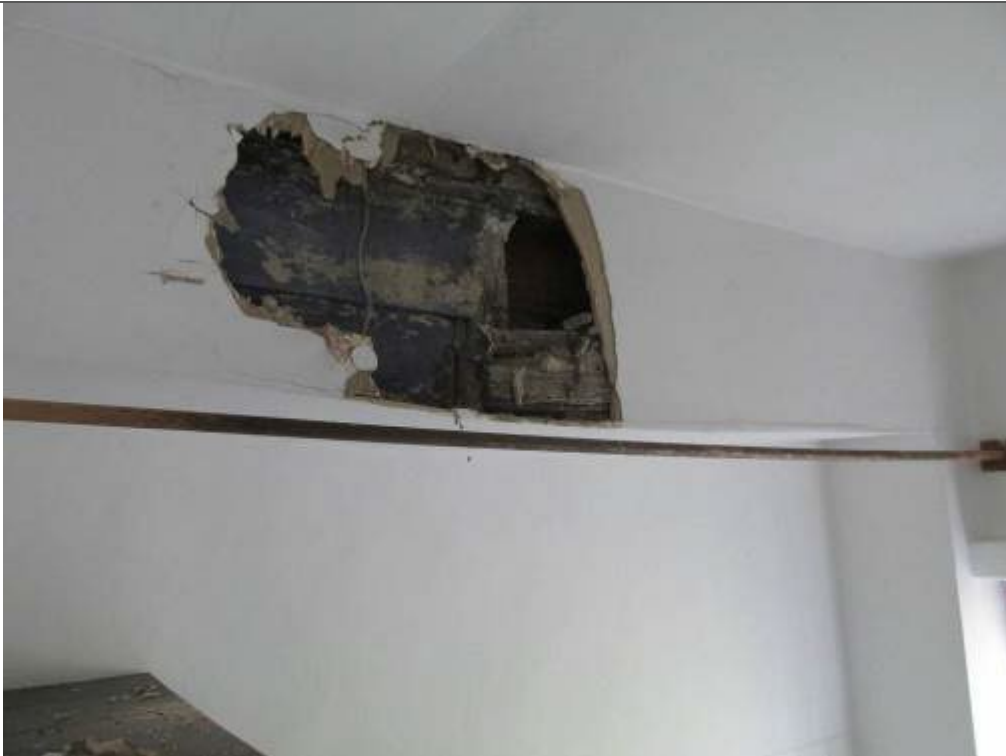
**Photograph 18 – Wall frame over kitchen partition to be strengthened to allow modern fletton brickwork to be removed**

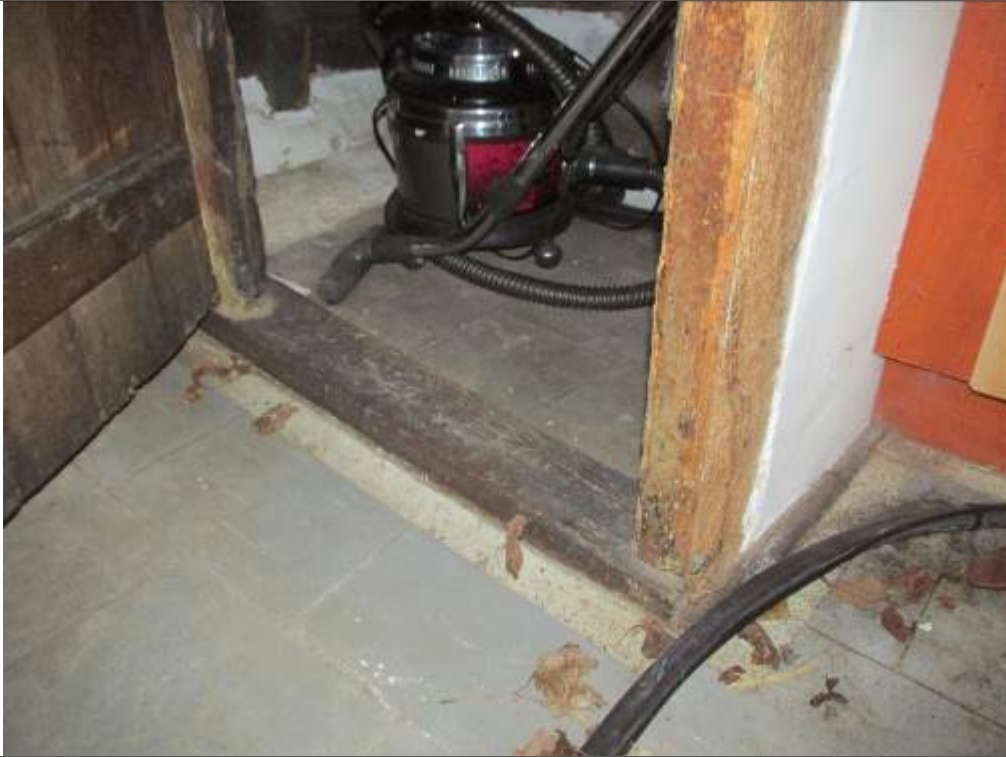
**Photograph 19 – Internal base to stairs to be re-supported on new limecrete slab**

- 3.6 There are internal walls to which the foundation depth has been investigated. To these, the plinth walls are also inadequate in depth, and will need to be reconstructed at low level off new limecrete footings. There is no requirement within the scheme for any new form of footing under the chimney stacks, where necessary protective limecrete retaining kerbs will be formed as part of the new floor make-up. The base of the stairs will be re-supported on the new slab.
