**STRUCTURAL FEASIBILITY
REPORT**

**THE HAYBARN
COLDHARBOUR FARM
ASHWELL**

REF: 222048 - MARCH 2022

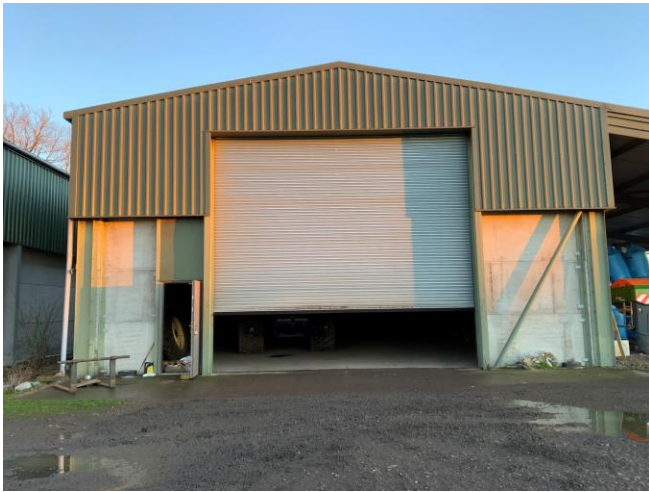
- 2.1 The Grain Barn was a single span steel portal frame, with a duo pitched roof, comprising 4No. bays and 5No. frames, with a lean-to at the side.
- 2.2 The frame was clad in lightweight metal sheeting at high level (see photographs 1 - 4).
- 2.3 At low level there was a precast concrete retaining wall, to take the horizontal load from the grain stored up against it (see photographs 1, 2, 5-7).
- 2.4 The steelwork was painted.
- 2.5 It was a single storey building with, what appeared to be, a ground bearing concrete floor slab (see photographs 5 & 6).
- 2.6 The barn was roughly 6m tall at eaves level and 7m tall at ridge level.
 - 2.6.1 It was generally in a good structural condition.

- 3.2.1 There was bracing in the first and last bay in the walls and roof, formed from circular hollow sections (see photographs 1, 5 & 8).
- 3.2.2 The beam/column connections were haunched, suggesting the frame was a moment frame (see photograph 6).
- 3.2.3 All of the steelwork portal frames appeared in a good structural condition, with no sign of deterioration.
- 3.2.4 The precast concrete retaining walls appeared in a good structural condition.
- 3.2.5 These appeared to be bolted to the main frame.

1. Front of Grain Barn.

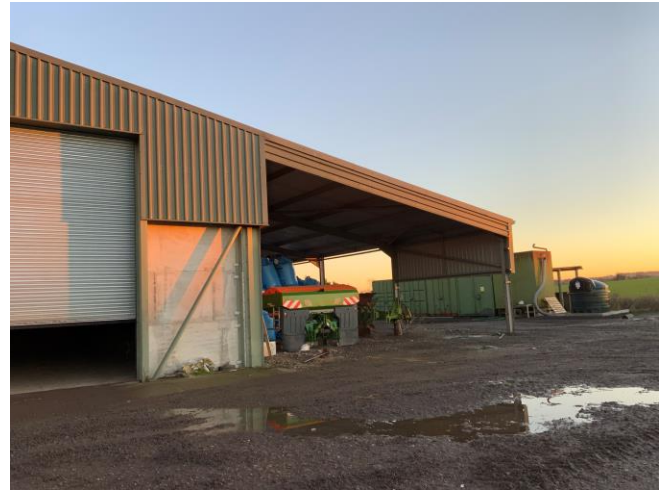
- 3.1.1 The cladding generally looked in an acceptable condition.
- 3.1.2 Some of the steelwork showed signs of rusting, most notably to the lean to section, but there was no sign of delamination or major corrosion.
- 3.1.3 There was no sign of any movement externally.
- 3.1.4 Generally the structure looked in a good condition externally.

2. Lean to, to right hand side of main barn.

- 4.9 It is assumed that the precast concrete retaining wall is not helping provide stability to the building.
- 4.10 The existing lean-to is to be removed and its removal is unlikely to affect the overall stability of the frame.

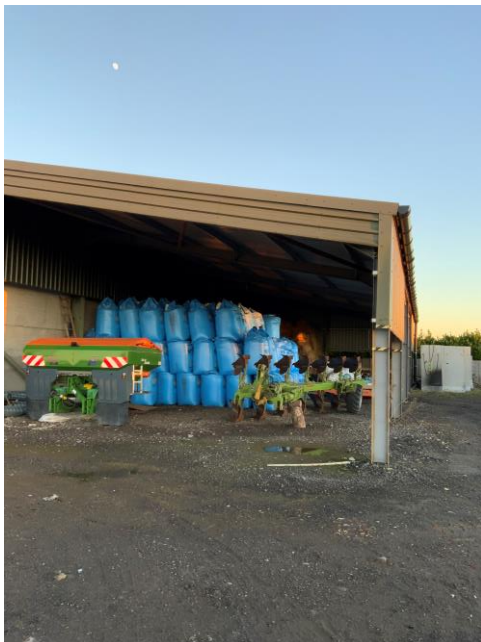
3. Lean to, to right hand side of main barn.

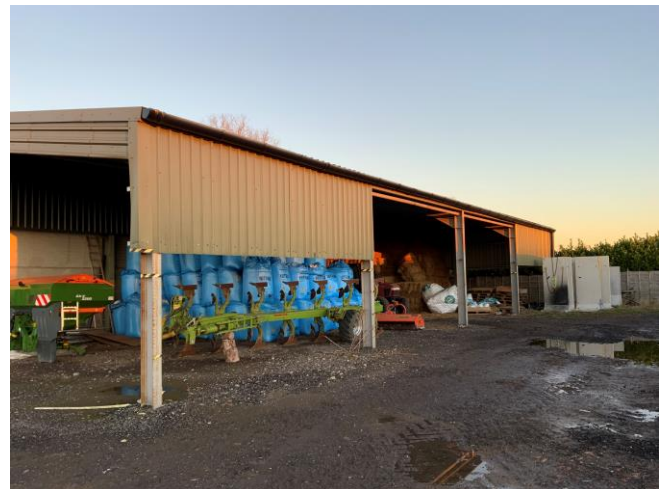
4. Side of lean to.

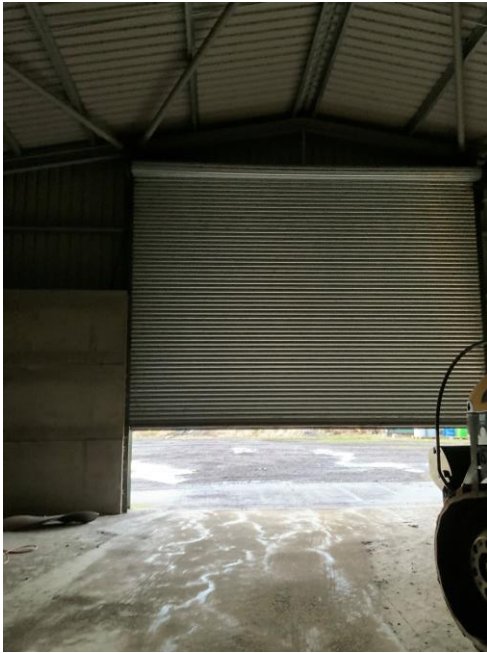
5. Front of Grain Barn from inside.
Note diagonal bracing in roof.

- 4.11 The vertical bracing in the walls and the bracing at roof level should remain in-situ so the stability of the building will not be affected by the proposals.

- 4.12 Where the first bay is to be reduced in size, the bracing will need to be altered to suit.

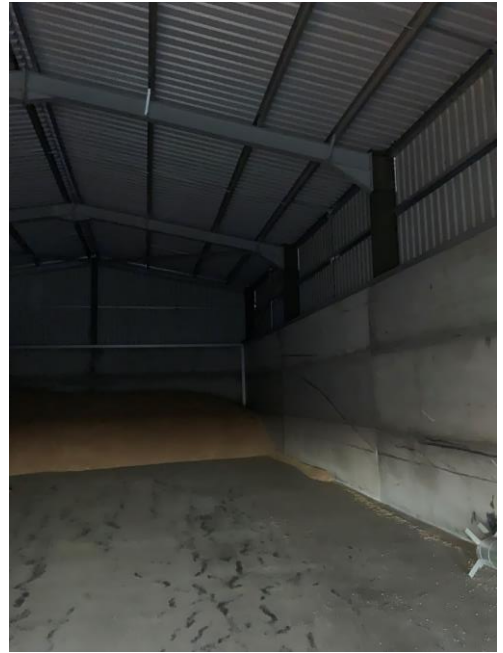
6. Internal view of barn, note haunched connections between beams & columns.

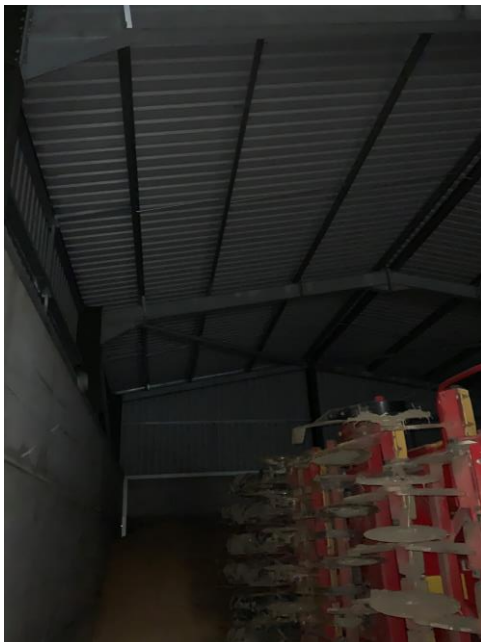
- 4.3 It wasn't possible to confirm the purlin and member sizes, apart from the columns.
- 4.4 It is expected that the main frames will be able to support the increase in load, but the existing purlins will likely need replacing or the centres closed up.

7. Roof - Steel purlins at wide centres spanning between steel frames.

- 5.3 It is likely that the existing frame can support the proposed new roof structure, however the existing purlins will need to be strengthened or the centres closed up.

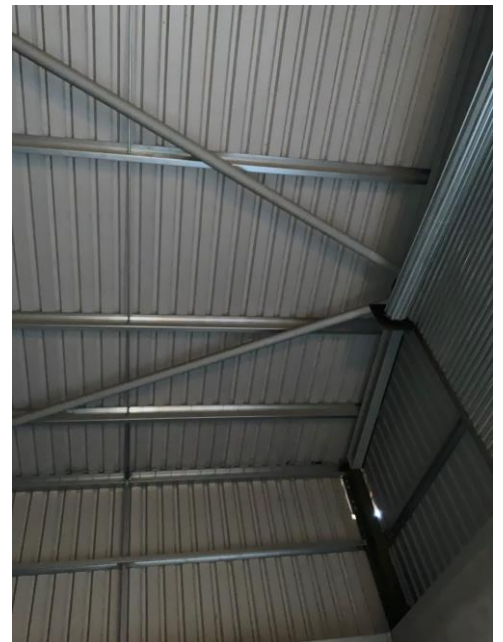
8. Diagonal bracing in roof to front of barn.

- 5.4 The existing bracing should remain in-situ, apart from where the first bay is being reduced in size, where the bracing should be amended to suit.
