**Site Visit and Report**  
**of**  
**The Roof Coverings at 15 Market Street, Woodstock**  
**for**  
**Lewis Property Renovations**

10<sup>th</sup> February 2023

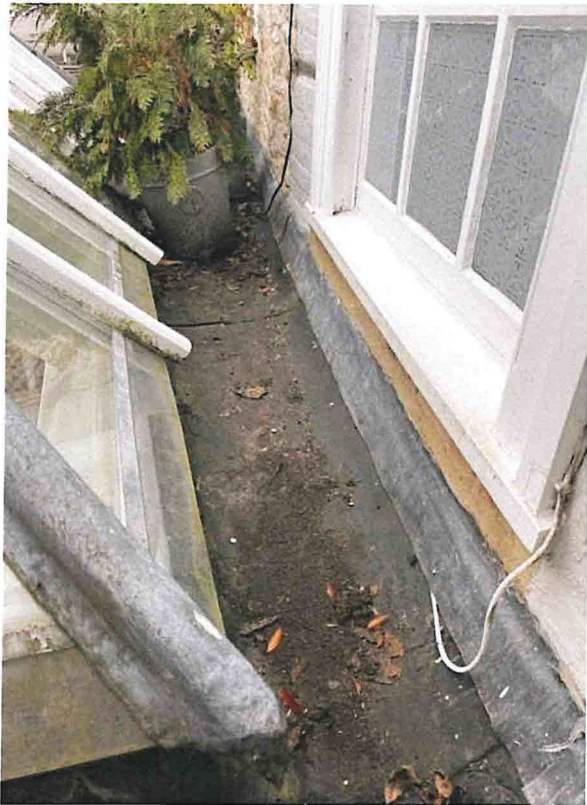
**Photograph 1**

Due to the type of material and age, our experience shows that EPDM rubber has issues of maintaining its integrity at laps and joins. This is borne out by a location easily visible from the bedroom window of mud curling to one of the laps of the EPDM rubber.

Shows the EPDM gutter taken from the bedroom window showing the lap approximately 200mm in front of the plant starting to curl at the edge. The EPDM membrane is dressed in a single piece to the underside of the lead cover flashing under the windowsill and to the other side, onto the timber curb, which would have been provided to support the lantern light.

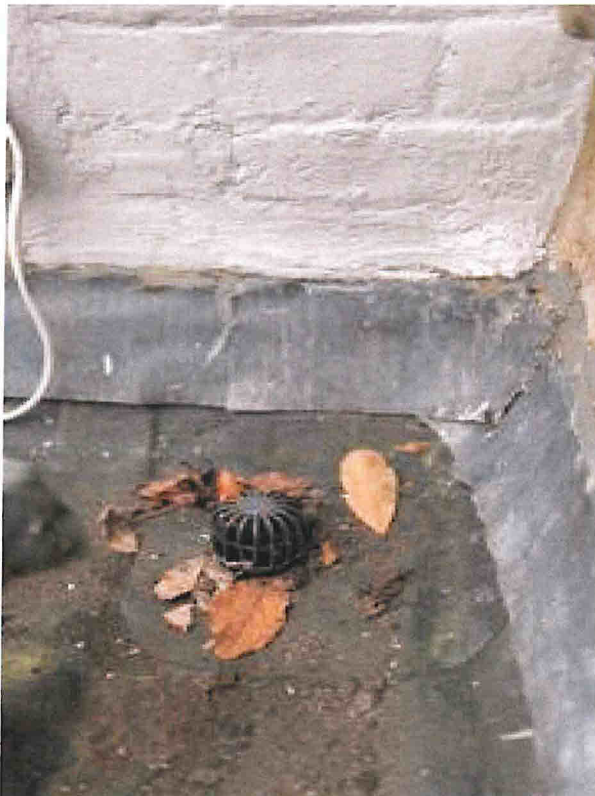
**Photograph 2**

Shows the location of the rainwater outlet, again in the corner from the bedroom window where viewed and photographed. The clients are maintaining the guttering to a high standard and a few leaves and debris are apparent but this is and will be an ongoing requirement to prevent blockage of drainage and overflow.

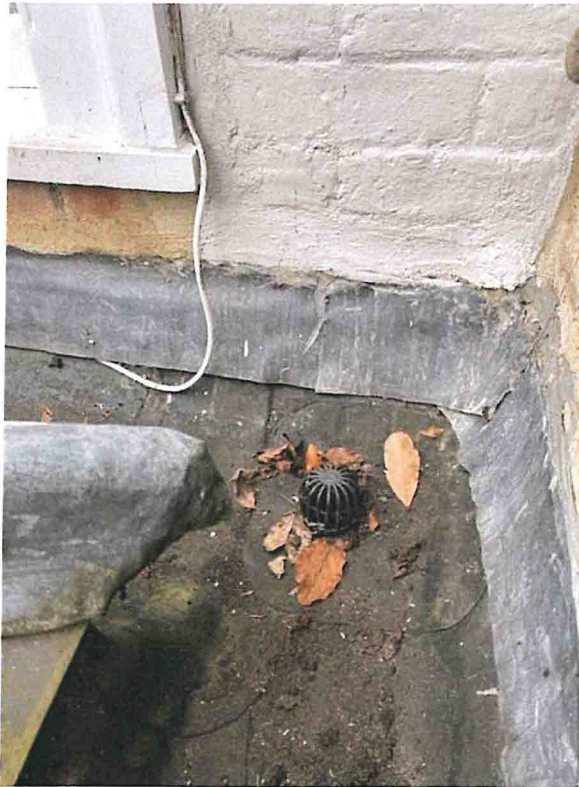
**Photograph 3**

Showing the same location with a coax cable being positioned under the lead flashing and also the lead hip to the corner of the glazed atrium.

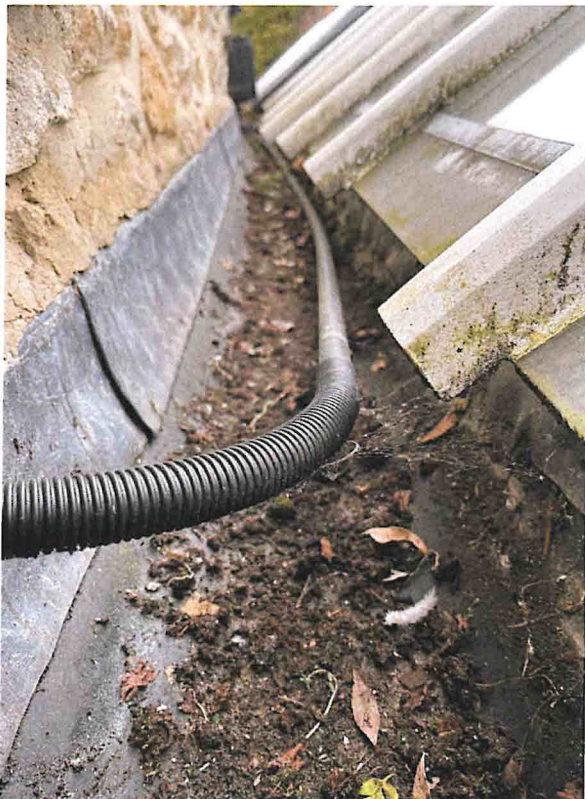
**Photograph 4**

To the left-hand side as viewed from the window, the narrow gutter shows a little bit more debris, which should where possible be swept out with a long broom to prevent blockage. It is noted that the width and accessibility would prevent any possibility of providing waterproofing in any meaningful way at this detail and location.

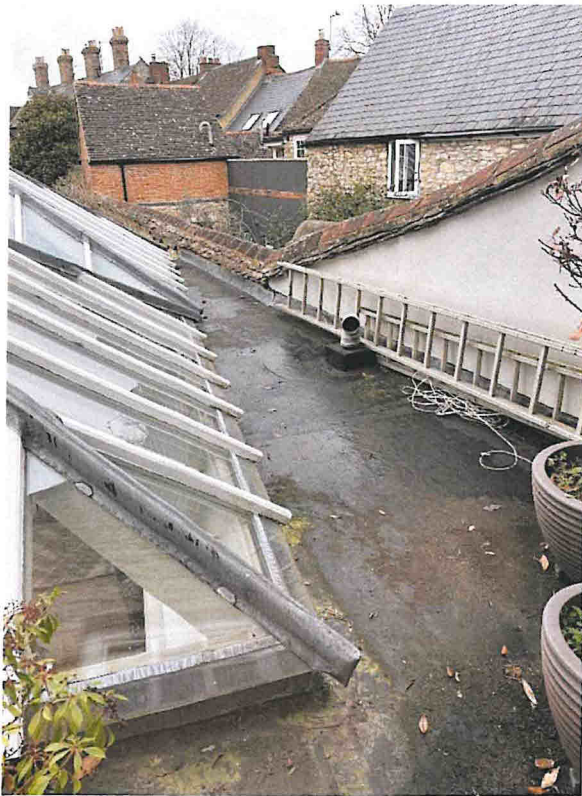
**Photograph 5**

Shows the adjacent side of the roof where there is a greater expanse of roof area, containing planters and pots / ladders and a pipe penetration from the assumed wood burning stove below.

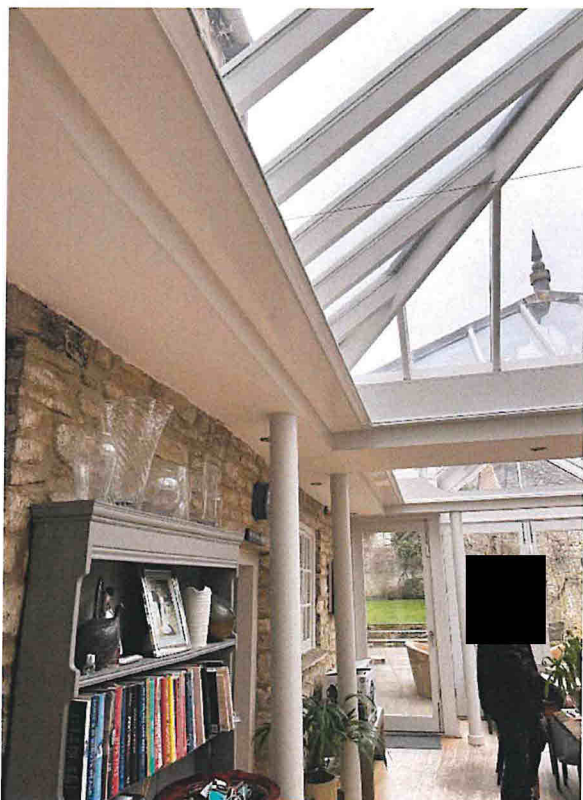
**Photograph 6**

Shows the underside of the construction taken from the viewpoint of where the outlets are photographed in photographs 1 and 2, with the internal boxed gutter being supported on the steel circular uprights.

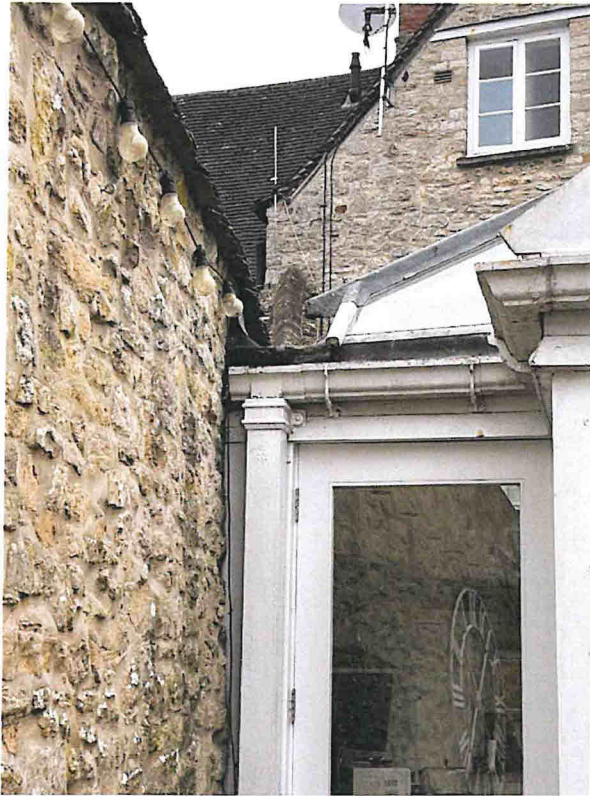
**Photograph 7**

Shows the left-hand side of the roof taken from the garden where water is discharging through and into an external gutter at the front edge.

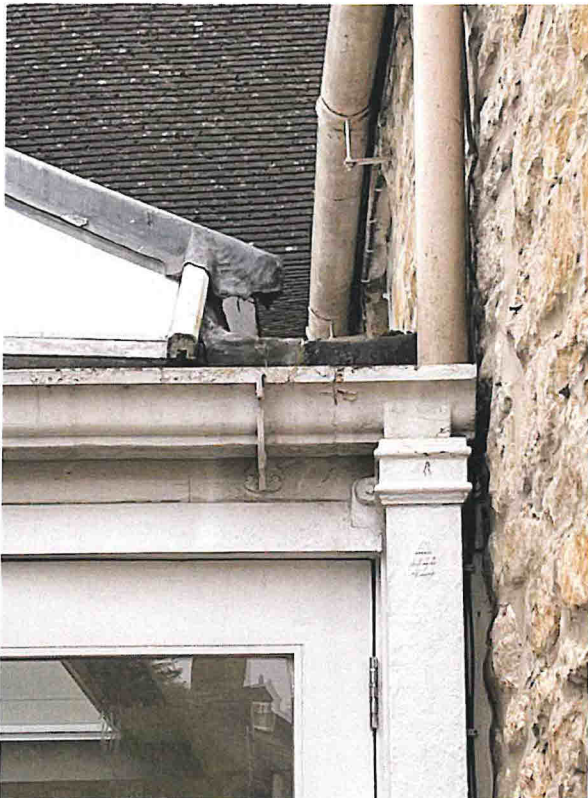
**Photograph 8**

As photograph 7 above, to the right-hand side.
