# BRIEF REPORT

58 High Street  
Burford  
OX18 4QF

McKelvie  
Lloyd  
Chartered Surveyors

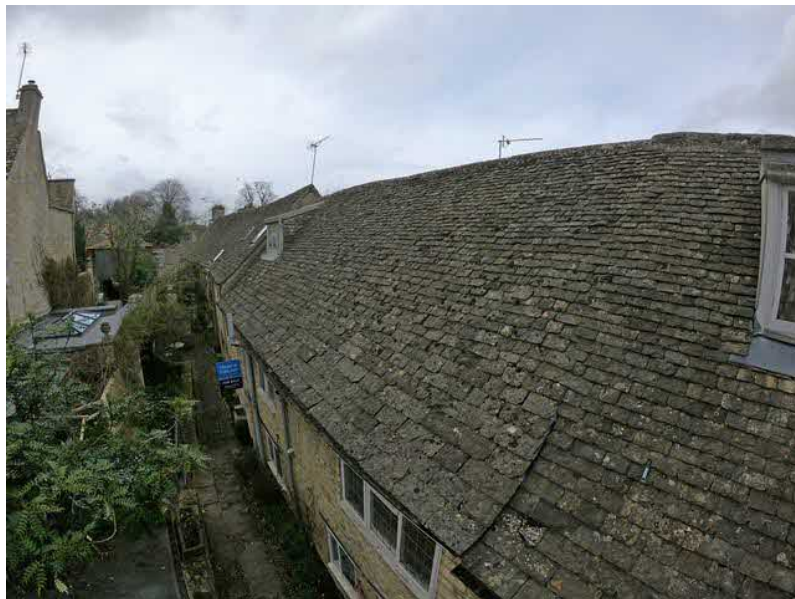
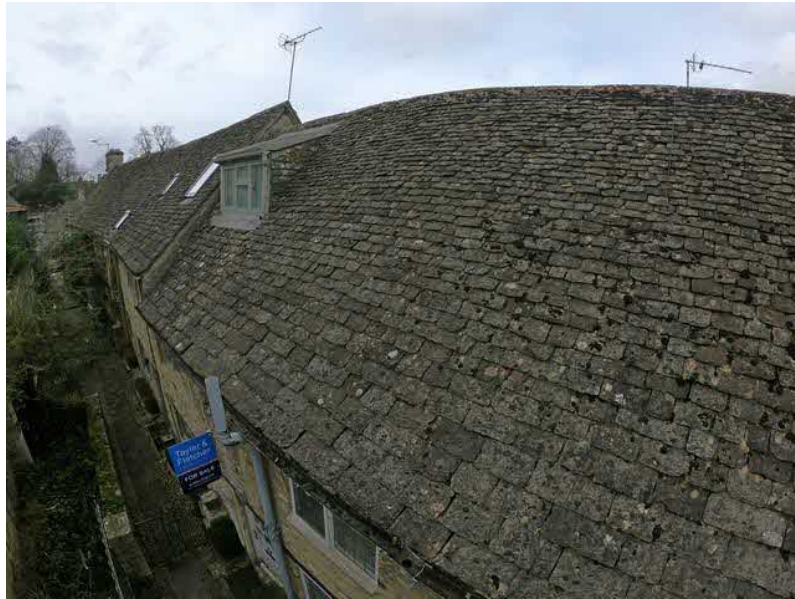
5.04 Roof at front

- 4.01 The front roof slope is clad in stone slates, the rear slope in plain concrete tiles, and the rear projection roof in plain slates. From what we could see in photographs taken with a pole mounted camera the second floor dormer projection at rear has a flat roof with a GRP covering.

- 4.02 Overall condition of main roof coverings appears to be fairly good. Nevertheless it would be prudent to instruct a competent roofing contractor to undertake basic maintenance now and occasionally in future. As a general rule stone slating should be assessed and maintained at intervals of not less than about five years.

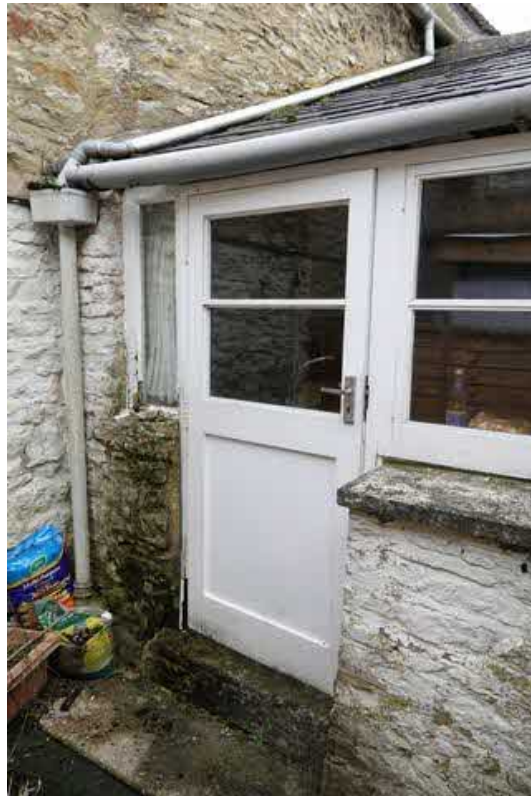
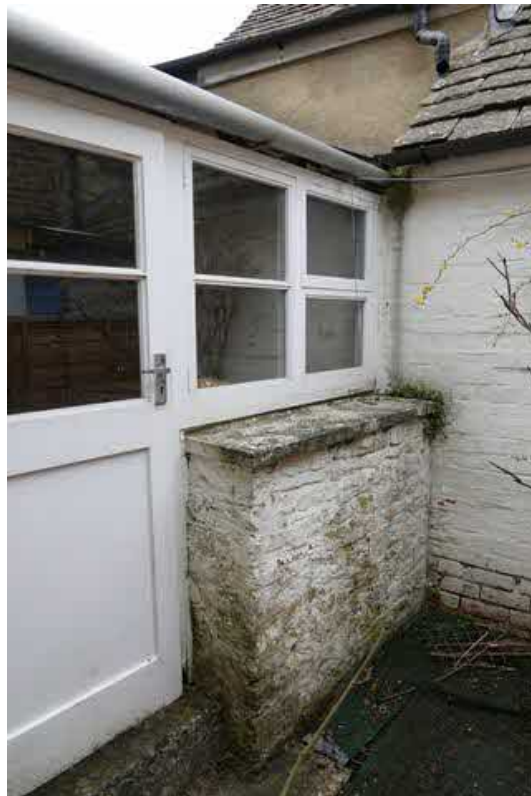
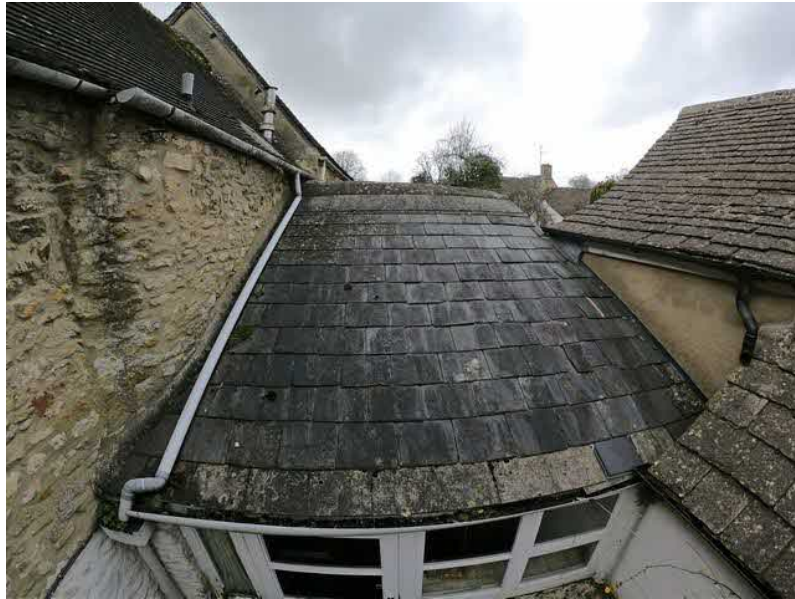
5.13 Rear projection

- 4.03 Some dilapidation is evident in the rear projection roof slating. At least one slate is broken. Slates at the eaves have an appearance indicating they are synthetic, rather than natural material, and are degrading.

- 4.04 From what we could see it is likely that the rear projection slating can be retained, subject to appropriate maintenance being undertaken, rather than it being necessary to strip and recover this roof. Taking down the kitchen ceiling should reveal whether there is a modern underlining beneath the slates and battens. If there were none, we would certainly recommend re-slating.

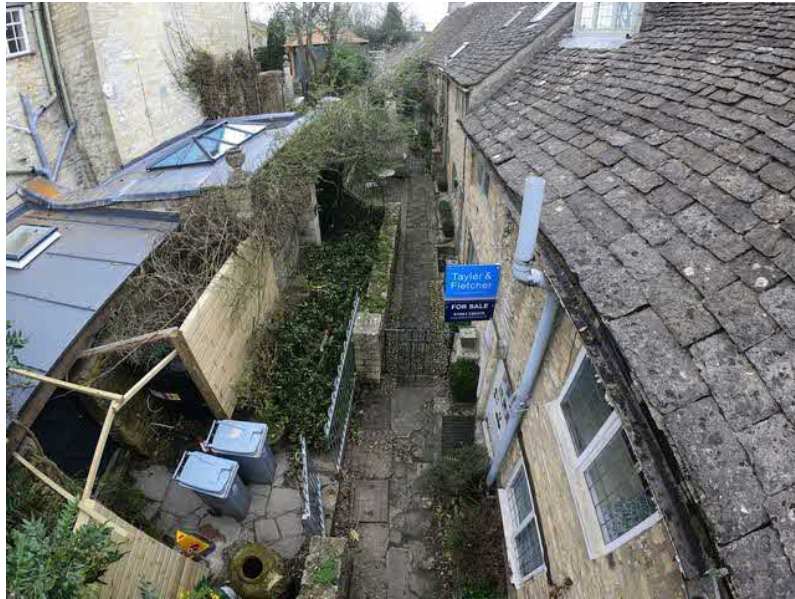
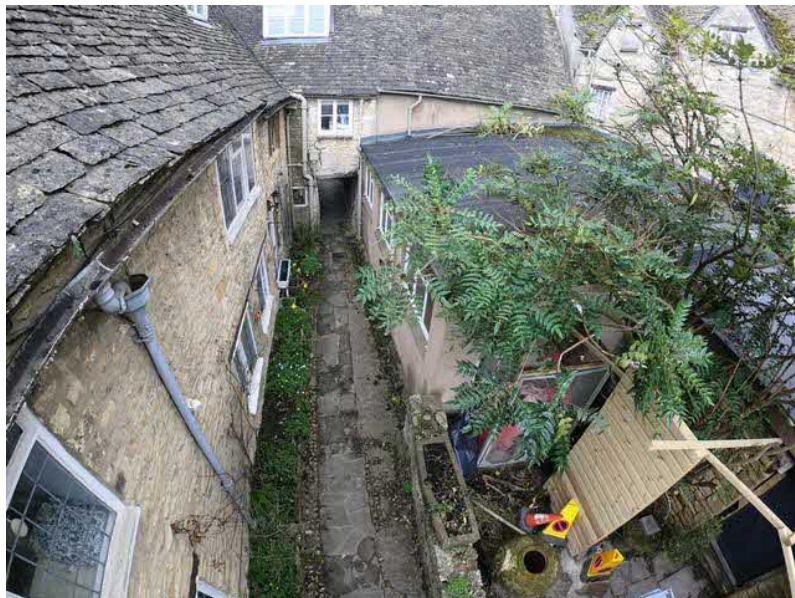
5.19 Shared path at front

- 4.09 The shared path at front serves this and a number of other properties. What are the ownerships of, rights of way over and repairing obligations relating to it? Can it be confirmed there will be no financial responsibility for maintaining the building adjacent to the High Street that the path passes through?
- 4.10 The small yard at rear is dilapidated. A grating appears to have been laid over an unpleasant void, possibly part of a drainage arrangement. Opening up, investigation and improvement are obviously required.
