Conservation Treatment Report – 6th July 2023

Waterwheel Frames

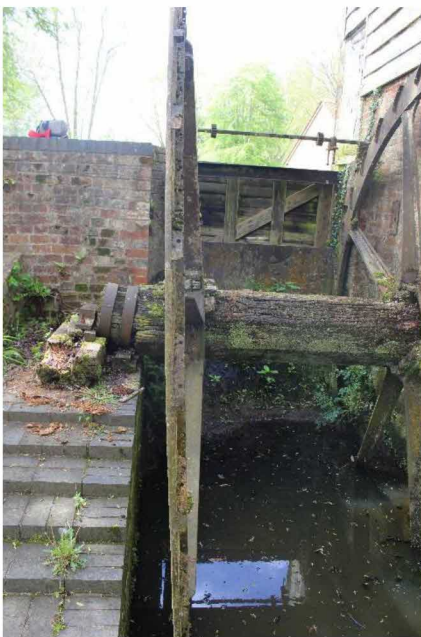
Figure 1: Before

Description: The cast iron water wheel frames required immediate attention to rectify the lack of support, security and safety due to the rotten oak axle and wedges. See page 3 of the Initial Conservation Assessment report dated 3rd June 2023 for further information.

Method: The two wheel frames were each brought as close as possible to the vertical plane. No stress or unnecessary force was applied to the venerable cast iron assemblies. Four-inch square, treated softwood timbers were cut to length to suit the distance between the two wheel frames. The timbers were secured at relevant intervals using black ratchet straps of the appropriate load rating. Black straps were selected to soften the visual appearance. The two frame assemblies were then essentially secured together. A ratchet strap was placed through the rear of the frames and secured to the RSJ at the rear of the penstock to secure the whole assembly.

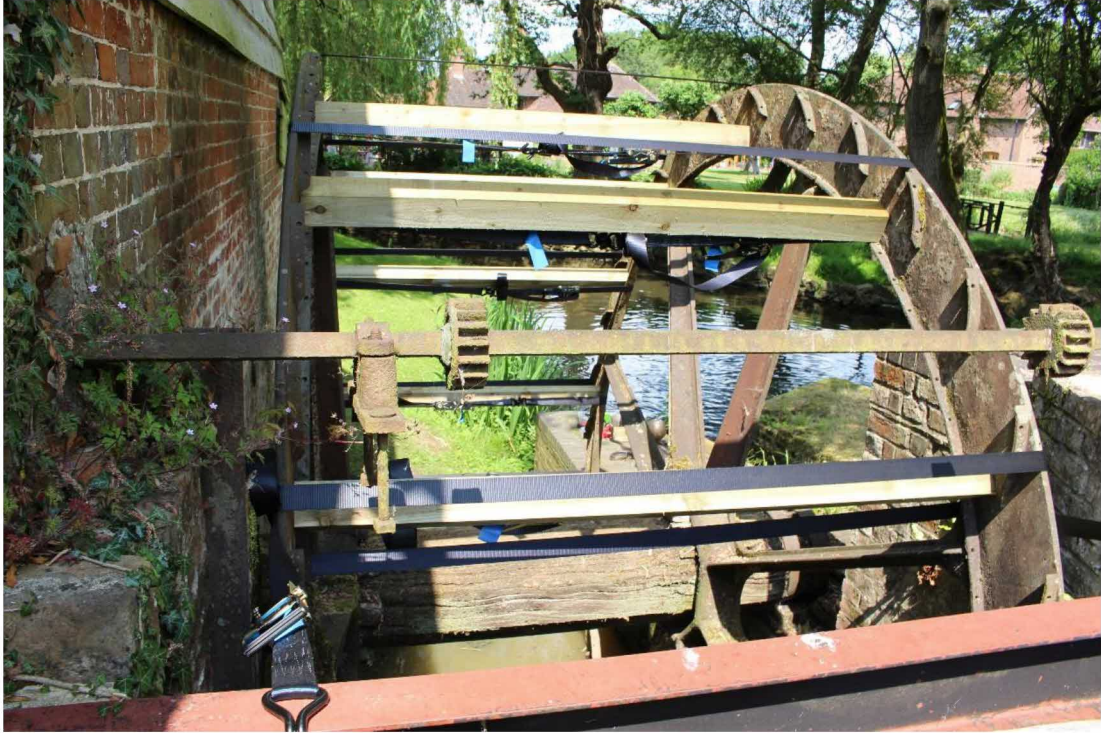
Figure 5: After

Result: Successful treatment. The wheel frames are now secure and stable and posing no safety risk.
