Conservation Treatment Report – 6th July 2023

Waterwheel Frames

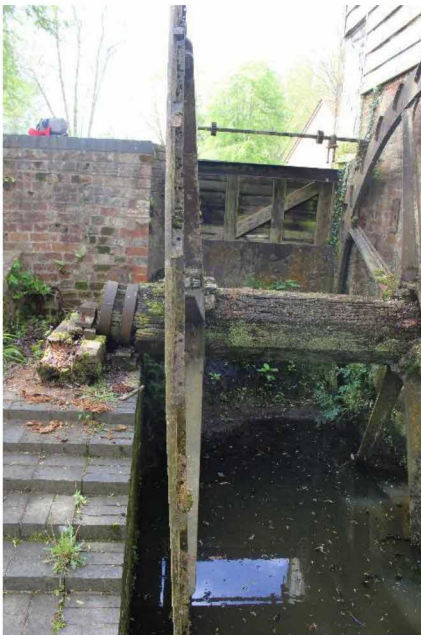
Figure 1: Before

Description: The cast iron water wheel frames required immediate attention to rectify the lack of support, security and safety due to the rotten oak axle and wedges. See page 3 of the Initial Conservation Assessment report dated 3rd June 2023 for further information.

Method: The two wheel frames were each brought as close as possible to the vertical plane. No stress or unnecessary force was applied to the venerable cast iron assemblies. Four-inch square, treated softwood timbers were cut to length to suit the distance between the two wheel frames. The timbers were secured at relevant intervals using black ratchet straps of the appropriate load rating. Black straps were selected to soften the visual appearance. The two frame assemblies were then essentially secured together. A ratchet strap was placed through the rear of the frames and secured to the RSJ at the rear of the penstock to secure the whole assembly.
