Our ref: 17163/PC/lc/Reports
By email: (r.gilroy@jonathan-rhind.co.uk)

Re: LANCARFFE, BODMIN – STABLE BLOCK

Further to our visit to the property on Thursday 29th June 2023, and our limited inspection of the stable block, together with having reviewed your supporting Planning Application documents, we comment as follows.

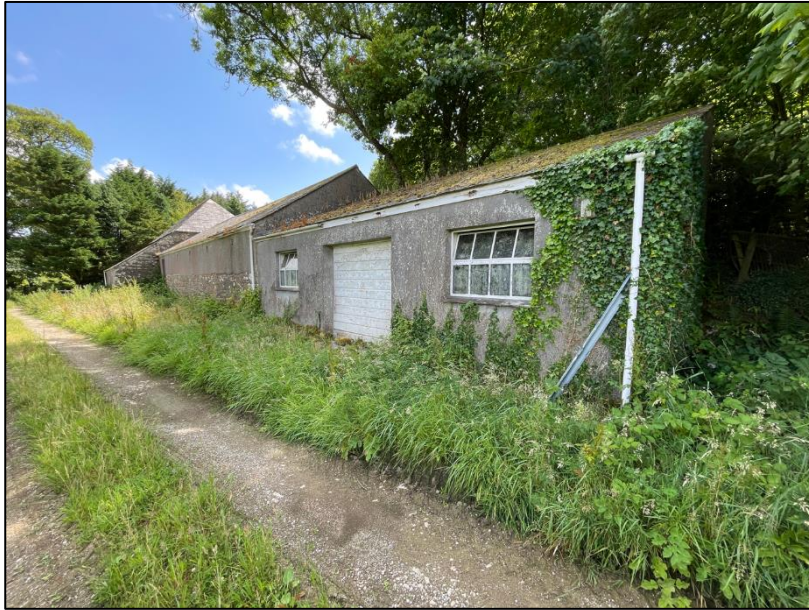
Modern barn or garage sited at the western end of the complex.

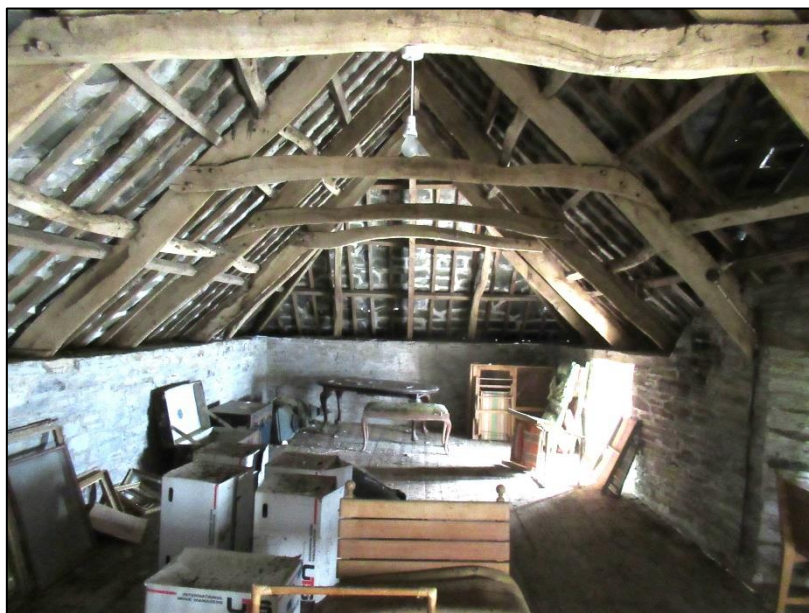
Original primary A frame oak trusses with later purlins & common rafters.

With respect to the stable block, the truss and purlin roof structure appears to be working reasonably well, but as part of the general maintenance and upgrading of the roof slating and infilling holes etc., it will be important to check the condition of the principal trusses and associated timberwork, including the truss connections, which may need tightening to a degree, together with the quality of the timber bearings which bear off the head of the stone wall. It is possible that some minor rot and deterioration has occurred to the underside of the timber where it is in contact with a damp bearing stone. It may also be found that some minor rafter repairs will be required, particularly local to the eaves, or where there has been longstanding holes in the slating.

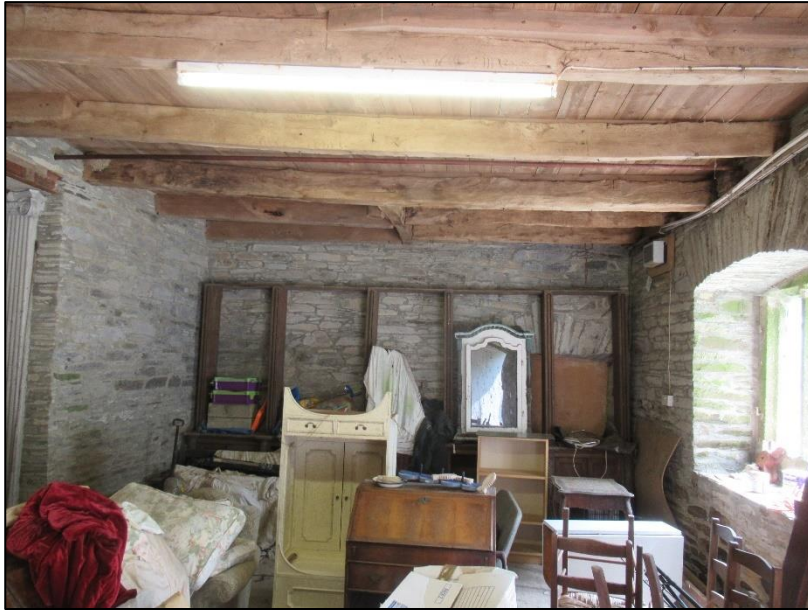
Existing first floor structure with original oak joists spanning the width of the building supporting later boarding.

The attic floor structure of boarding and joists is quite weak, with the joists being set at 800c/c; however, it is proposed to retain the current usage of light storage and it is not intended to attach a ceiling to the underside of the floor structure, thereby adding more weight and making it more vulnerable to excessive deflections.

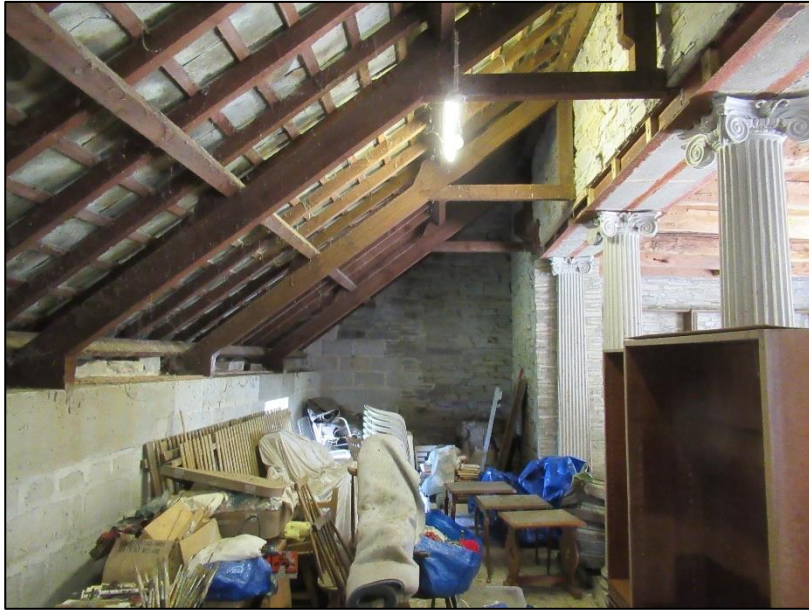
C20 extension built on to the north west side of the original stables.

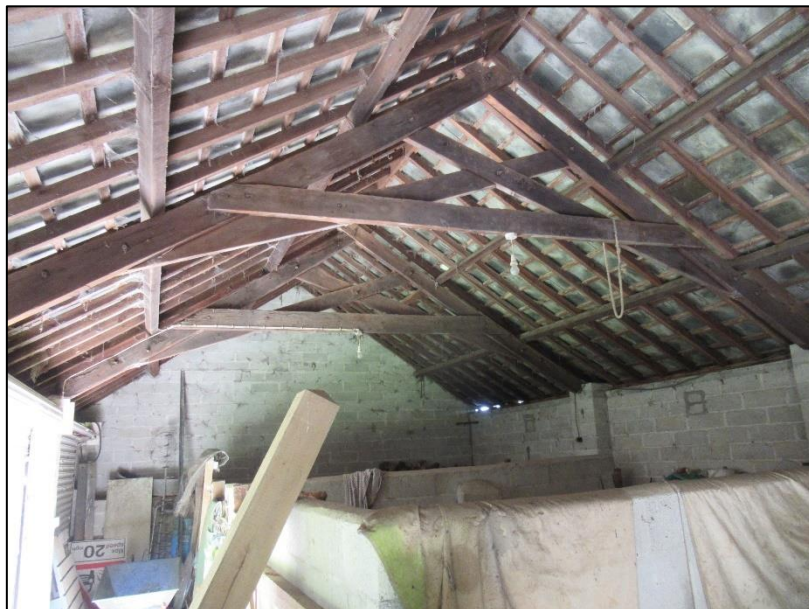
Truss and purlin roof structure supported on concrete block walls, in turn generally built off earlier stone walls.

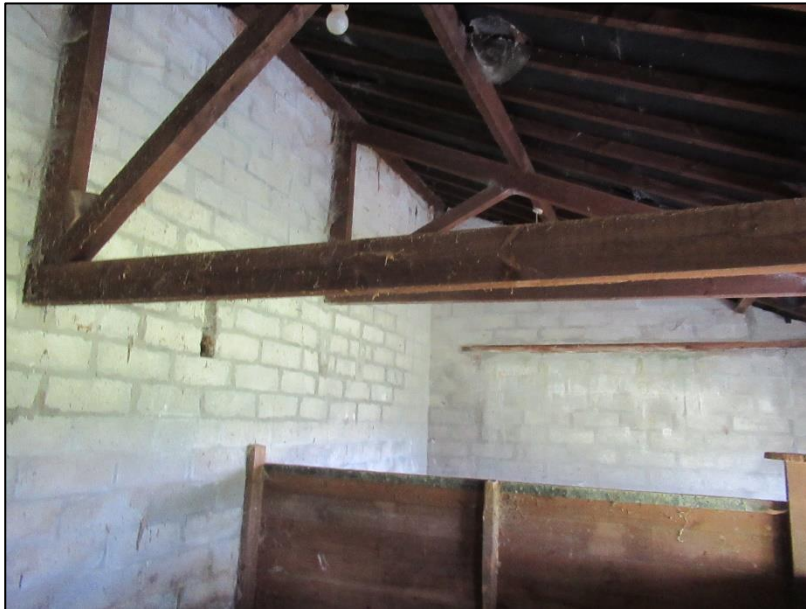
Monopitch trusses within the modern west barn supporting the roof structure.

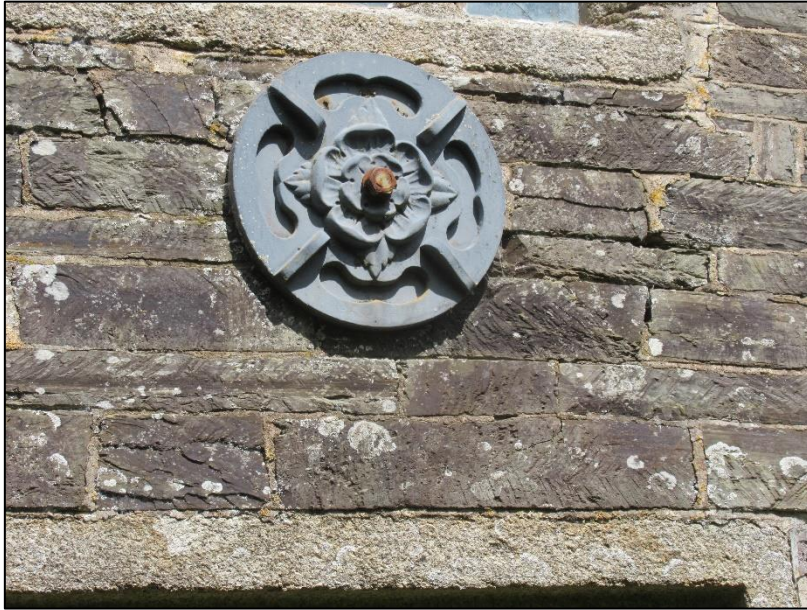
The original principal walls to the stable are quite robust and structurally adequate. However, there is longstanding evidence of some delamination between the inner and outer veneers of stonework on the front south eastern elevation around the windows and over the doorway. Historically a steel tie rod has been added over the eastern window set within the attic floor zone, linking the front and rear walls and curtailed with pattress plates.

Pattress plate set between the eastern windows within the front elevation.

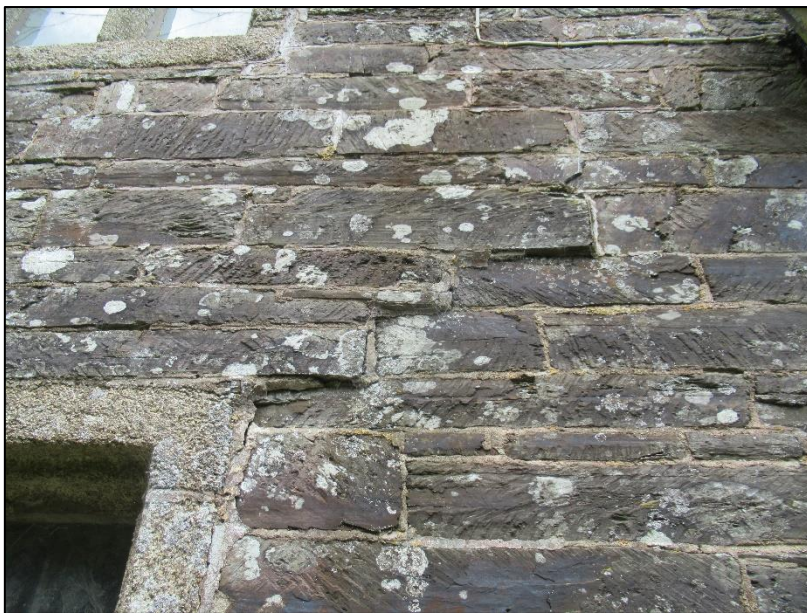
The localised minor movement has been worsened to a degree by open joints and the ingress of water. It is also likely that there is no mechanical connection between the granite window surrounds and the abutting stonework.

Longstanding delamination and bulging of the stonework over the eastern window within the front elevation

Localised repointing and possible rebedding of one or two stones would be recommended, together with potentially adding some remedial stainless steel ties, resin fixed to the back of the inner leaf and built in to the outer leaf. The localised cracking and elements of misshapen wall are not of structural concern, but localised repairs would be prudent as part of the upgrading of the building.

The repair mortar for undertaking remedial works to the random rubble stone should be an approved lime mortar as near compatible with the original as is possible, although as previously outlined, this was largely earth based. The optimum remedial mortar should be a lime and sand mix.

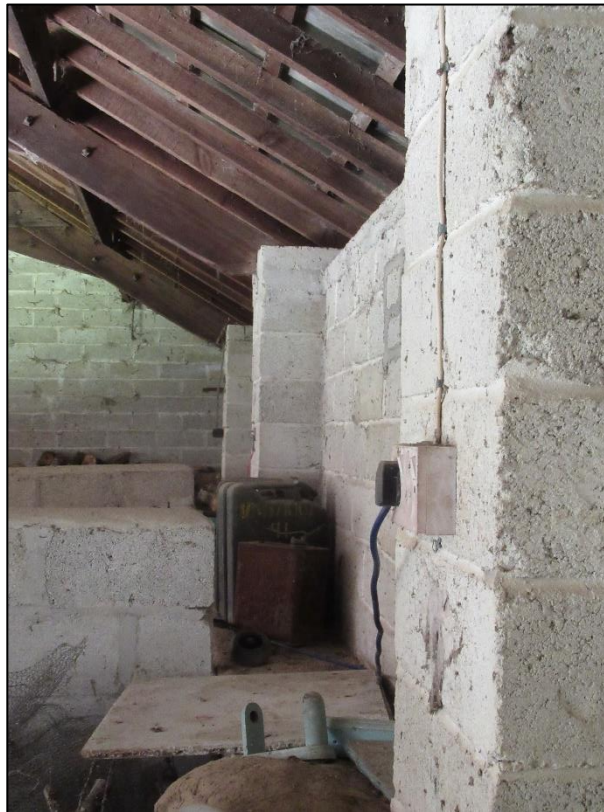
There is evidence of slight long-term structural movement associated with the rear north west wall of the central barn, which as outlined, includes concrete blockwork built off an original random rubble stone wall. The principal scissor roof trusses are tied just above eaves and show minimal deflection, but it is evident that the north west wall has rotated outwards slightly, including the lower random rubble stone wall off which the blockwork is built.

The wall and piers are built on the outer edge of the stone wall, resulting in a degree of eccentricity with the loading arrangement onto the stone wall, and it is thought that there has been some marginal transverse differential settlement of the stone wall and its substructure as a result of being on the downhill aspect of the site, shallowly founded poor quality bearing ground, very possibly made worse by inadequate discharge of roof rainwater.

North west wall of middle barn suffering from longstanding marginal differential transverse settlement.

As part of the upgrading of the building we would recommend that the evident cracking is stitched and repointed, the roof rainwater gutters and downpipes are replaced or upgraded, allowing for the downpipes to be collected in suitable gulleys and discharged at least 5m away from the building.

In addition, the substructure and dwarf wall stonework should be locally repointed where required and open jointed, with the situation subsequently monitored.

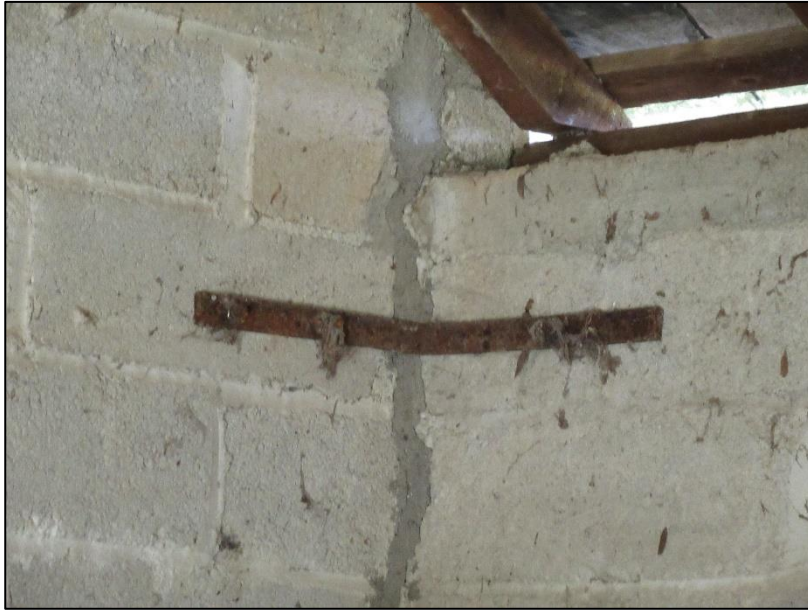
It is thought that this movement probably occurred fairly soon after the blockwork was constructed on top of the wall in C20. It has resulted in reflective cracking where the wall abuts return internal blockwork walls, with noticeable cracking evident.

**Previous strapping introduced to western corner of the barn with previous cracking infilled.
No serious evidence of recent significant movement in this area.**

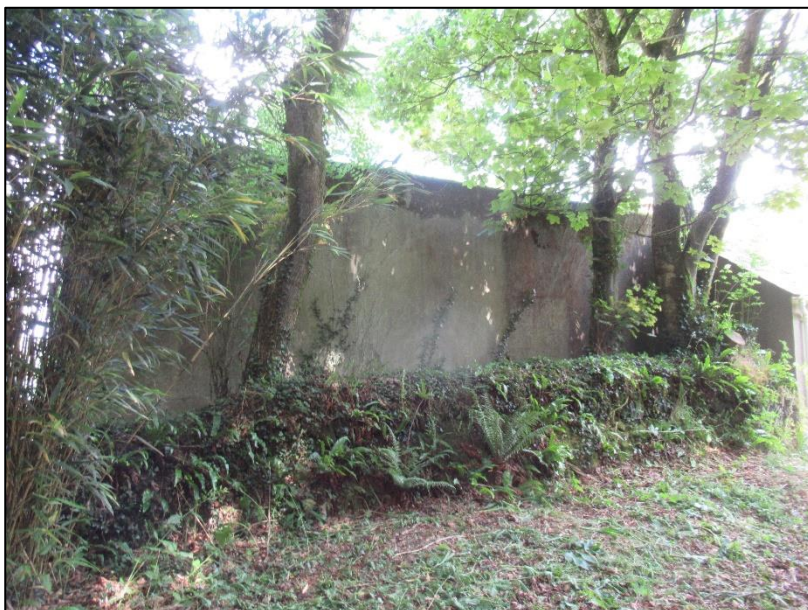
The modern western is sited very close to the Cornish bank on the south east side, which is well vegetated and includes quite large trees growing over the building. It would be prudent to allow for an arborist, or similar tree surgeon, to check the trees and possibly coppice them, to ensure that they do not have a detrimental effect on the building.

Trees and Cornish bank very close to south east wall of barn.

In addition, the gap between the bank and the front wall of the building should be kept clear of vegetation with surface water adequately 'channelled' away from the building.

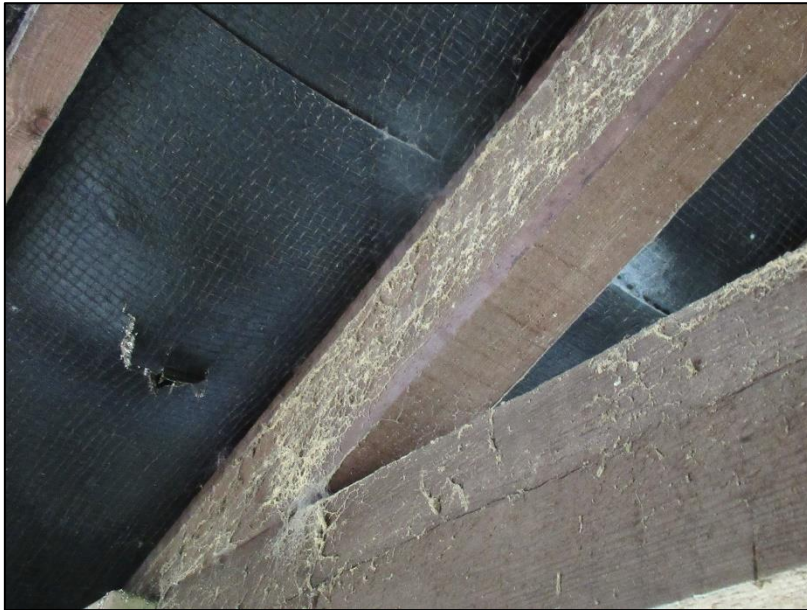
We noted in the later barns that there were a number of the C20 timbers which were suffering from beetle attack. These should be checked and treated.

Live furniture beetle infestation on C20 timbers should be sporadically treated as required.
