Appendix B Photofile of Current Site Conditions

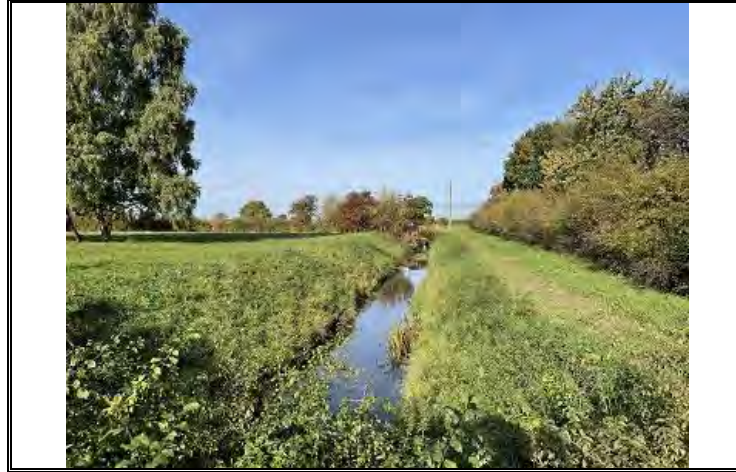
Photo OE/1702/1048/R1/P01 – View of drainage ditch on left hand side of site entrance

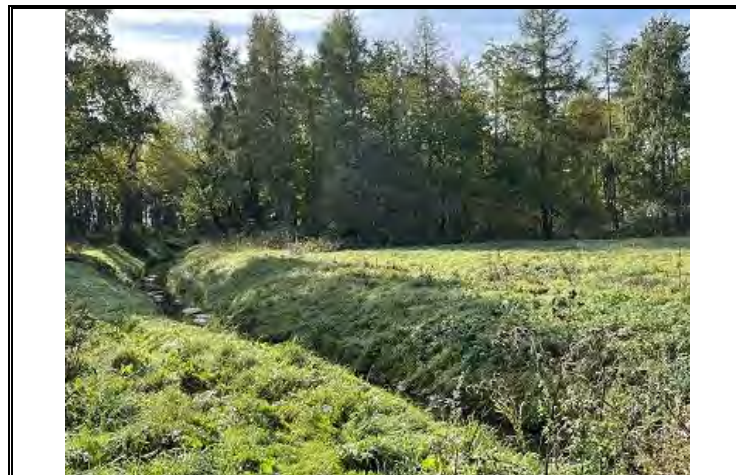
Photo OE/1702/1048/R1/P02 – View of drainage ditch on right hand side of site entrance

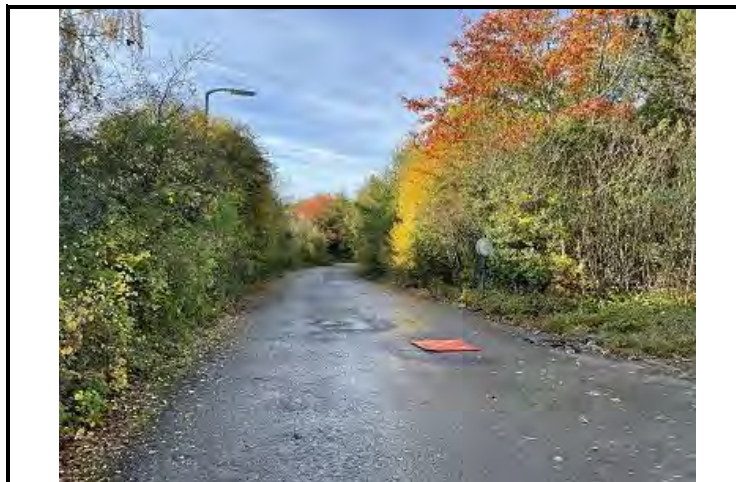
Photo OE/1702/1048/R1/P03 – Access road into the site to be retained

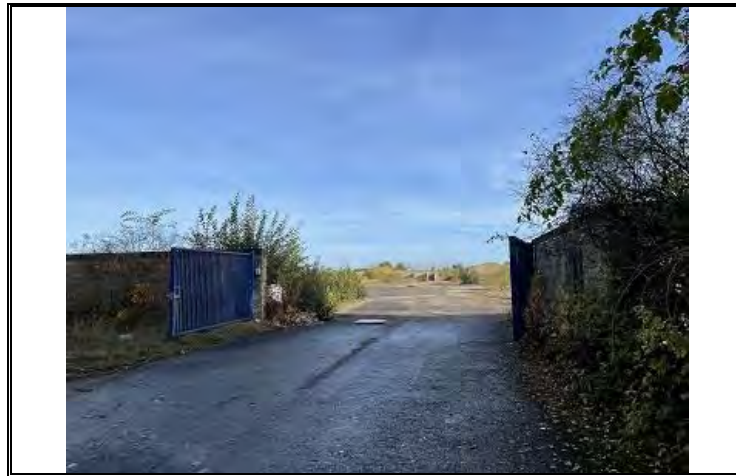
Photo OE/1702/1048/R1/P04 – Access to main area of the site – location of the two former 7.0m diameter mine shafts – now capped

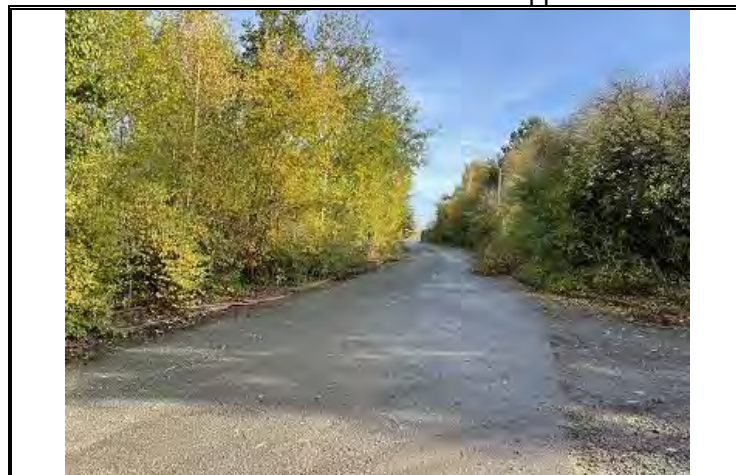
Photo OE/1702/1048/R1/P05 – Internal access roads to be retained

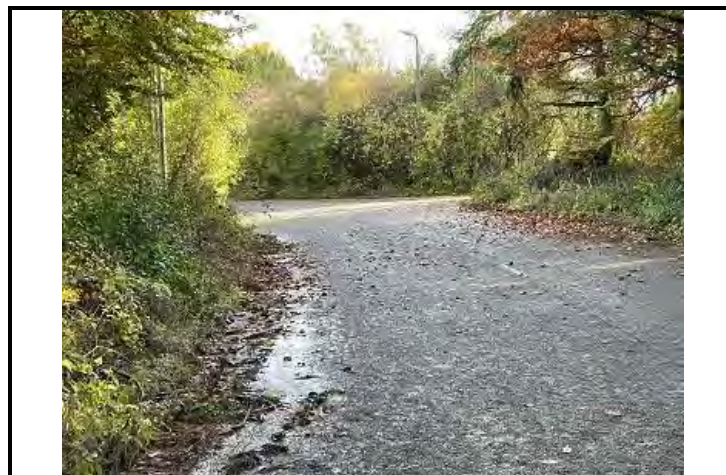
Photo OE/1702/1048/R1/P06 – Internal access roads to be retained

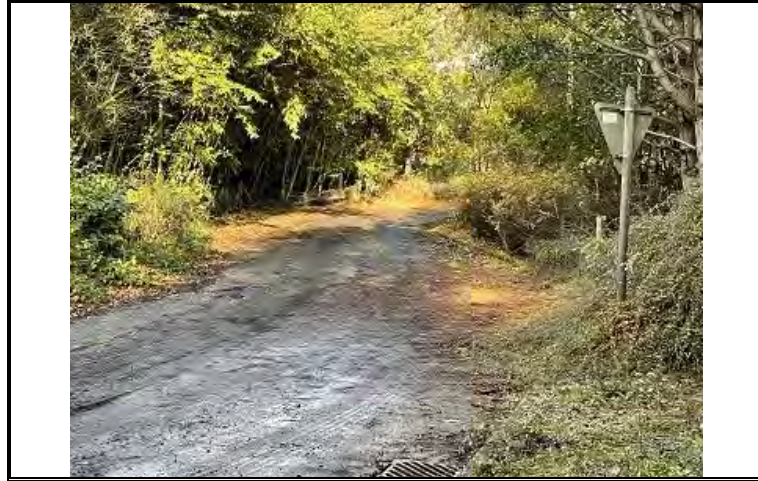
Photo OE/1702/1048/R1/P07 – Internal access roads to be retained

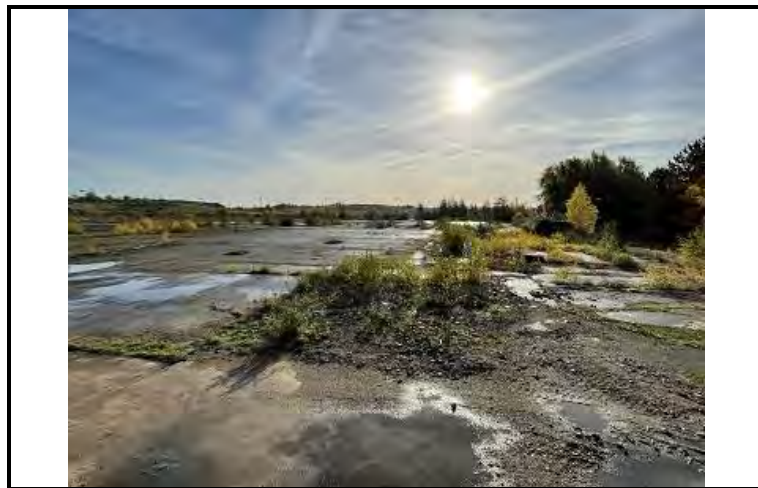
Photo OE/1702/1048/R1/P08 – General view of site and exposed concrete slabs - looking southeast.

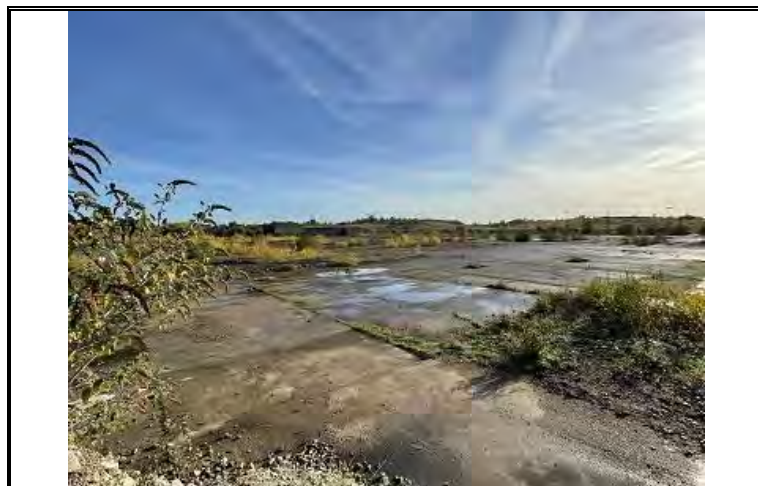
Photo OE/1702/1048/R1/P09 – General view of site and exposed concrete slabs – looking north.

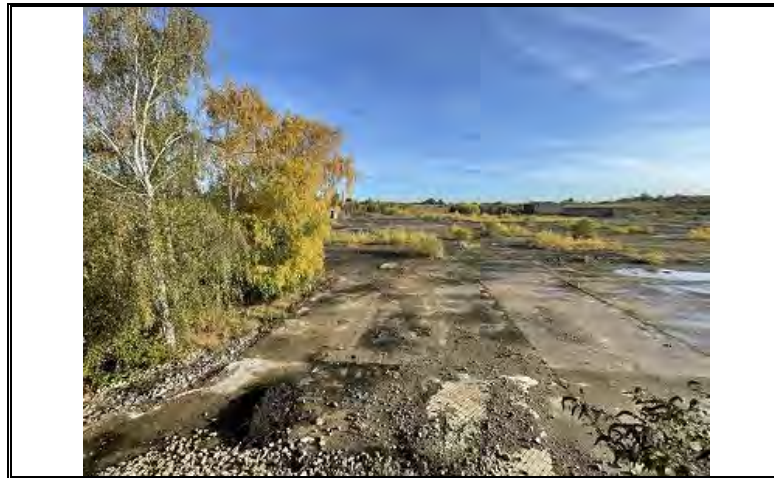
Photo OE/1702/1048/R1/P10 – General view of site and exposed concrete slabs – looking southwest.

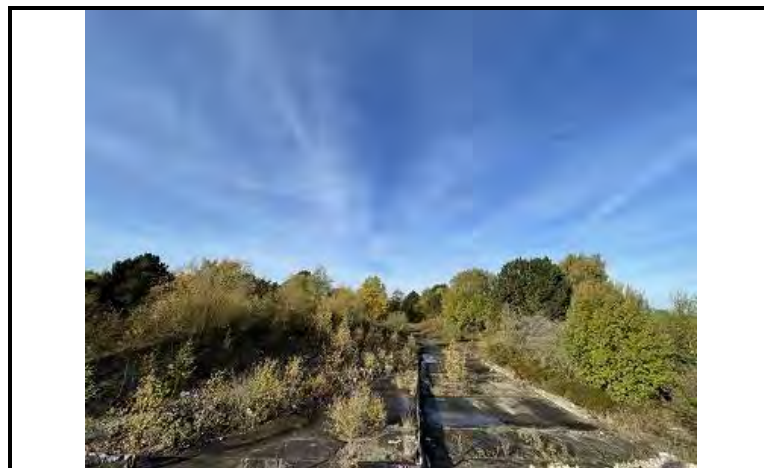
Photo OE/1702/1048/R1/P11 – Exiting stockpile – material tested in 2021 - RSK Report

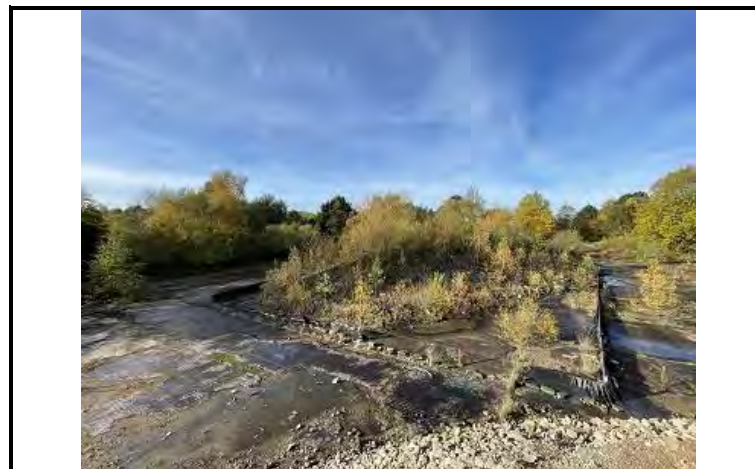
Photo OE/1702/1048/R1/P12 – Exiting stockpile – material tested in 2021 - RSK Report – southern area of the site.

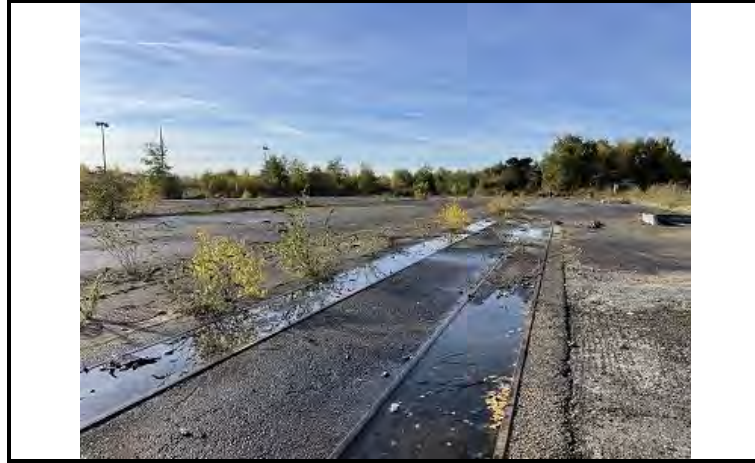
Photo OE/1702/1048/R1/P13 – View of mineral railway line within concrete slabs.

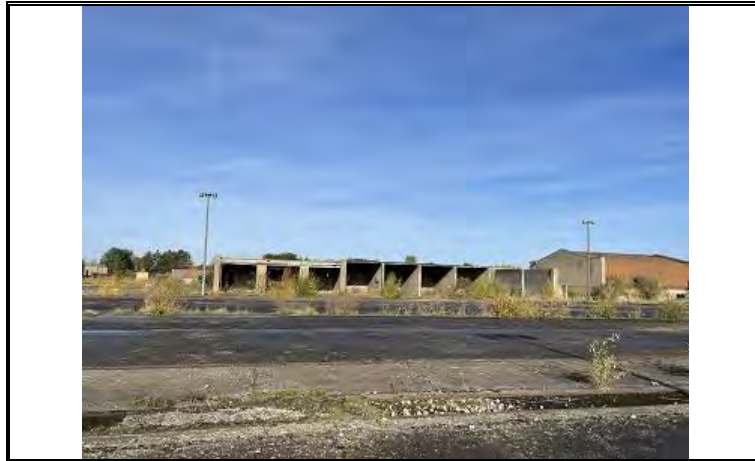
Photo OE/1702/1048/R1/P14 – General view of eastern side of former buildings – looking southwest.

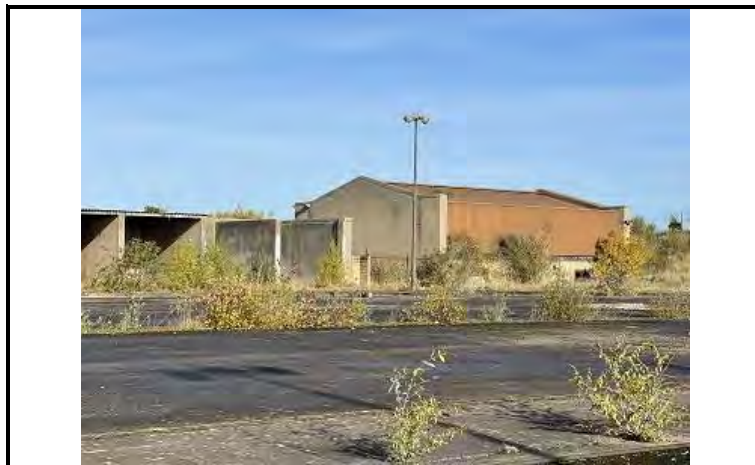
Photo OE/1702/1048/R1/P15 – Former buildings – looking southwest – to be refurbished.

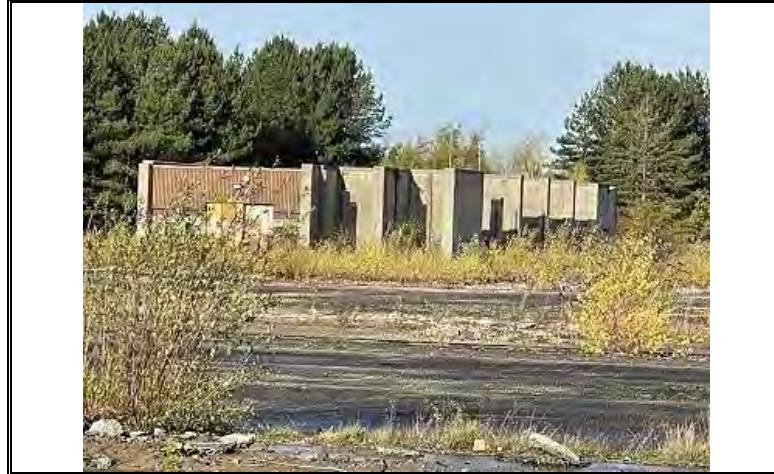
Photo OE/1702/1048/R1/P16 – Former buildings – looking southwest – to be refurbished.

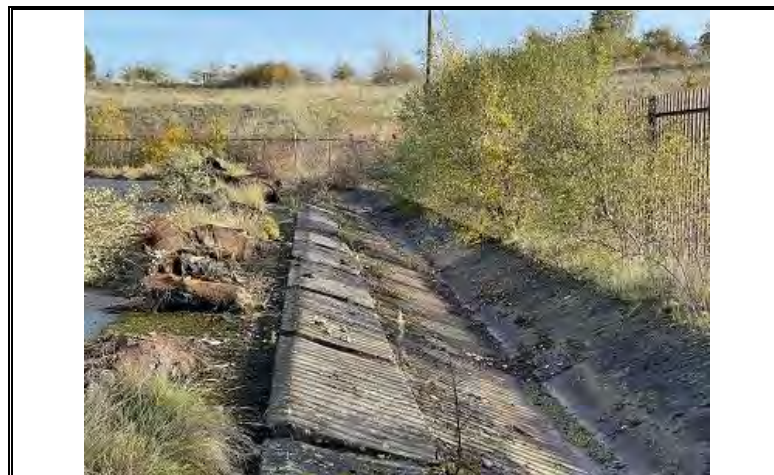
Photo OE/1702/1048/R1/P17 – Concrete lined storm water channel at perimeter of former coal mine site – east side of site – looking north

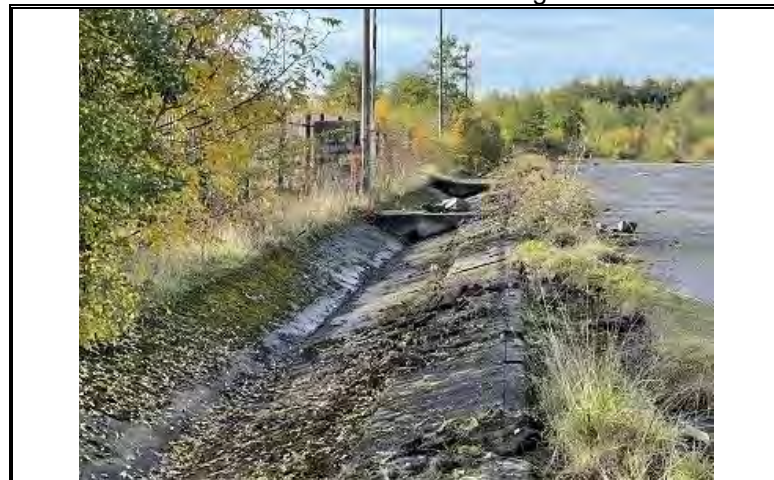
Photo OE/1702/1048/R1/P18 – Concrete lined storm water channel at perimeter of former coal mine site – east side of site – looking south

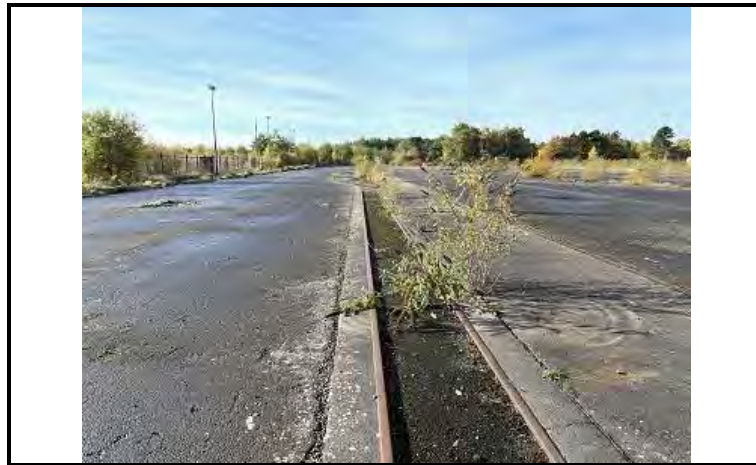
Photo OE/1702/1048/R1/P19 – View of mineral railway line within concrete slabs, near to eastern boundary and landscaping area.

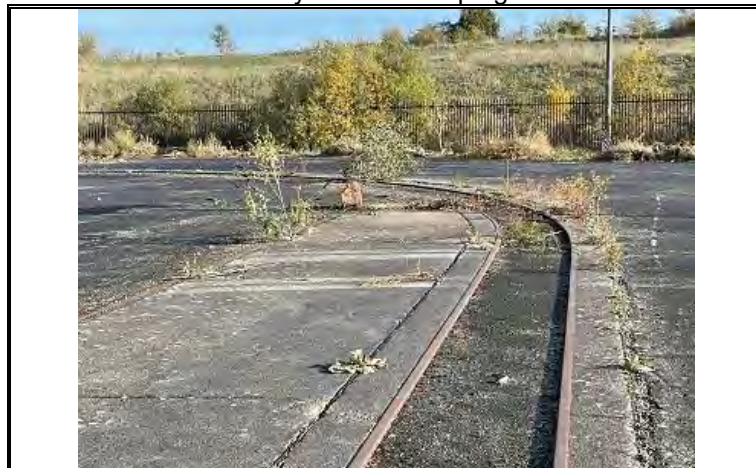
Photo OE/1702/1048/R1/P20 – View of mineral railway line within concrete slabs, near to northern boundary and landscaping area/bund.

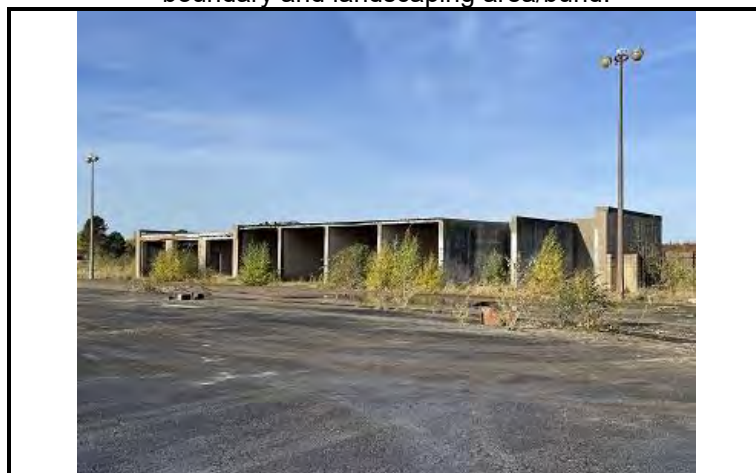
Photo OE/1702/1048/R1/P21 – Existing buildings on the site – to be refurbished.

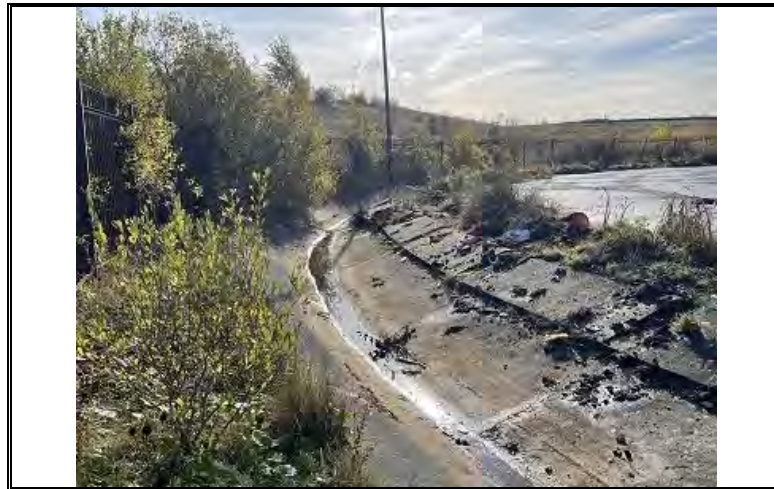
Photo OE/1702/1048/R1/P22 – Concrete lined storm water channel at perimeter of former coal mine site – north side of site – looking east.

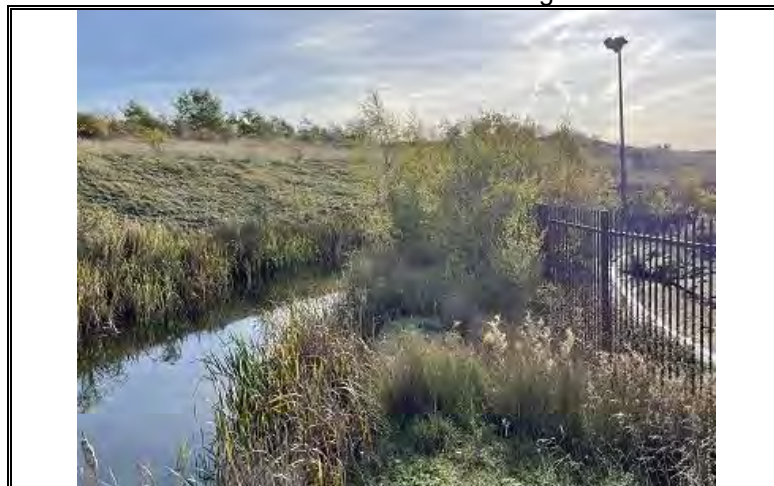
Photo OE/1702/1048/R1/P23 – Downstream collection pond from the storm water channels between the boundary of the site and the landscaping bund on the northern boundary.

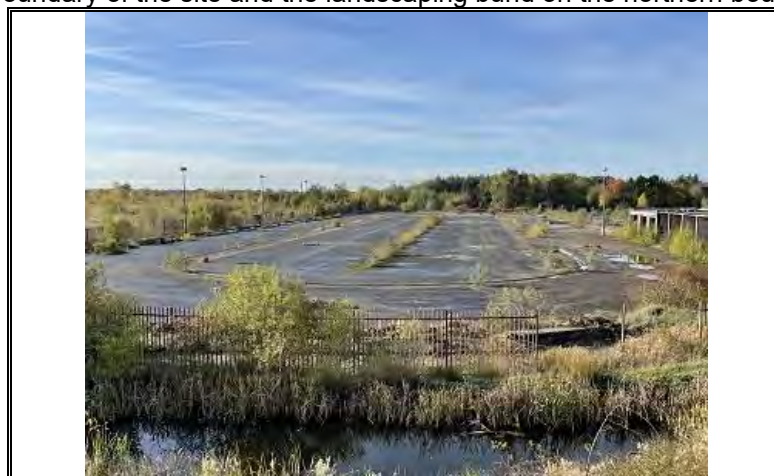
Photo OE/1702/1048/R1/P24 – View of pond and site from northern bund.

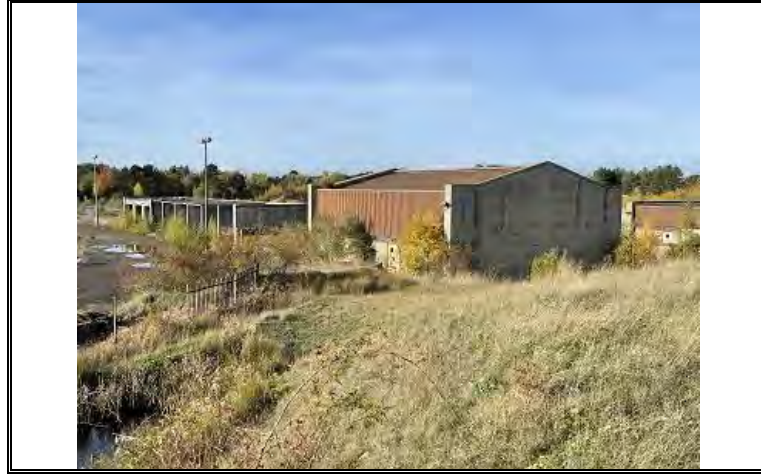
Photo OE/1702/1048/R1/P25 – Buildings on the site near to western boundary.

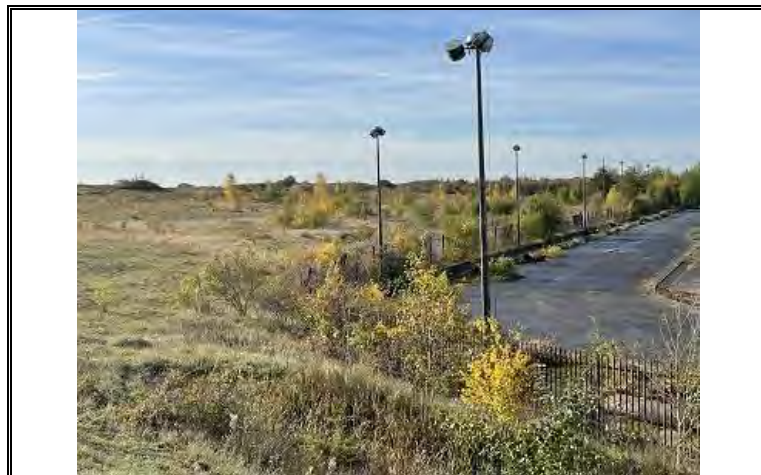
Photo OE/1702/1048/R1/P26 – Landscaped area on eastern side of the site.

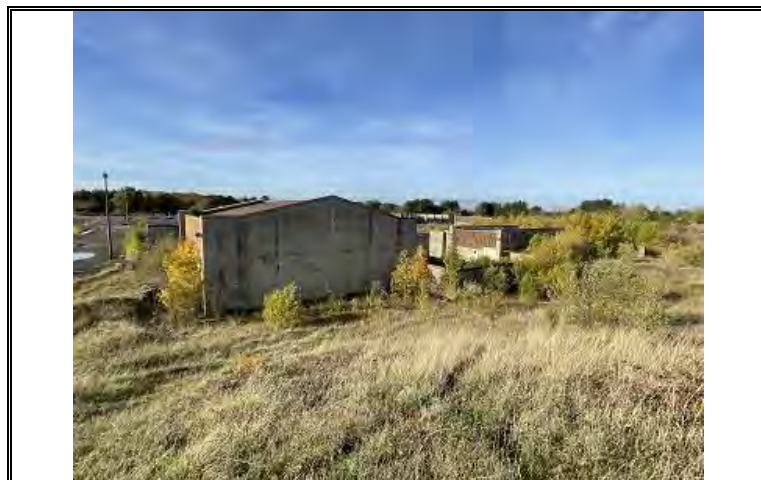
Photo OE/1702/1048/R1/P27 – Landscaped area and bunds on western side of the site.

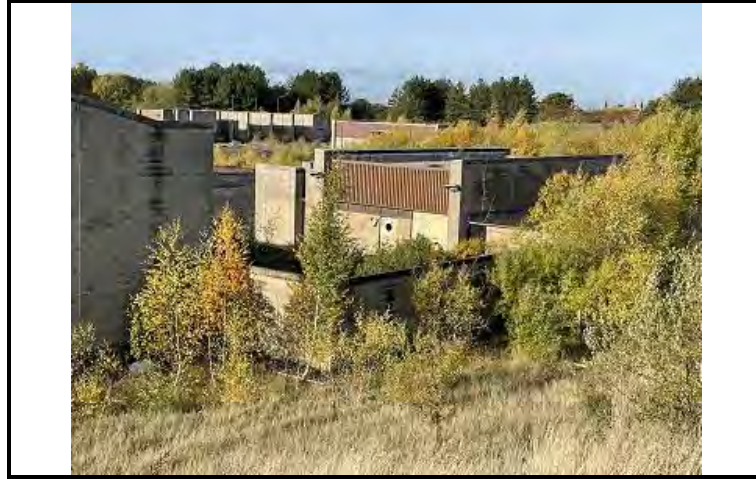
Photo OE/1702/1048/R1/P28 – Landscaped area and bunds on western side of the site.

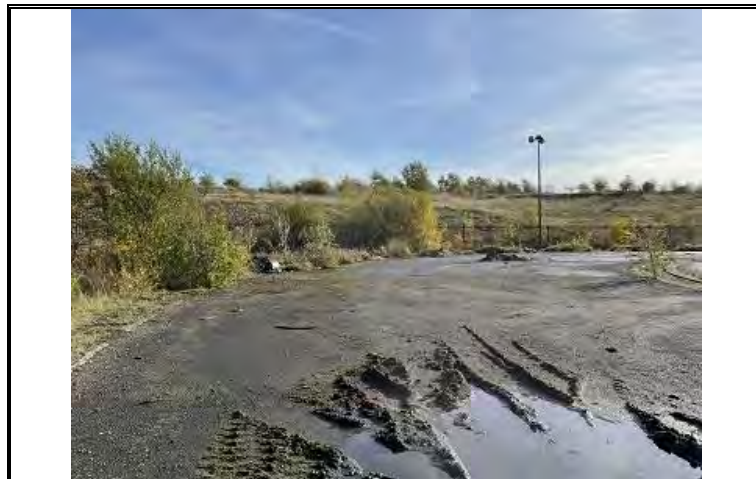
Photo OE/1702/1048/R1/P29 – View of northern boundary bund.

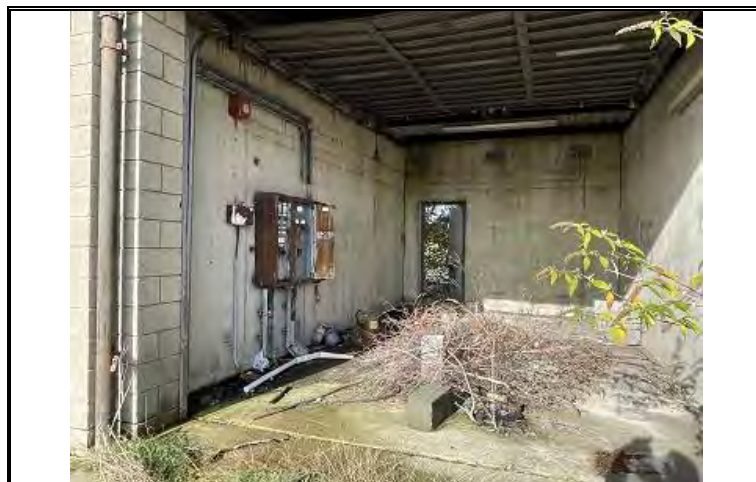
Photo OE/1702/1048/R1/P30 – Inside a building on the western side of the site.

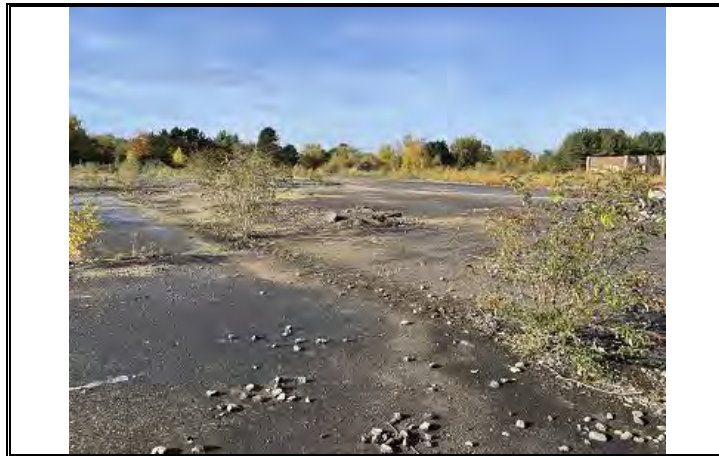
Photo OE/1702/1048/R1/P31 – View of central area – looking north to south

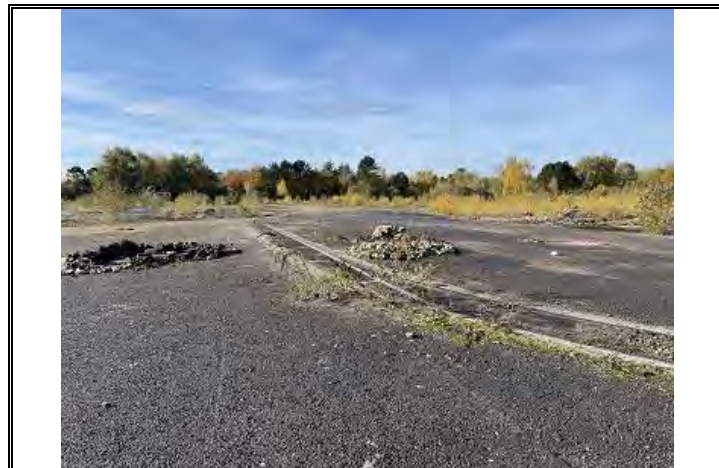
Photo OE/1702/1048/R1/P32 – View of central area – looking north to the southeast.

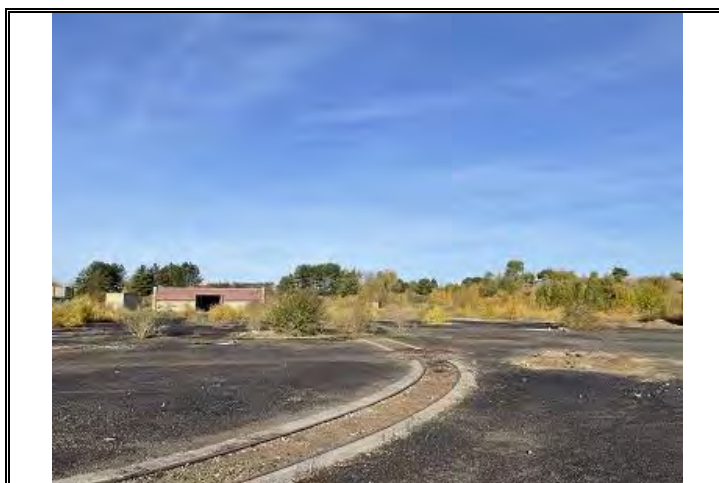
Photo OE/1702/1048/R1/P33 – View of central area – looking north to the west.

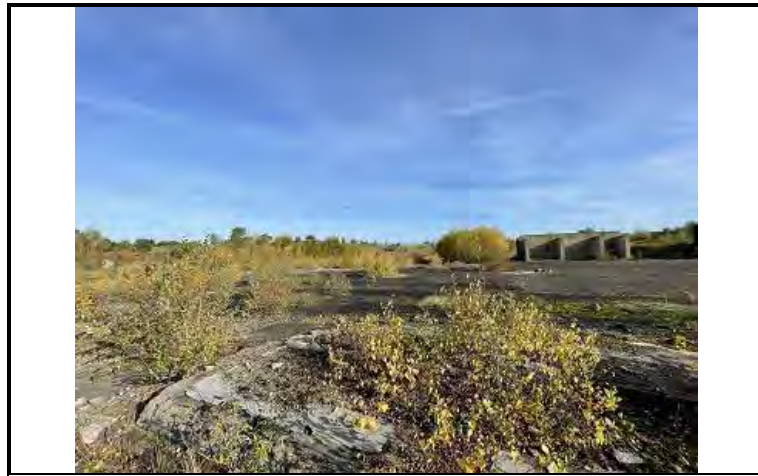
Photo OE/1702/1048/R1/P34 – General view of the site – looking north.

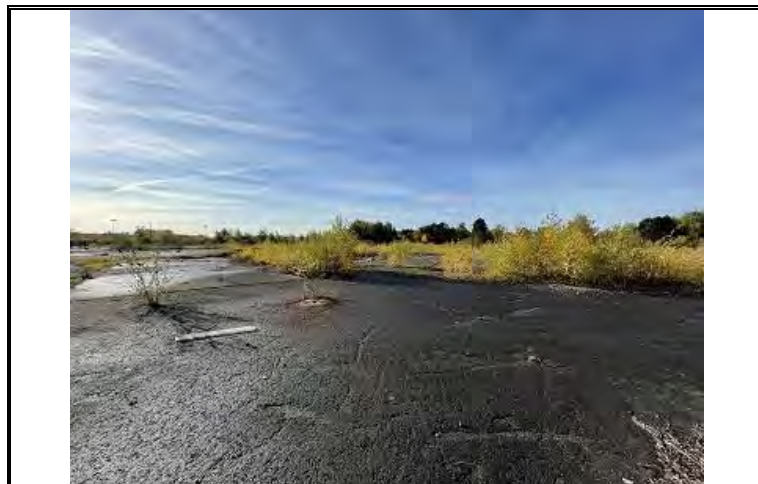
Photo OE/1702/1048/R1/P35 – Central area.

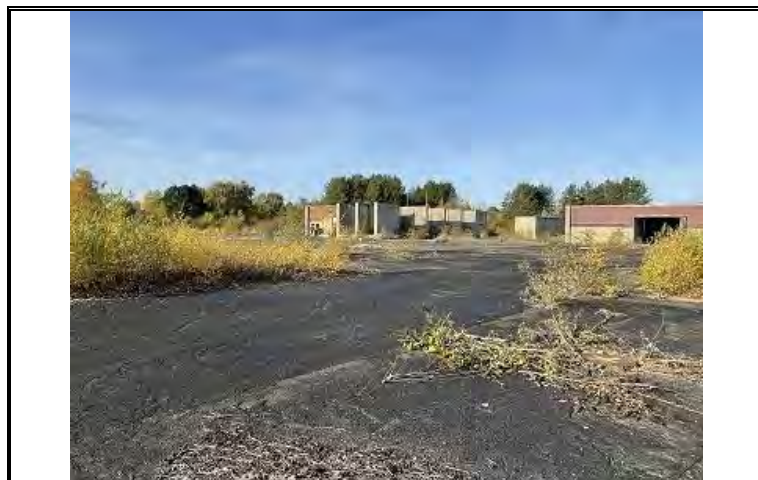
Photo OE/1702/1048/R1/P36 – Existing buildings on the site.

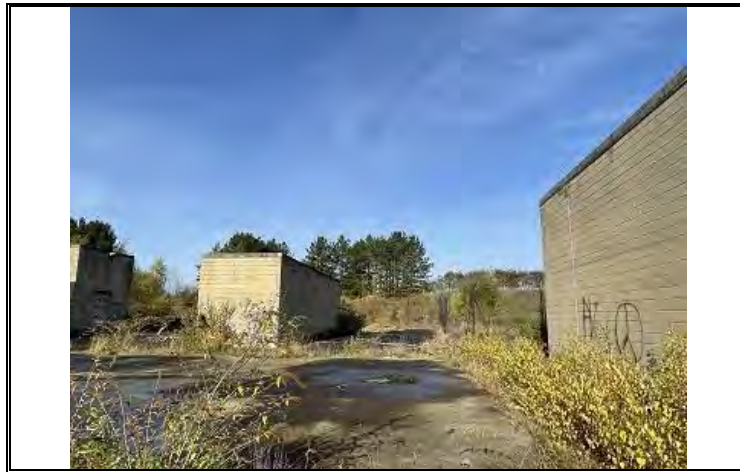
Photo OE/1702/1048/R1/P37 – Existing buildings on the site.

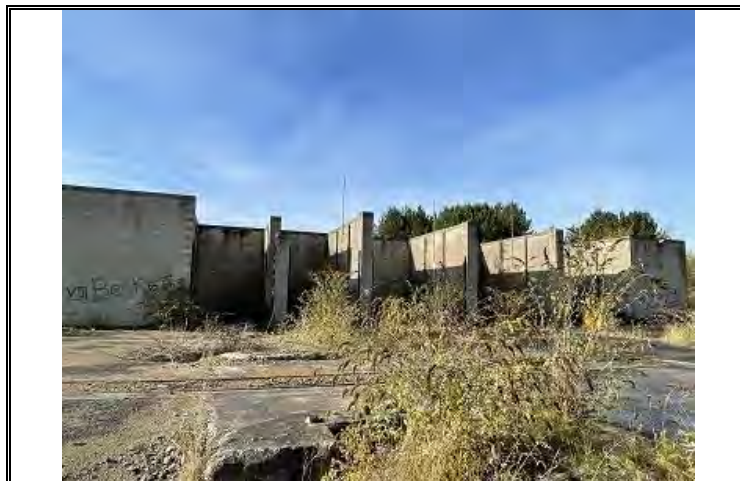
Photo OE/1702/1048/R1/P38 – Existing buildings on the site.

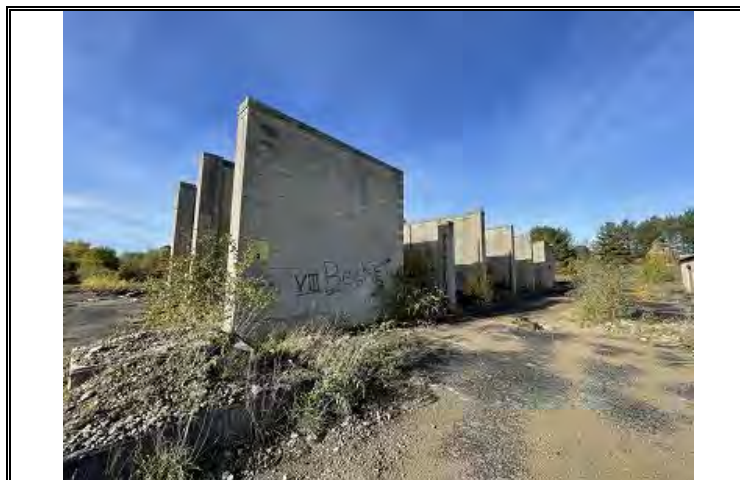
Photo OE/1702/1048/R1/P9 – Existing buildings on the site.

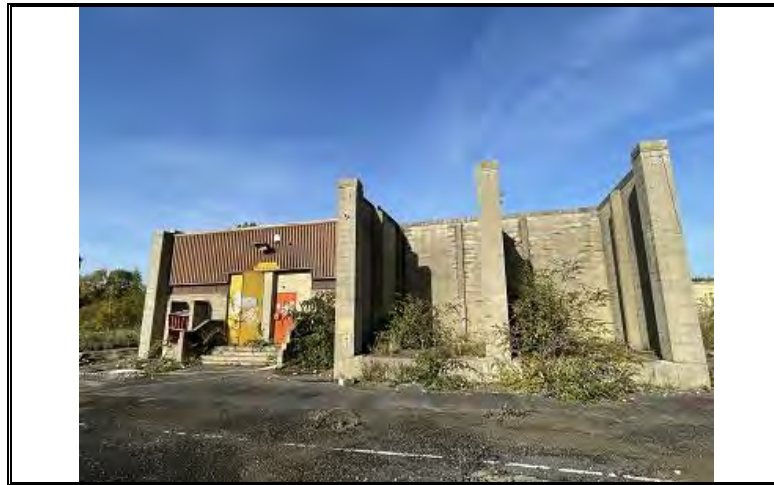
Photo OE/1702/1048/R1/40 – Existing buildings on the site – main electrical sub-station on the site – near western boundary.

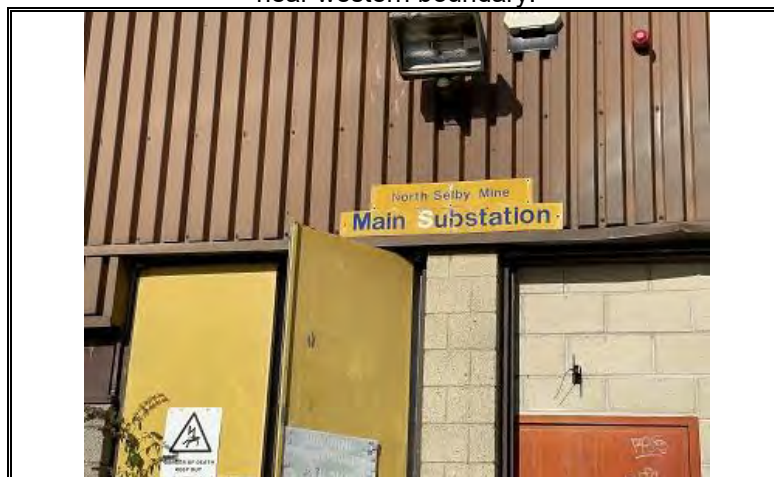
Photo OE/1702/1048/R1/P41 – Existing buildings on the site – main electrical sub-station on the site – near western boundary.

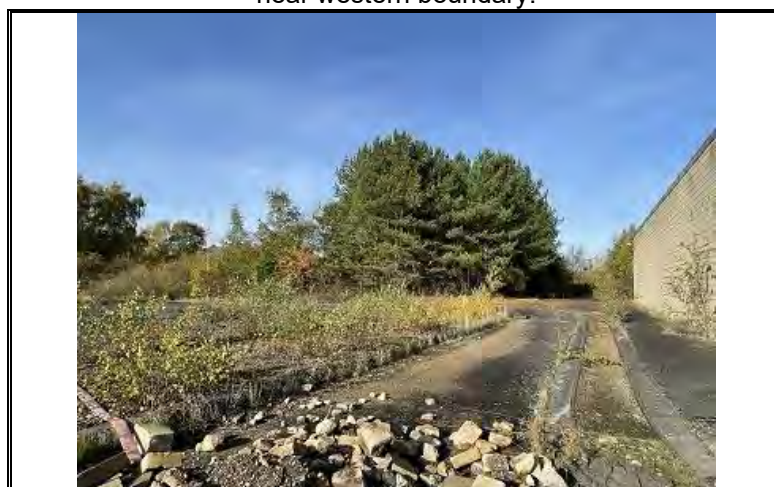
Photo OE/1702/1048/R1/P42 – General at western side of the site – side of electrical sub-station.

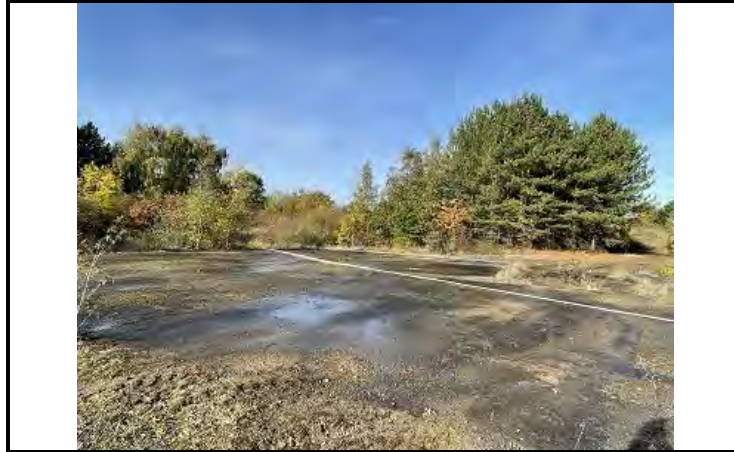
Photo OE/1702/1048/R1/P43 – South west corner of the site – main area.

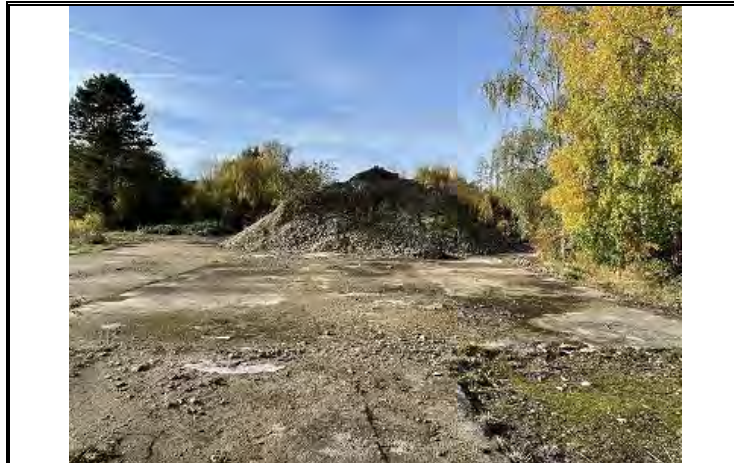
Photo OE/1702/1048/R1/P44 – Existing mound of crushed demolition waste – sampled and tested – see RSK Phase II Report 2021.

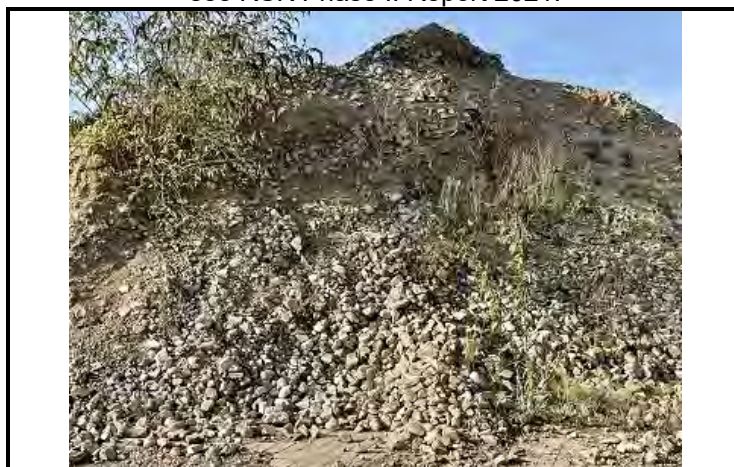
Photo OE/1702/1048/R1/P45 – Existing mound of crushed demolition waste – sampled and tested – see RSK Phase II Report 2021 – southern area of main site.

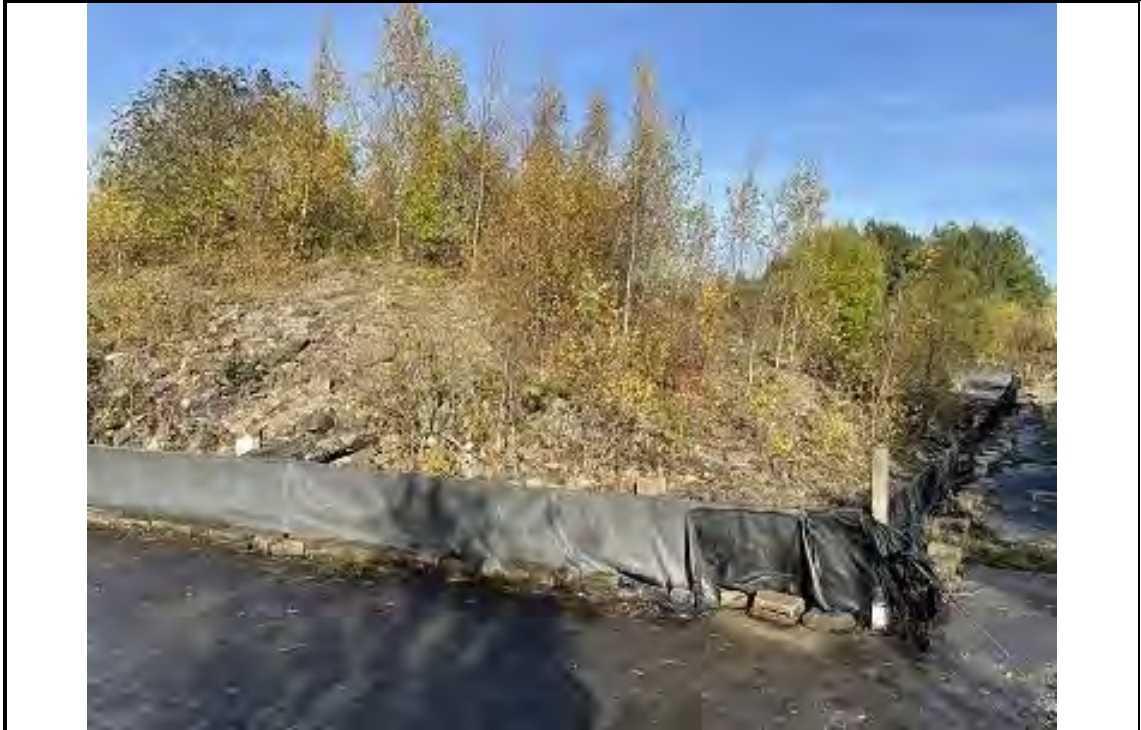
Photo OE/1702/1048/R1/P46 – Existing mound of crushed demolition waste – sampled and tested – see RSK Phase II Report 2021 – southern area of main site.

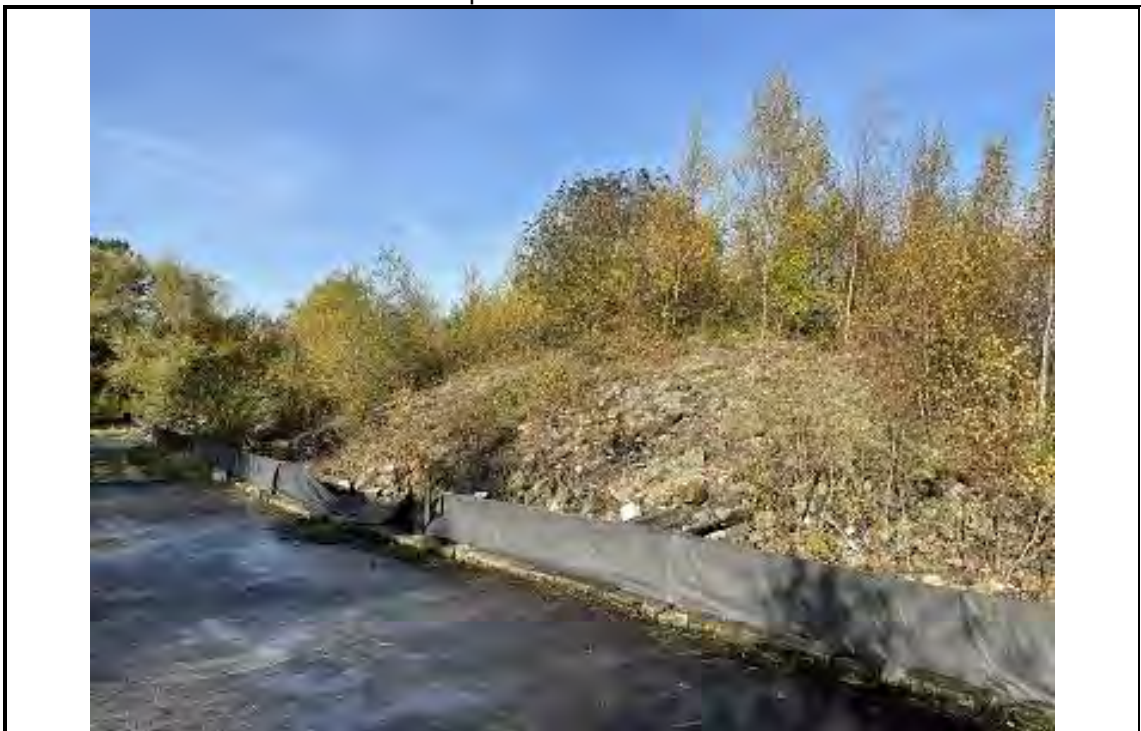
Photo OE/1702/1048/R1/P47 – Existing mound of crushed demolition waste – sampled and tested – see RSK Phase II Report 2021 – southern area of main site.
