## TECHNICAL REPORT ON A SUBSIDENCE CLAIM

Crawford Reference: SU2202775

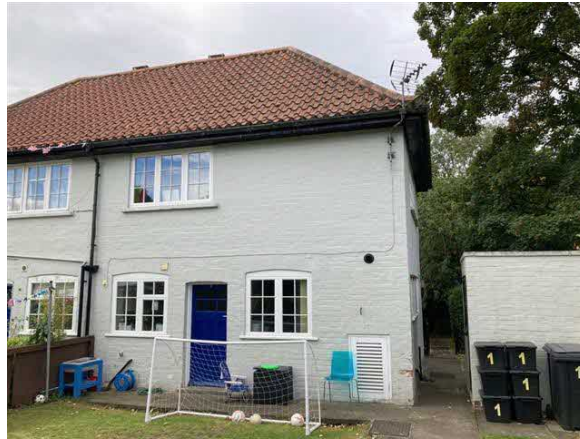
The Joseph Rowntree Foundation  
1 Western Terrace  
York  
YO32 4BW

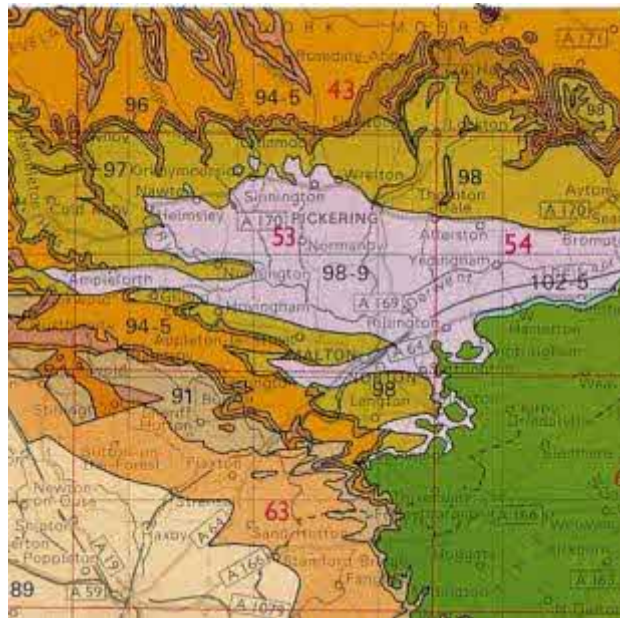
Geology. Reproduced with consent of The British Geological Survey at Keyworth. Licence IPR/34-7C CSL British Geological Survey. ©NERC. All rights Reserved.

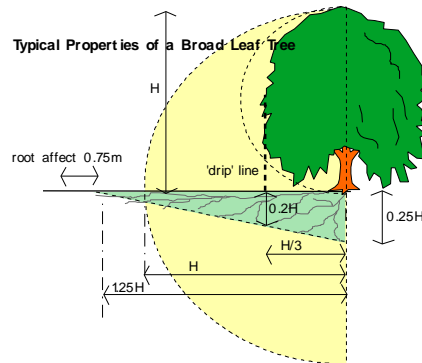
Typical proportions of a broadleaf tree. Note the potential root zone. It must be noted that every tree is different, and the root zone will vary with soil type, health of the tree and climatic conditions.

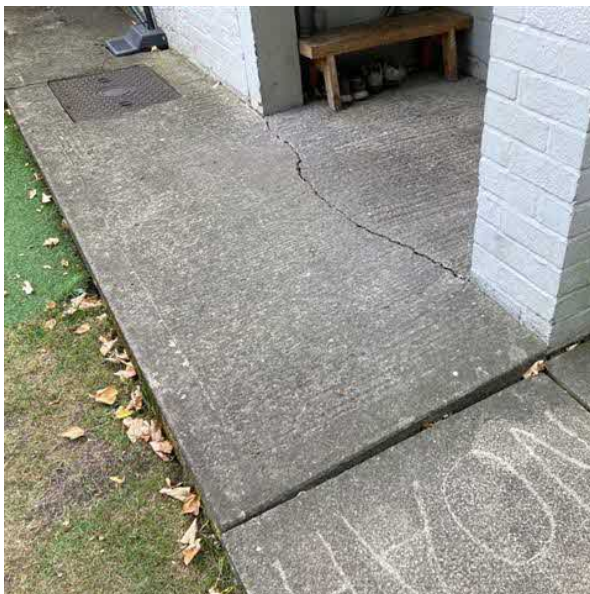
Previously cracked concrete path

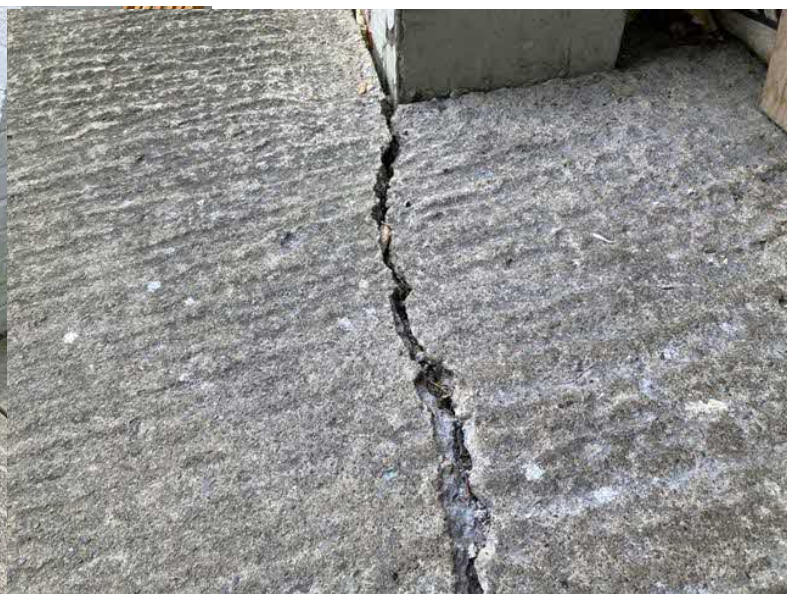
Detritus etc within crack

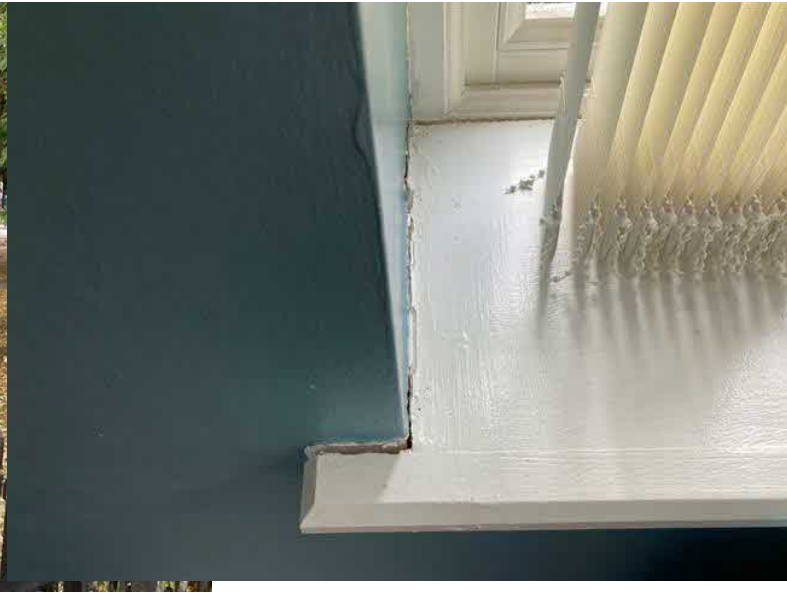
Loose sill to left side of bay

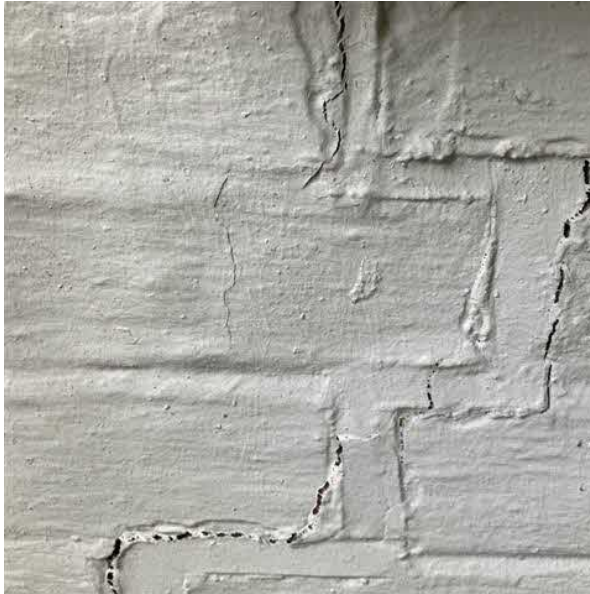
Previous repairs re-opened

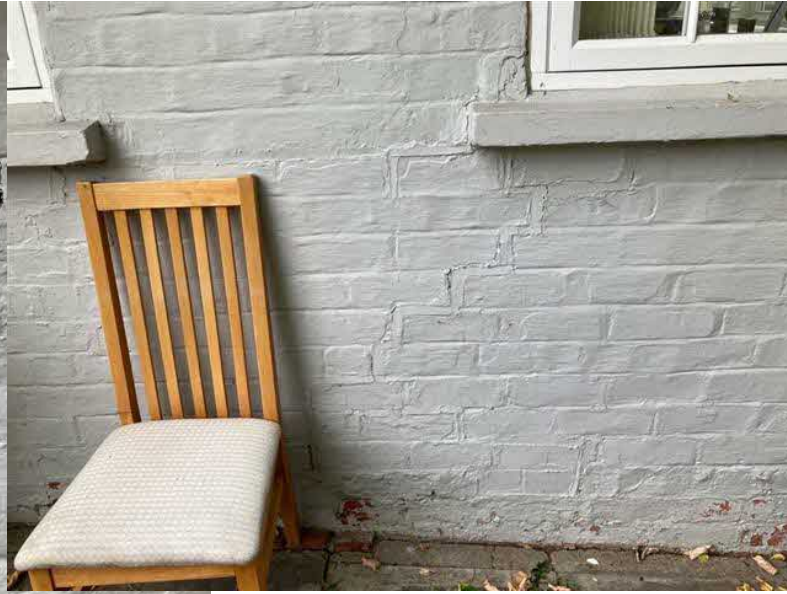
Crack to right side of bay

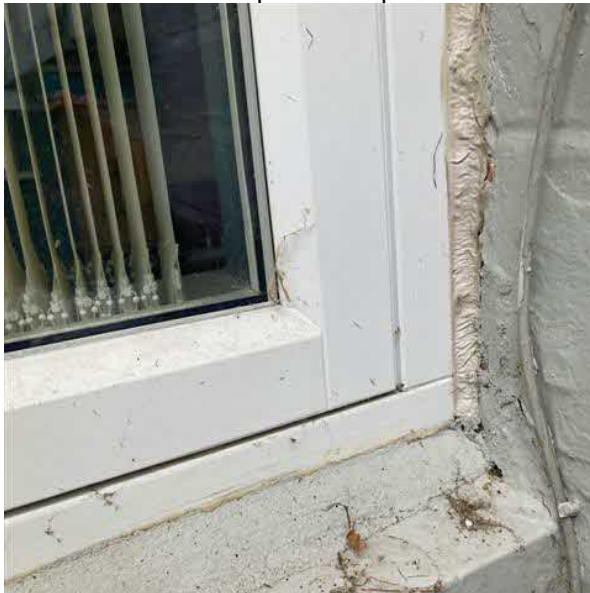
Aged and poorly applied mastic intact to left side of bay

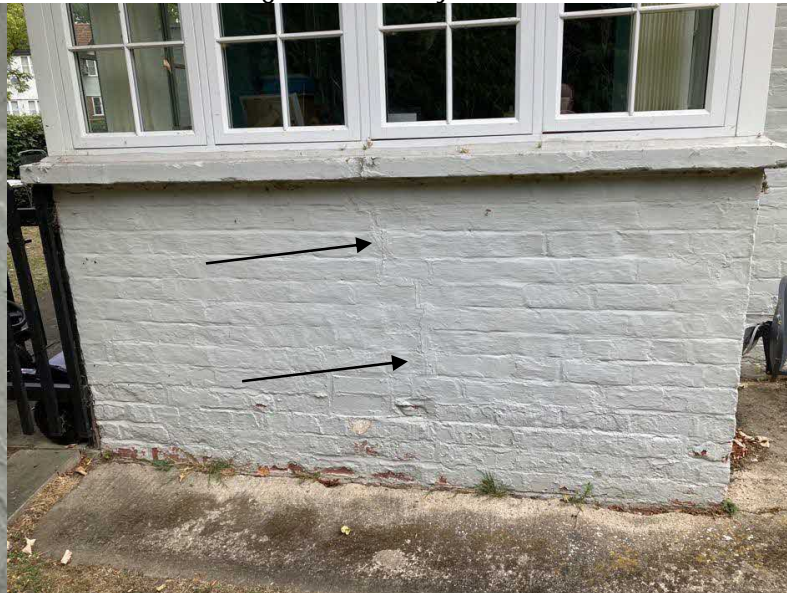
Crack to rear of bay
