LJG/223/0588

Ref: Garage at 2 Percheron Close, Impington, Cambridge CB24 9YX

Further to your request for a structural assessment of the impact of a large pine tree on a detached double garage at the above address, we visited the premises recently and would accordingly advise as follows.

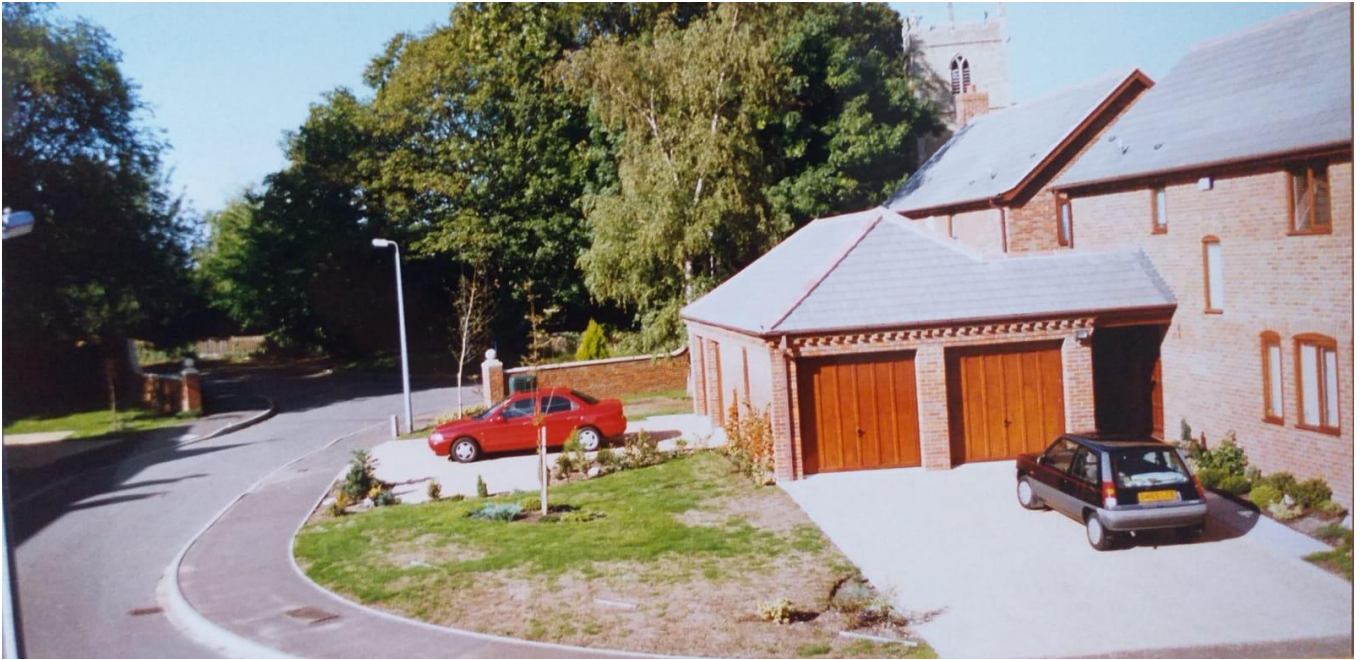
From photographs shown to us at the time of our visit, it is evident that this tree has been planted after the initial construction of the houses and garages on the development. From a visual assessment, we would suggest that the tree was originally planted some 25 years ago, as illustrated in the first photograph below.

Front garden to No.2 showing pine tree planted after development completed

In order to prevent ongoing problems of this nature and, more particularly, anticipated future structural damage to the fabric of the garage, our strong recommendation would be to obtain permission for complete cut down and removal from site of this pine tree.

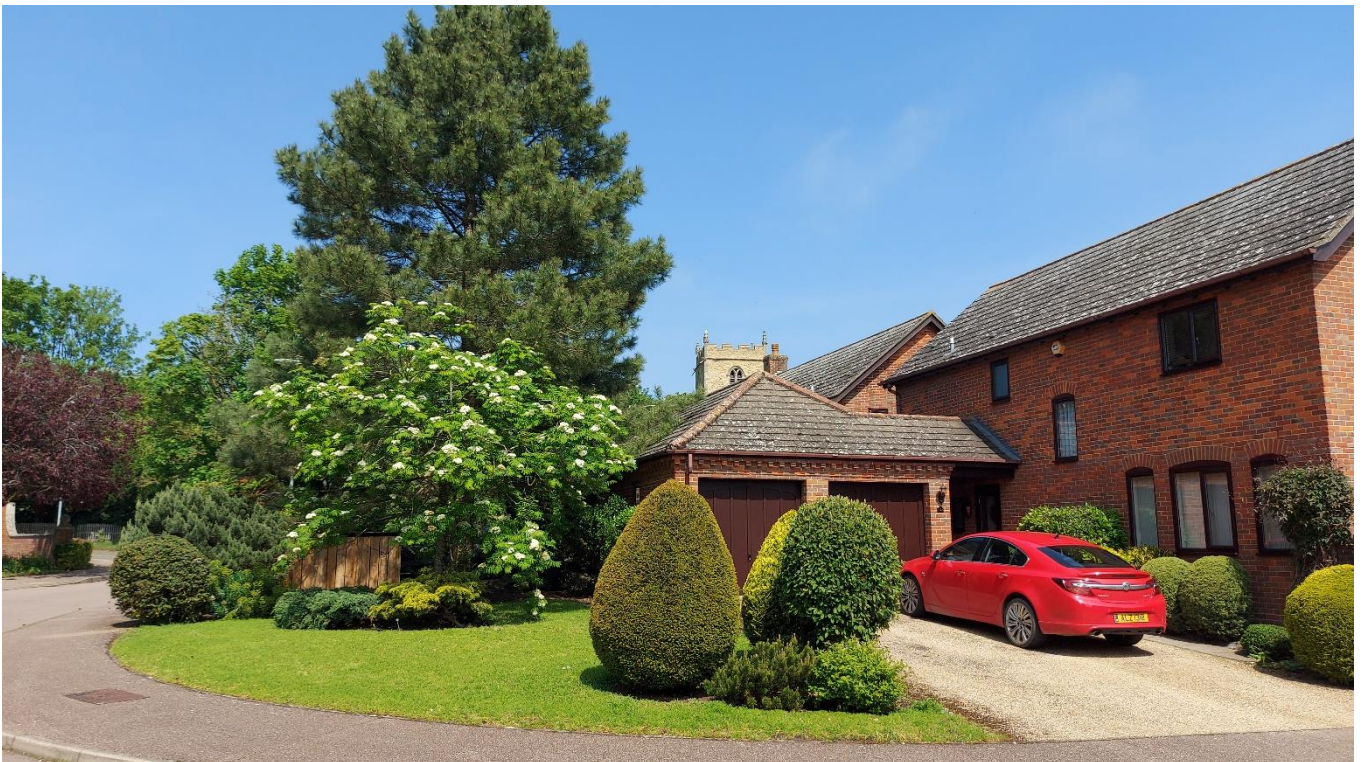
The tree has subsequently grown very significantly, extending to its current height of around 13.0/14.0m. Where the tree has been planted some 25 years ago, there remains significant growth potential still for this tree, which could potentially extend up to around 20.0m in height. A current view of the tree is also shown in the photographs below.

Current view of front driveway to No.2

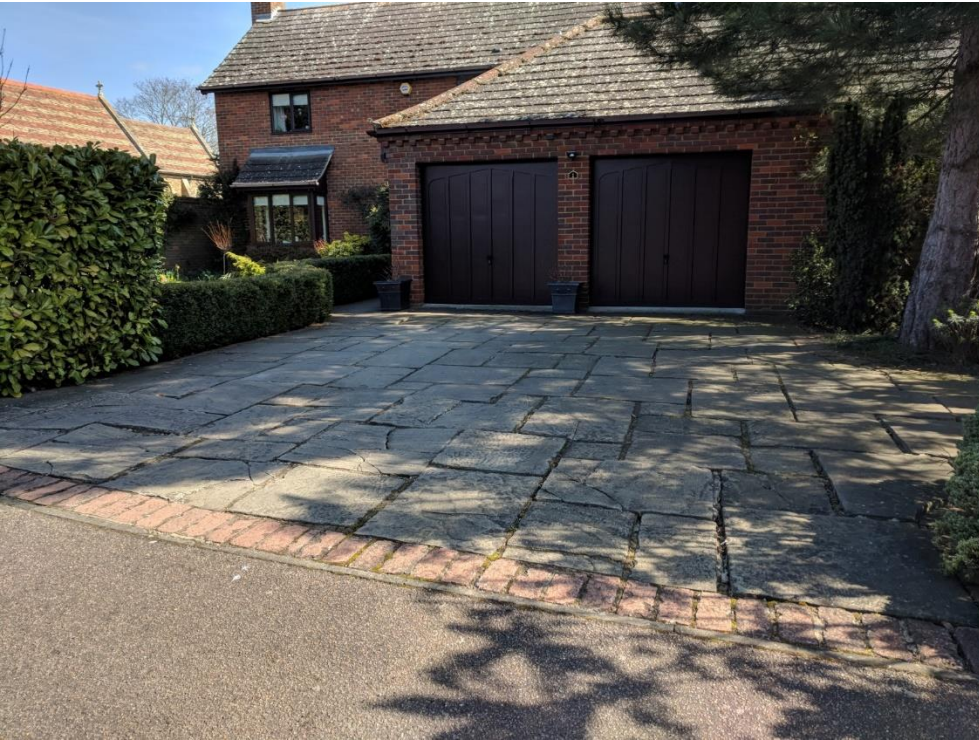
Front elevation of garaging to No.1 Percheron Close

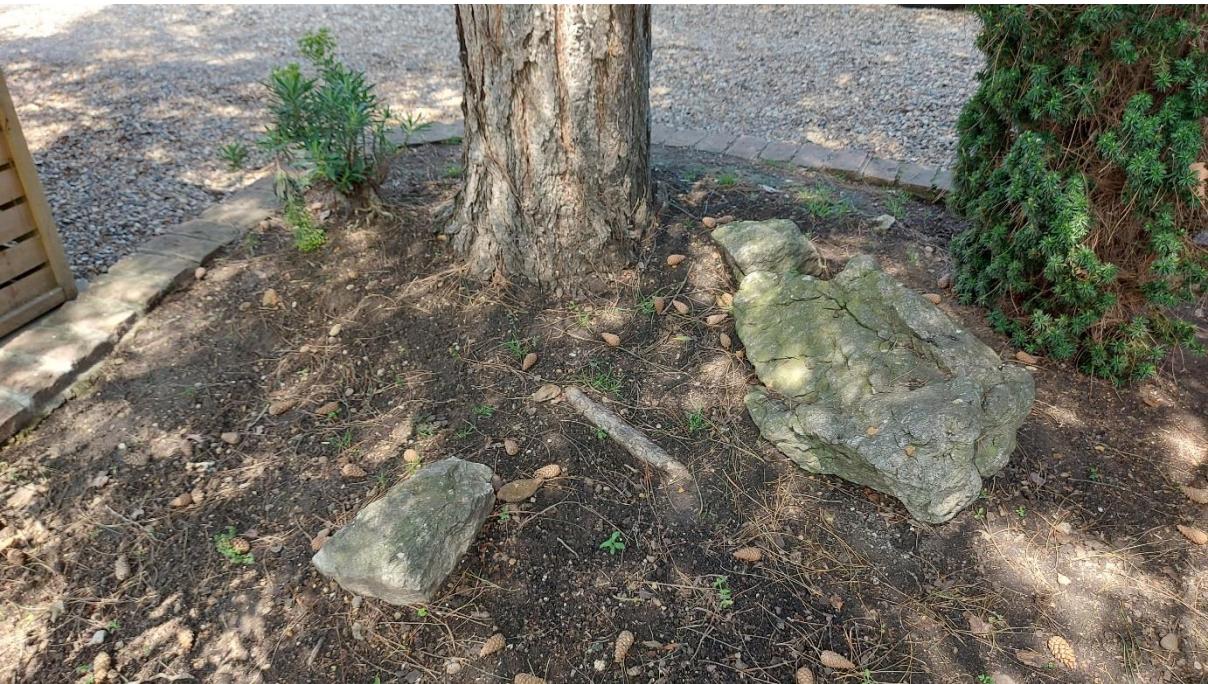
Directly adjacent to the base of the tree ground levels are significantly raised and disturbed as a result of root action.

Disturbance to finishes adjacent to base of tree

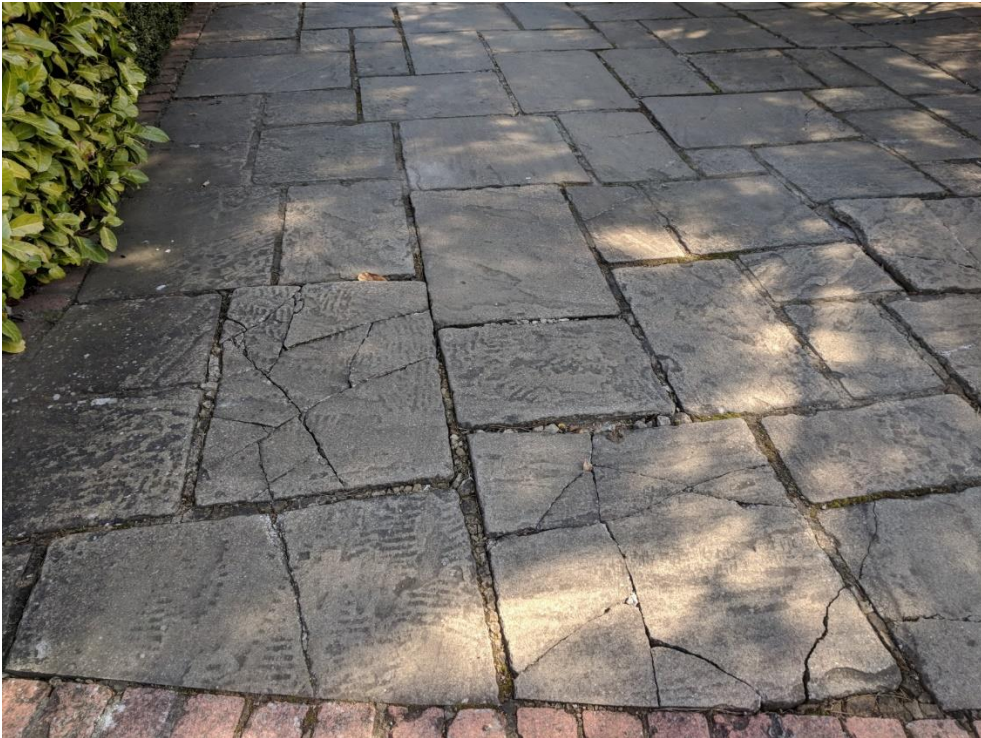
Cracking to paved finishes

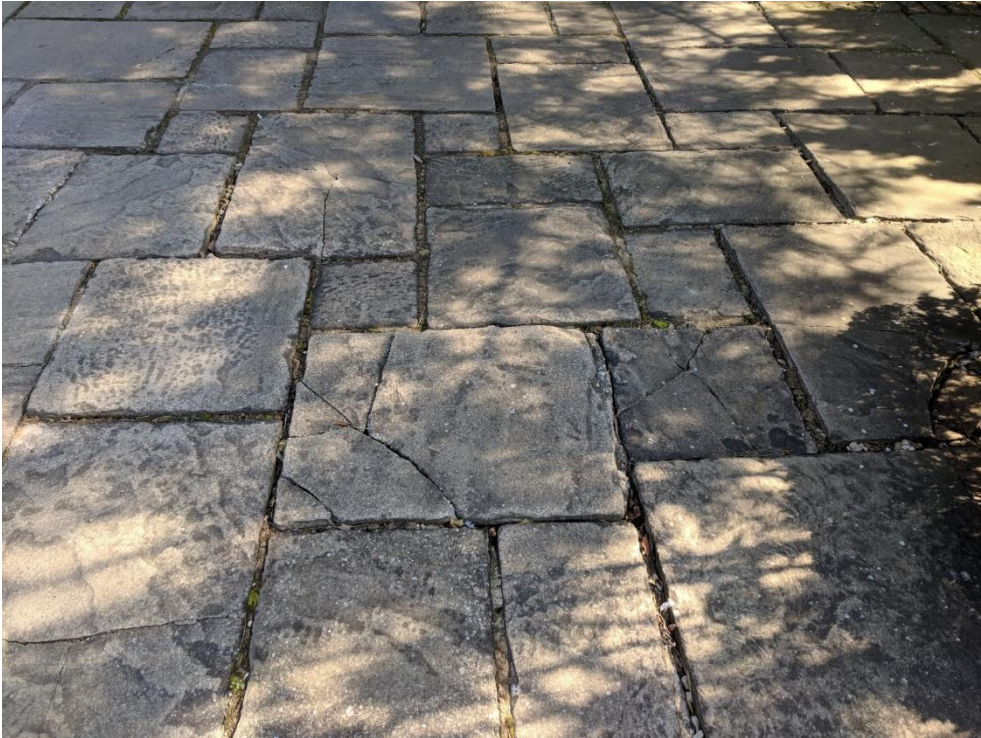
Cracking to paved finishes

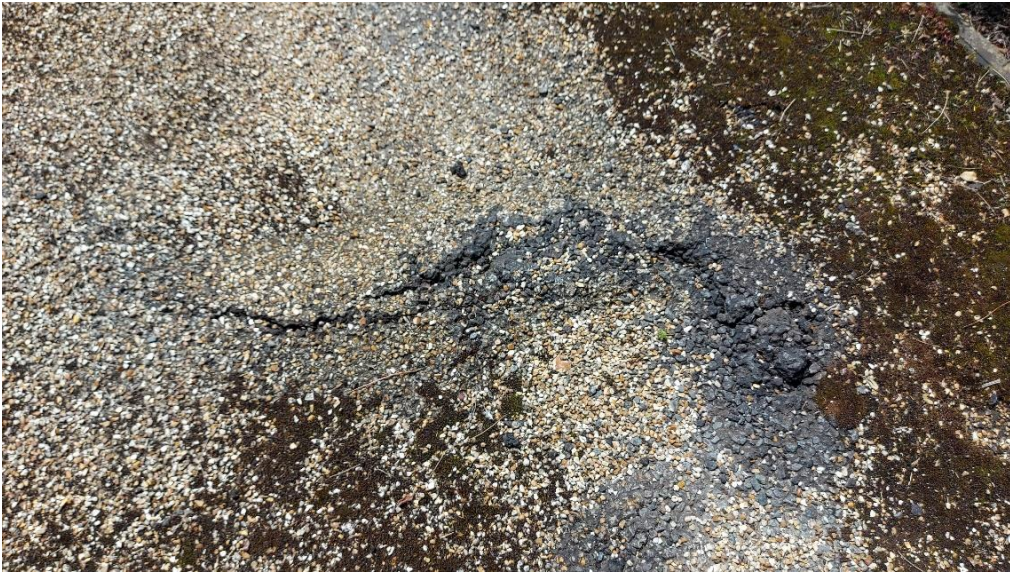
Significant rippling of tarmac finishes can be seen here, set approximately 8.0m away from the tree, with the main disturbance set approximately 2.40m off the front garage door opening. Root disturbance has resulted in corresponding unevenness and misalignment of up to 100mm in the driveway finishes. This has become a significant trip hazard.

Disturbance to tarmac finishes to driveway to No.2 Percheron Close
