STRUCTURAL APPRAISAL

**RE DEVELOPMENT AT GLEN GARRY FARM
FEN ROAD, RUSKINGTON, LINCONSHIRE, NG34 9TH**

STONEGATE AGRICULTURE LIMITED

Project : 2022.100
Date : June 2022
Engineer : Graham Schofield C Eng, MI Struct E, MICE, MIEI
Issue No 1 : 12.07.2022

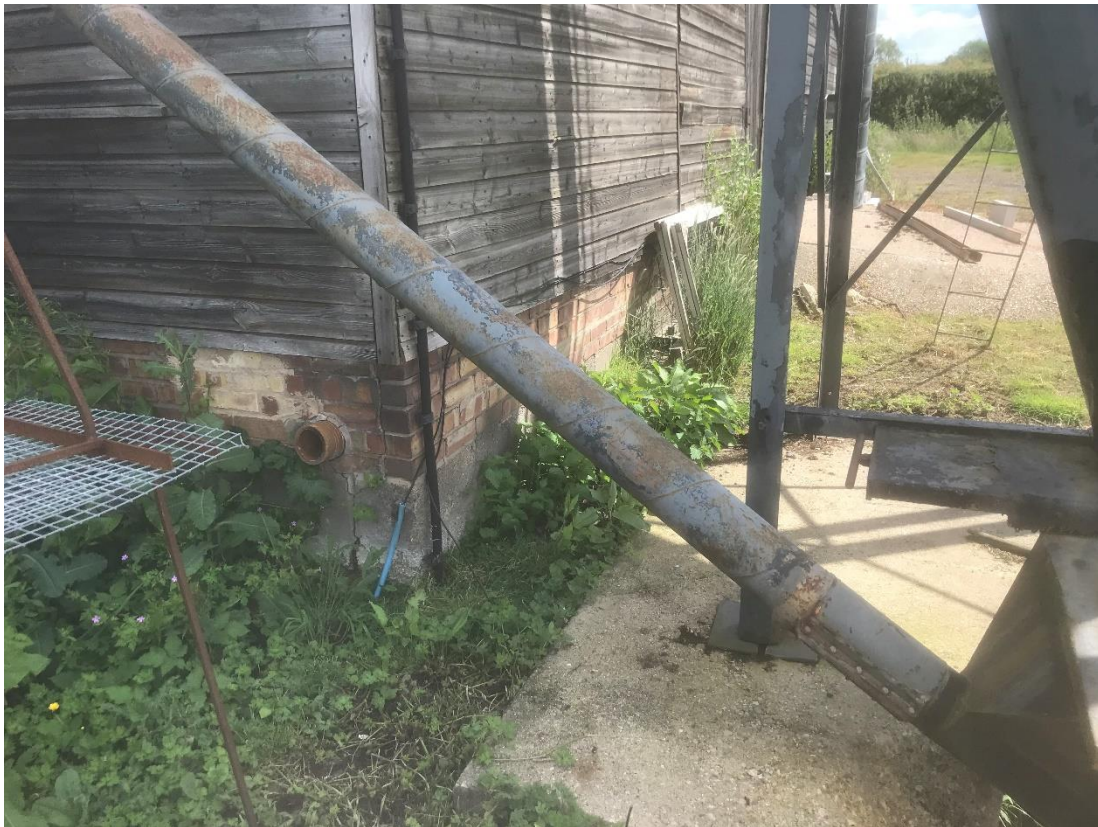
- Walls** The brick base plinth is in reasonably good condition and could be retained with some localised rebuild and repair. However, its solid nature probably precludes its effectiveness for compliance with the current Building Regulations. The upper timber studded wall has experienced a degree of rotation on the brick plinth. This is due to a combination of roof spread inducing a horizontal load onto the top of the wall and deterioration of the fixing of the studded wall to the brickwork.

Photograph 5 – Typical View Showing Assembly Detail Wall → Plinth → Base Slab

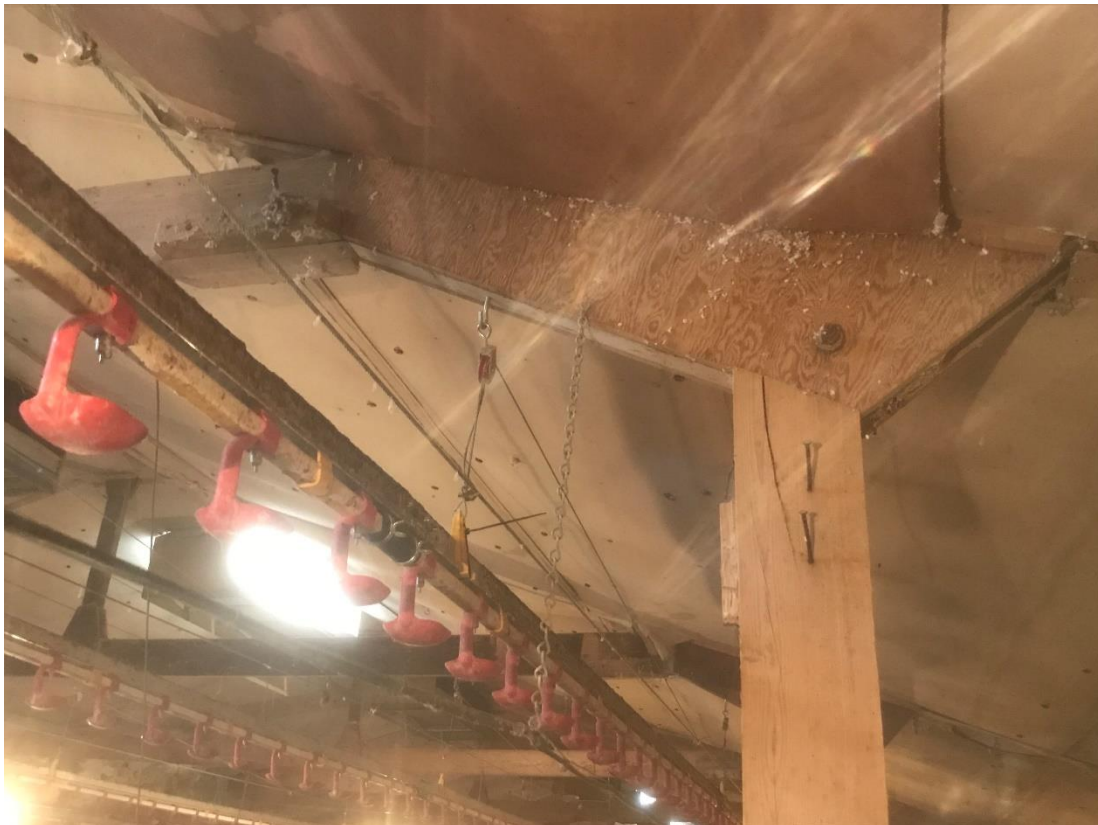
Photograph 6 – General View of “Key” Joint Detail Post to Rafter

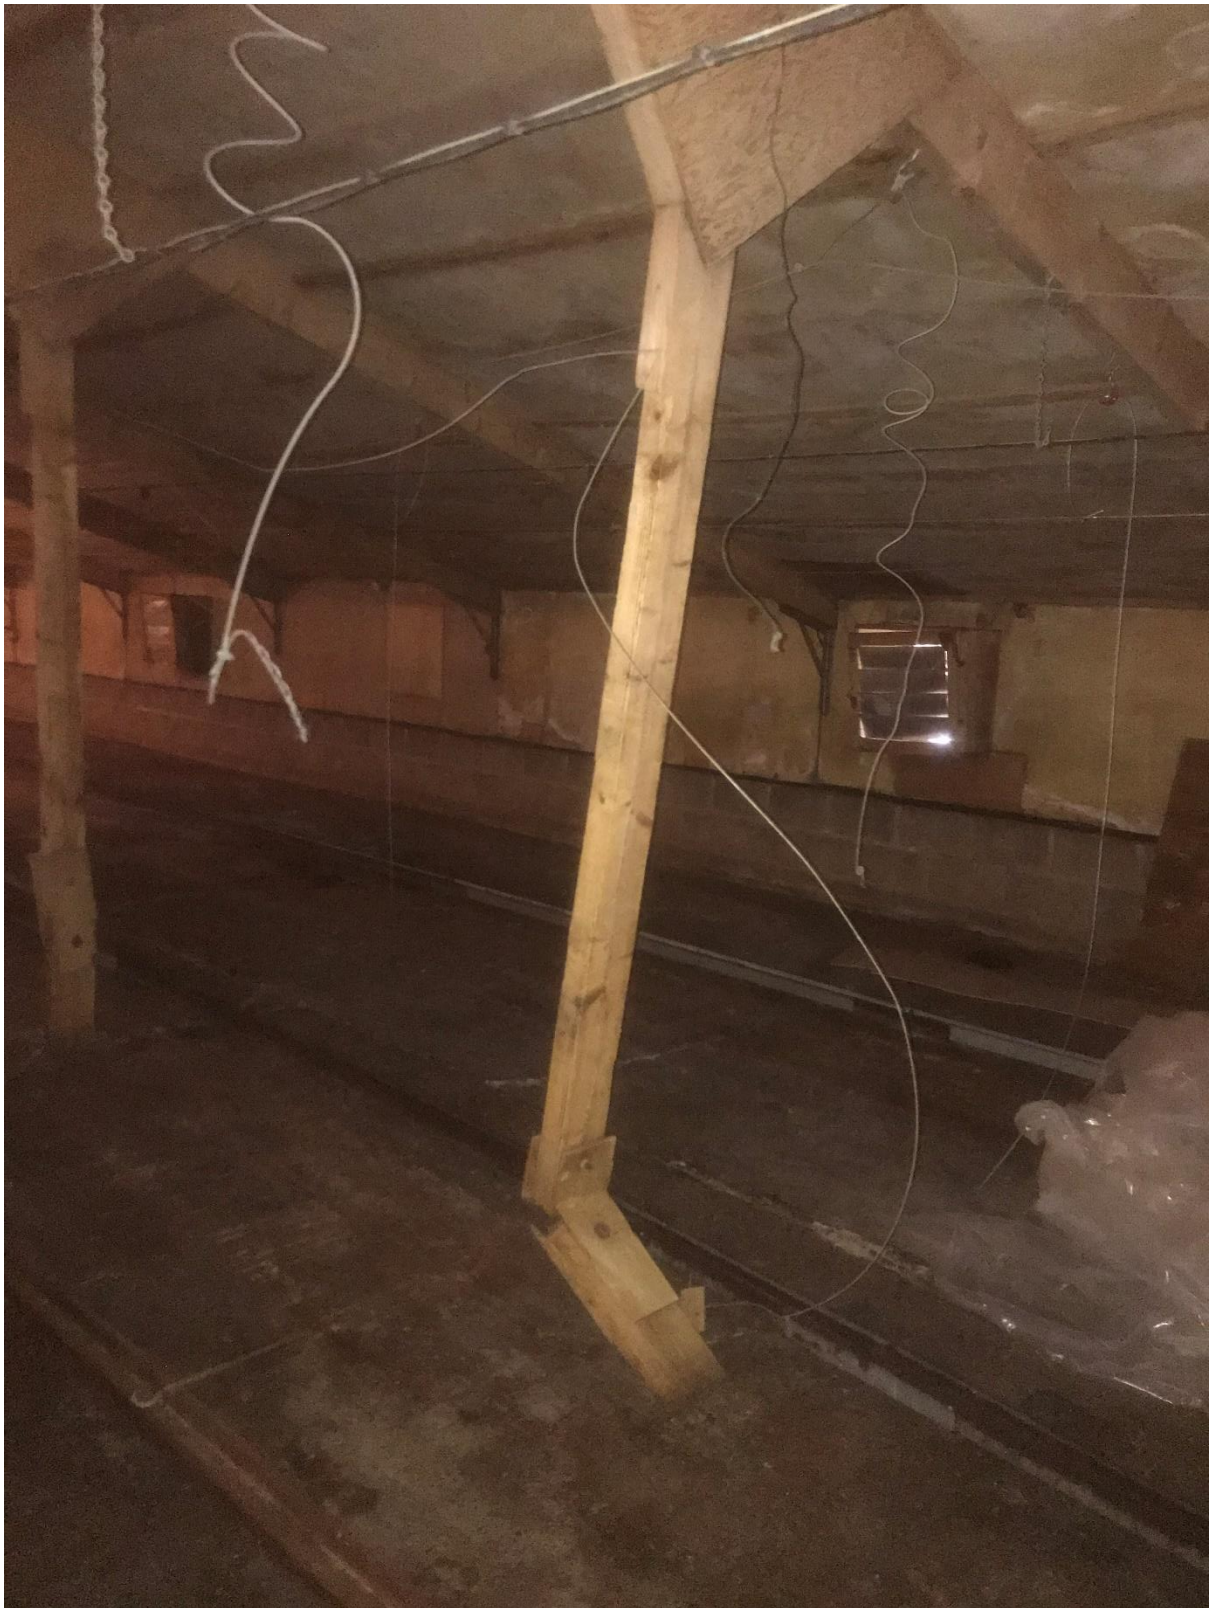
Photograph 7 – Broken Post to Frame '3'

| FRAME L0 | DEFECT |
|---|--|
| 3 | JOINT STRENGTHENING + FOOT REPAIR + NEW TIE BEAM |

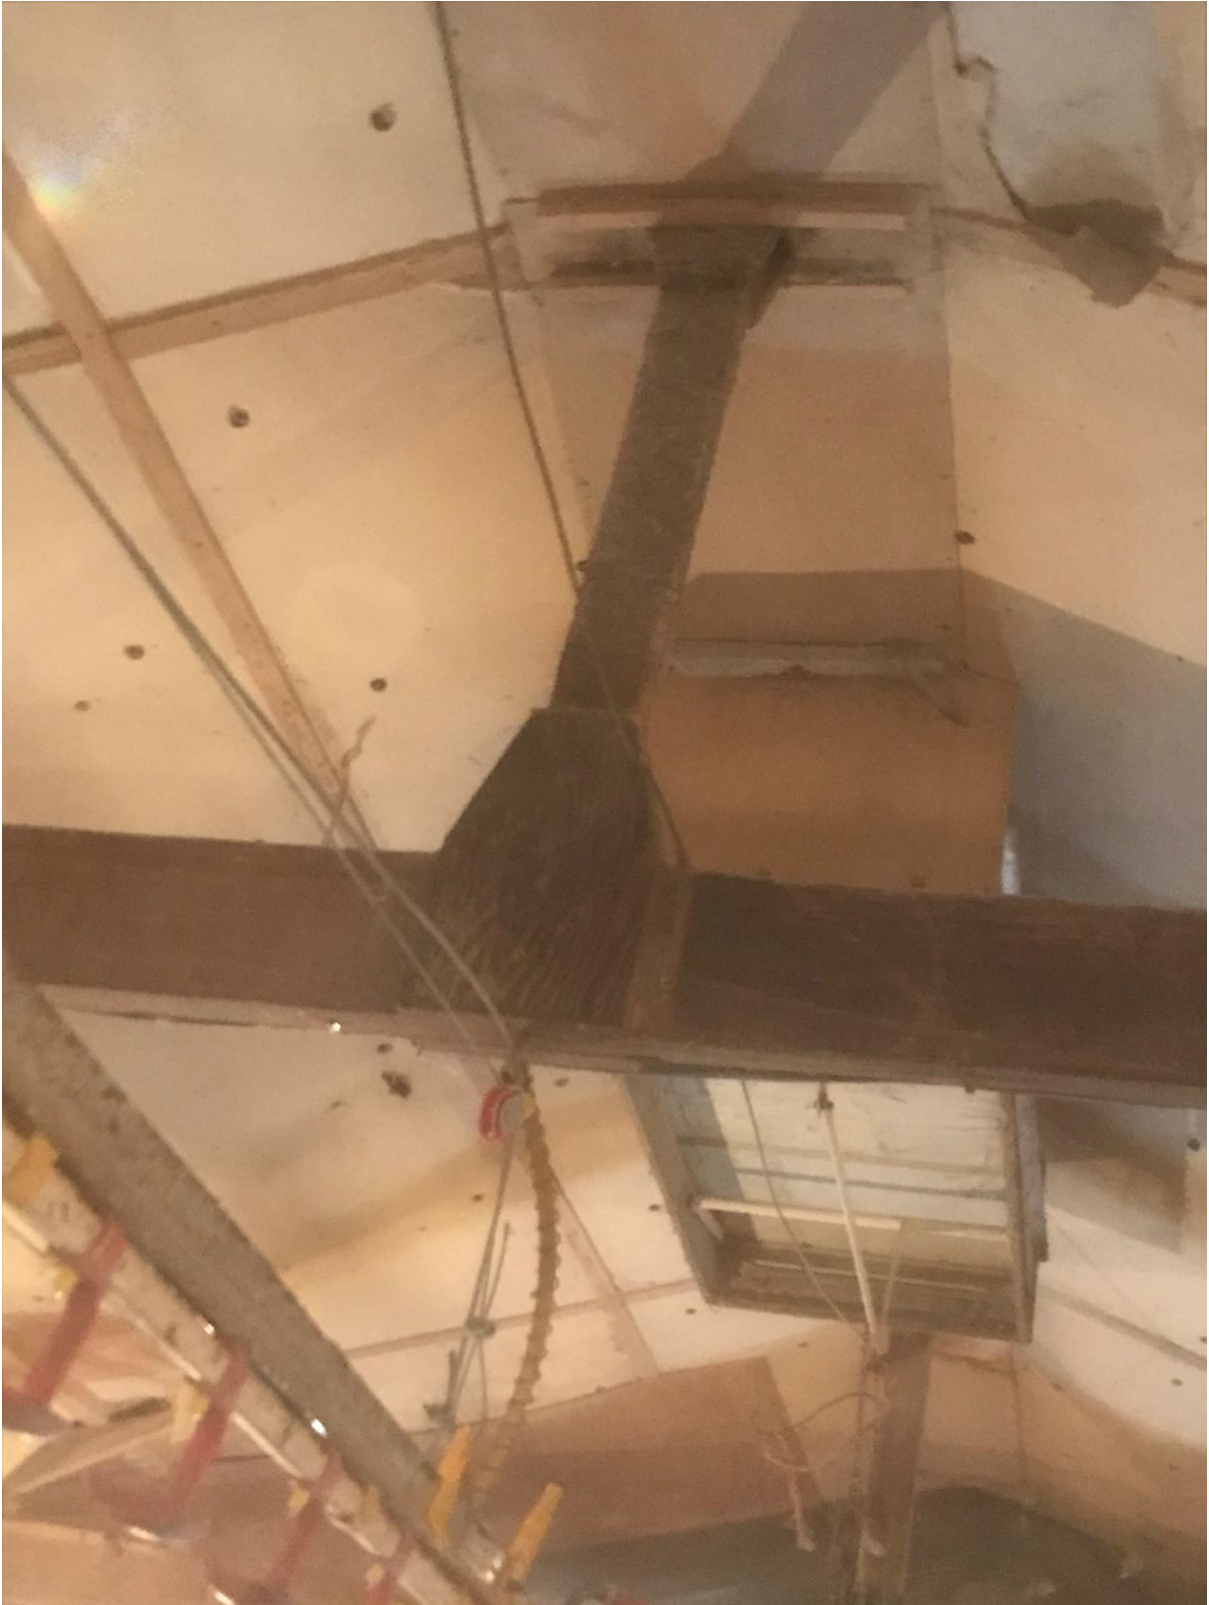
Photograph 8 - Typical Ply Gusset Connections to Roof "Truss"

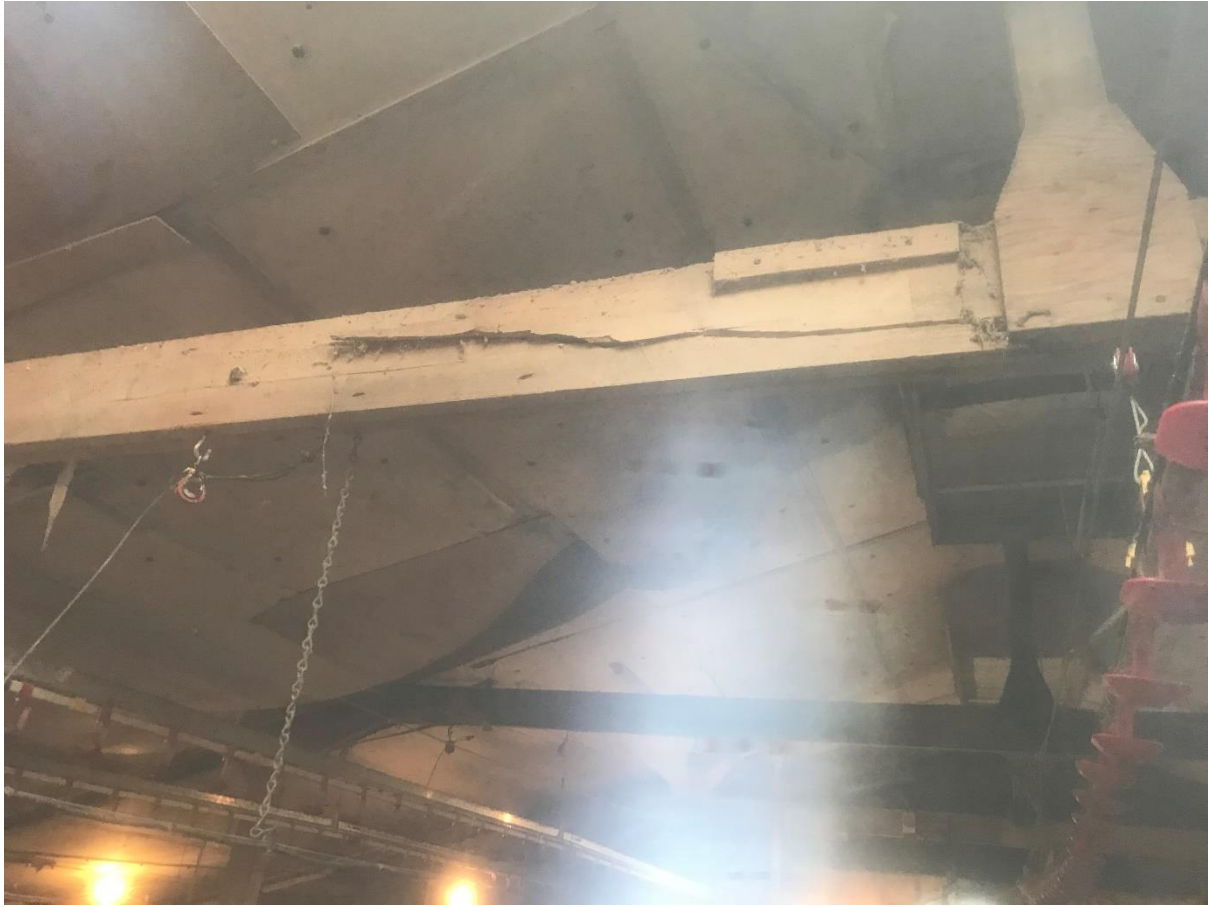
Photograph 9 – Split to Roof Tie

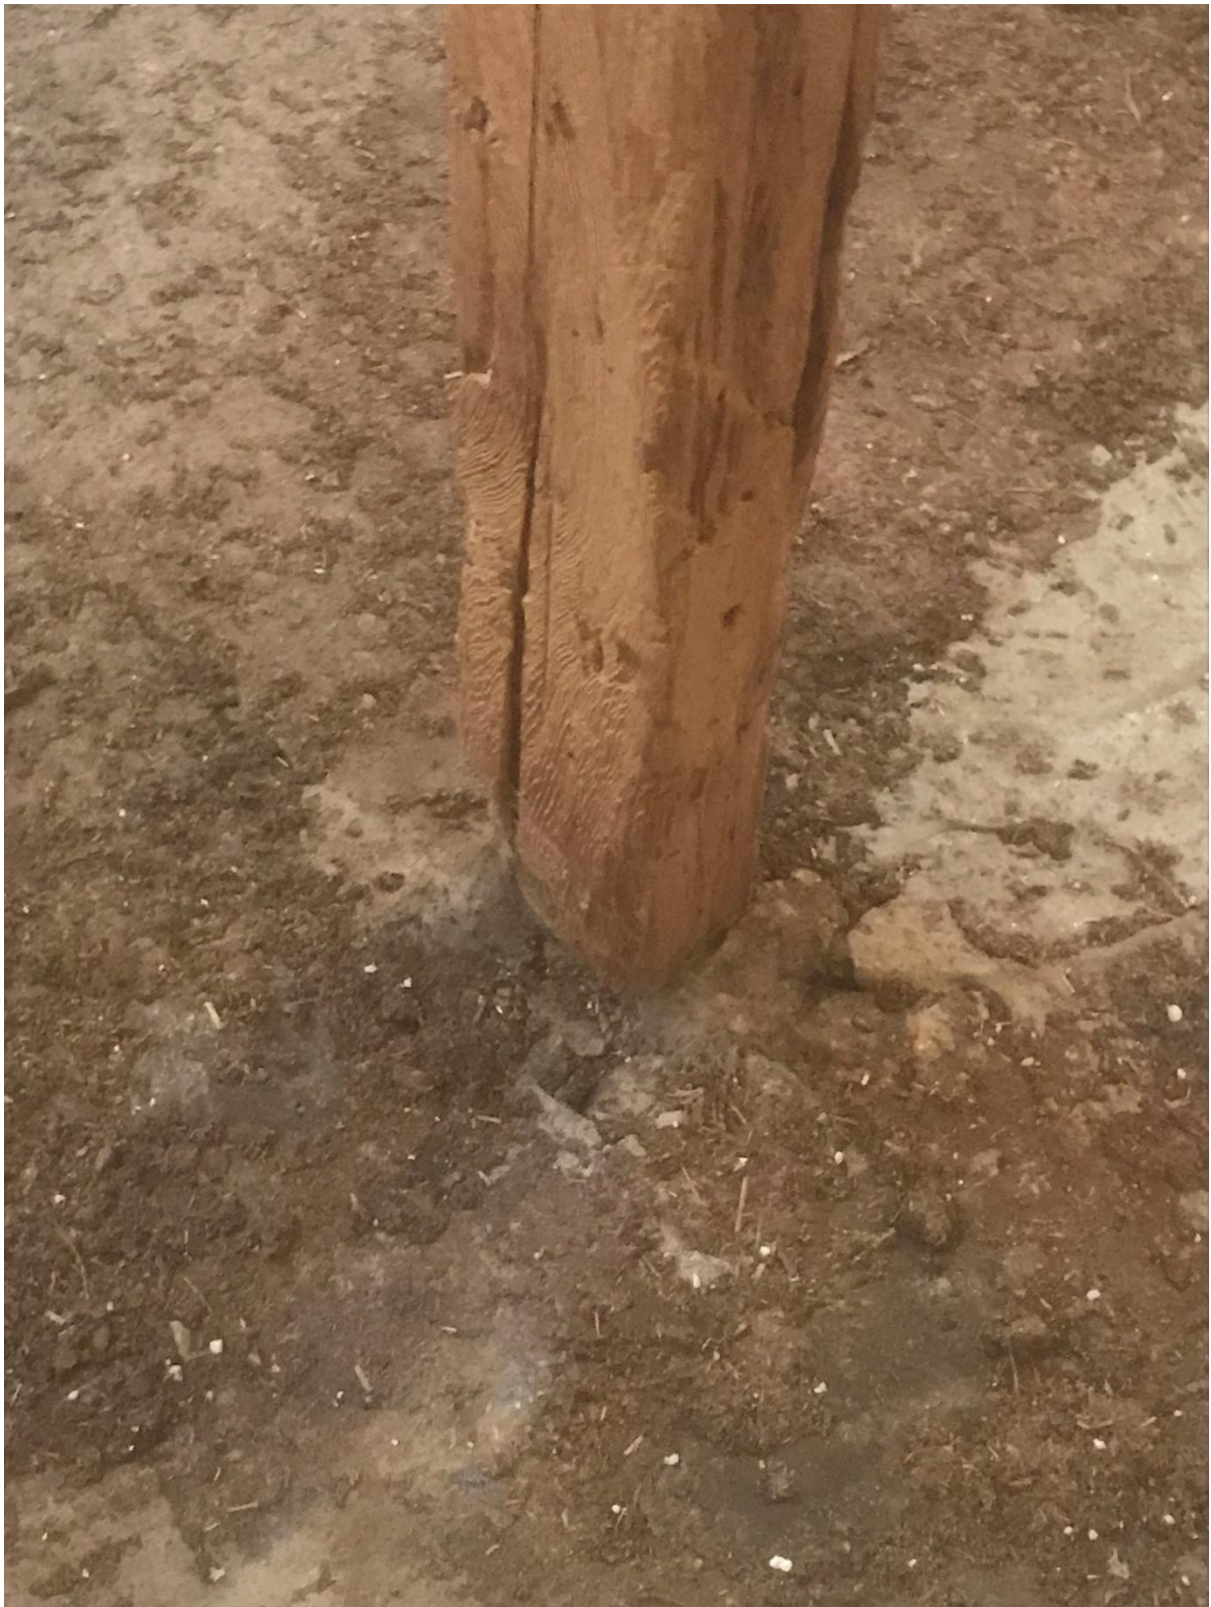
Photograph 10 – Deterioration to Foot of Post

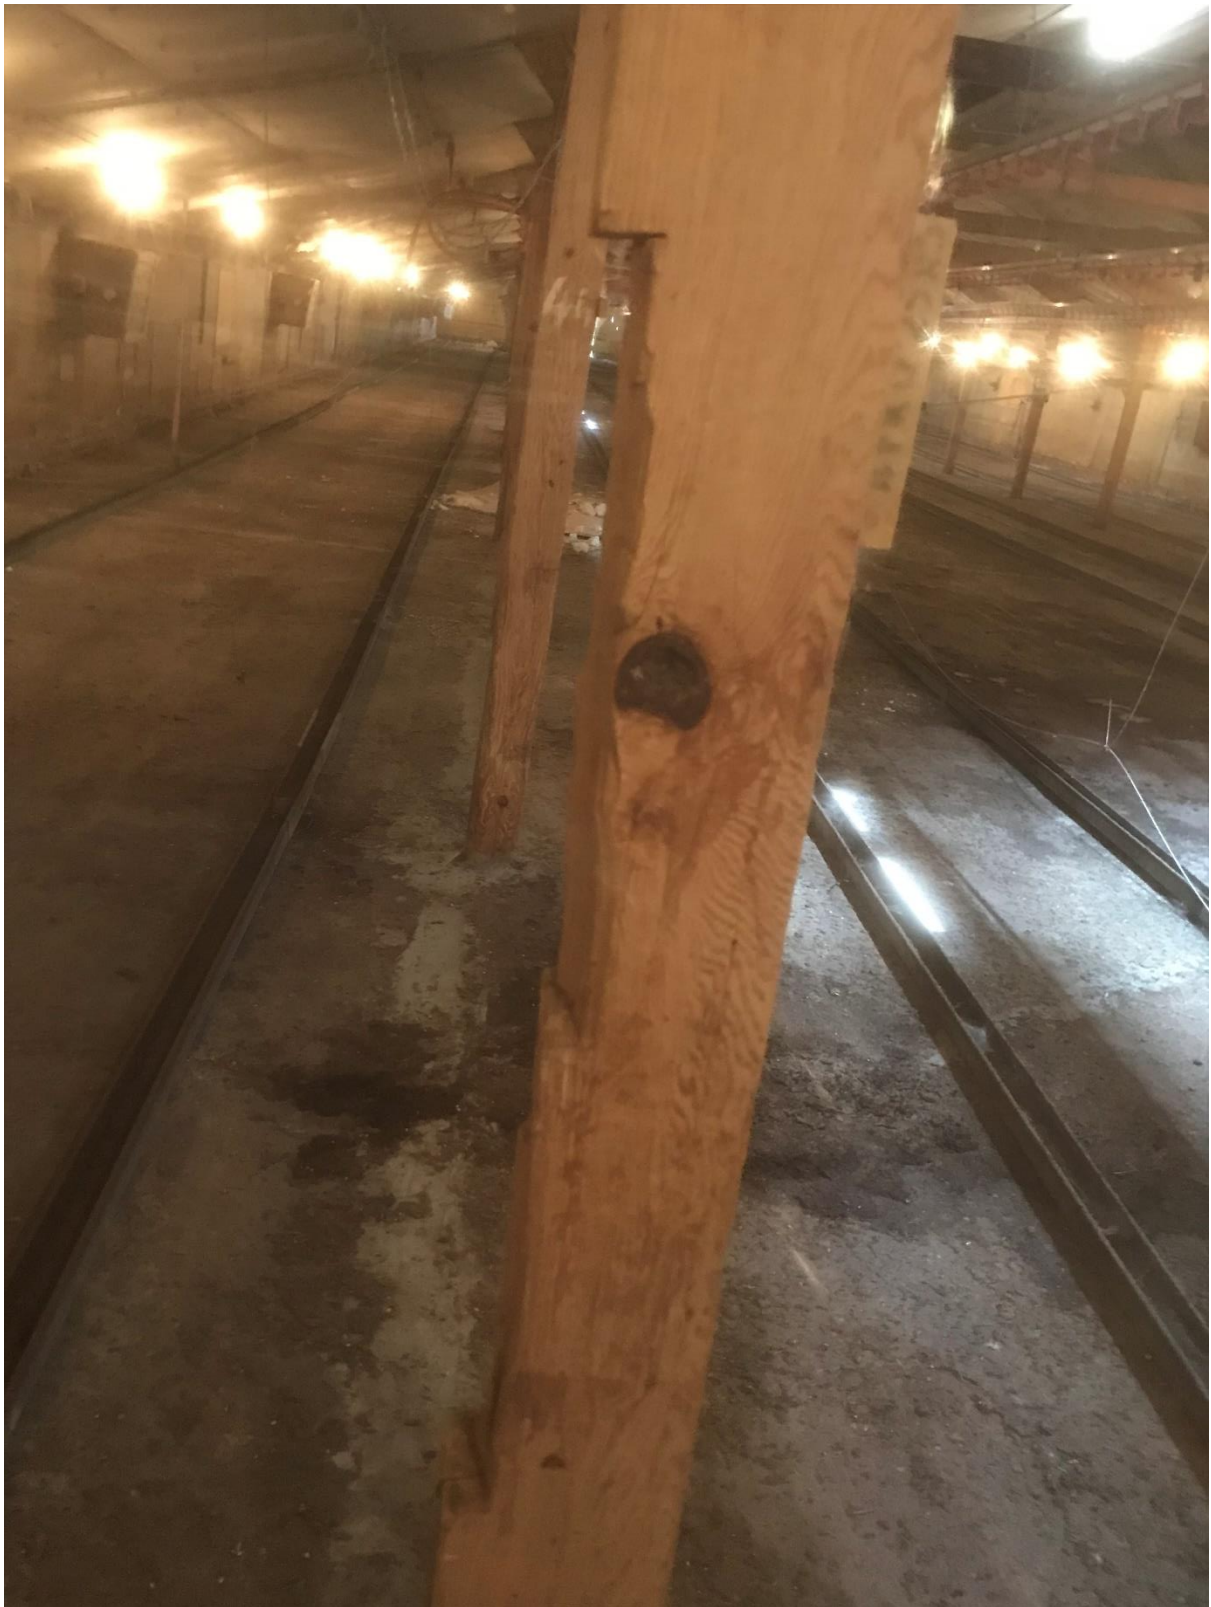
Photograph 11 – ill Advised Modifications to Post

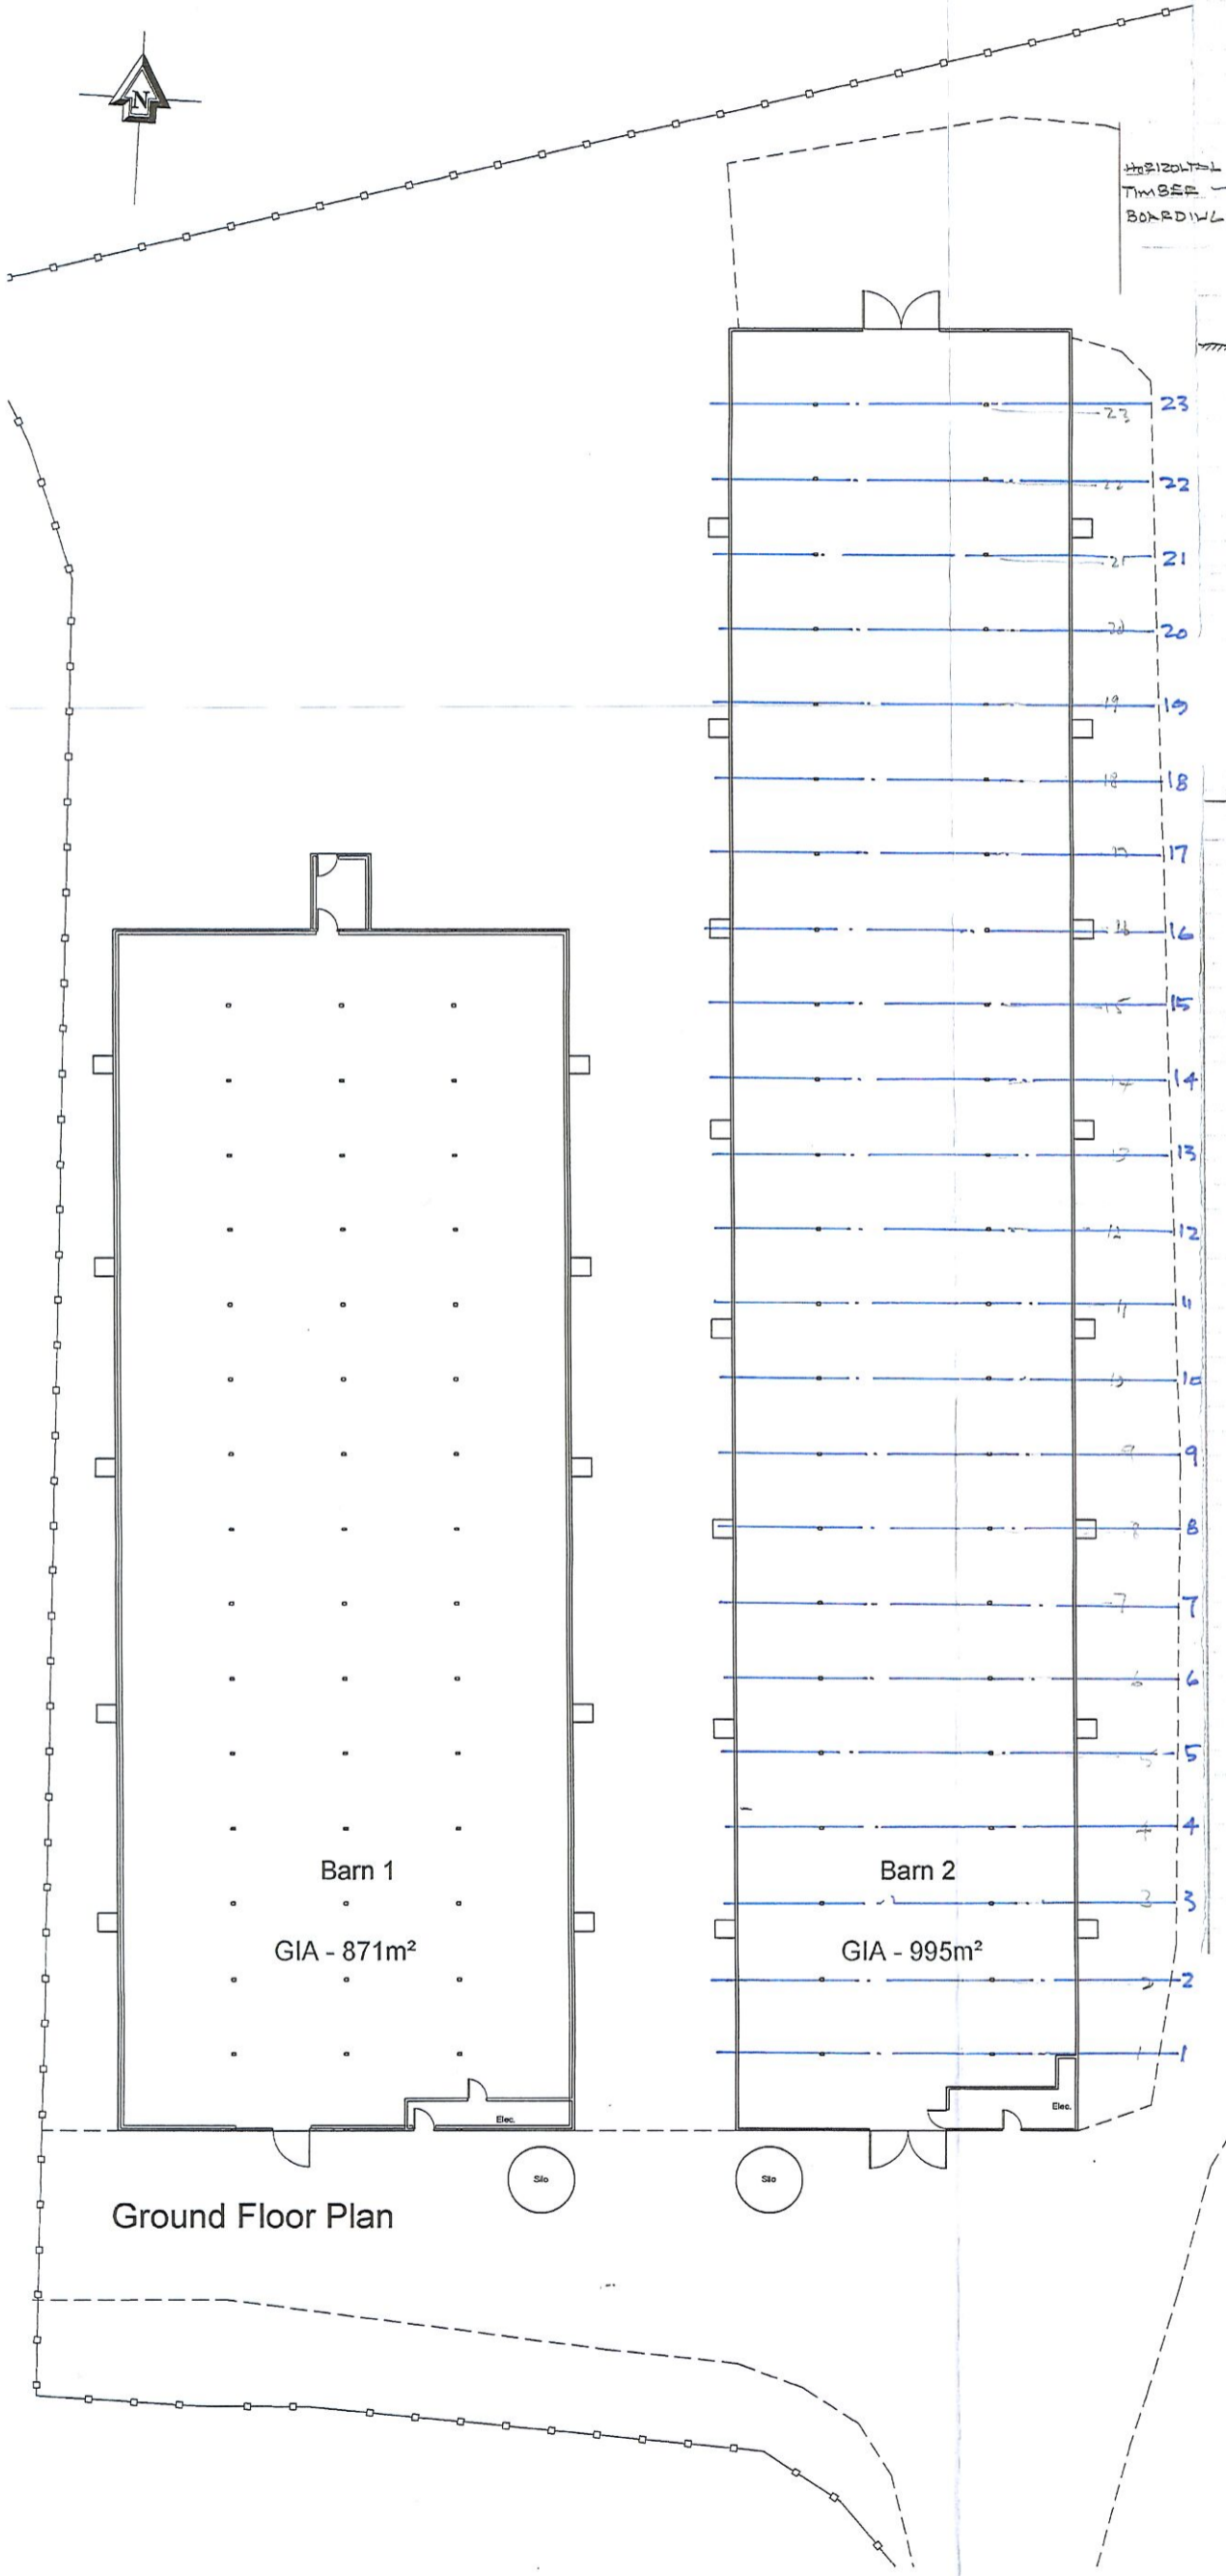
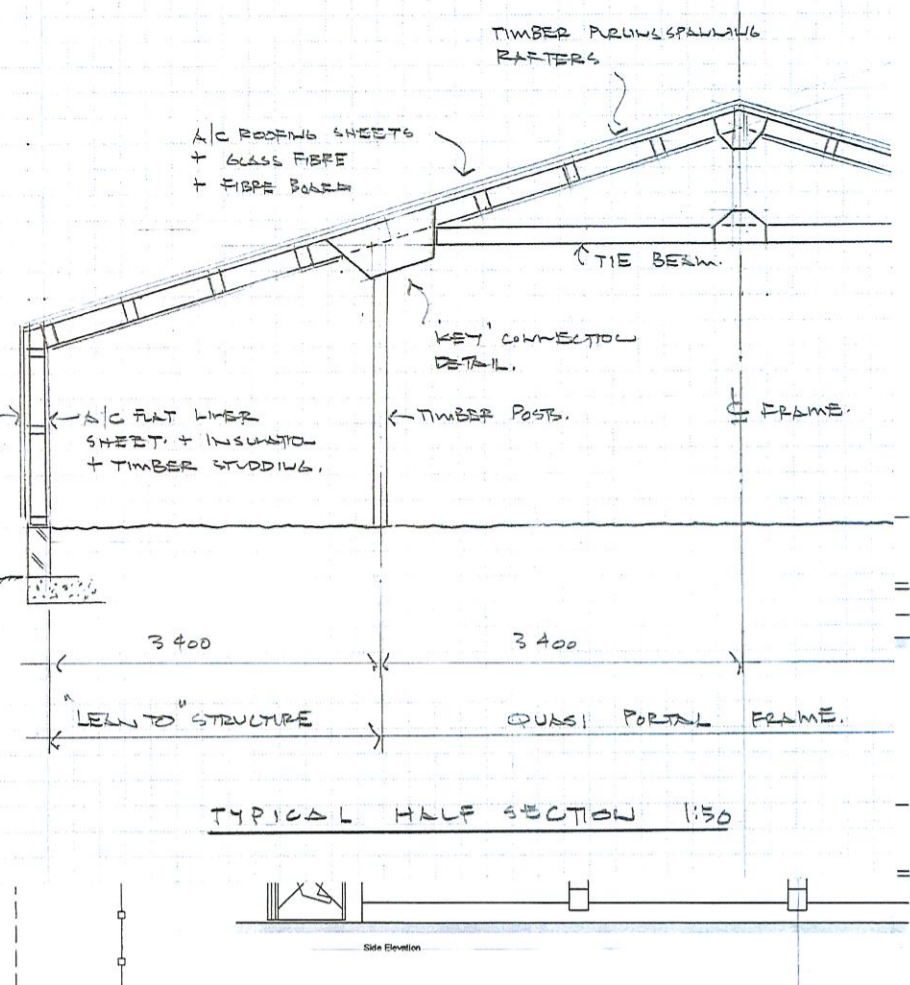
Sketch No. 2022.100.Sk01 – Existing Structure Noting Defects

- The quasi-timber portal frames have, in the main, retained their shape and integrity. However, several frames have experienced damage and/or long term deterioration either to the individual members or to the joints. By reference to sketch no. 2022.100.Sk01 in Appendix 'B' we have itemised each frame, its present condition and any necessary improvements.

| FRAME L0 | DEFECT |
|---|--|
| 1 | JOINT STRENGTHENING + FOOT REPAIR. |
| 7 | " " + STRENGTHENING TO POST SPLIT. |
| 11 | REPLACE FIRE DAMAGED TIE BEAM AND POST |
| 19 | " " + POST REPAIR |
