# GEOTECHNICAL REPORT

job number	C3485/23/E/5292	date	14.07.23
------------	-----------------	------	----------

site address	Former Quarry off Low Lane
	Draughton
	Skipton
	North Yorkshire BD23 6EA

Location:	<b>Former Quarry off Low Lane</b> Draughton, Skipton, North Yorkshire BD23 6EA	
For:	Skyraikes Ltd	
Report No.	C3485/23/E/5292	
Version:	Final.v1	Report date: 14.07.23
Previous Versions	Draft.v1, dated 05.07.2023

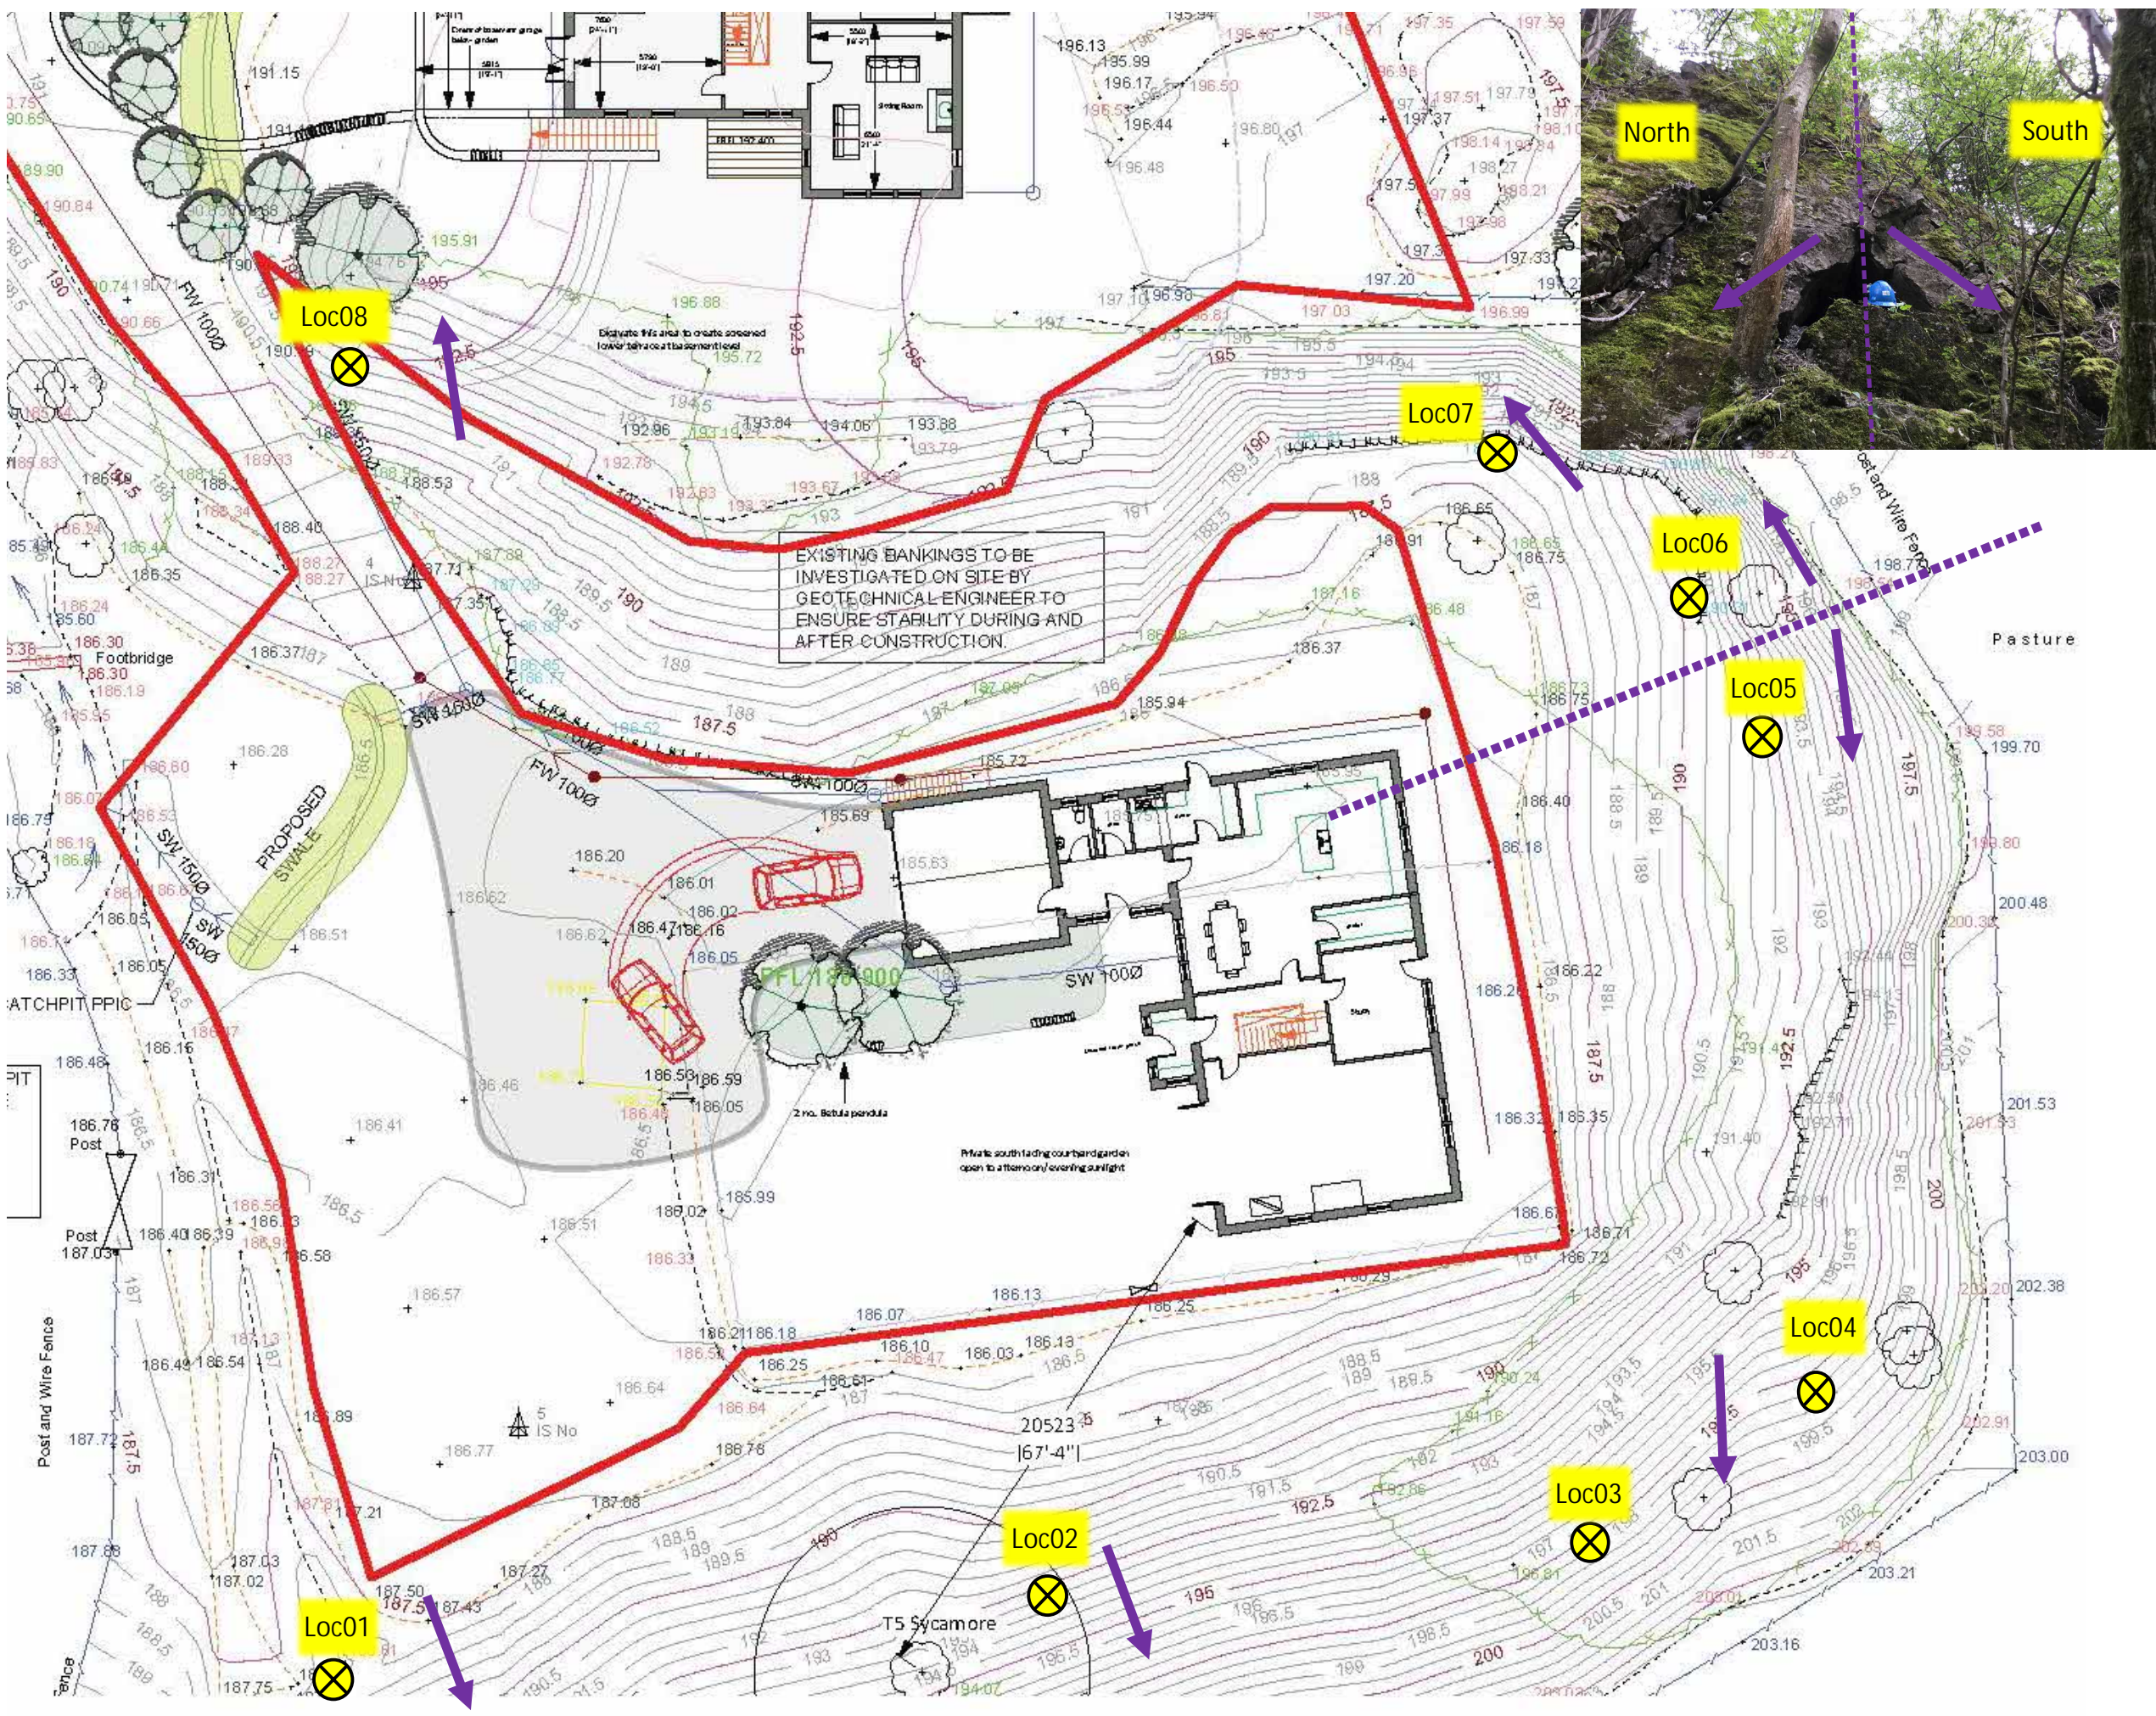
**Notes:**  
 Purple arrows indicate dip of solid geology. Dotted line is approx orientation of anticline axis.

- Loc01 074/52°SSE
- Loc02 083/44°S
- Loc03 078/30°S
- Loc04 078/30°S
- Loc05 048/21°S
- Loc06 096/78°NW
- Loc07 068/52°NW
- Loc08 074/34°N

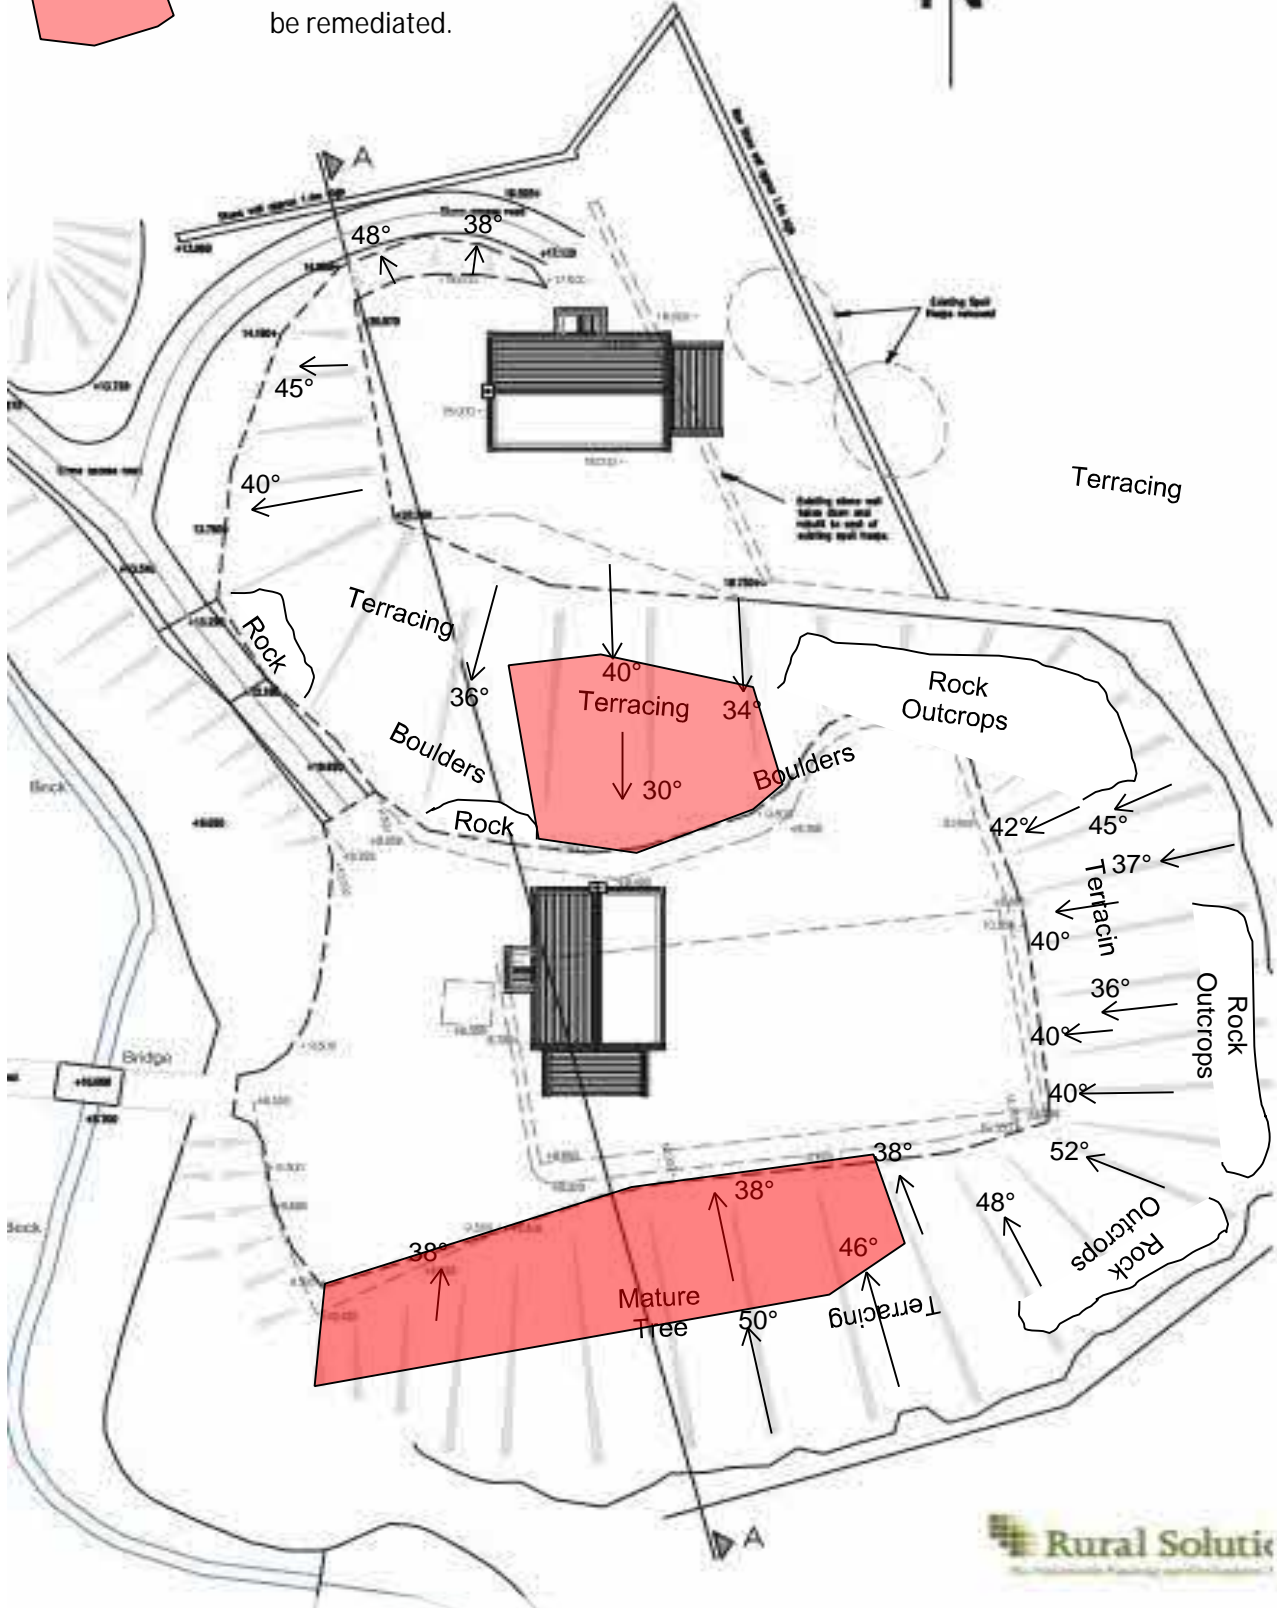
Title: **Slope Remedial Location Plan**

Red areas indicate areas to be remediated.

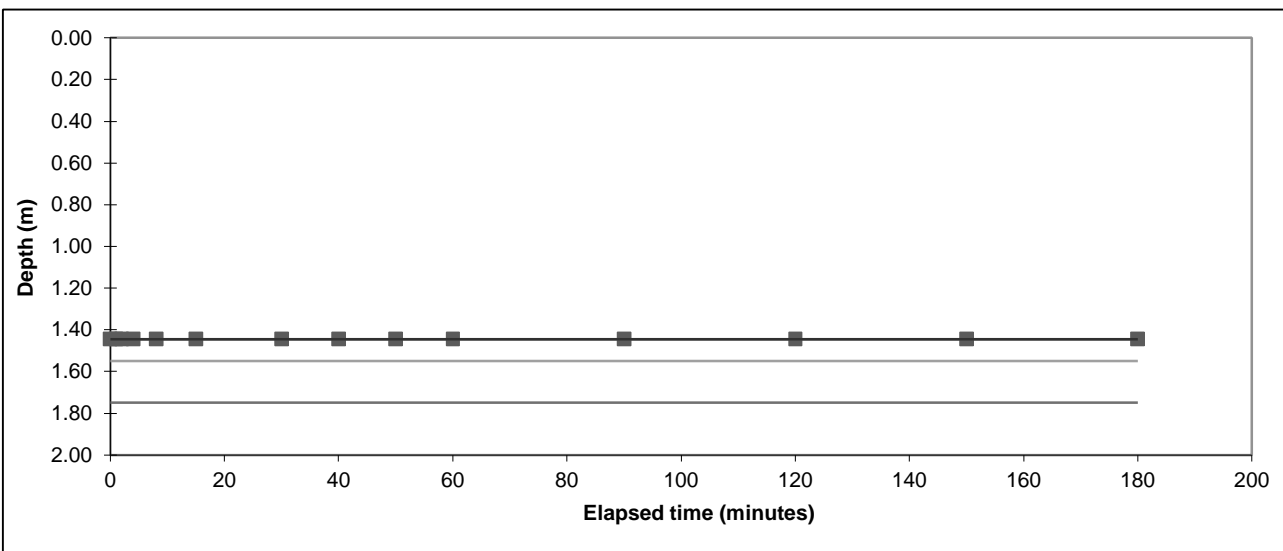
Trial Pit No:	SA1	Test No:	1	Date:	04/05/2023
Length (m):	1.700	Datum Height:			0.00 m agl
Width (m):	0.70	Granular infill:	None		
Depth (m):	1.85	Porosity of infill:	1	(assumed)

<b>Soil infiltration rate (m/s):</b>	<b>Test incomplete as 25% effective depth not achieved. Unable to reliably determine soil infiltration rate.</b>
--------------------------------------	--

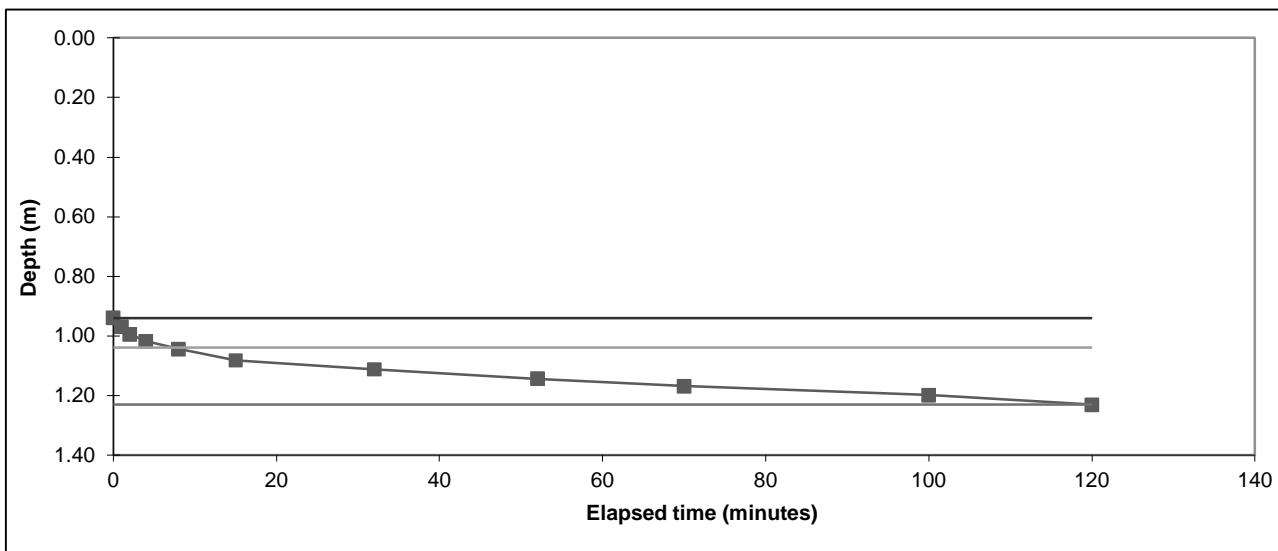
Trial Pit No:	SA2	Test No:	1	Date:	04/05/2023
Length (m):	1.800	Datum Height:			0.00 m agl
Width (m):	0.70	Granular infill:	None		
Depth (m):	1.33	Porosity of infill:	1	(assumed)

<b>Soil infiltration rate (m/s):</b>	<b>1.6E-5</b>
--------------------------------------	---------------

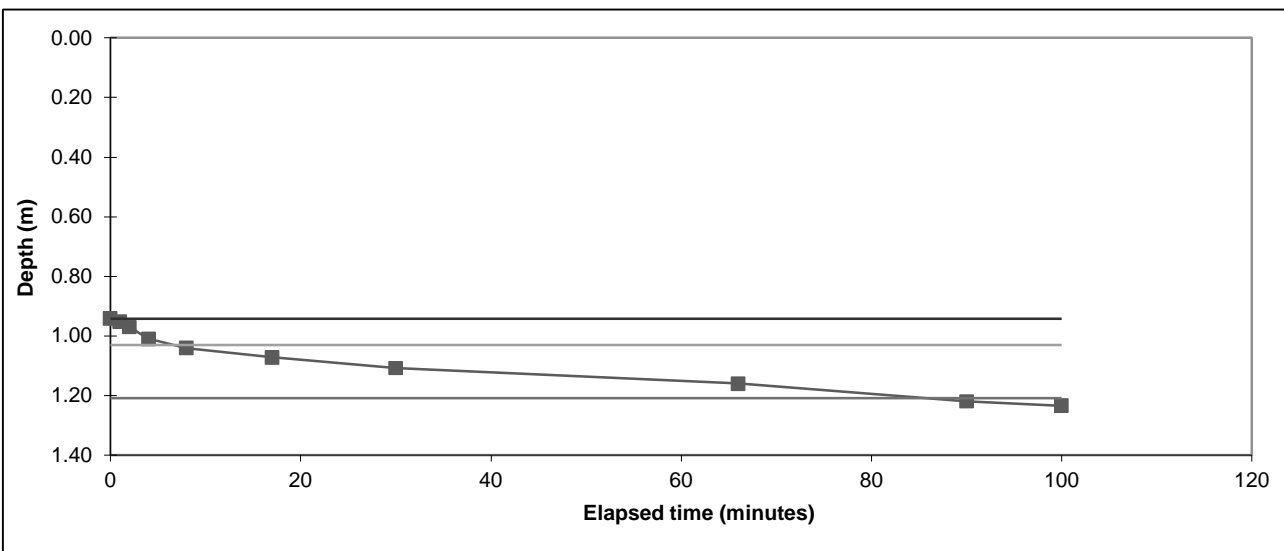
Trial Pit No:	SA2	Test No:	2	Date:	04/05/2023
Length (m):	1.800	Datum Height:			0.00 m agl
Width (m):	0.70	Granular infill:	None		
Depth (m):	1.30	Porosity of infill:	1	(assumed)

<b>Soil infiltration rate (m/s):</b>	<b>2.2E-5</b>
--------------------------------------	---------------

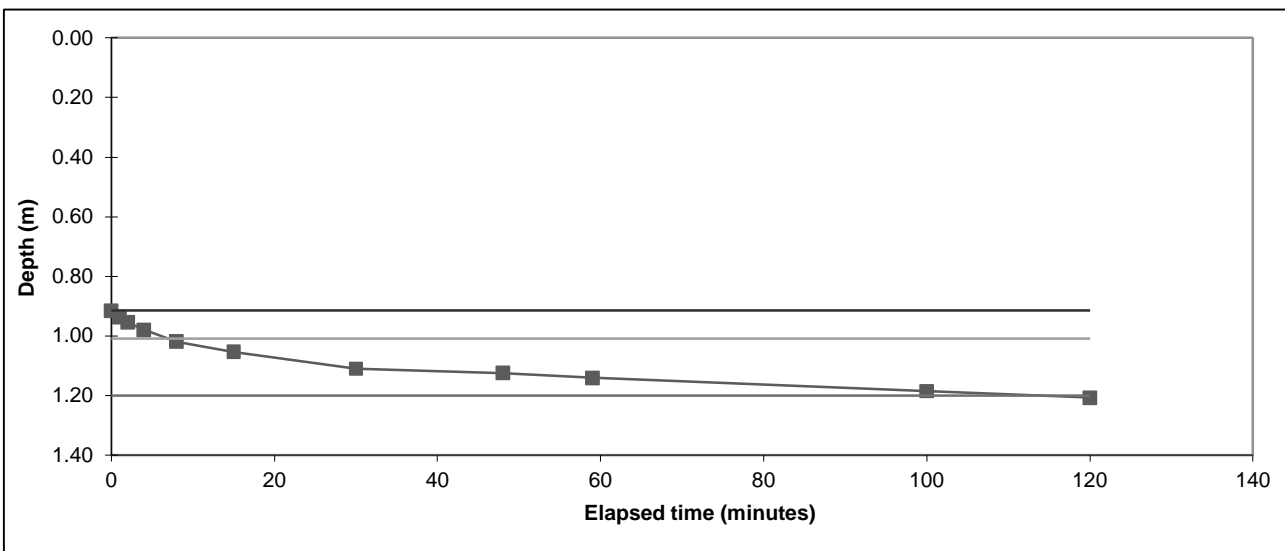
Trial Pit No:	SA2	Test No:	3	Date:	04/05/2023
Length (m):	1.800	Datum Height:			0.00 m agl
Width (m):	0.70	Granular infill:	None		
Depth (m):	1.29	Porosity of infill:	1	(assumed)

<b>Soil infiltration rate (m/s):</b>	<b>1.7E-5</b>
--------------------------------------	---------------
