Appendix 5

Site Photographs and Notes

C3485/23/E

Draughton Quarry

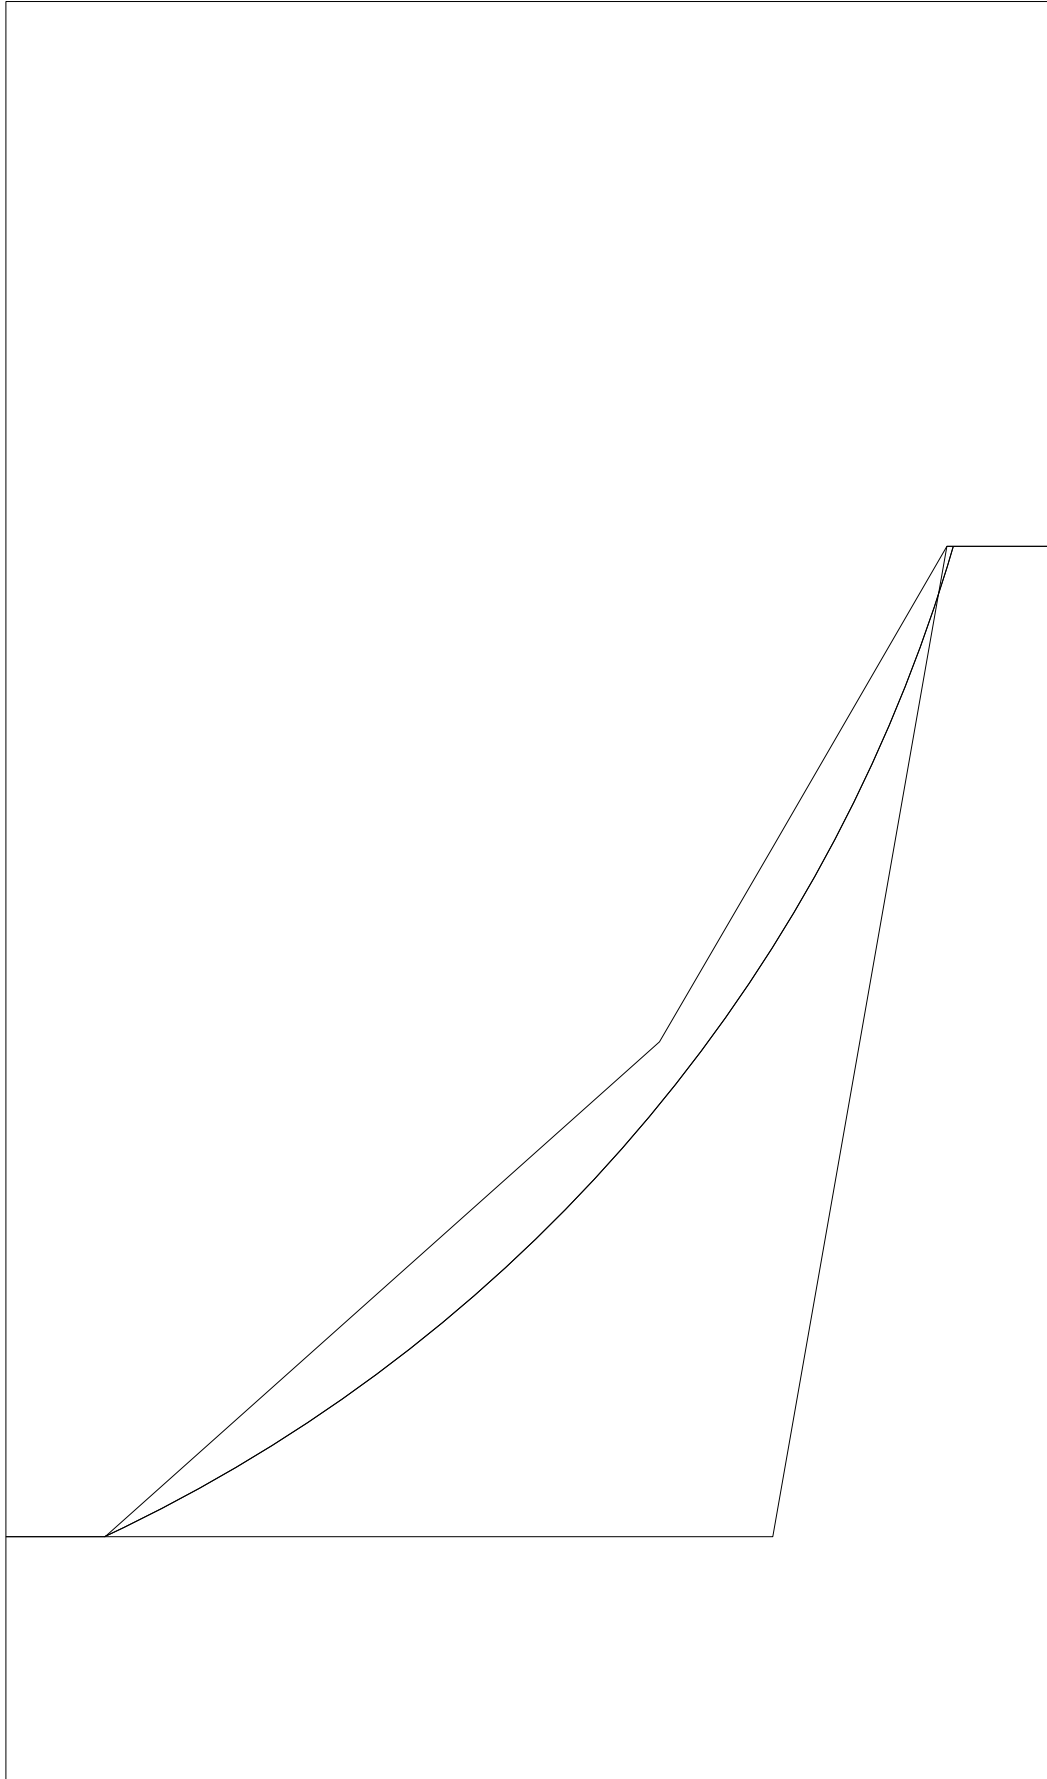
Diagram showing all circles

- (Analysis 1) With slip planes daylighting at the base, FoS = 0.69
- (Analysis 1-2) With slip planes daylighting at the change in gradient halfway up the slope i.e. failure within the upper section of the slope, FoS = 0.42
- The effects of the 10kN/m² surcharge were found to be negligible due to the likely presence of rockhead at shallow depths below the high level.

Circle centre X coordinate	-5.80 m
Circle centre Y coordinate	14.50 m
Circle radius	16.02 m
Disturbing moment	1264 kNm/m
Restoring moment due to soil shear	877 kNm/m
Restoring moment due to reinforcement	0 kNm/m
Stability factor	0.69

In light of the above, it is recommended in the first instance that a maximum angle for the soil slopes at the site of 30° is considered. However, through the use of reinforcement within the slopes, it may be possible to maintain the current angles. These options are discussed further below.

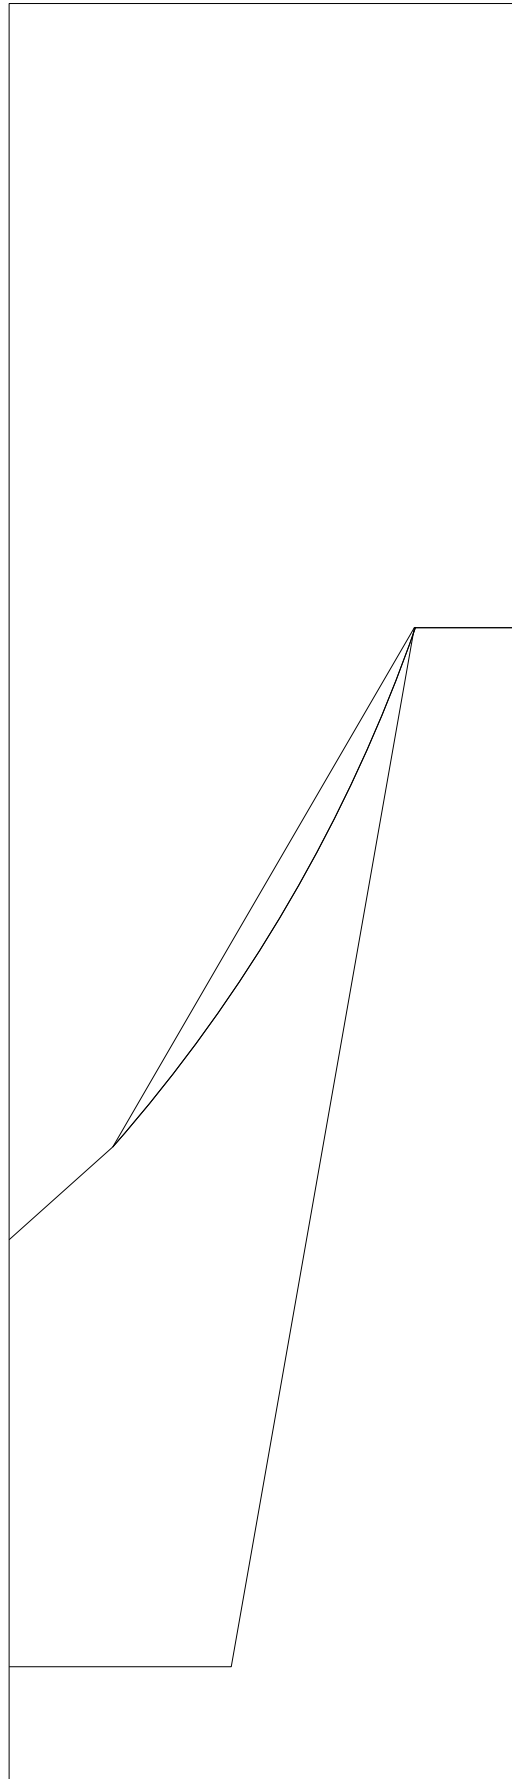
Diagram showing all circles

Circle centre X coordinate	-4.80 m
Circle centre Y coordinate	15.00 m
Circle radius	15.16 m
Disturbing moment	261 kNm/m
Restoring moment due to soil shear	110 kNm/m
Restoring moment due to reinforcement	0 kNm/m
Stability factor	0.42

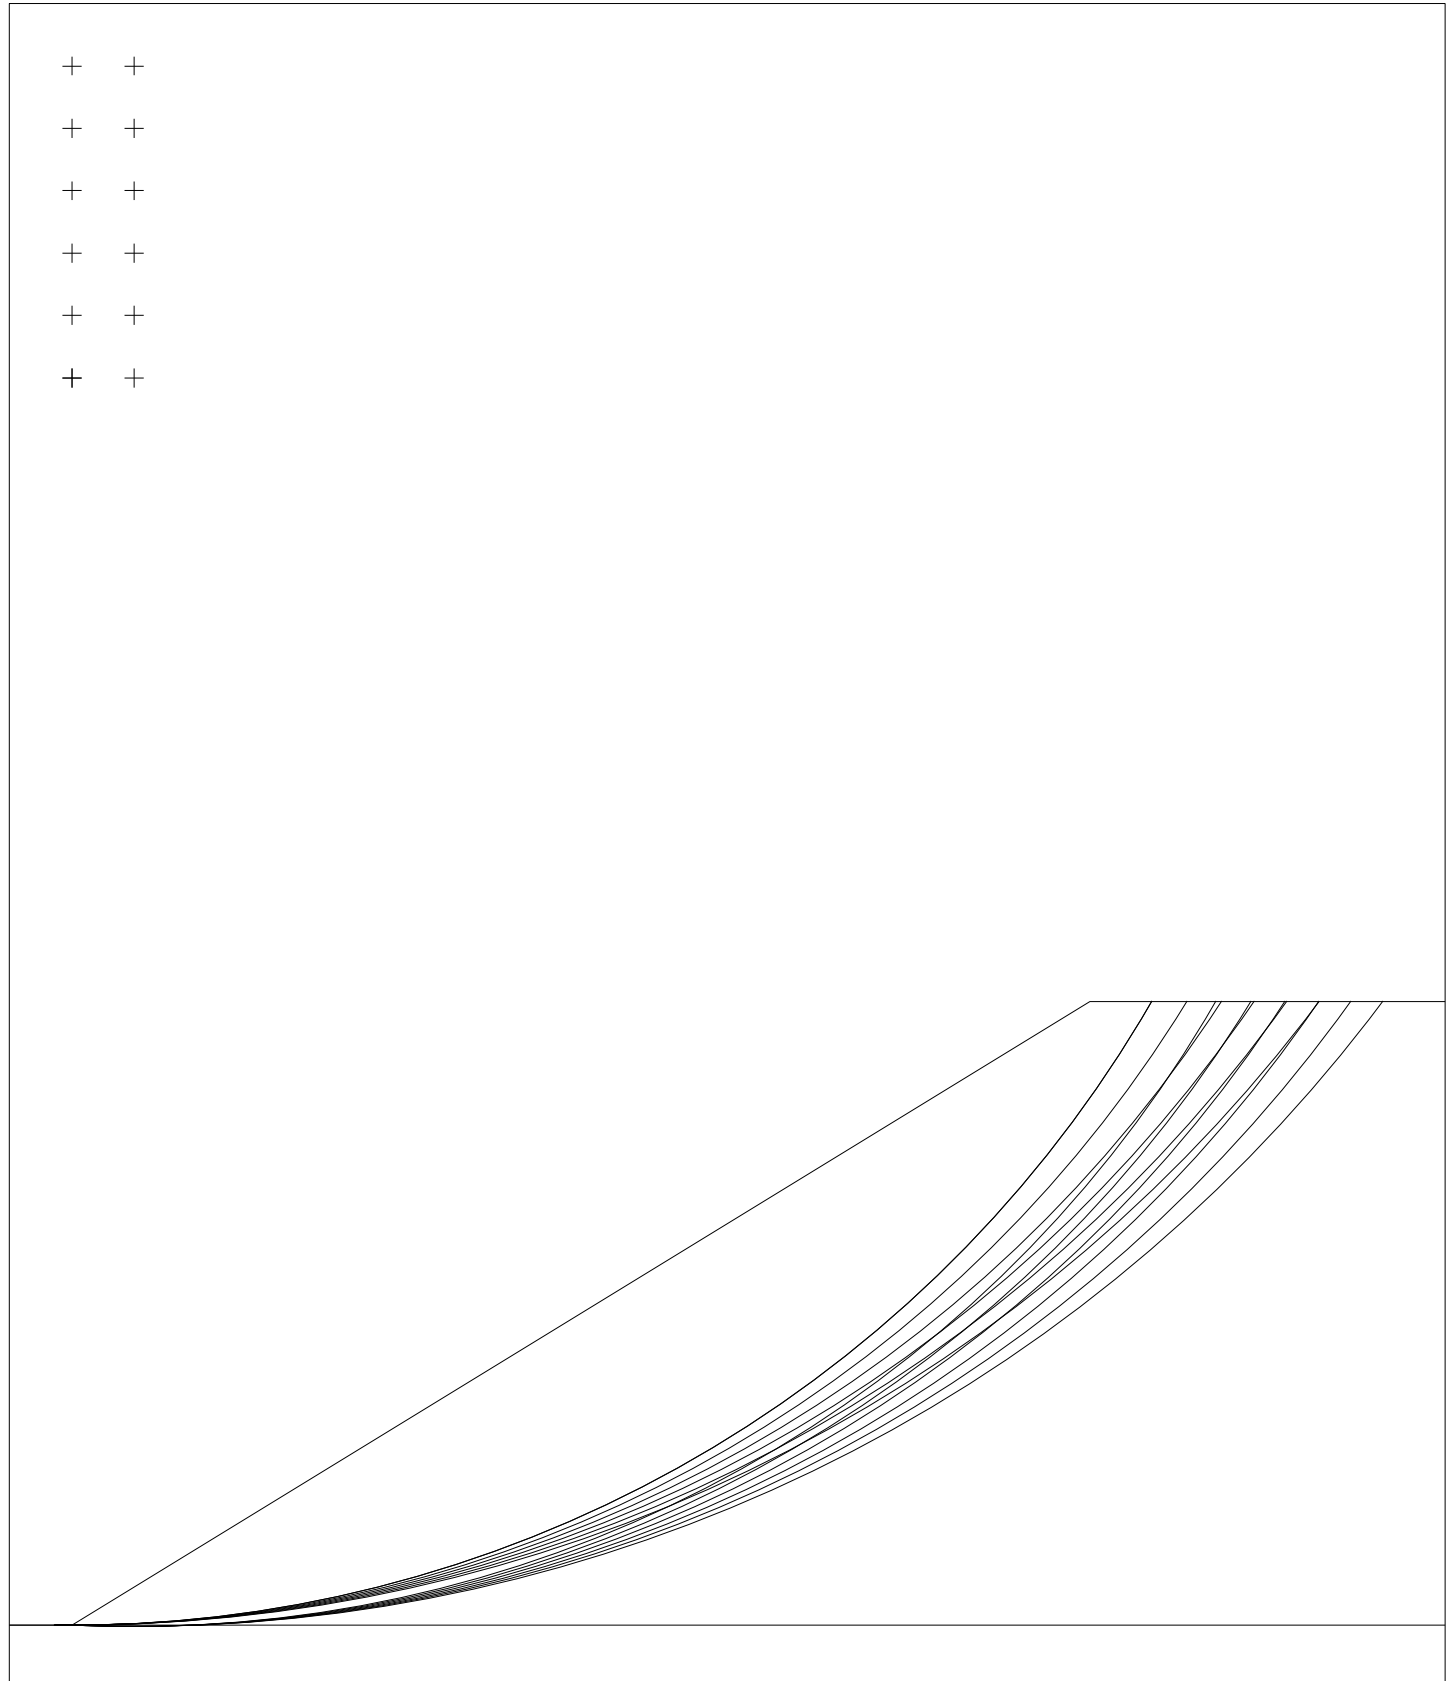
Diagram showing all circles

- (Analysis 2-1) Slope angle of 32°; FoS = 1.20, with water profile; FoS = 1.08
- (Analysis 2-2) Slope angle of 30°; FoS = 1.35, with water profile; FoS = 1.10
- The effects of the 10kN/m² surcharge were found to be limited typically reducing the factor of safety by 0.01.

Circle centre X coordinate	1.00 m
Circle centre Y coordinate	20.00 m
Circle radius	20.00 m
Disturbing moment	7108 kNm/m
Restoring moment due to soil shear	9544 kNm/m
Restoring moment due to reinforcement	0 kNm/m
Stability factor	1.34

Although the groundwater profile of the site is not fully established, there is a potential for groundwater to ingress the slope over the life time of the structures. Therefore, it is recommended that slope angles of 30° or less are adopted at the site. This however does come with some acceptance that the presence of water may reduce the factor of safety for the slopes to low levels, albeit that the slopes should remain stable.

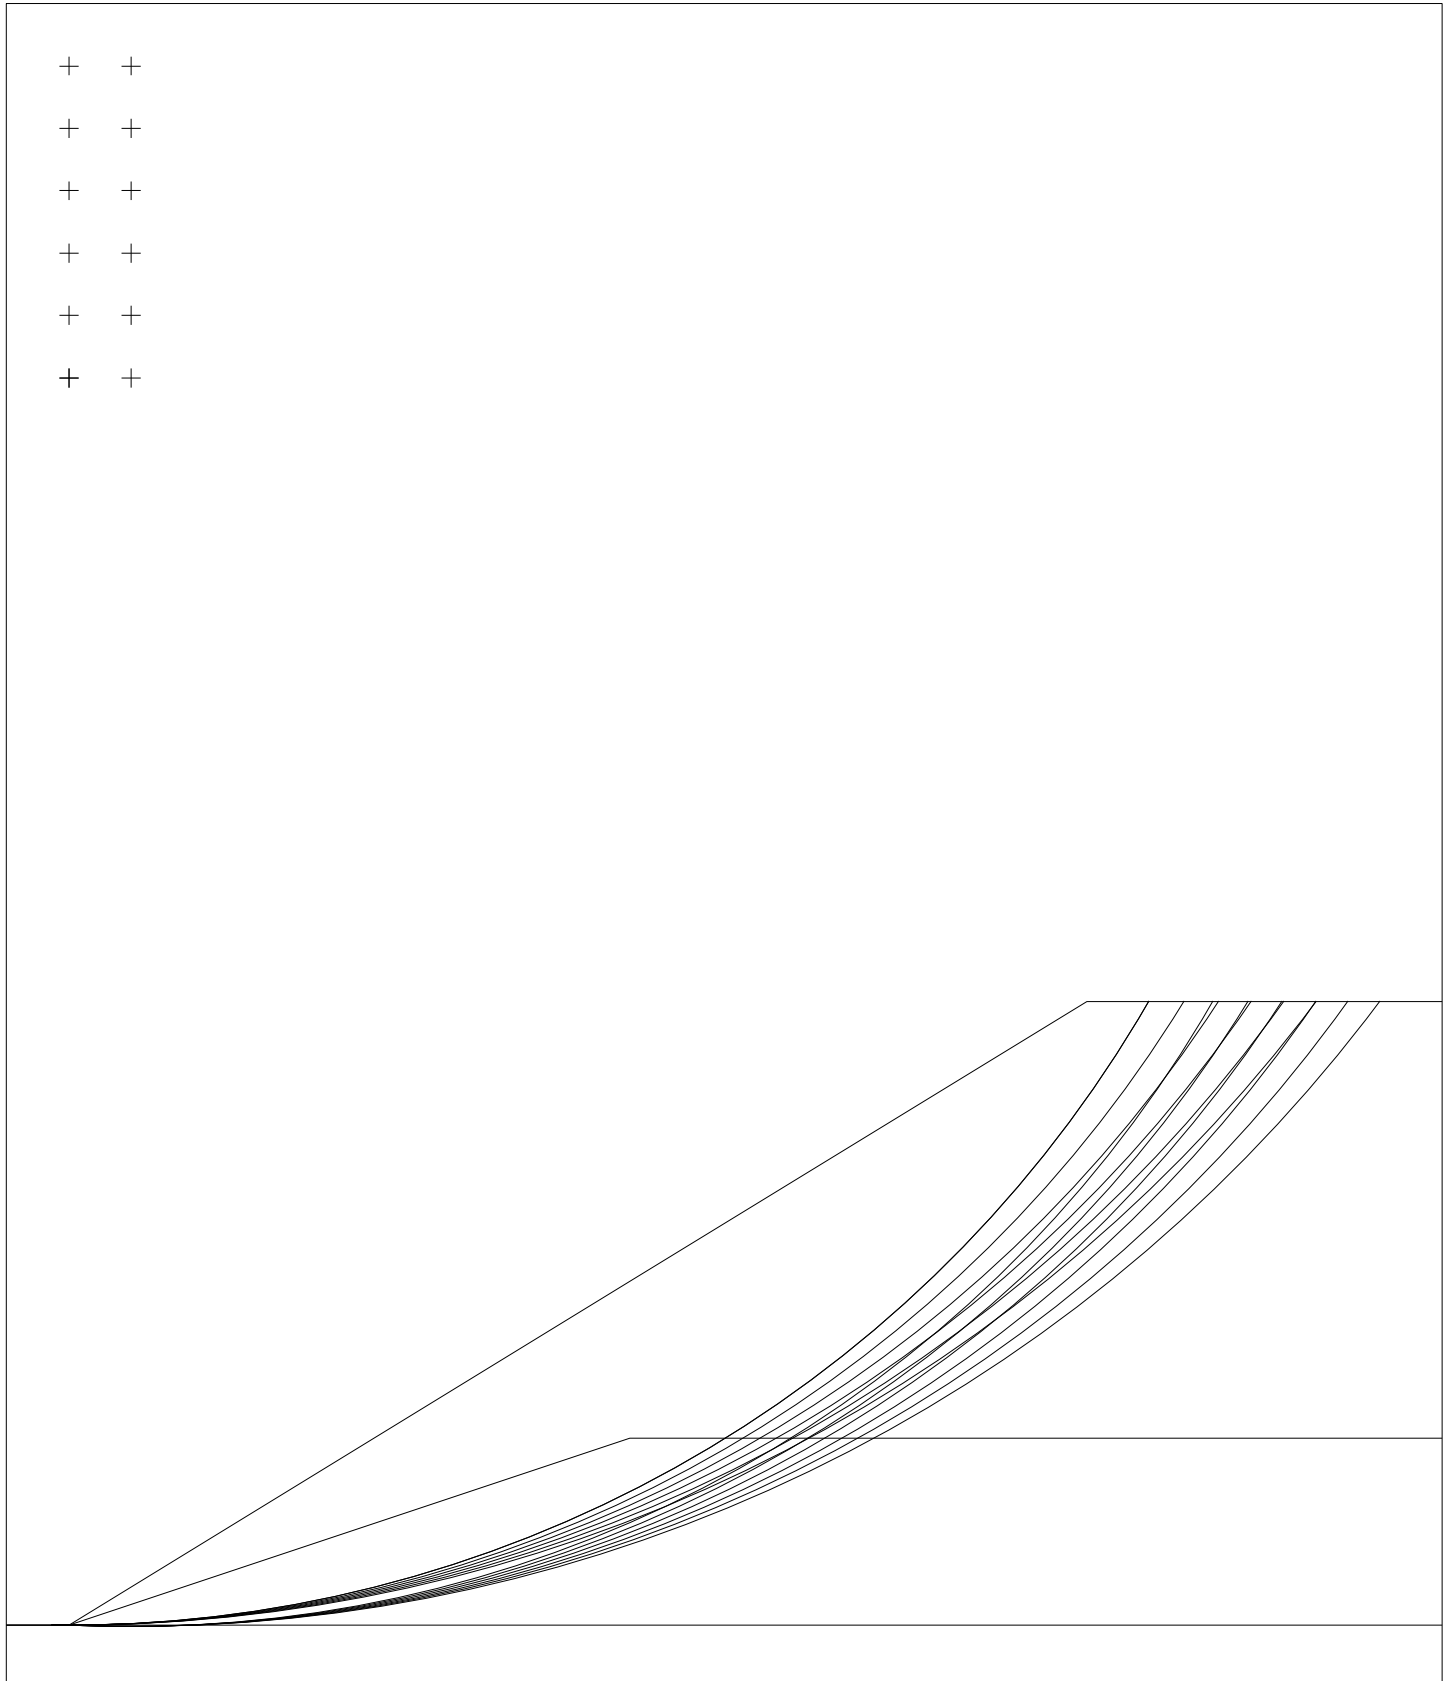
Diagram showing all circles

Circle centre X coordinate	1.00 m
Circle centre Y coordinate	20.00 m
Circle radius	20.00 m
Disturbing moment	7120 kNm/m
Restoring moment due to soil shear	7765 kNm/m
Restoring moment due to reinforcement	0 kNm/m
Stability factor	1.09
