Our Ref: ET/nc/ss/6870/1

Structural assessment for conversion of a barn

Further to your instruction to undertake an inspection of the former agricultural building at Clamp Farm, I include the following notes below regarding the structure, condition, and suitability for conversion.

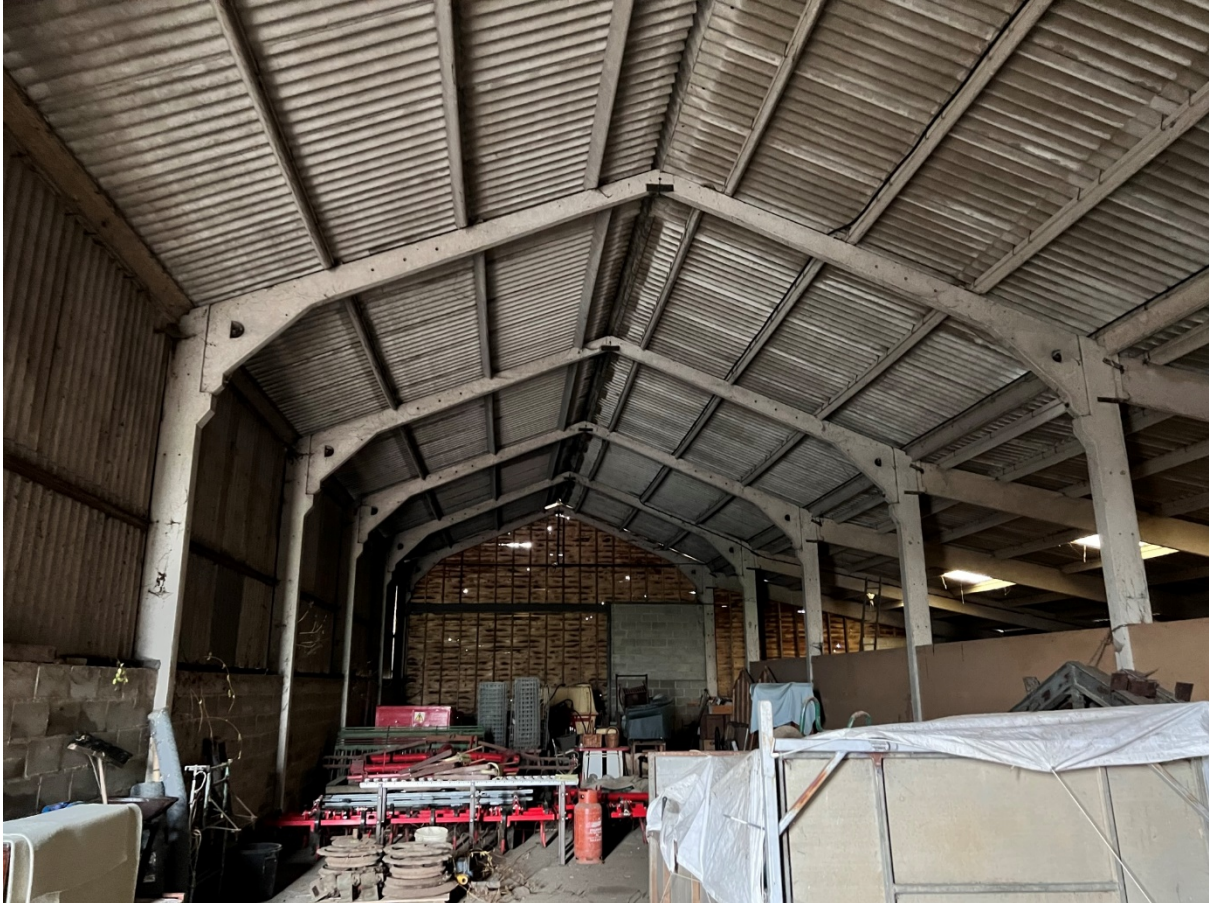
The structure for the main portion of the barn consists of a series of pre-cast concrete portal frames. These are a series of pre-cast sections which are bolted together on site and connected with pre-cast concrete purlins that run between the frames. These purlins not only form part of the main structural arrangement but also support wall and roof cladding materials. The structural arrangement consists of a symmetrical portal frame with an addition of further lean-to frame sections to the side on the north.

To the west end of the barn an additional bay has been added without the lean-to section. This is formed with a galvanised steel portal frame connected to the concrete structure with steel purlins.

The main structural elements of the building currently appear in good condition. There is some light surface corrosion to bolts that connect the concrete pre-cast units together. This does not appear to be to the degree where it has caused any compromising structural integrity. There is also some light surface corrosion to the steel sections for the steel portal frame as well as the steel purlin. Again this is not to the degree where it has compromised the structural integrity. The structural arrangement here is in good condition and still adequately performing its function. Whilst some light surface damage and deterioration to some of the structural elements has occurred this is not to the degree where it raises any concerns regarding the ongoing integrity of the structure.

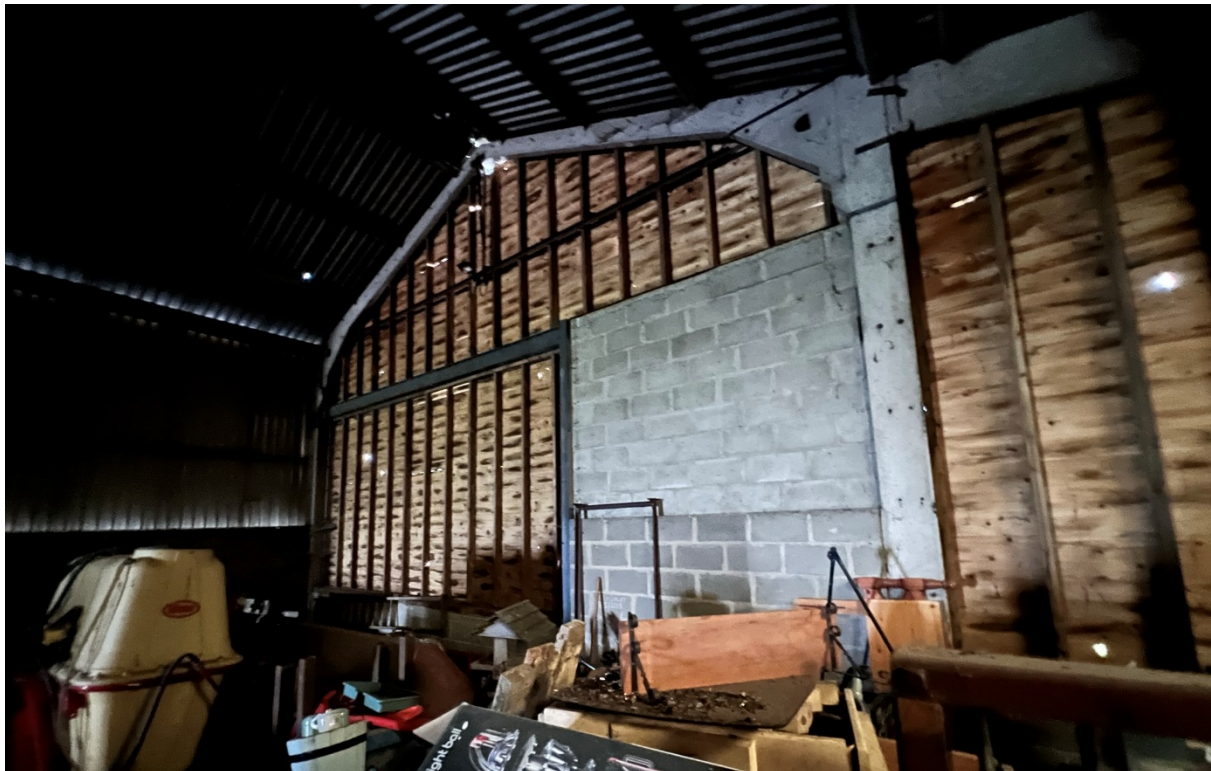
The external walls at low level to all but the east elevation are formed by concrete blockwork walls up to about 1½ metres high. The blockwork is in thick dense concrete blocks bedded in cement mortar. On the east elevation there is a section of blockwork to the north east corner otherwise this wall is finished with timber framing and timber cladding.

The blockwork walls at low level all appear sound, intact and in satisfactory condition with no obvious evidence of any notable weakness or deterioration. Some minor impact damage has occurred in some places. I have not been able to see every part of the low level external walls in detail due to the presence of stored items, and therefore cannot confirm that every element is in good condition, although all wall appear intact and in reasonably good alignment.

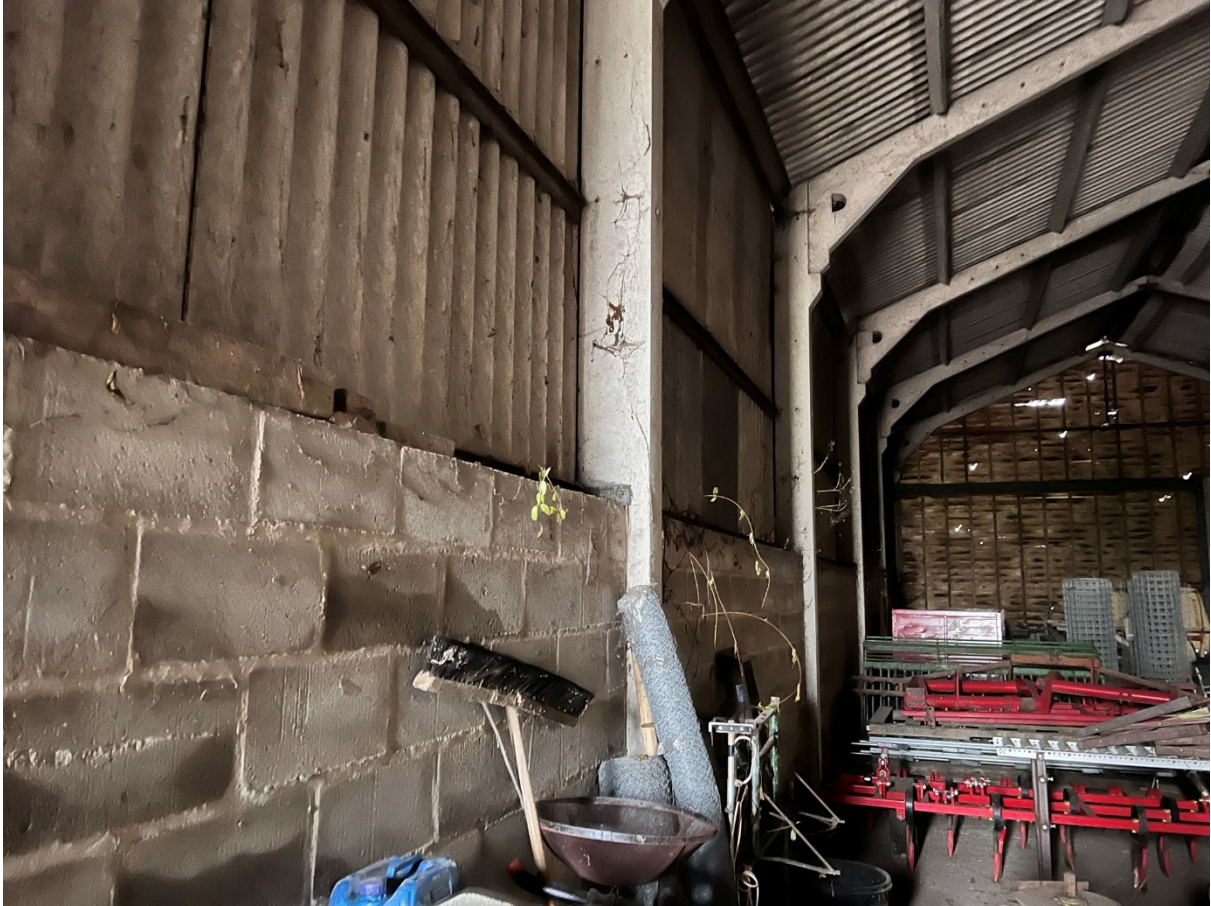
The eastern gable wall is mostly formed in timber studwork between the concrete frame elements with timber weatherboarding forming the external cladding over the top. The reason for the variation in finish here compared to the other walls is not known. Currently the timberwork all appears intact and in satisfactory condition as illustrated above.

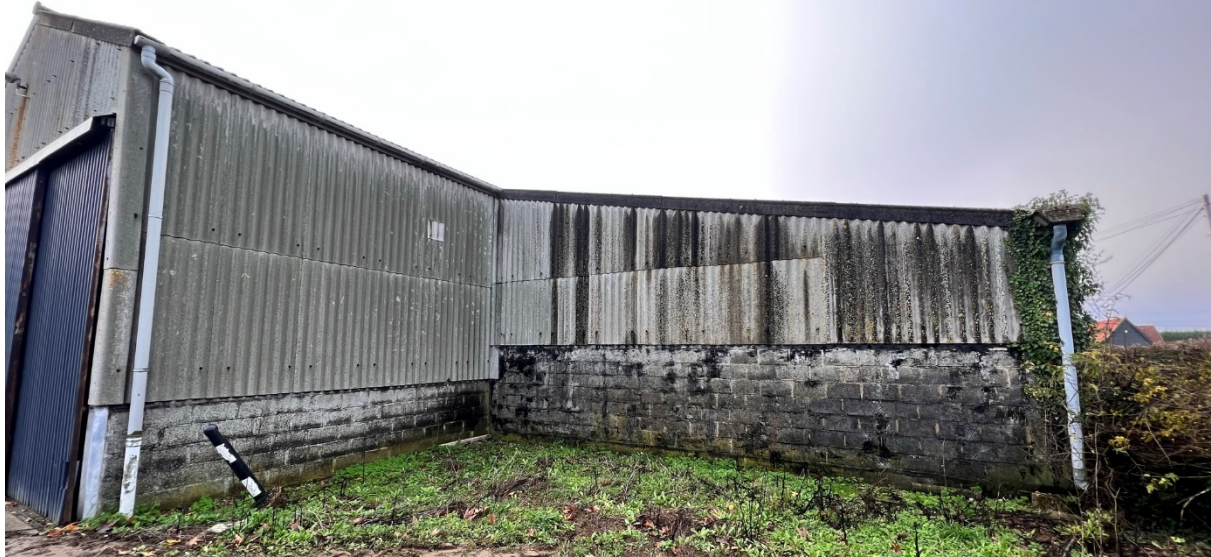
To all walls except the east end the external finish is formed by corrugated fibre cement sheeting above the concrete blockwork plinths. This all appears intact and in satisfactory condition. There are some areas where minor damage has occurred. This has not compromised the integrity of the building. Currently the wall finishes are all in satisfactory condition with only minor deterioration evident.
