Our Ref: 6870/2

### ***Structural assessment for conversion of a barn***

Further to your instruction to undertake an inspection of the former agricultural building at Elm Farm, I include the following notes below regarding its' structure, condition, and suitability for conversion.

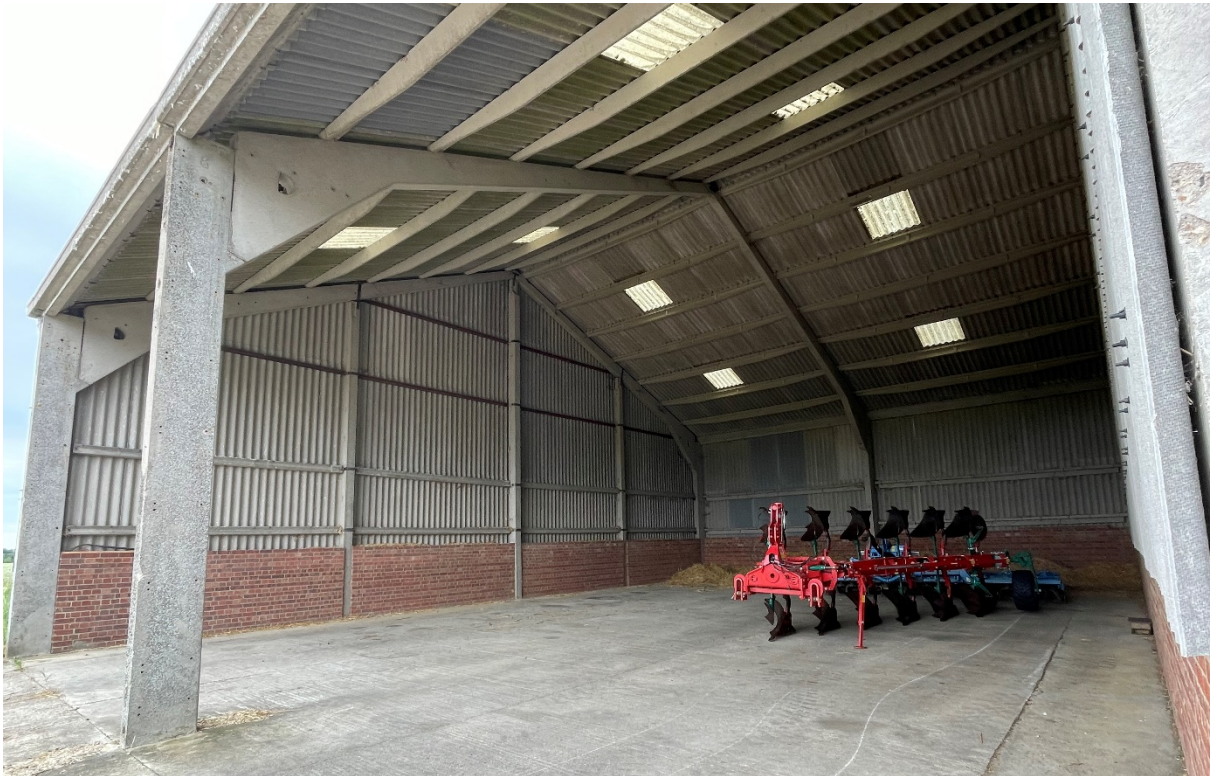
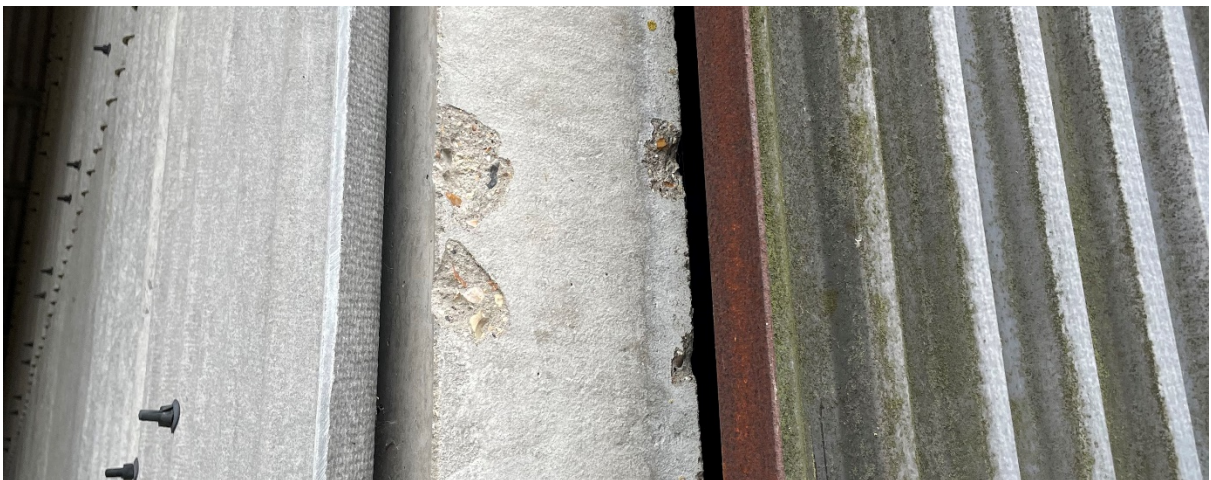
These elements of the structure of the building form the main structural frame which currently appears in sound condition. The frame is still in good alignment with no indication of any notable movement or distortion. There are a few minor areas of damage to the concrete columns forming the portal frame. These are only light surface damage and have not impaired the integrity of the structure.

Minor deterioration to face of concrete frame section

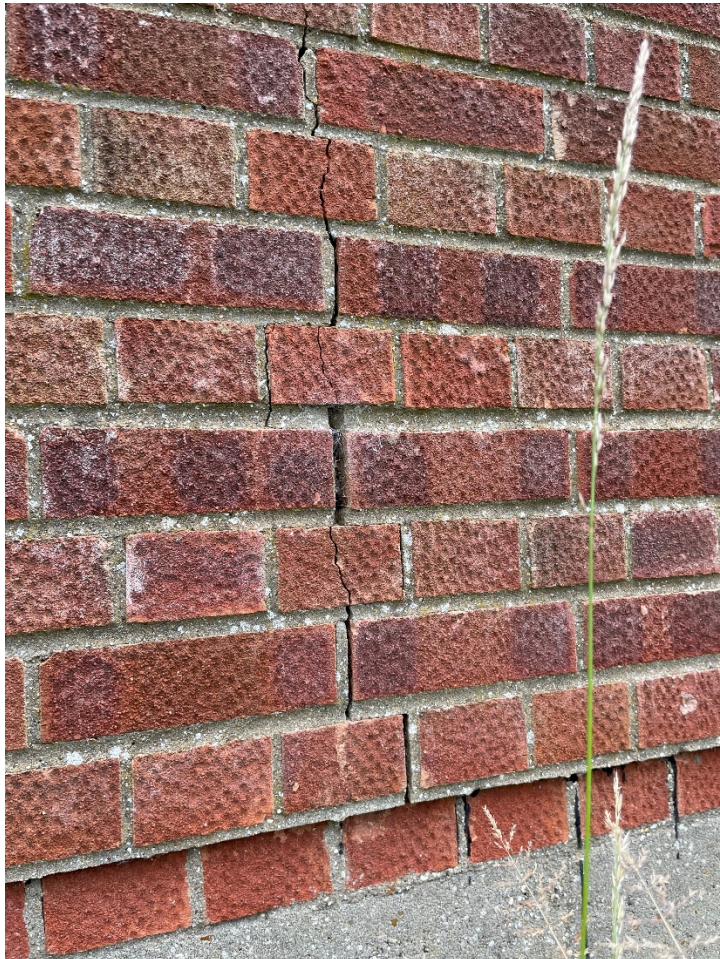
The masonry walls at low level are generally in good condition. There is some cracking to the eastern bay on the south elevation due to impact damage internally which has resulted in some vertical and horizontal cracks. The wall above the damp proof course has been slightly displaced outwards. Despite this impact and displacement movement the wall here is actually still in sound condition.

Cracks resulting from impact damage

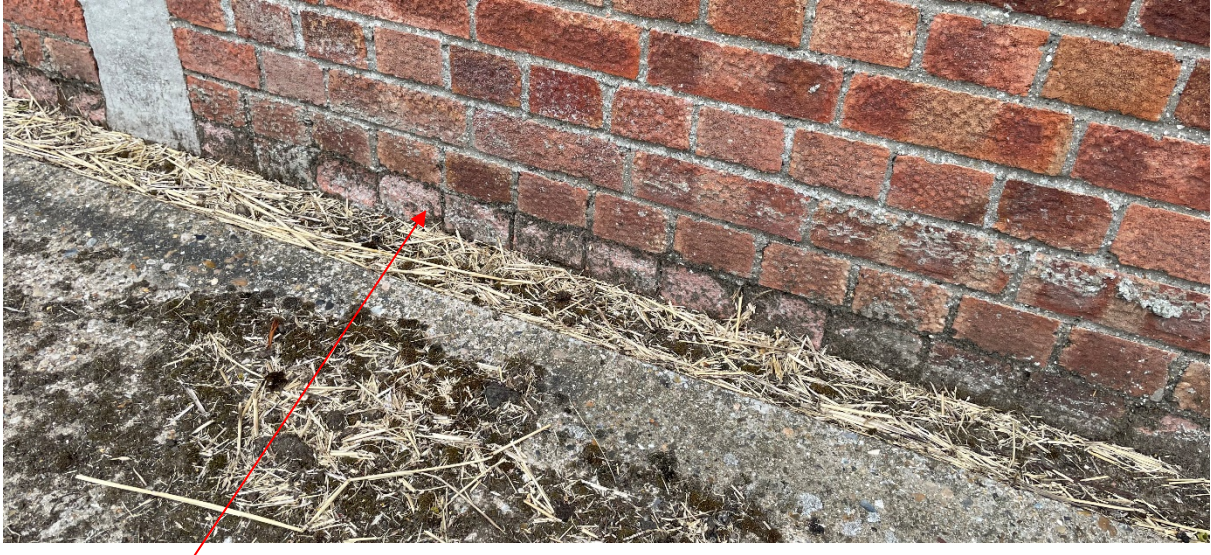
There is no indication of any similar damage to any other bays. Generally the brickwork is in good order with very little evidence of surface deterioration to the bricks. The only area where there is a small amount is one brick course above ground level externally on the west elevation. Here the bricks are still sound but with minor surface spalling having occurred.

Minor deterioration to bricks at low level

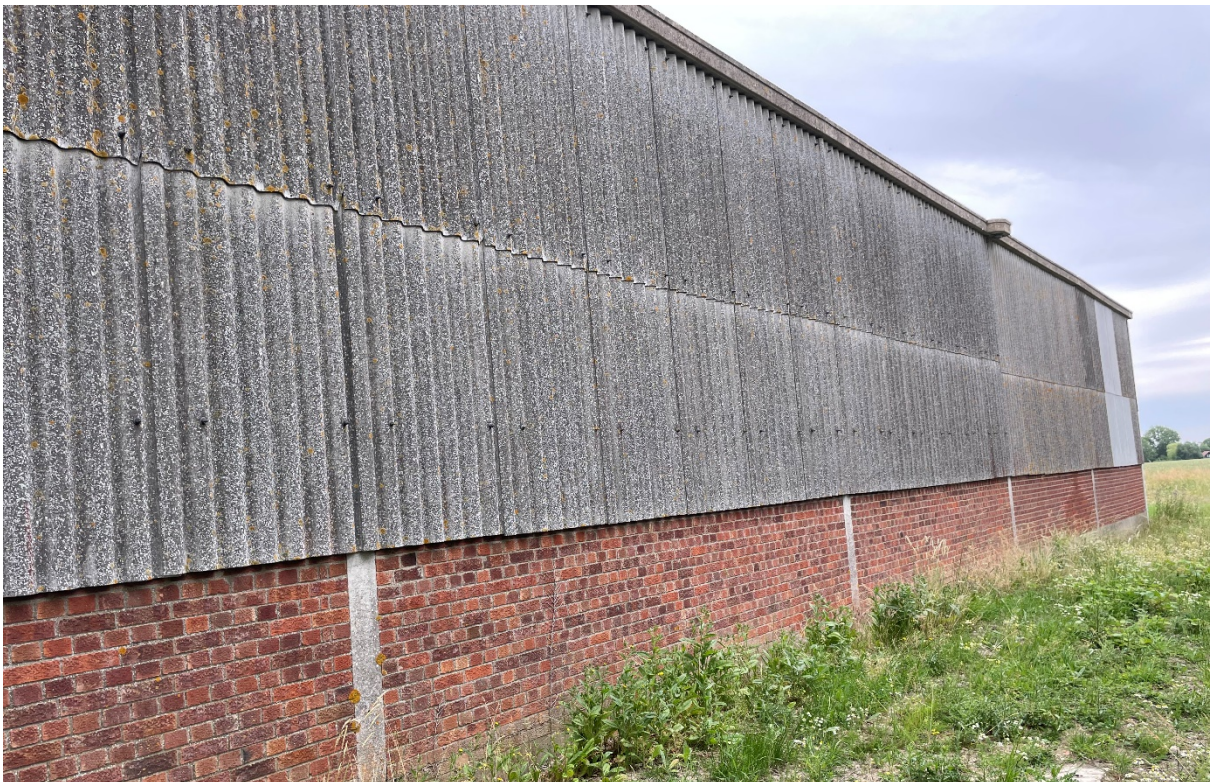
The fibre cement cladding sheets above the low level masonry walls are currently all intact and in fair condition. There are some areas of minor damage with some cracks and chips to the cladding panels. Despite these the cladding is still intact and weathertight.

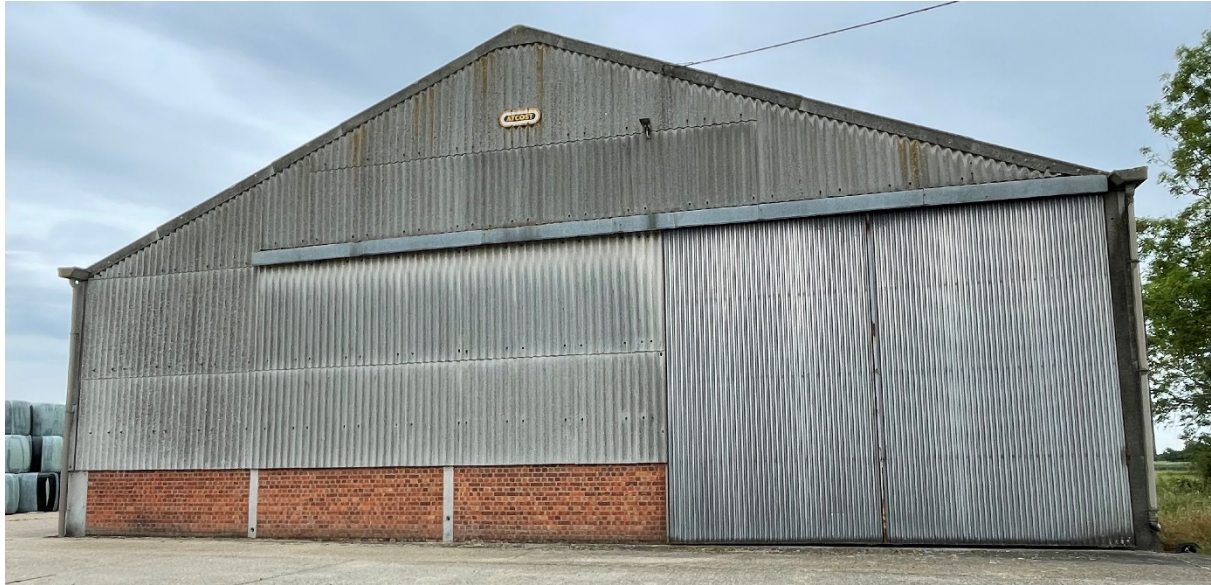
The large sliding doors are steel frame doors with profile aluminium sheeting. The doors run in steel channels within the ground. They are currently all intact and all in sound condition.

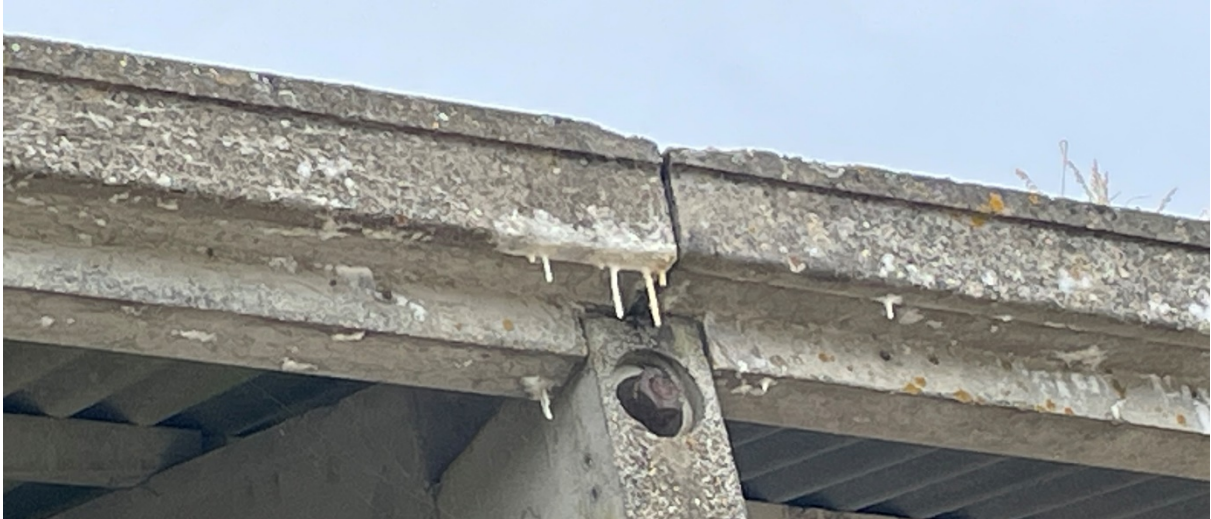
Rainwater from the roof of the building is taken away by pre-cast concrete gutter units that sit at the head of the two side walls. These have outlets to each end and at the centre of the run. These gutter units appear sound and intact. They lead to uPVC large diameter downpipes. Currently the arrangement here appears in good condition. There are no downpipes on the central outlets for the gutters. For the current use of the building this is probably not required. The pre-cast gutter units all appear intact and in satisfactory condition.
