Building 3  
Manor Farm, Church Road  
Swindon Village  
Cheltenham

## Visual Structural Inspection

Project Ref: 12973rev1

November 2020

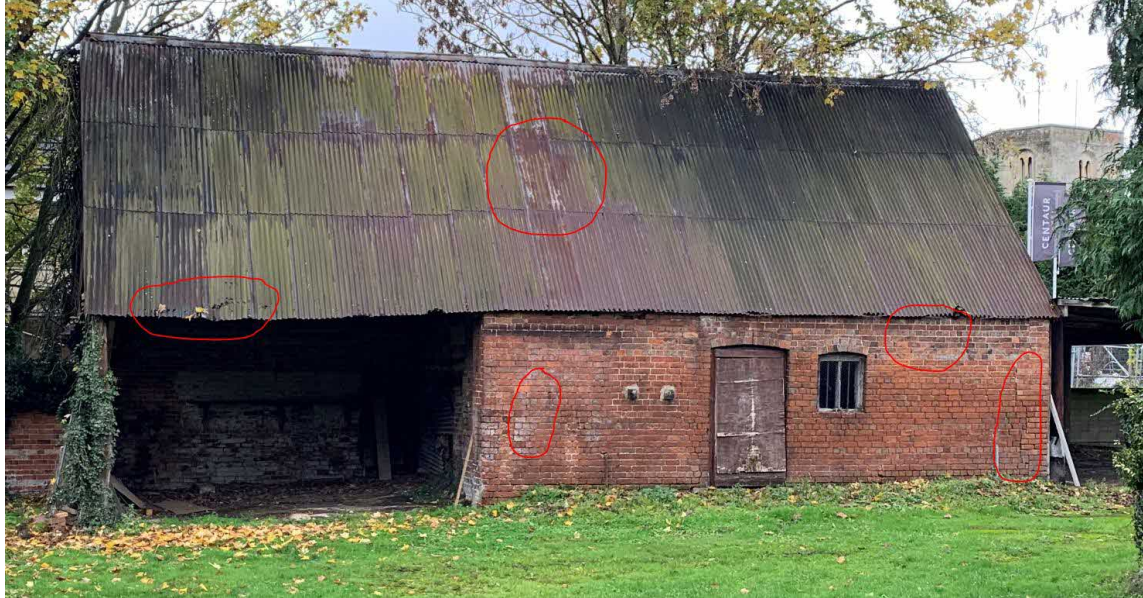
Photo 1.

- 2.1 The barn is of brick and timber construction with a dual pitched rusting corrugated tin roof, and straight gables. The plan dimensions are approximately 9.2m x 6.6m. The front or east elevation includes a predominant opening providing access into the barn, which may have been used for parking agricultural vehicles (photo 1). The north elevation also has a covered area or lean-to. The lean-to is mainly open with only a mid-height wall to the west and has plan dimensions of approximately 14.3m x 6.6m maximum. The roof is flat corrugated tin with only a slight fall for drainage but no gutters.

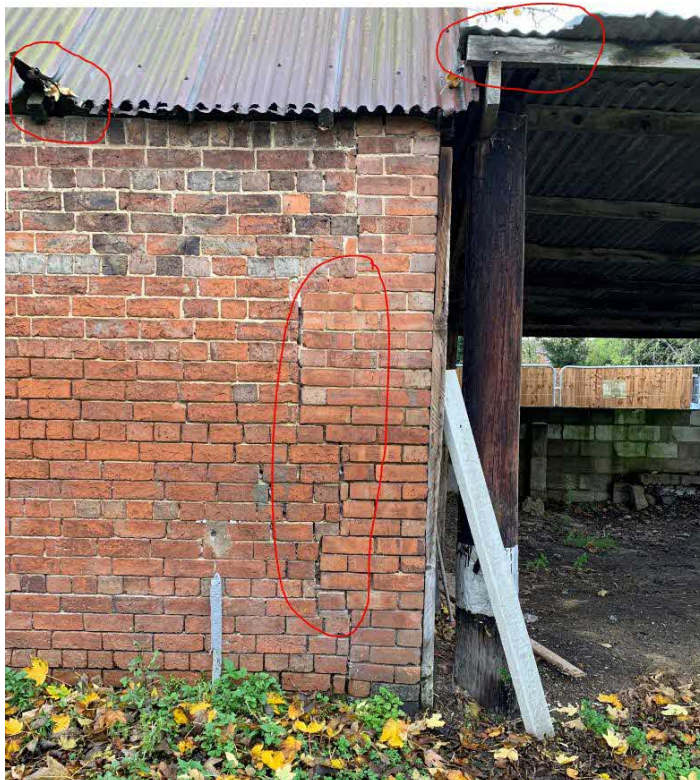
Photo 2.

- 2.2 The external walls look to be 9" thick brickwork which have been constructed using various brick types with poor and deteriorating bed joints with various cracks from either poor original construction or foundation movement (photo 2).

- 4.1 Foundations have not been investigated as part of this report. However, it is likely that the existing masonry is founded at a shallow level and is corbelled brickwork. Given the condition of the existing masonry underpinning would be required.

- 4.2 Much of the masonry is in poor conditions showing signs of distress and debonding this would require most areas to be re-pointed as a minimum or in many areas re-built.

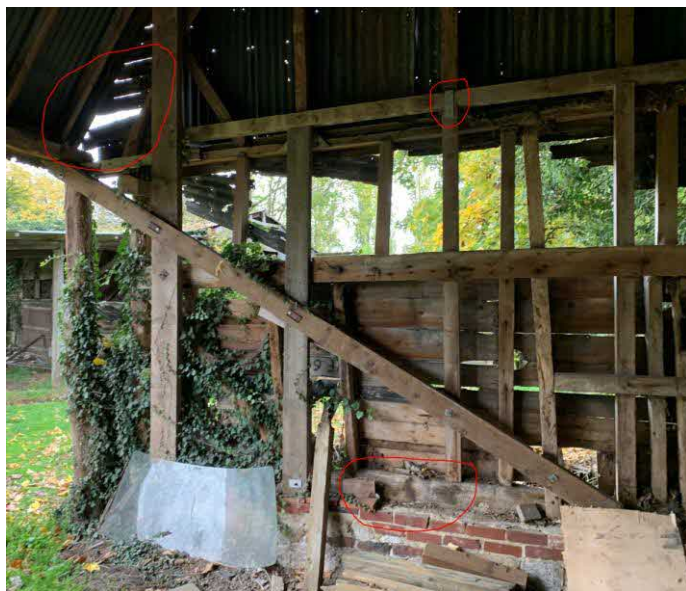
Photo 3.

- 2.3 The south elevation external wall is of timber construction using a variety of different timber sections poorly fixed to a wall plate onto a masonry low level wall. The elevation is braced to eaves level, but timbers are poorly fixed and appear to have attempted repairs. The cladding is not weather tight. The lower levels are timber boarding in poor condition possible rotten with significant openings. Above eaves the cladding is rusting corrugated tin (photo 3).

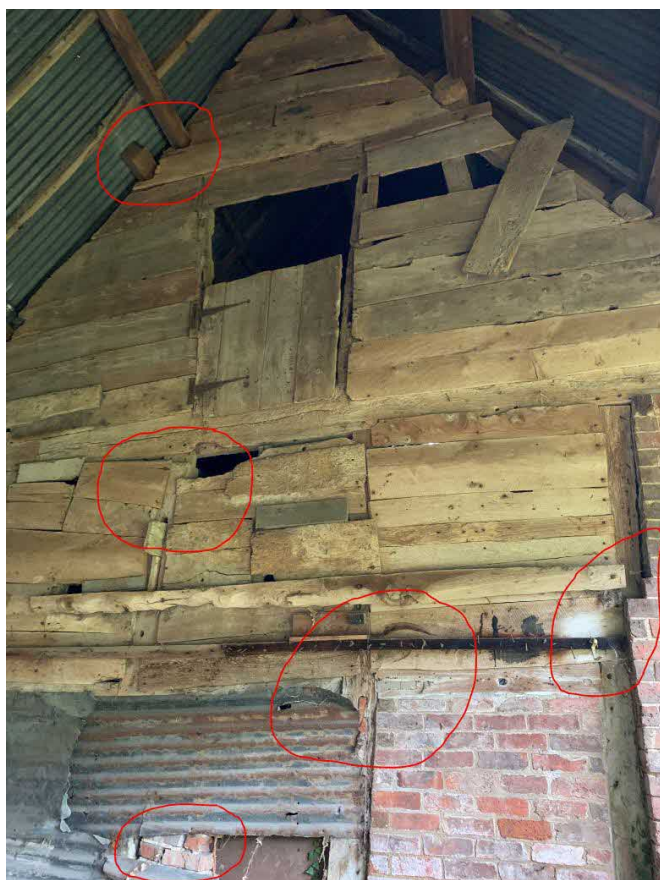
Photo 4.

- 2.4 The internal wall dividing the parking area with the internal barn is a roof supporting wall of various sections of differing masonry, corrugated tin and mixed timbers; all is in extremely poor condition. (photo 4)

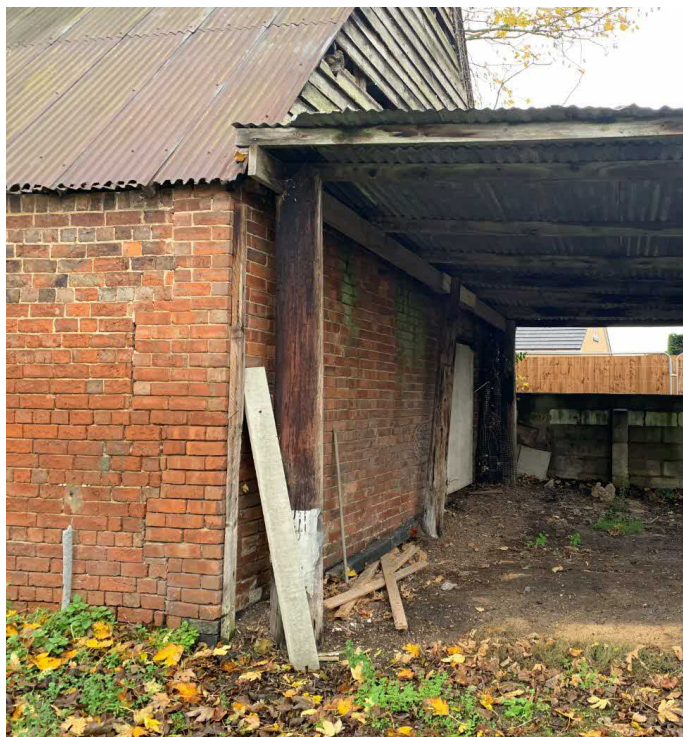
Photo 5.

- 2.5 The north elevation external wall is of brick construction to eaves level with timber into the straight gable. The brickwork to eaves is not in good condition but appears to be the best of the elevations and is likely providing current stability (Photo 5).

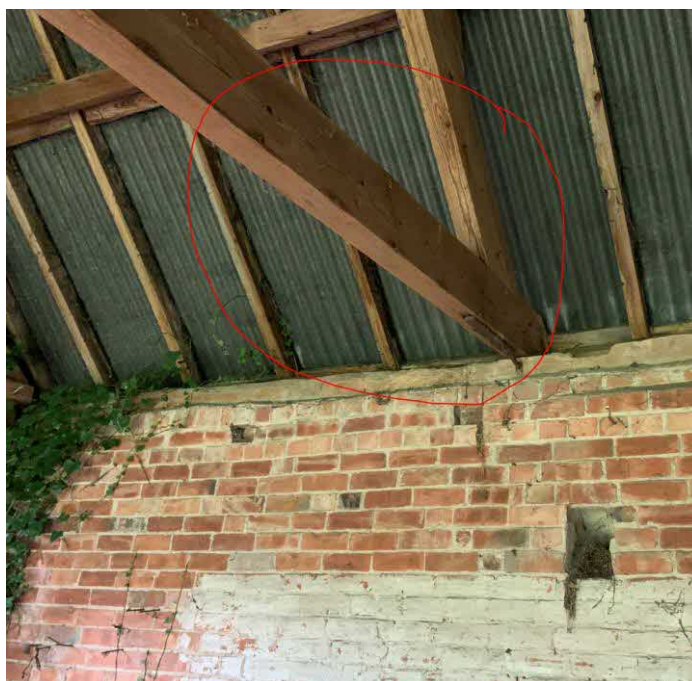
Photo 6.

- 2.6 The roof is of timber construction supported by its straight gables and a series of dual pitched king post trusses which in turn supports timber purlins and rafters. The trusses and rafters are connected to a timber wall plate positioned on the brickwork. The timber roof structure is supporting rusting corrugated tin cladding which is not weather tight. Due to water ingress structural timbers are not in good condition and are likely to be suffering from wet rot. Structural strapping is not evident therefore traditional methods are in use which are likely to have been compromised from weathering (Photo 6 & 7).

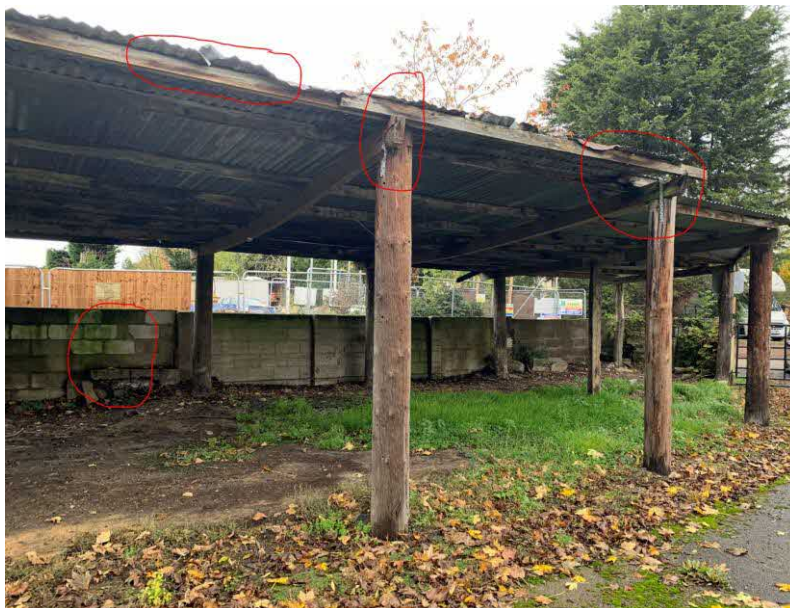
Photo 8.

- 2.7 The lean-to is an open area bordered by a mid-height wall to the west elevation. The wall appears to be of a newer construction to the rest of the barn and is constructed in standard blocks with strengthening piers. The wall is not connected to the lean-to structure. The lean-to is built from approximately 10" diameter timber posts with timber beams between at roof level forming a "goal post" arrangement or rudimentary portal. The portals look to create a slight mono pitch to form a fall for drainage. There are a number of portals of varying spans (maximum approximately 14.3m) which are connected by a series of flat purlins. The timber roof structure is supporting rusting corrugated tin cladding which is not weather tight. Due to water ingress structural timbers are not in good condition and are likely to be suffering from wet rot. Strapping and connections are not adequate to provide stability therefore stability for the lean-to is either provided from the depth of the posts or from connection to the main barn (Photo 8).

- 3.2 The lean-to  
Laterally the portalised nature (goal post) of the posts and beams are providing stability however the poor strapping at eaves level would suggest that the posts are fixed deep into the ground. This could also be assumed longitudinally alternatively the lean-to is reliant on the barn.
