**Phase 1 Land Contamination  
Risk Assessment**

**Proposed Works on Clopton Hall**

**Clopton Hall, Clopton Green,  
Rattlesden IP30 0RN**

**Date: July 2023**

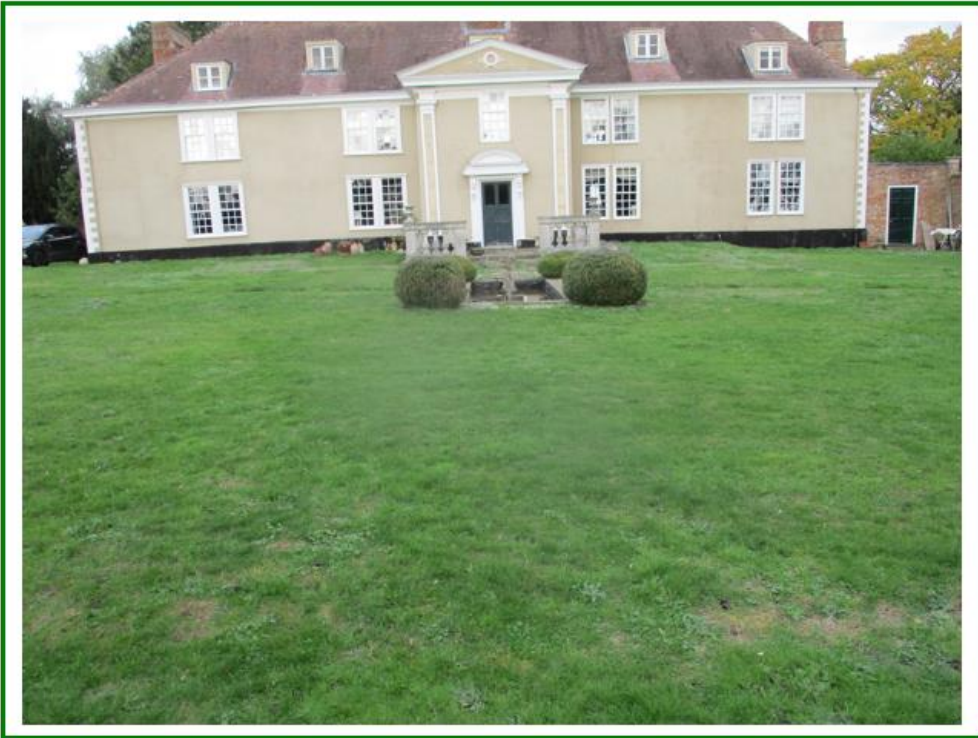
**Photo No.1: Facing north from south of Clopton Hall showing the southern face and large, open gardened area**

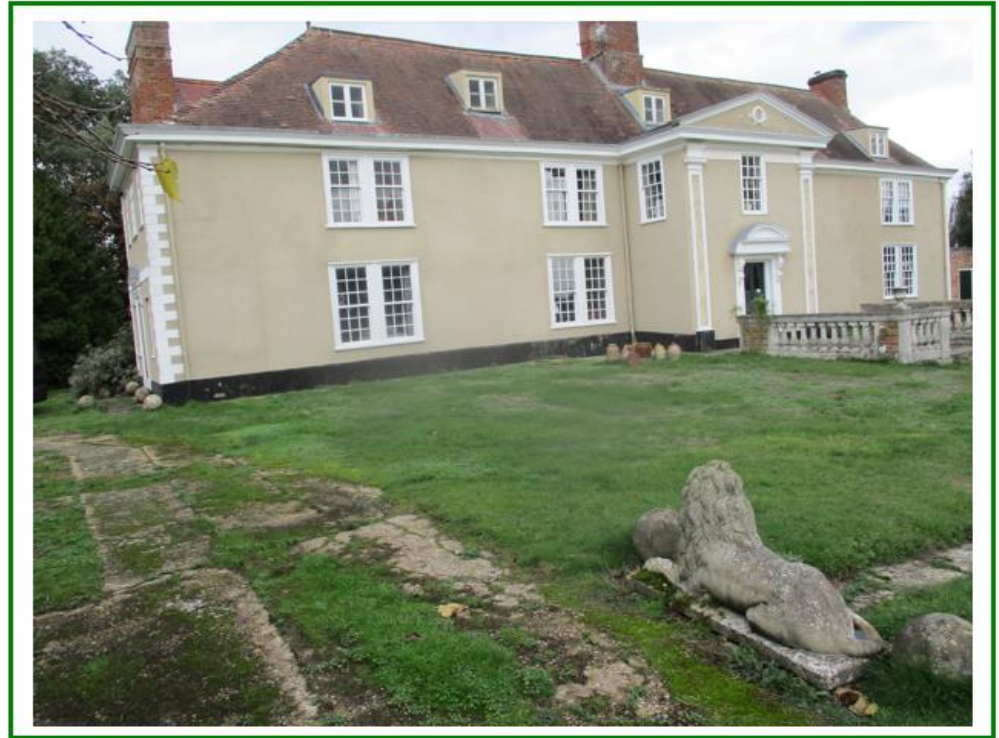
**Photo No.2: Facing slightly NE from outside the SW corner of Clopton Hall showing the rear (southern) face of the building**

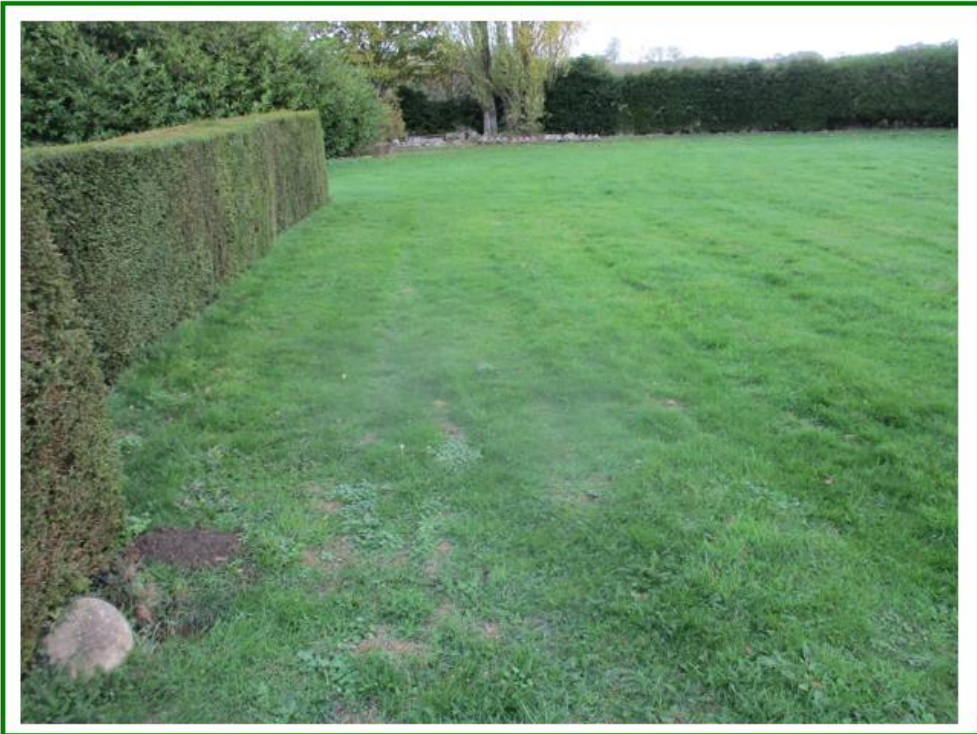
**Photo No.3: Facing west from NE of the hall showing further, well-maintained garden and lawned areas**

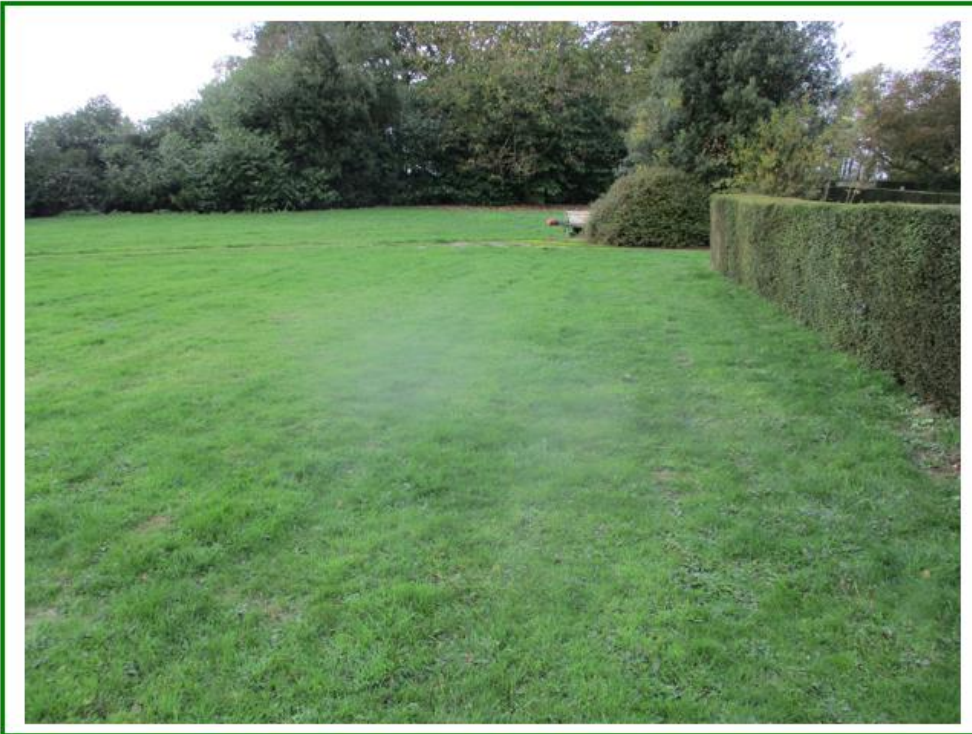
**Photo No.4: Facing north in the same location showing the gardened areas located NE of the hall**

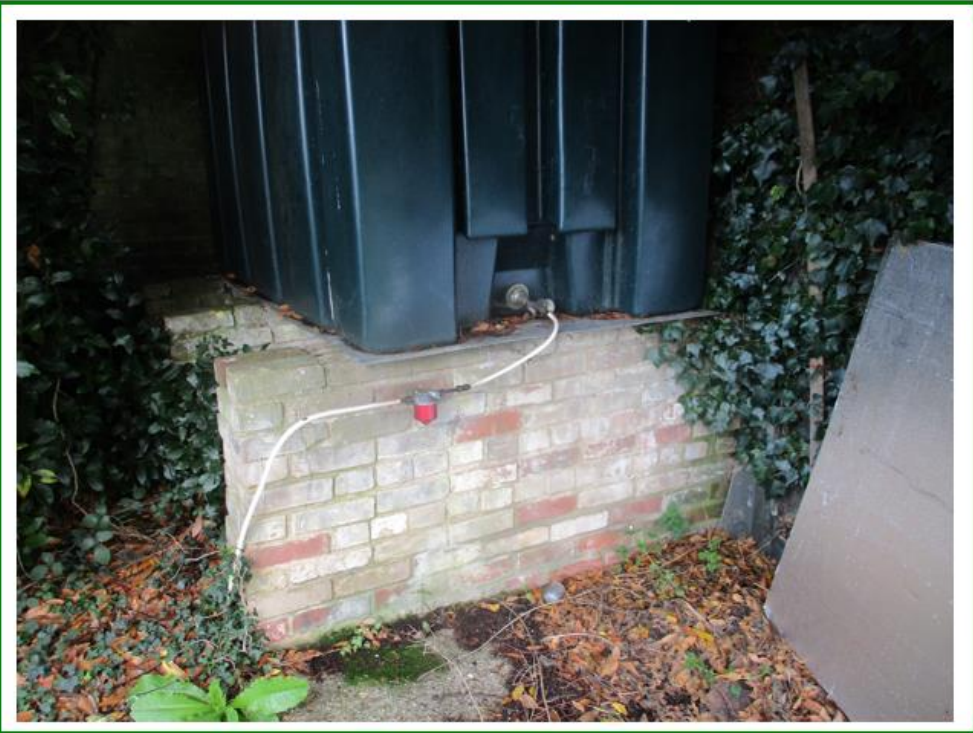
**Photo No.5: Bunded fuel tank noted on western face of the outbuildings located SE of the hall itself**

It is also recommended that the bunded oil tank be professionally removed.

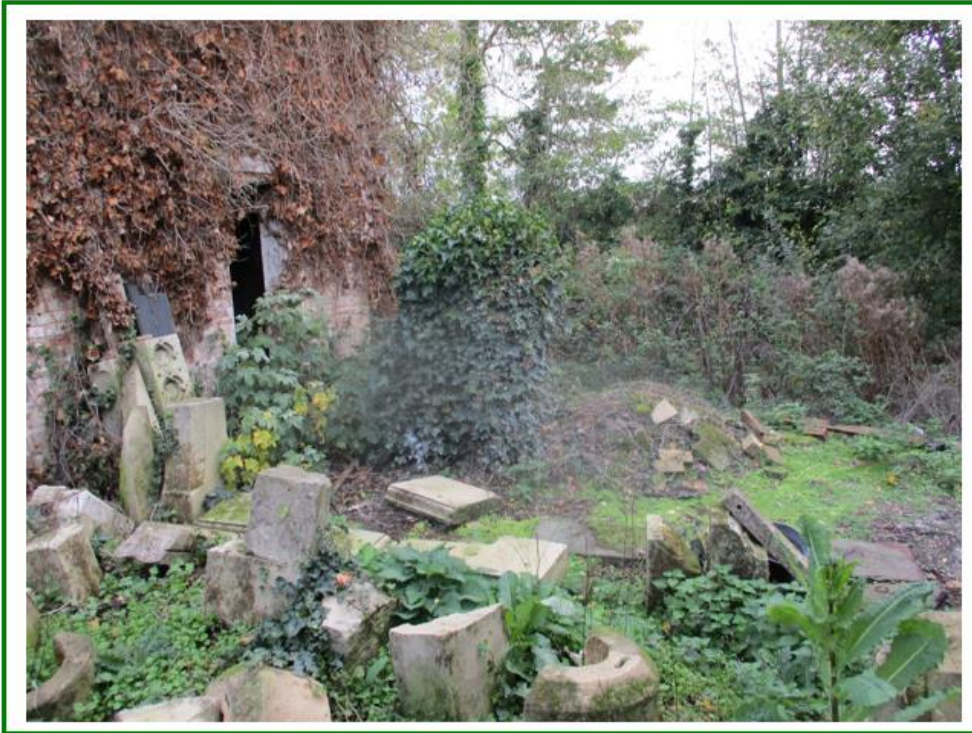
**Photo No.6: Facing west in the small yard are located between outbuilding and shed showing building stone storage**

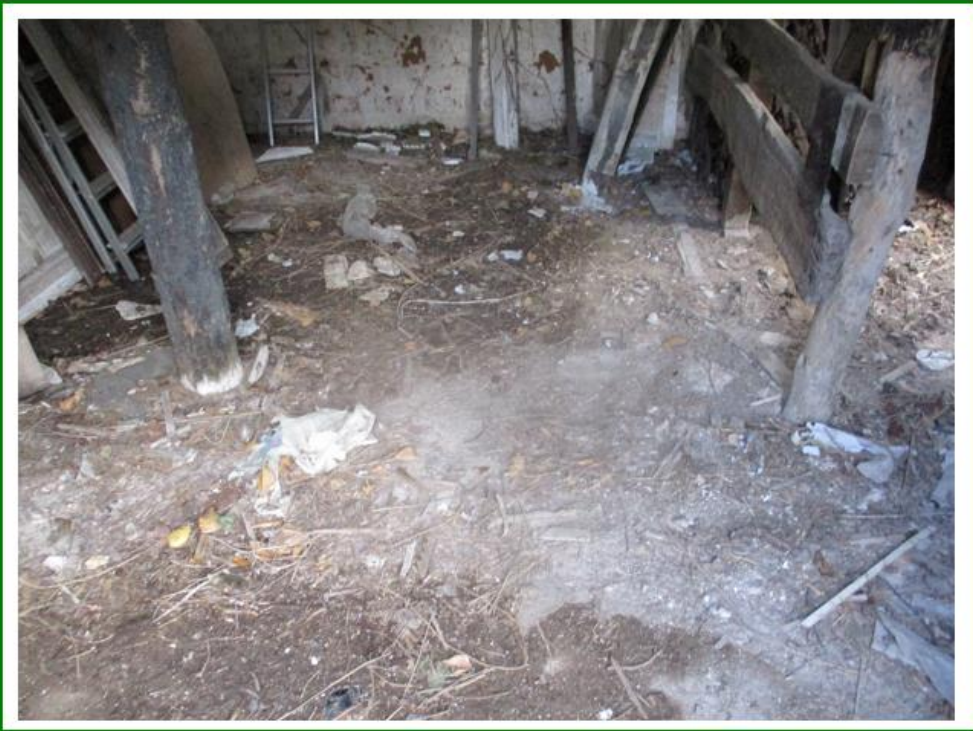
**Photo No.7: Facing north showing example shot of flooring within the outbuilding and adj. brewhouse.**

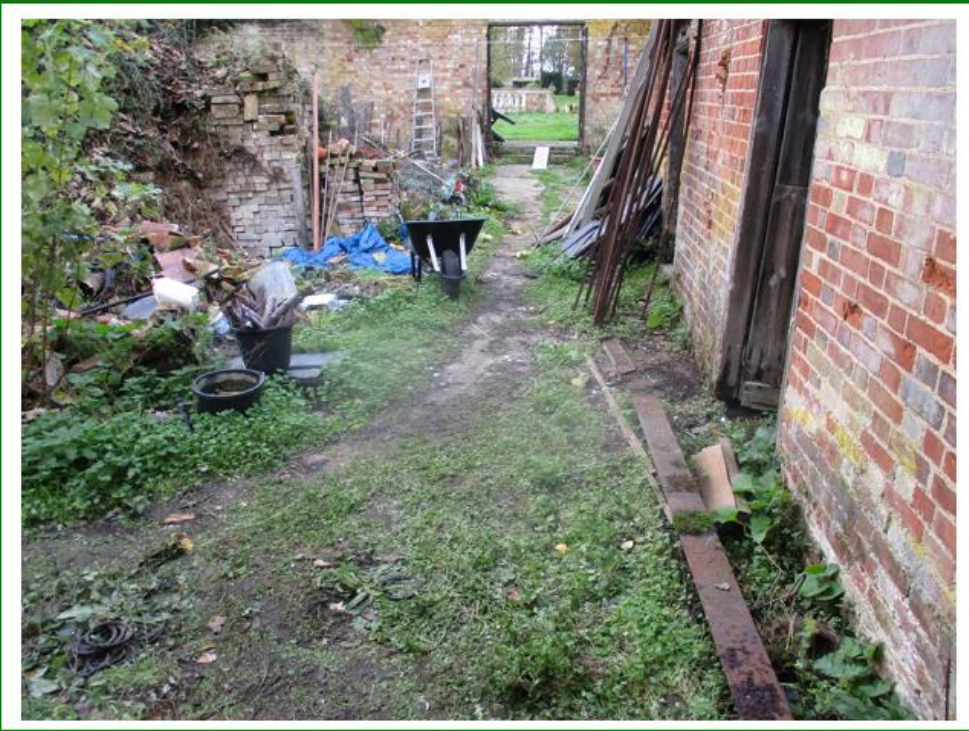
**Photo No.8: Facing west from just south of the outbuilding (right) showing access to rear garden area of the Hall**

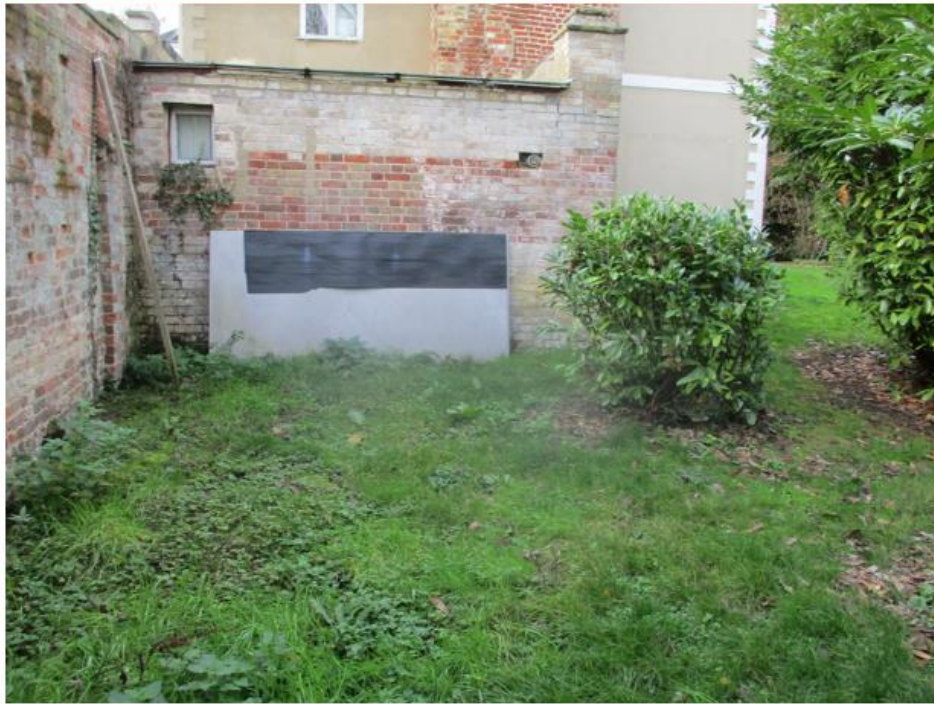
Photo No.9: Facing west from outside the eastern face of the hall and north of the outbuildings showing rear of buildings

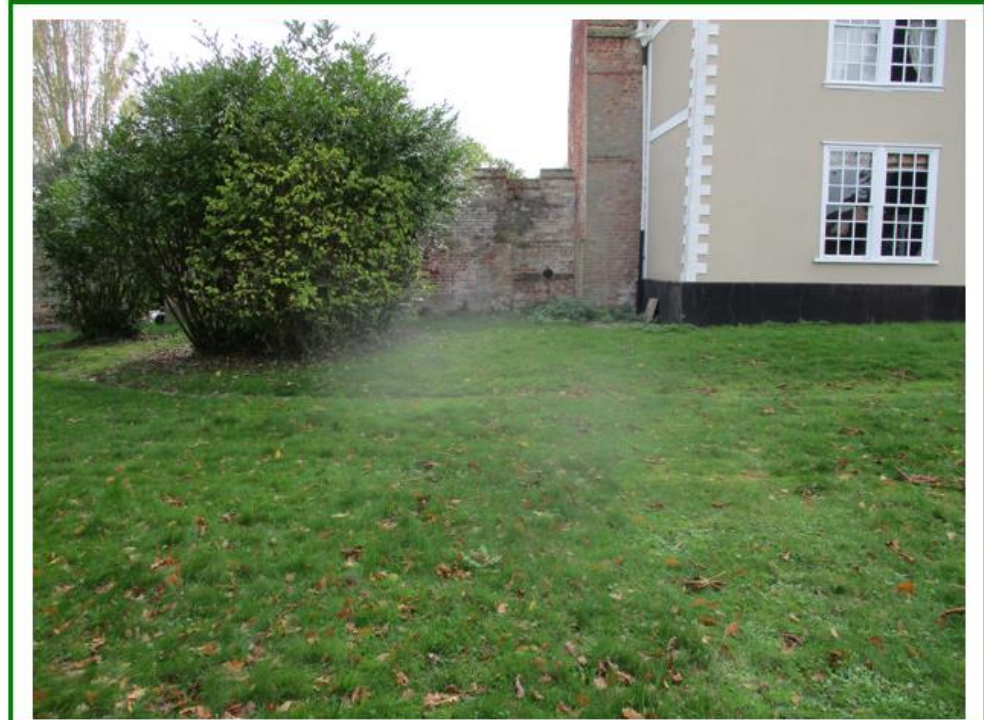
Photo No.10: Facing south from outside the NE corner of Clopton hall showing the rear of the outbuildings area
