Site Westcroft Somerton Rd Hartest
 Date of survey 11/08/2022
 Surveyor J Choat

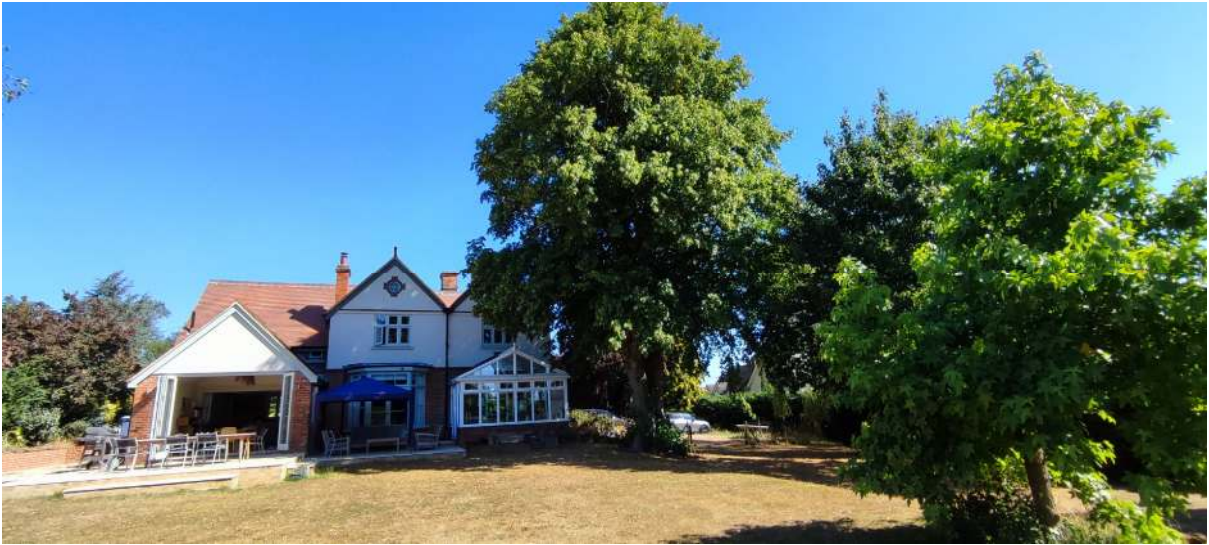
Photo 1 T1

Plan Number	Tree Number	Species	Age	Height in m	Condition	Recommendations	Informed by risk	
							Work Priority	Inspection
1	T1	Common Lime <i>Tilia x europaea</i>	M	19	Stem forks at 0.3m to form 2 co-dominant stems, compression fork formed with included basal union. Stem welding at 1m. Occasional deadwood within crown approx. 10cm dia mostly on the south / western aspect. Leaves appear to be good size, shape and colour for time of year. Tree causing shading in summer months limiting use of patio and conservatory during morning / midday.	Reduce crown height by 3m. Reduce lateral spread by 2m. Raise crown to 6-7m removing 6 lowest primary laterals around the circumference of the stem (approx. 10-25cm dia). Remove remaining sub-laterals to achieve crown clearance of 6-7m.	3	3
1	T2	Lawsons cypress (Blue) <i>Chamaecyparis lawsoniana</i>	M	12	Twin stem. Slightly sparse higher crown. Tree causing shading in summer months limiting use of patio and conservatory during morning / midday.	Fell and grind stump following below ground service check.	3	0

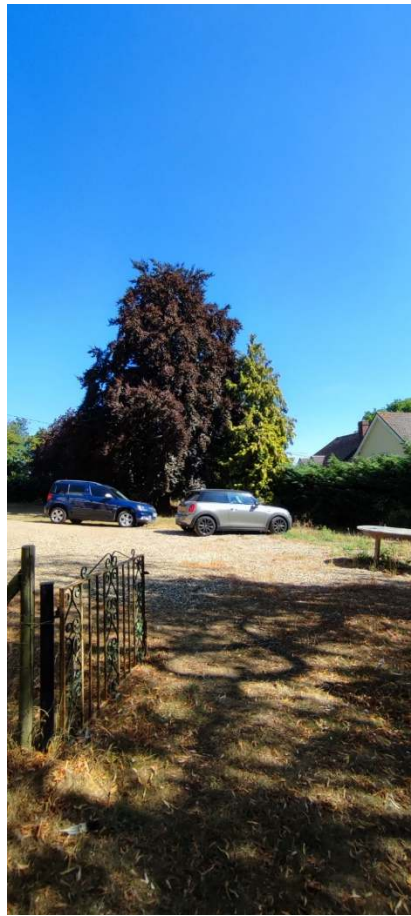
1	T3	Lawsons cypress (Gold) <i>Chamaecyparis lawsoniana</i>	M	11	Crown spread and height limiting lateral growth of adjacent copper beech.	Fell in favour of adjacent copper beech.	3	0
1	T4	Purple plum <i>Prunus cerasifera nigra</i>	M	7	<i>Phellinus sp</i> at 1m on stem. Low included basal union. Decay pockets at various locations on stem and crown structure. Branch recently failed at 2m and resting on BT service.	Fell and grind stump following below ground service check.	3	0

Photo 3 T3 (T3 right of copper beech)

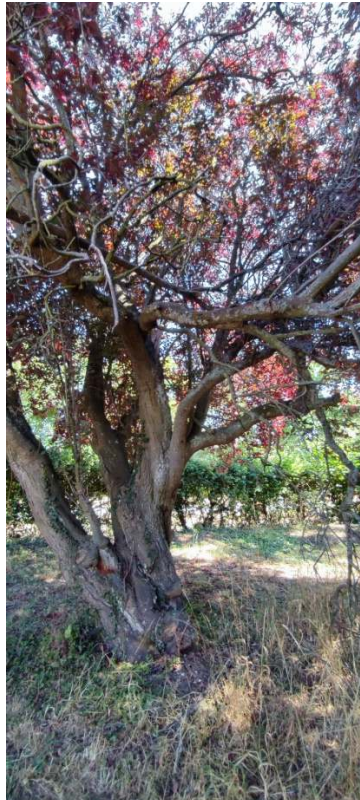
Photo 4 T4 Branch torn and resting on BT service
