**Phase 1 Land Contamination
Risk Assessment**

**Proposed Residential Conversion
of Agricultural Building**

**Brindlewood, Dakings Lane,
Felsham IP30 0QW**

Reference: 3474D P1 Scaife – Bury St. Edmunds

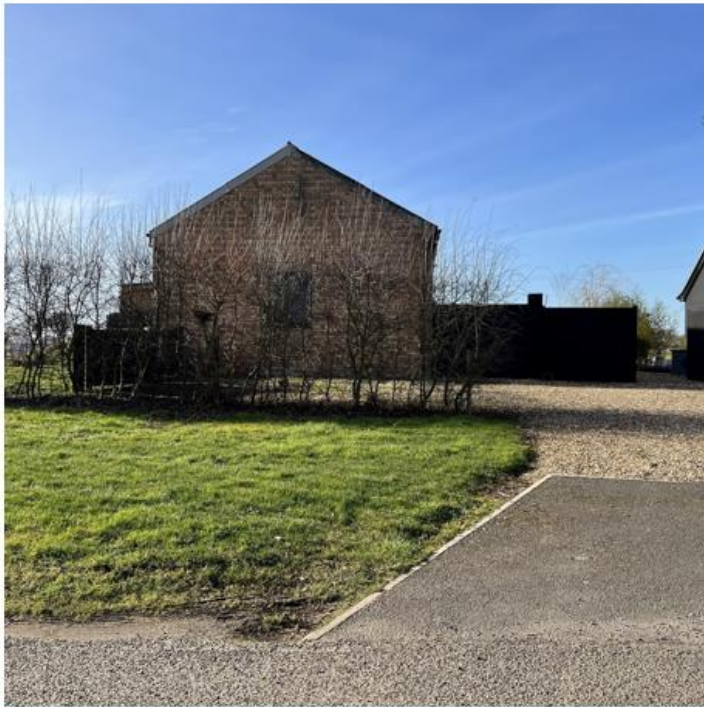
Photo No.1: Facing west from outside the eastern boundary of site on Dakings Lane showing the site access

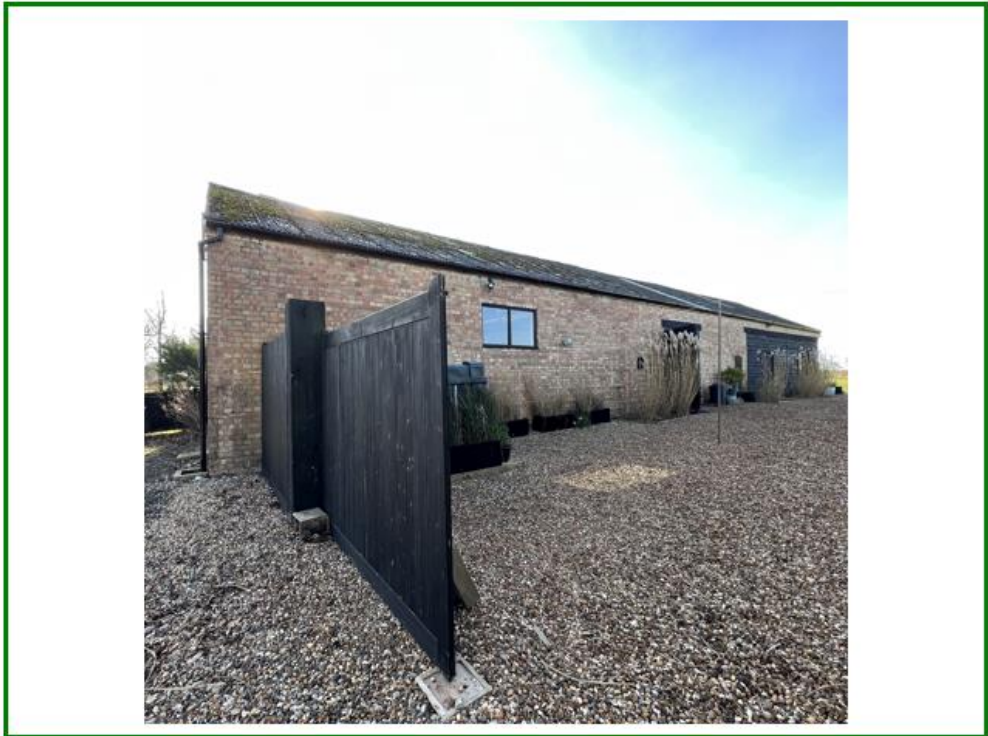
Photo No.2: Facing SW from the NE corner of site showing the gravelled parking area north of the site building

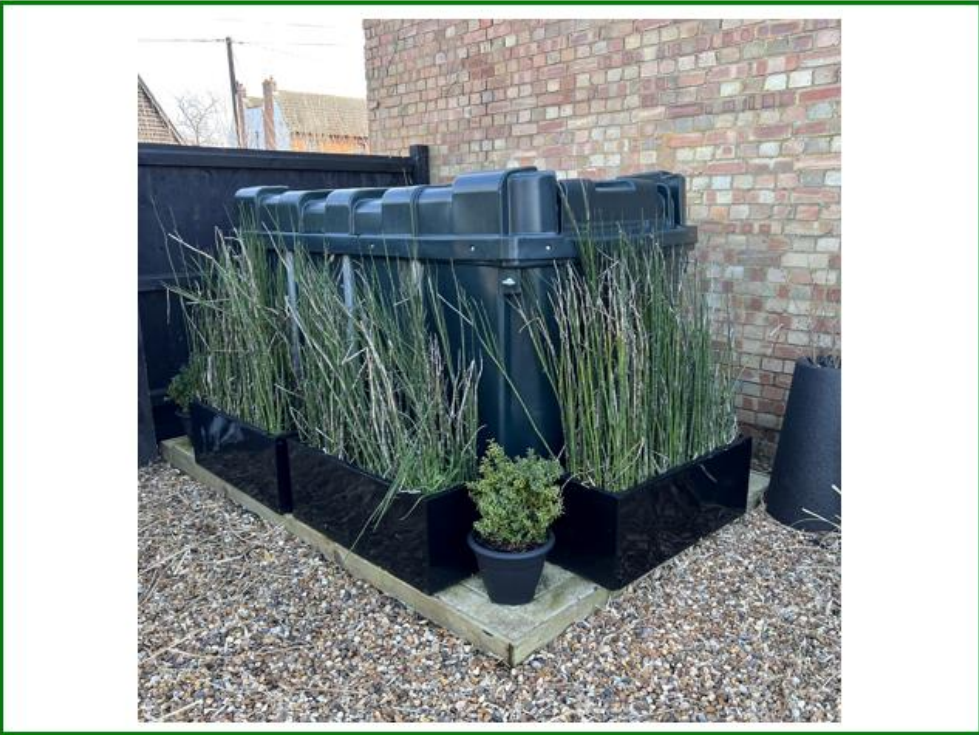
Potential sources of contamination noted on the walkover include potentially asbestos containing materials (PACM's) noted on the building itself, the oil tank on the northern face of the building (seen to be self-bunded and atop a clean, intact concrete base) and the scattered refuse and debris along with the heap of topsoil seen south of the building. The ride-on lawn mower and adjacent fuel canister were not considered significant potential sources of contamination, with no visual or olfactory evidence of hydrocarbon spillage associated with the machinery noted.

Photo No.3: Bunded oil storage on NE corner of the building and atop a concrete base – visual or olfactory evidence of spillages

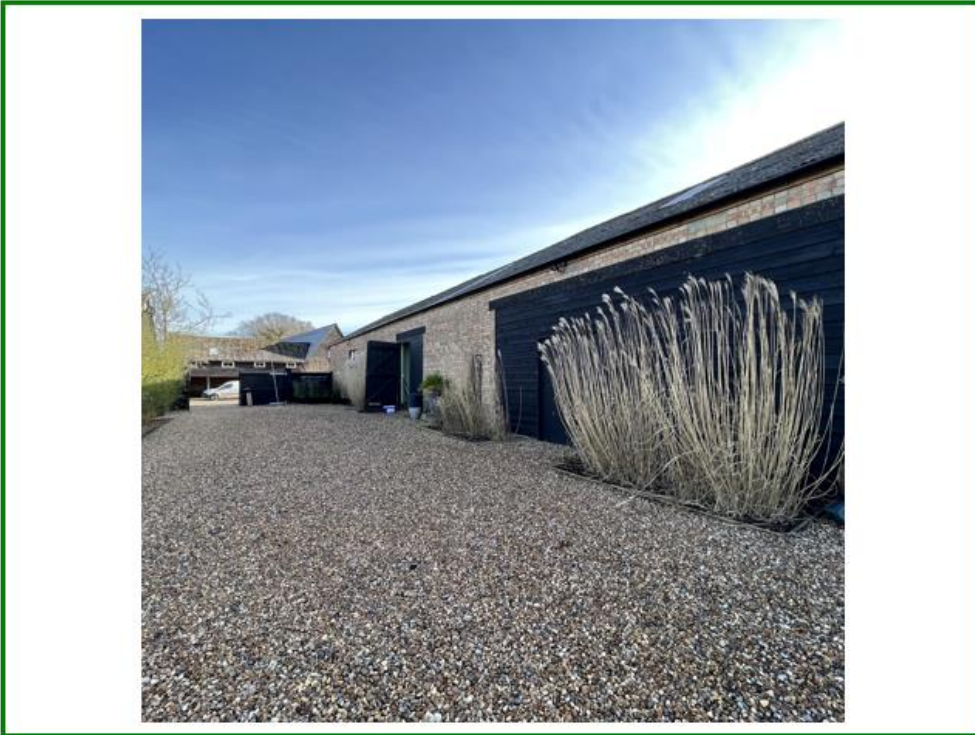
Photo No.4: Facing SE from outside the NW corner of the building on site showing the front (northern) face of the building

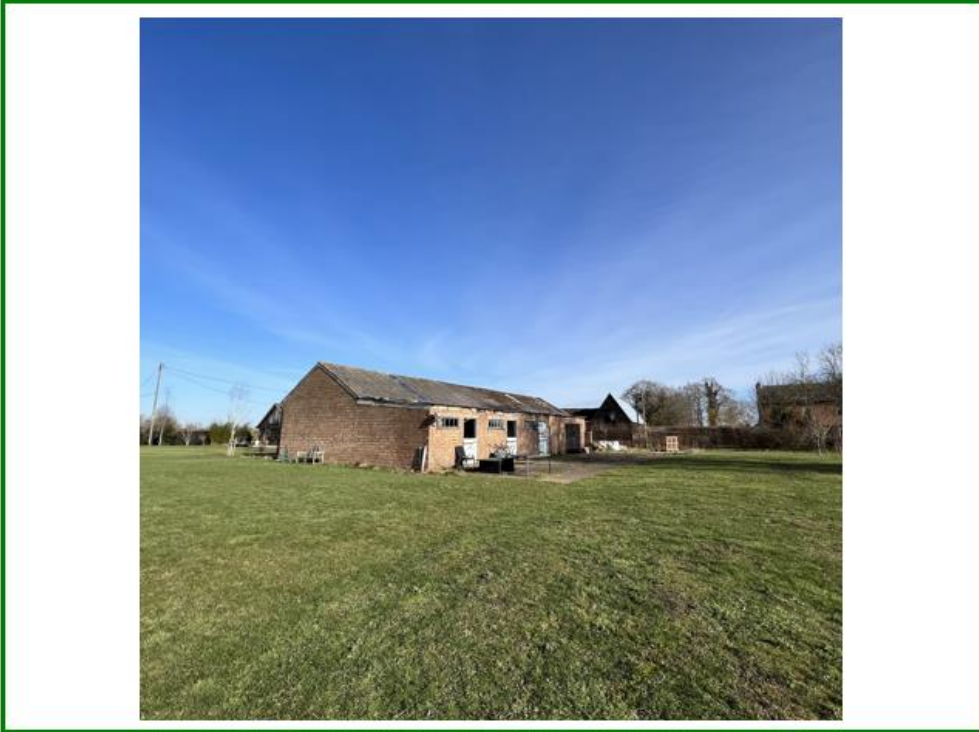
Photo No.5: Facing slightly NE from the SW extent of site

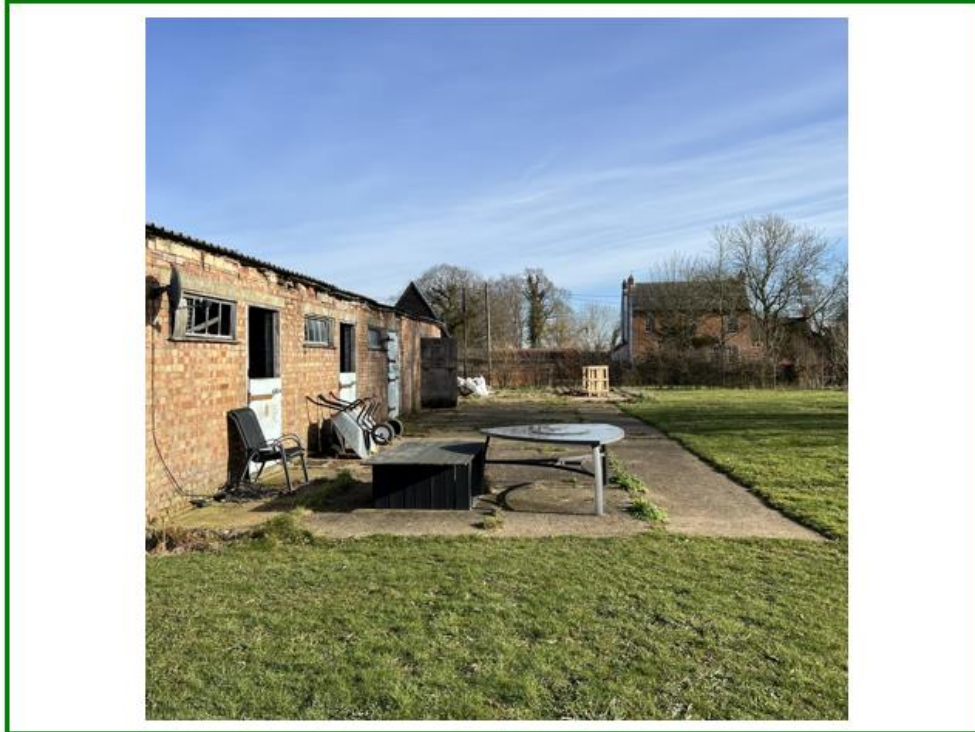
Photo No.6: Facing east from the western extent of the area directly south of the buildings and adjoined stabling

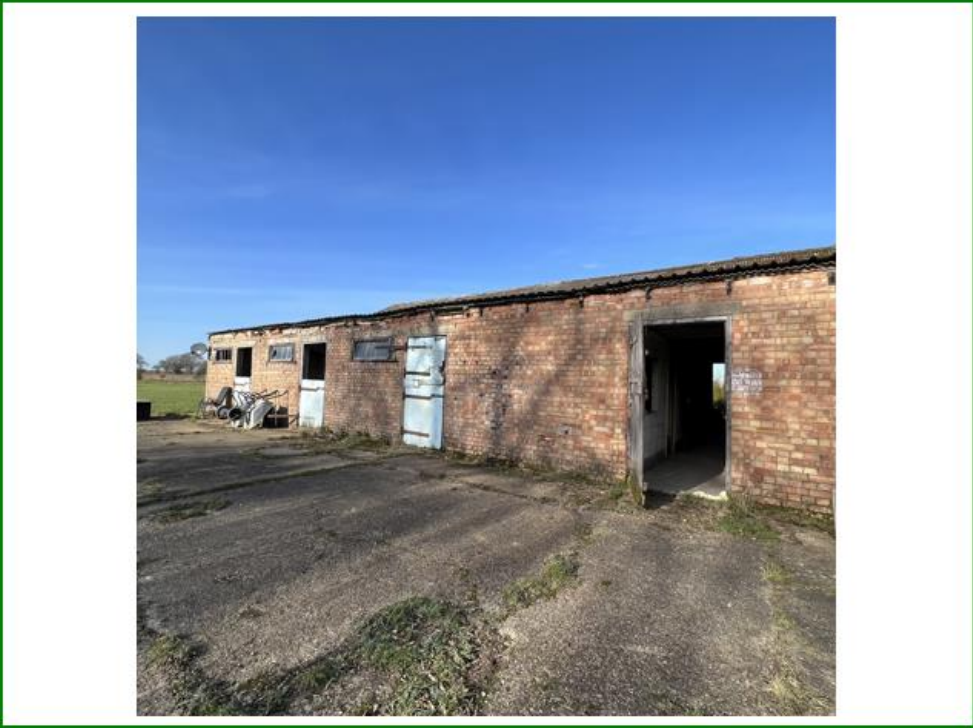
Photo No.7: Facing slightly NW from outside the stable units located on southern face of the larger building

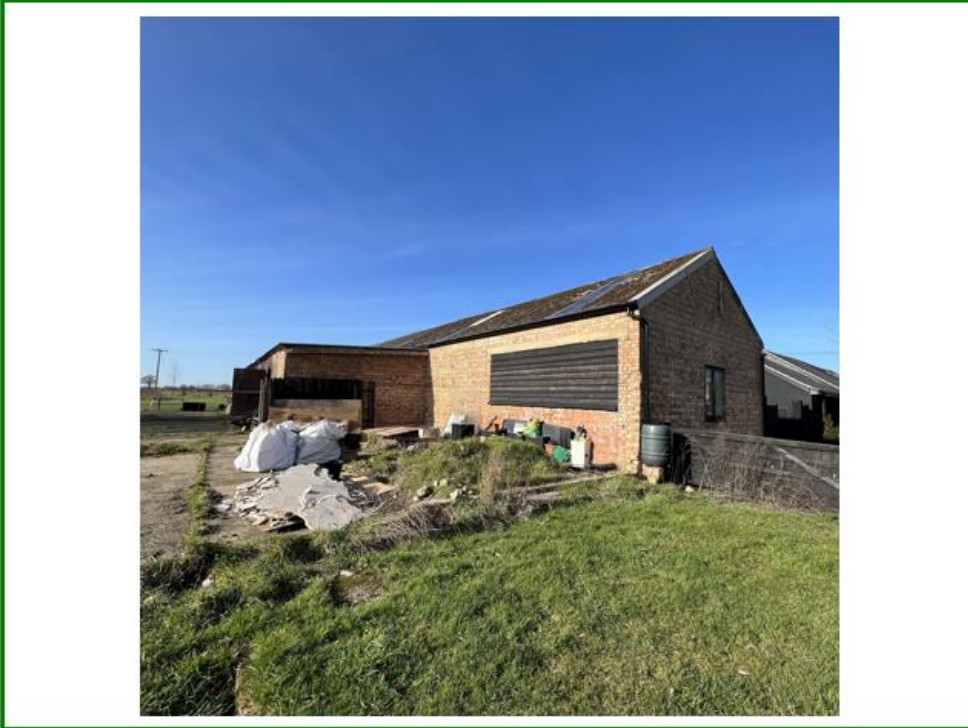
Photo No.8: Facing NW from the SE extent of site showing small yard area on southern face of larger building adj. to stables

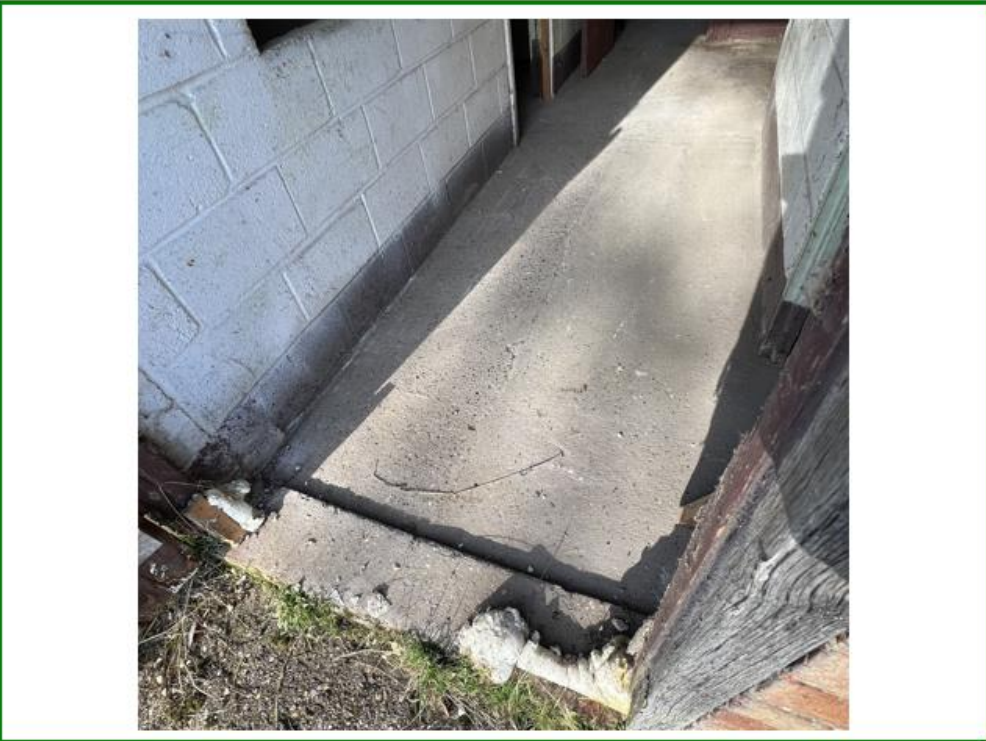
Photo No.9: Showing concrete flooring noted in stables

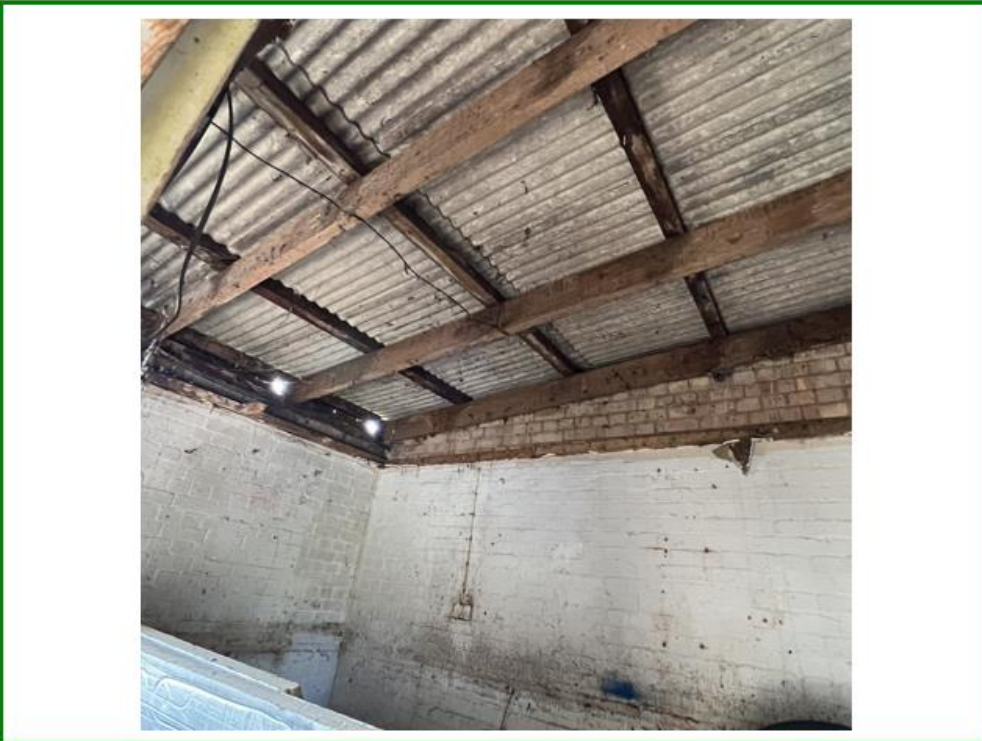
Photo No.10: Showing potentially asbestos roofing beneath newly installed corrugated metal roofing atop stables

It is recommended that the remaining structure on site be subject to an asbestos survey (and subsequent removal, if required) by appropriately qualified personnel. This should be carried out prior to any demolition or redevelopment occurring in order to ensure site works do not cause future contamination of the site.

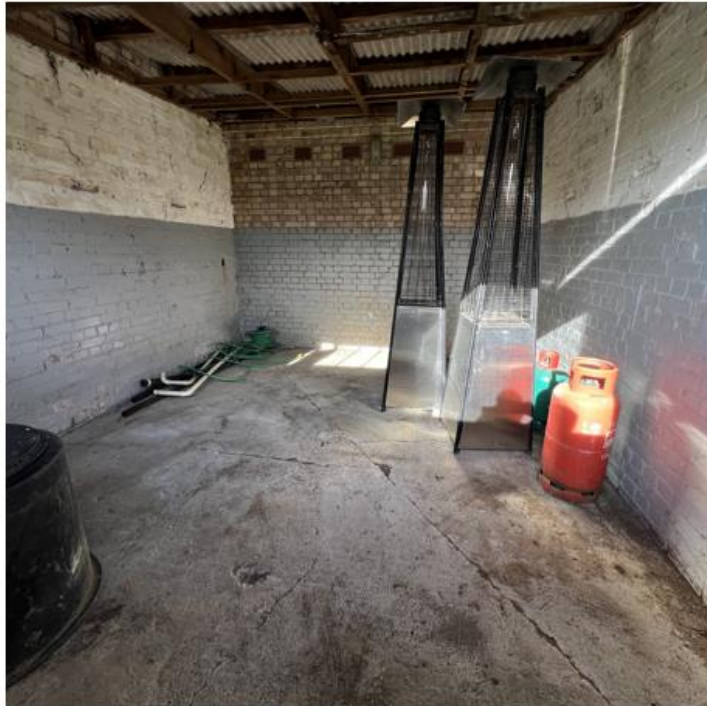
Photo No.11: Example shot of interior of stables showing concrete flooring and miscellaneous storage

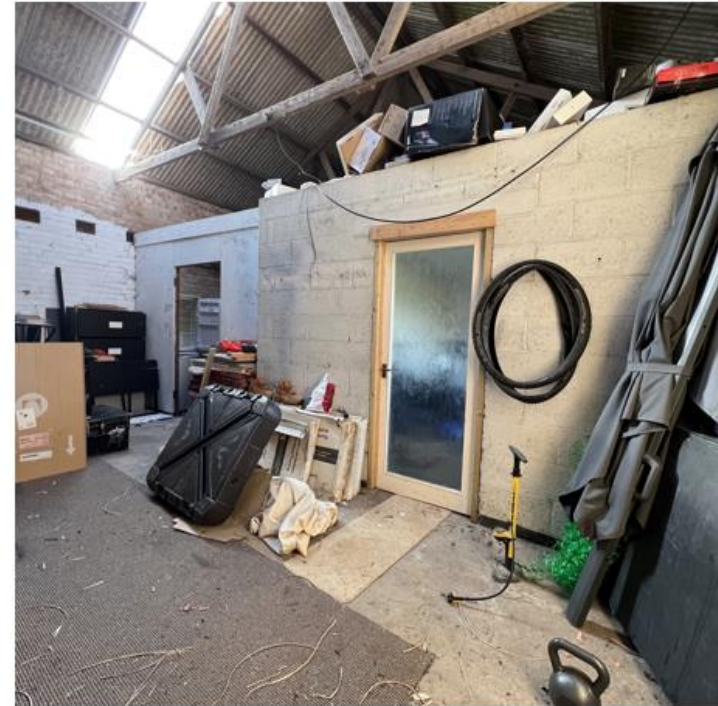
Photo No.12: Facing SW inside the barn unit showing interior rooms (location of gym equipment)

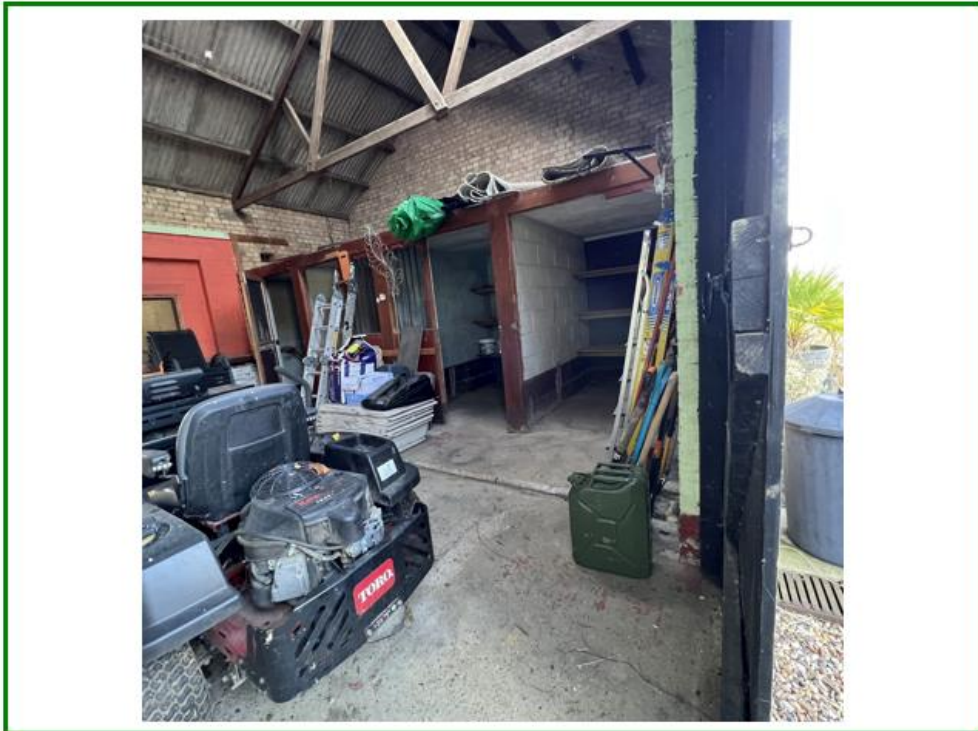
Photo No.13: Taken from the northern extent of the barn facing south west showing ride on mower and miscellaneous storage

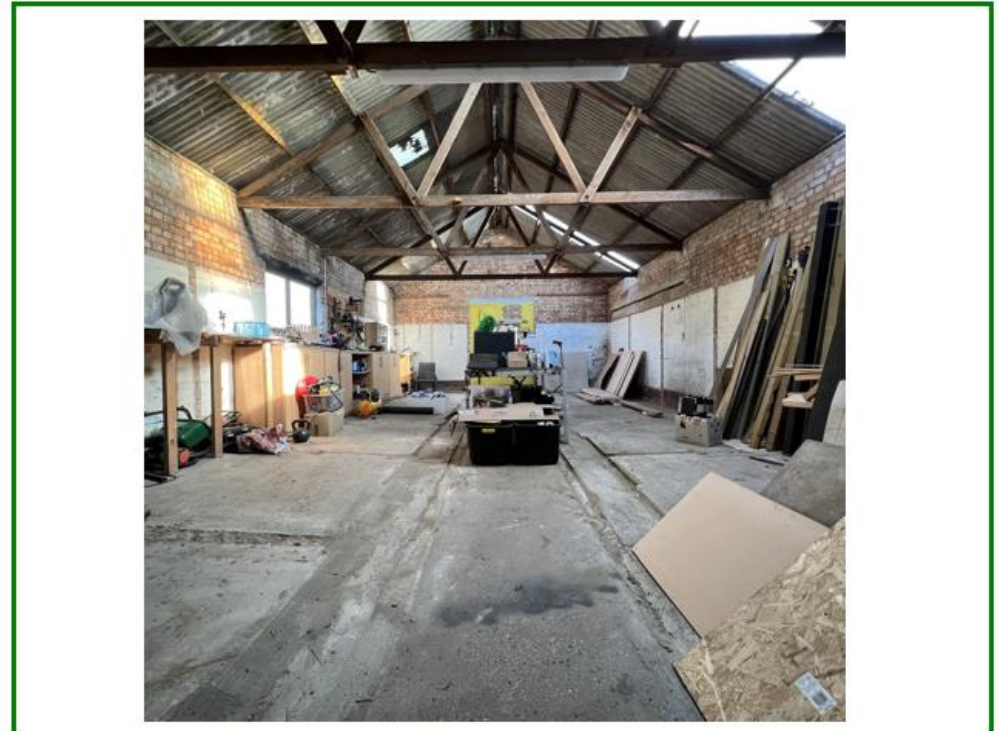
Photo No.14: Taken west to east of the eastern end of the barn showing a workshop area with timber storage

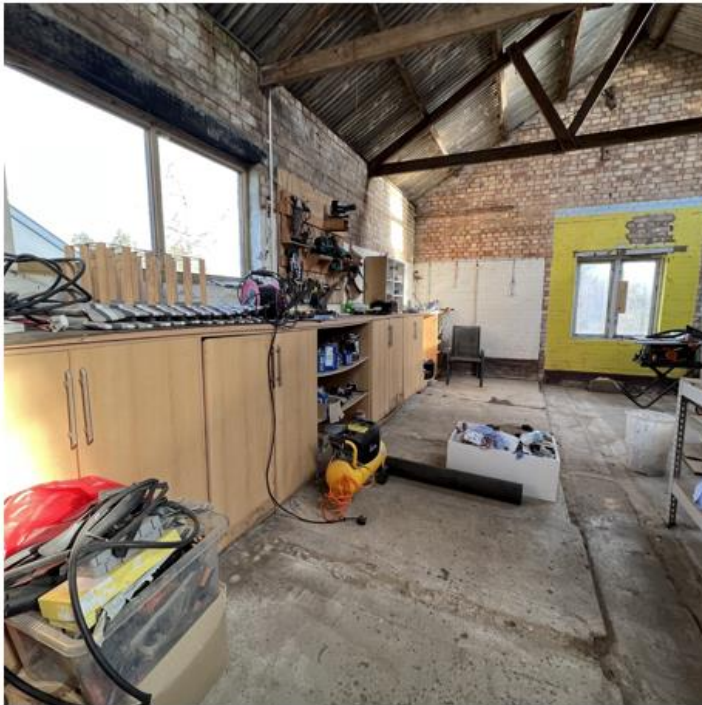
Photo No.15: Workshop area taken facing north east showing power tools and work bench

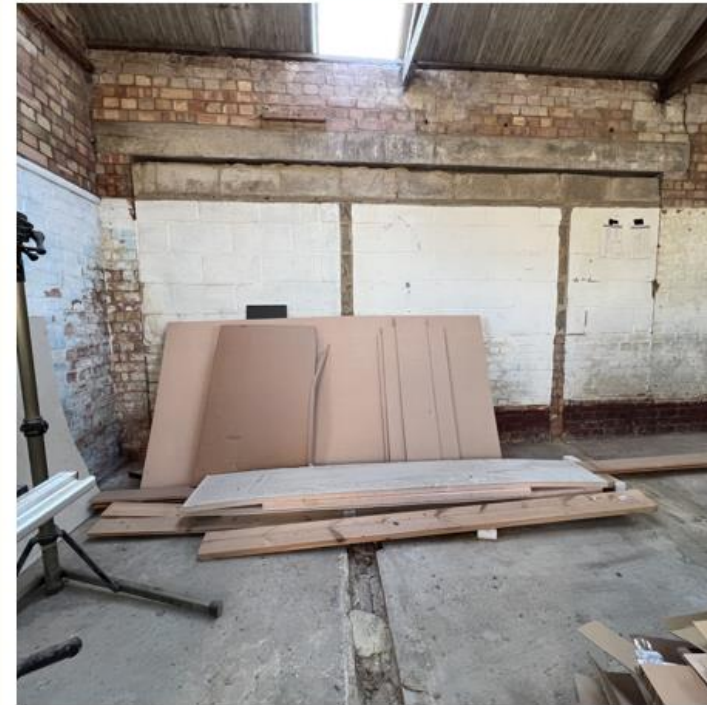
Photo No.16: Taken facing south of the workshop area timber storage
