# ARBORICULTURAL ASSESSMENT REPORT

7 Magdalene Crescent, Silver End, Witham, CM8 3XP

**Client Ref:** QG1T1214472

**PRI Ref:** 266344

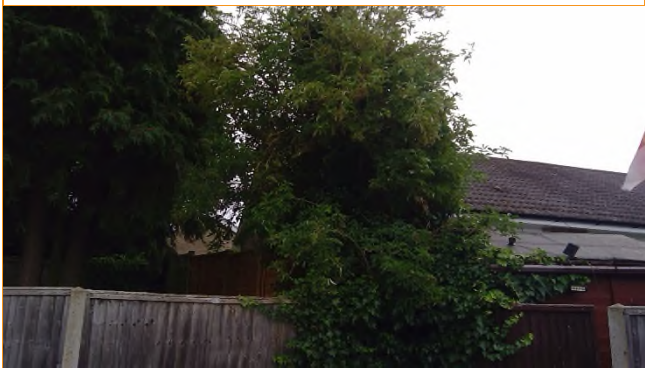
T4 - Elder

Tree No	Common Name	Age Class	Condition	Height (m)	Crown Spread (m)	Stem diam. (mm)	Dist to bldg. (m)	Roots Implicated	Pruning history	Recommendation	Tree work constraints	Notes	Owner address	Owner
T4	Elder	Mature	Good	3	3.0	345	4.2	N	No significant past tree works.	No work required.			7a Temple Lane Silver End Witham CM8 3QY	P3P
