# Site Investigation Report

Auger Ref:  
146117.1USI

Client	Questgates
Client ref	QG1T 2 1472
Visit date	10/03/2023
Report date	06/06/2023

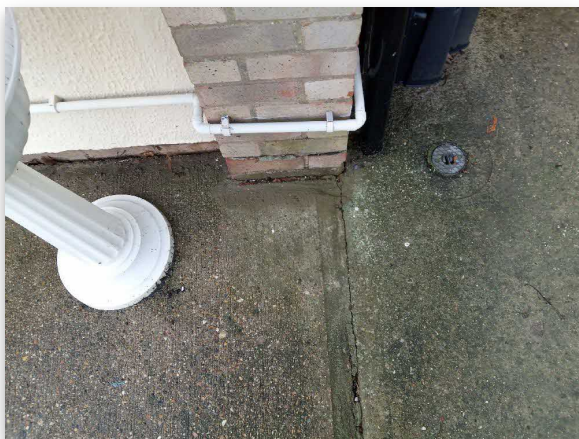
Fig 1.1: Trial Hole 1 Location

Within TH1 we revealed the footing but we were unable to reach the required depth in TH1 because we encountered chalk which our engineer could not auger through at 1.6m. The Trial Hole was excavated in the proposed location. We took soil and root samples. These measurements are shown in Trial Hole Log 1 below.

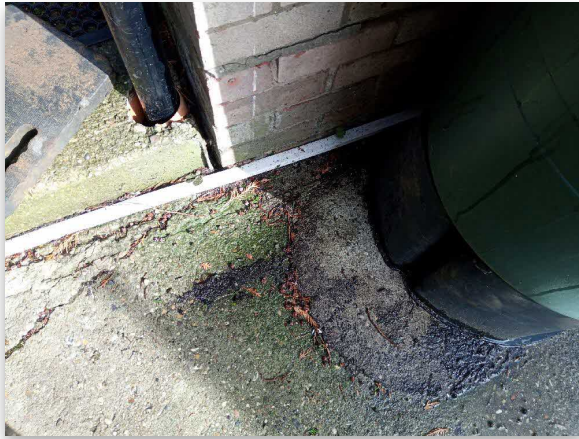
Fig 2.1: Trial Hole 2 Location

Within TH2 we revealed the footing but we were unable to reach the required depth in TH2 because we encountered chalk which our engineer could not auger through at 1.6m. The Trial Hole was excavated in the proposed location. We took soil and root samples. These measurements are shown in Trial Hole Log 2 below.

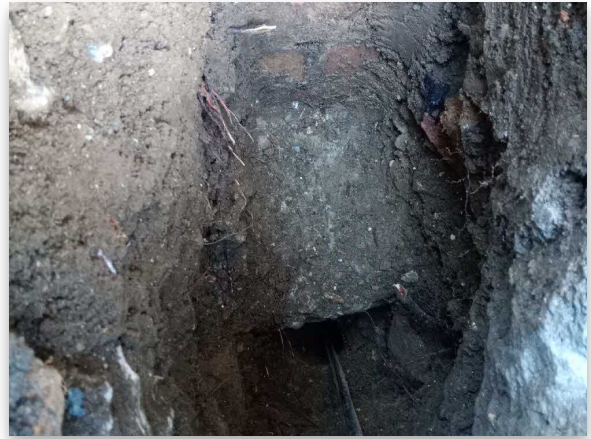
Fig 2.2: Trial Hole 2 Footing

The base of the footing for TH2 was determined by probing to a depth below 1m and therefore the exact profiles/depth cannot be guaranteed.

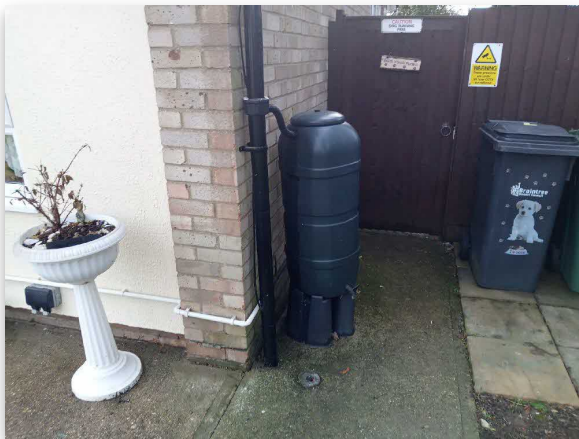
Fig 4.1: RWP1 area of excavation

Our survey of line 2 revealed mass amounts of silt/debris that we were unable to clear of survey past. This line is suspected to lead to a soakaway however we are unable to confirm this.

<b>Refer Back to Client</b>	<p>It is recommended that the following repairs are carried out to prevent an escape of water from the system:</p> <p><b>Line 1</b> Sonde, excavate and replace 1m of 100mm pipework including a branch connection approximately 1m downstream of RWP1 at a depth no greater than 1.0m through concrete.</p> <p>carry out jetting to clear the line up and downstream of the excavation.</p> <p>We will then need to conduct a further CCTV investigation upstream and downstream on this line.</p> <p>Please note that the further CCTV investigation may reveal additional defects to the drainage system. This will be reported whilst on-site and could potentially cause an increase in repair costs and provide further inconvenience to the customer/occupants.</p> <p>During the clean-up/reinstatement process we will endeavour to leave the area we are working in clean and tidy and as close to how we found it as possible. There will always be an element of general debris/mud/waste that will build up in the area which cannot be prevented. There may however be elements of this process that are outside our remit i.e., Repainting or cleaning. If this is the case, then we will need to speak to the customer's insurers to help in this regard.</p> <p>We will now refer the claim back to the client in order to progress the claim.</p>

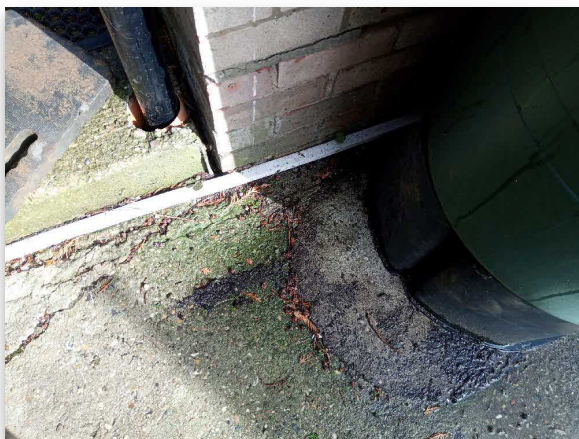
Fig 4.3: RWP2

Our survey of line 2: We were unable to pass a 90 degree bend approximately 1.5m downstream of RWP2 we were therefore unable to get a full visual of the pipework. This line is also filled with silt and debris.

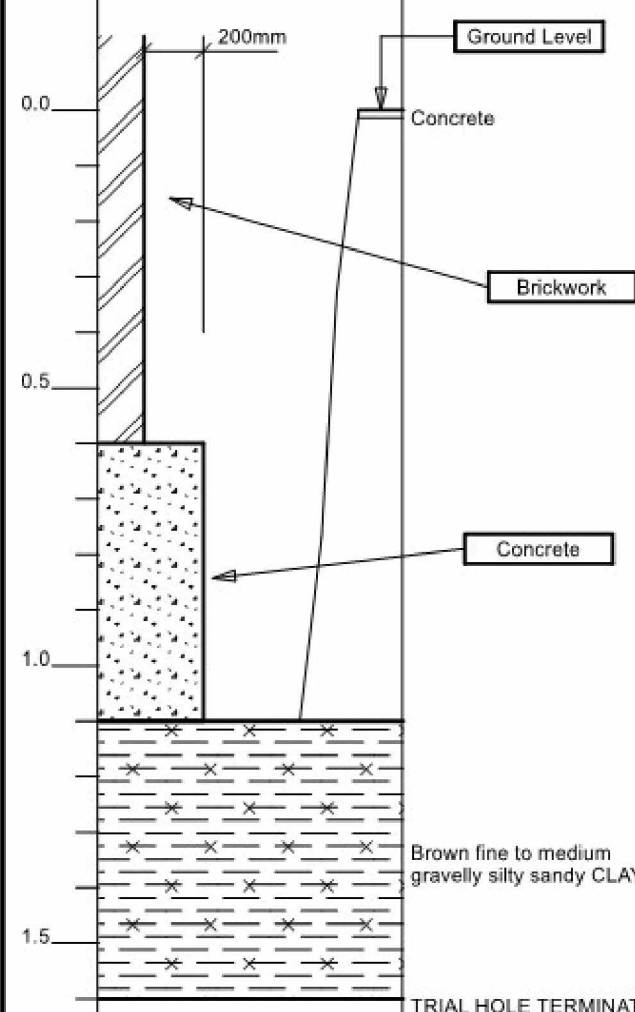
# Trial Hole Log No.2

<p>Ground Level</p> <p>Concrete</p> <p>Brickwork</p> <p>Concrete</p> <p>Brown fine to medium gravelly silty sandy CLAY</p> <p>TRIAL HOLE TERMINATED</p>	140kpa		Soil @ 1.1m	Root @ 1.1m
