Job No. SE18-451

**STRUCTURAL FEASIBILITY STUDY FOR THE CONVERSION OF . . . EXISTING BARN AT
BOSANKETH FARM TO HABITABLE DWELLING**

Barn

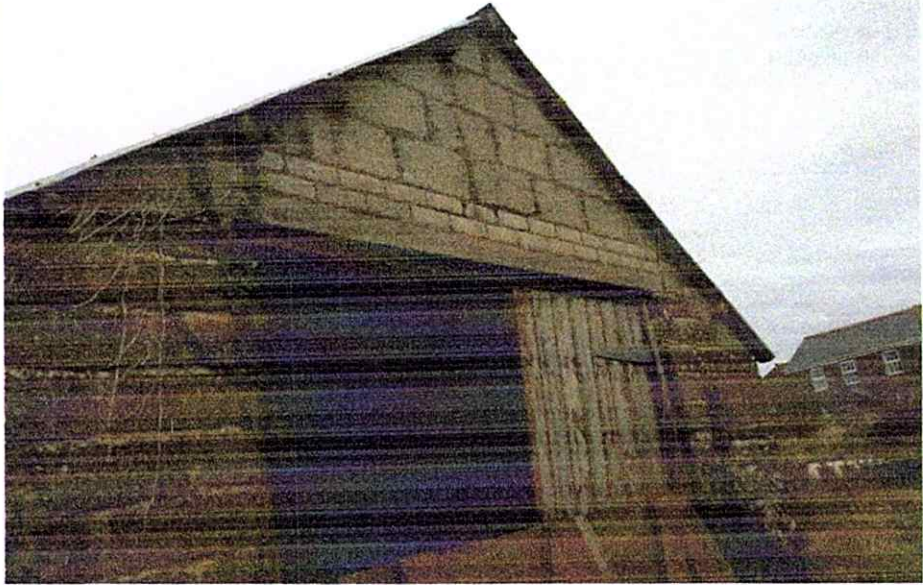
<p data-bbox="687 1039 1038 1066"><i>Photo 7 - Barn south east elevation</i></p>
<p data-bbox="193 1120 272 1146">Photo</p> <p data-bbox="193 1173 352 1258">Barn , south west elevation (Area 1)</p>

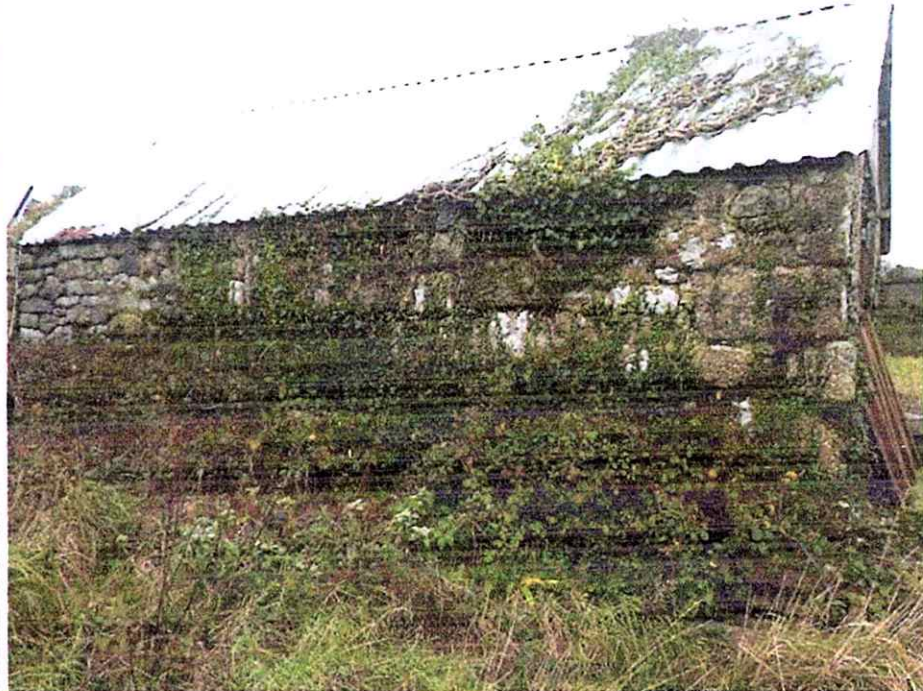
<p data-bbox="647 1809 1086 1836"><i>Photo 8 - Barn south west elevation (Area 1)</i></p>

1. The stone walls should be repointed where mortar joints are missing, with a lime mortar which will allow the walls to breathe.
2. Concrete core testing of the slab should be undertaken, to determine the thickness and whether it is reinforced.
3. Although the roof timbers are in good condition, it is unlikely that they would be capable of supporting the more substantial roof covering required for a domestic property. An assessment may be carried out to determine their suitability, otherwise the roof structure should be replaced.
4. Head height is somewhat limited in this area, so it is recommended that a ridge beam is introduced to support the rafters if the roof structure is to be replaced. This will eliminate the need for ties, thereby increasing head height in the centre of the room.

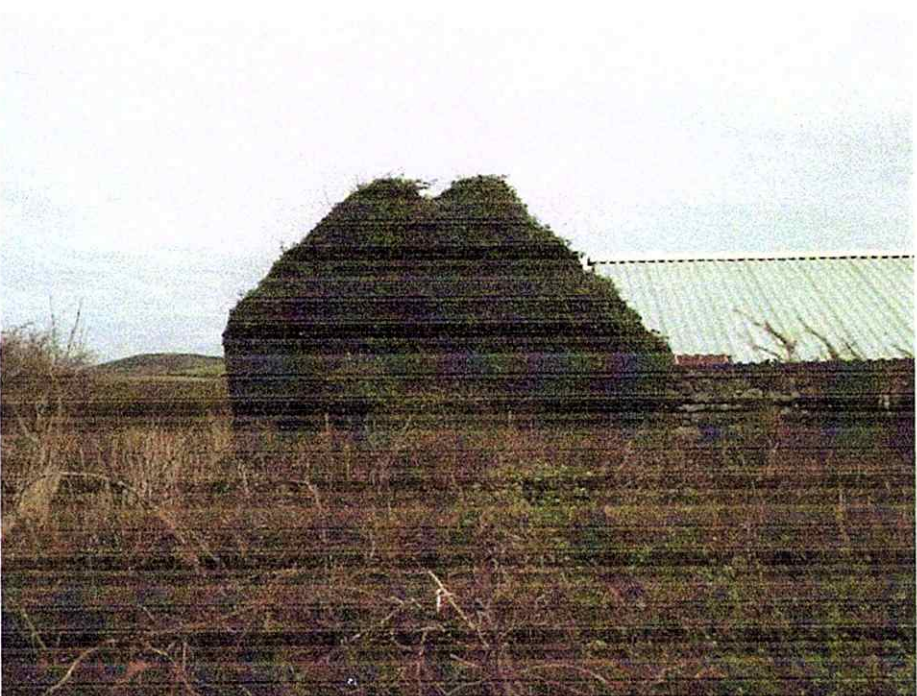
1. The stone walls appear to be in good condition, but the south west gable wall is covered in ivy (Photo 9), so the condition could not be verified. It remains standing, however, and appears to be plumb.
2. The remaining roof timbers are severely degraded.

Reference	Photo
<p>Photo 9</p> <p>Barn south west elevation, showing Area 3 and vegetation growth on gable wall</p>

Refer to the recommendations for Area 2, as they also apply to Area 3 due to it being part of the same structure.

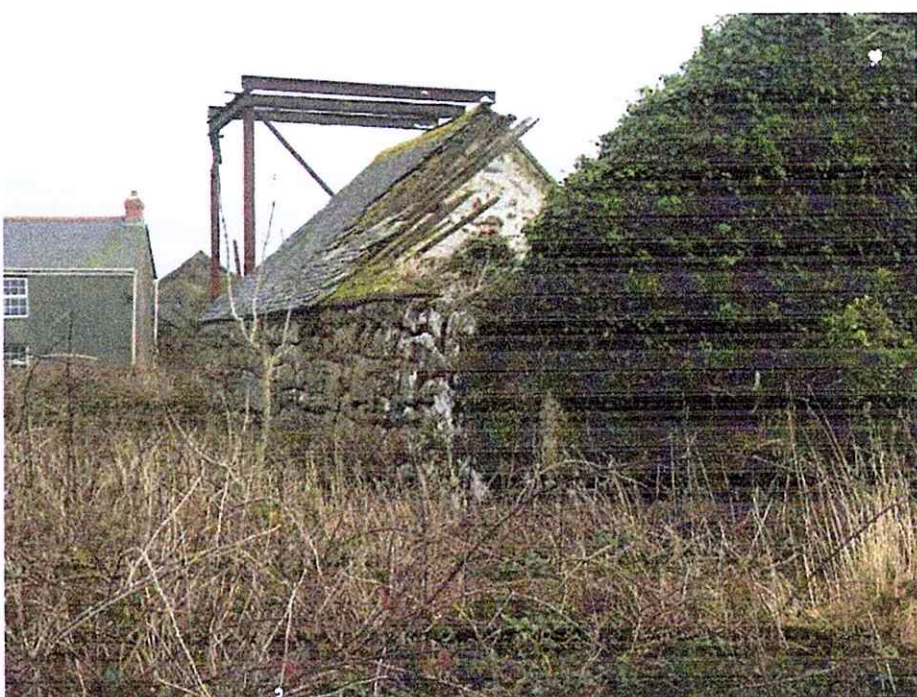
Internal access to this area was not possible due to extensive bramble growth around it, accordingly only an external survey was undertaken. This area occupies approximately a third of the structure forming Areas 2 & 3. The walls are constructed from large stones, with two low openings providing access. It is not known whether access may also be gained from Area 3, as access was not possible

<p style="text-align: center;"><i>Photo - South west elevation (Area 3)</i></p>
<p>Photo</p> <p>Barn north west elevation showing Areas 2 and 3 (access limited due to bramble growth)</p>

<p style="text-align: center;"><i>Photo 10 - Barn north west elevation</i></p>

1. All vegetation should be cleared from the walls, taking care not to dislodge the stones.
2. The stone walls should be repointed where mortar joints are missing, with a lime mortar which will allow the walls to breath.
3. It is likely that the roof timbers are degraded, the roof structure should therefore be replaced.
4. A concrete ring beam should be cast on the tops of the walls, which will tie the structure together, and increase the head height at the eaves. In addition, this will allow a ground bearing slab to be installed without excessive excavation and potential undermining of the walls.

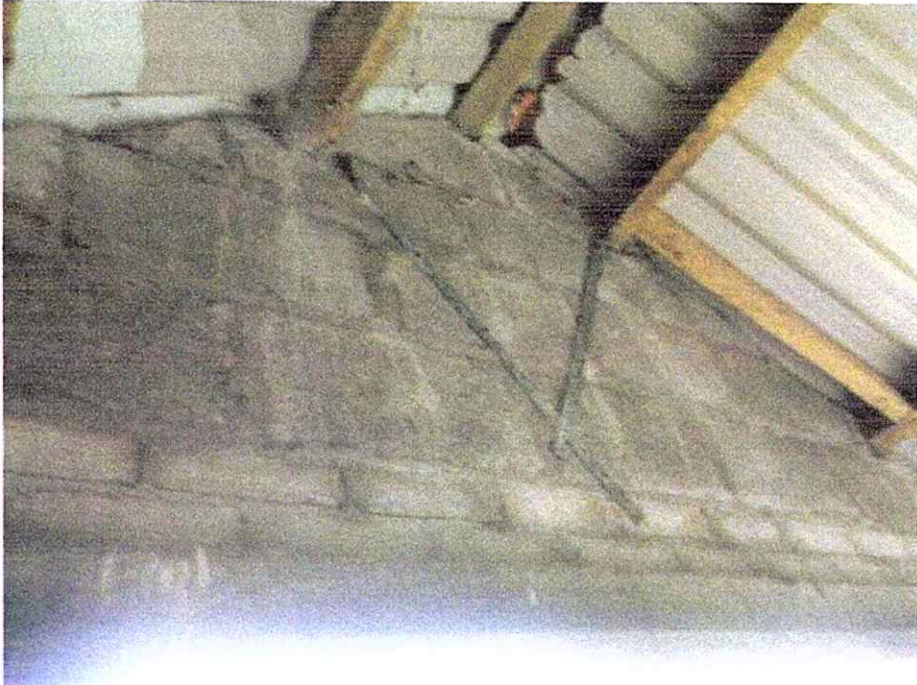
The roof construction appears to be relatively new, consisting of corrugated steel laid on purlins, which are built into pockets in the gable walls and supported off tied rafter trusses, positioned at approximately 600mm centres along the side walls. Straps have been installed on some, but not all, of the purlins.

Reference	Photo
<p>Photo 15</p> <p>Barn showing roof structure and straps</p>

<p><i>Photo 15 - Barn Area 1 roof structure and straps</i></p>
<p>Photo 16</p> <p>Barn Area 1 showing stone side wall and front gable wall partially rebuilt in concrete block</p>

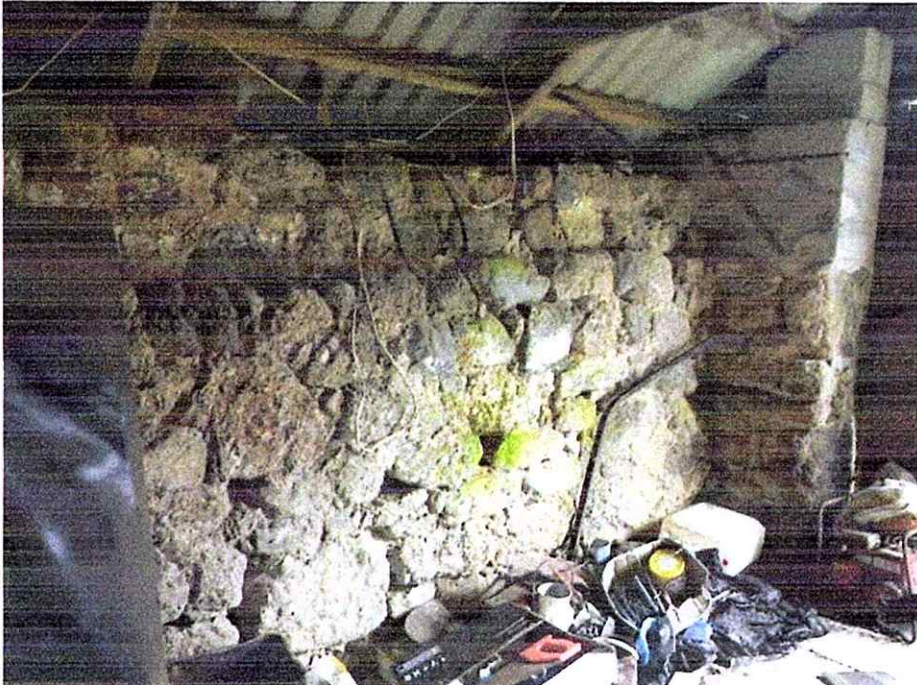
The side walls and the south-west gable wall are constructed from random stone, with the external elevation of this gable having been faced with concrete block masonry. The north west gable wall was originally formed by the side wall of Areas 2 & 3, this has been partially rebuilt in concrete block masonry. A concrete lintel has been installed over the opening on the south west elevation.

<p><i>Photo 16 - Barn Area 1 stone side wall</i></p>
