## Desk Study

**Hempland Primary School**

for  
**Department for Education**

**Project Number** PC218325

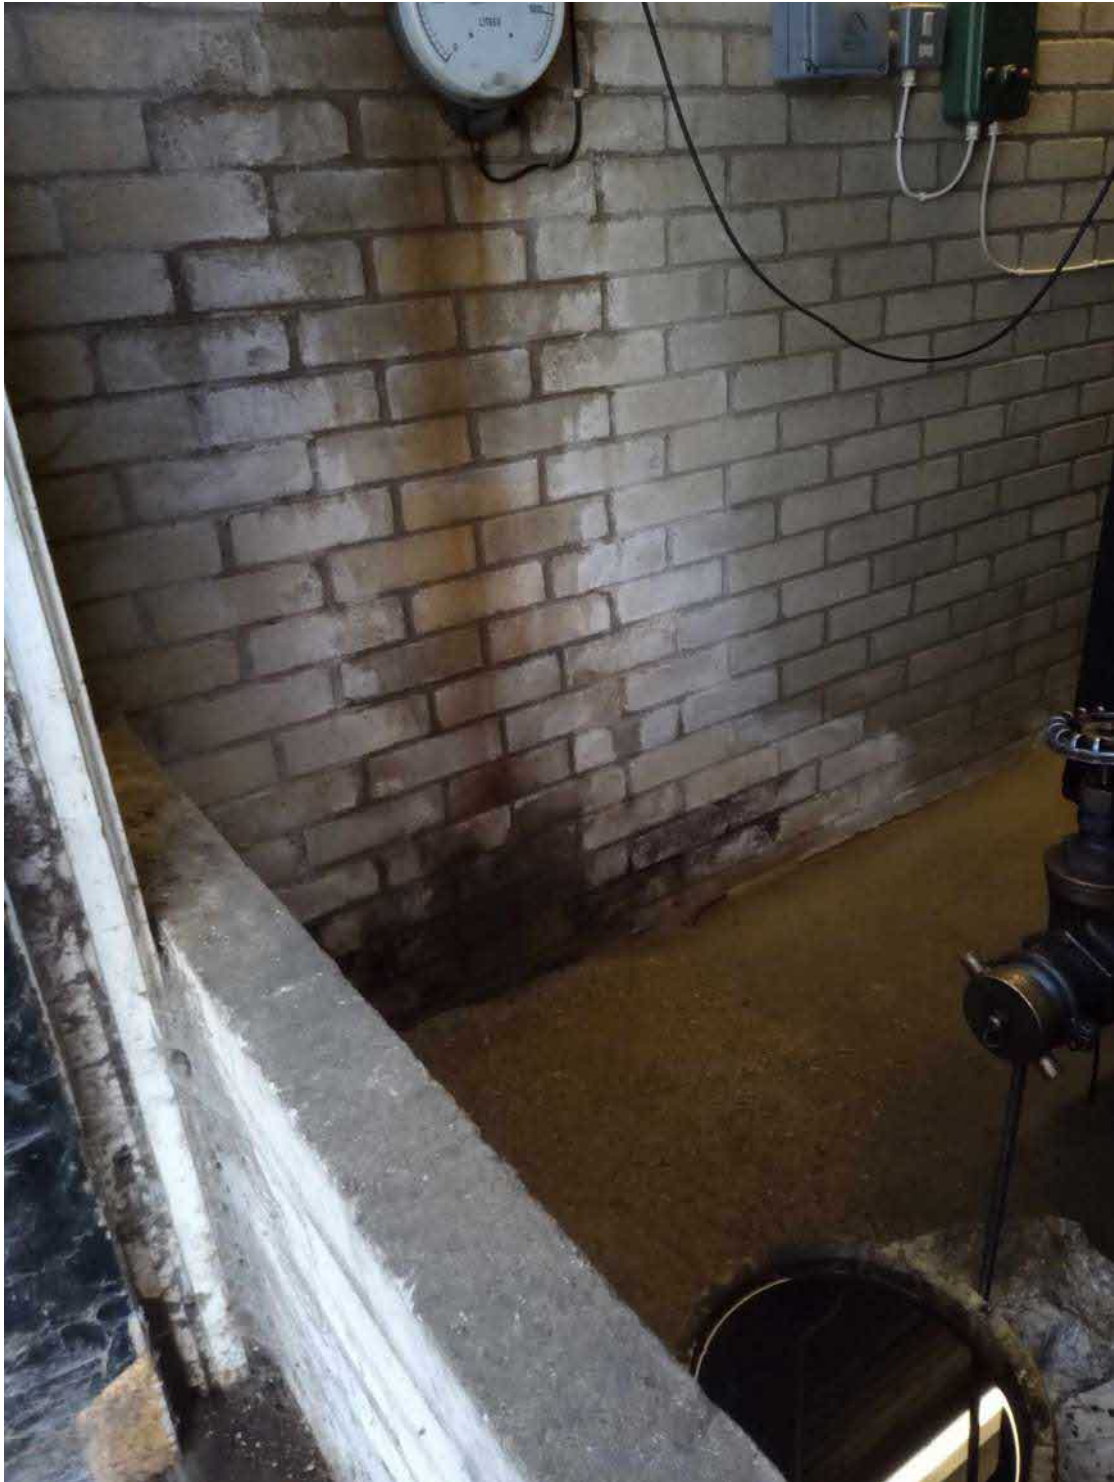
Location 03 - Oil Tank (1)

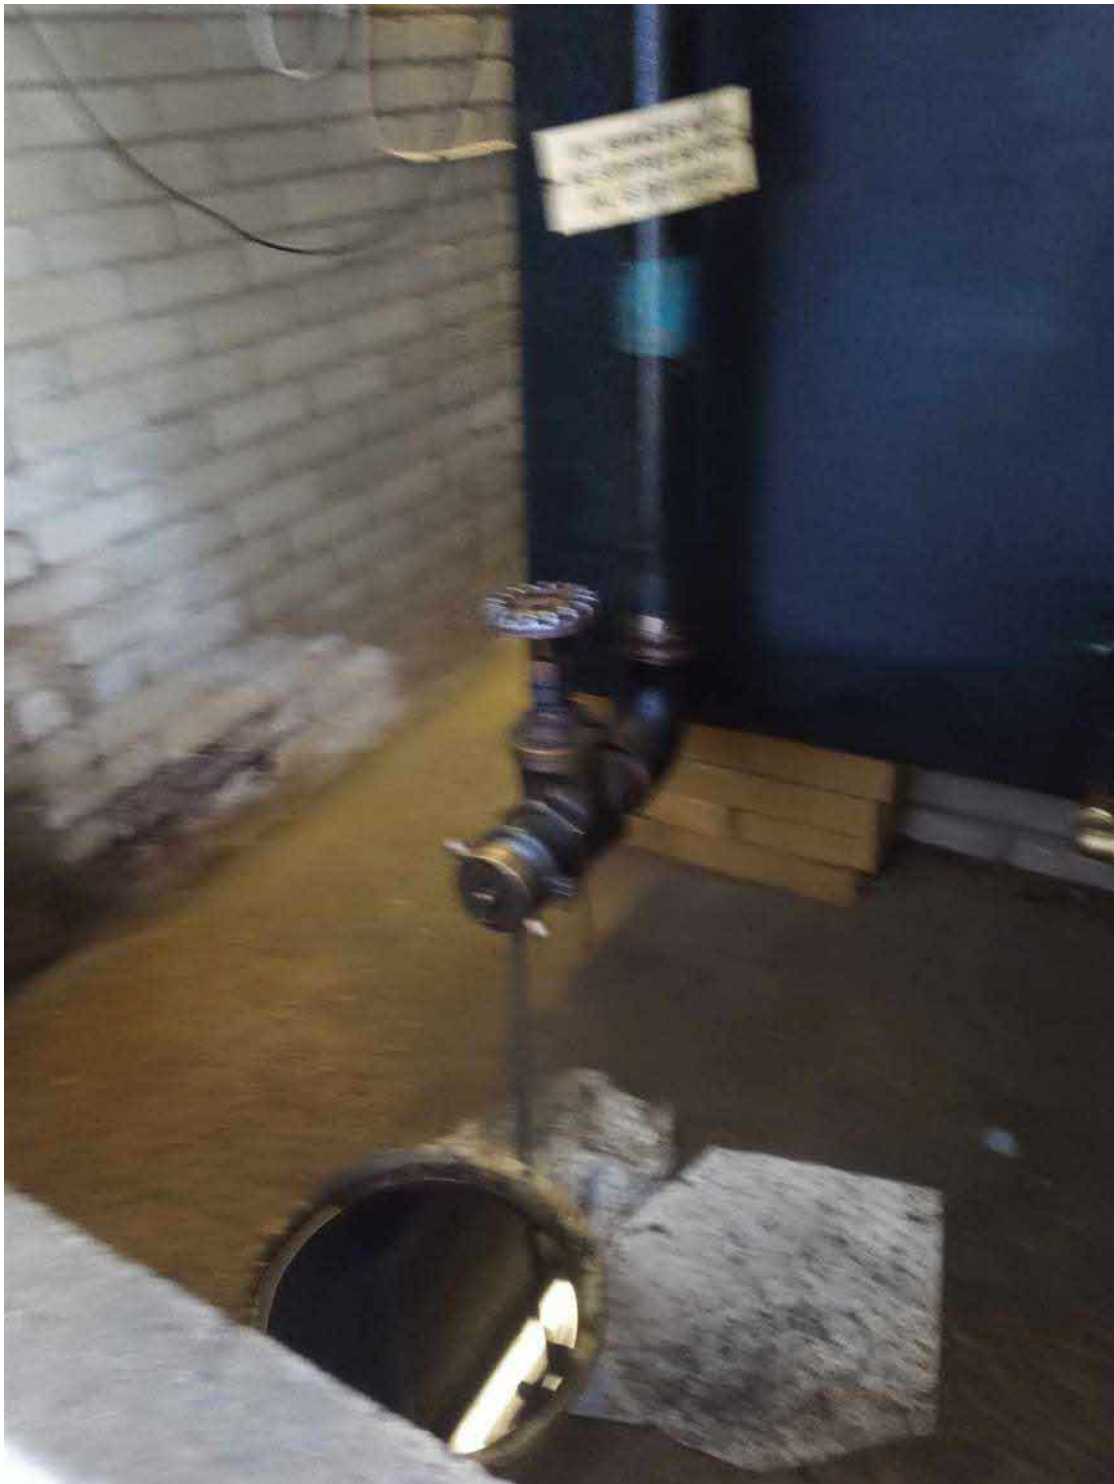
Location 03 - Oil Tank (2)

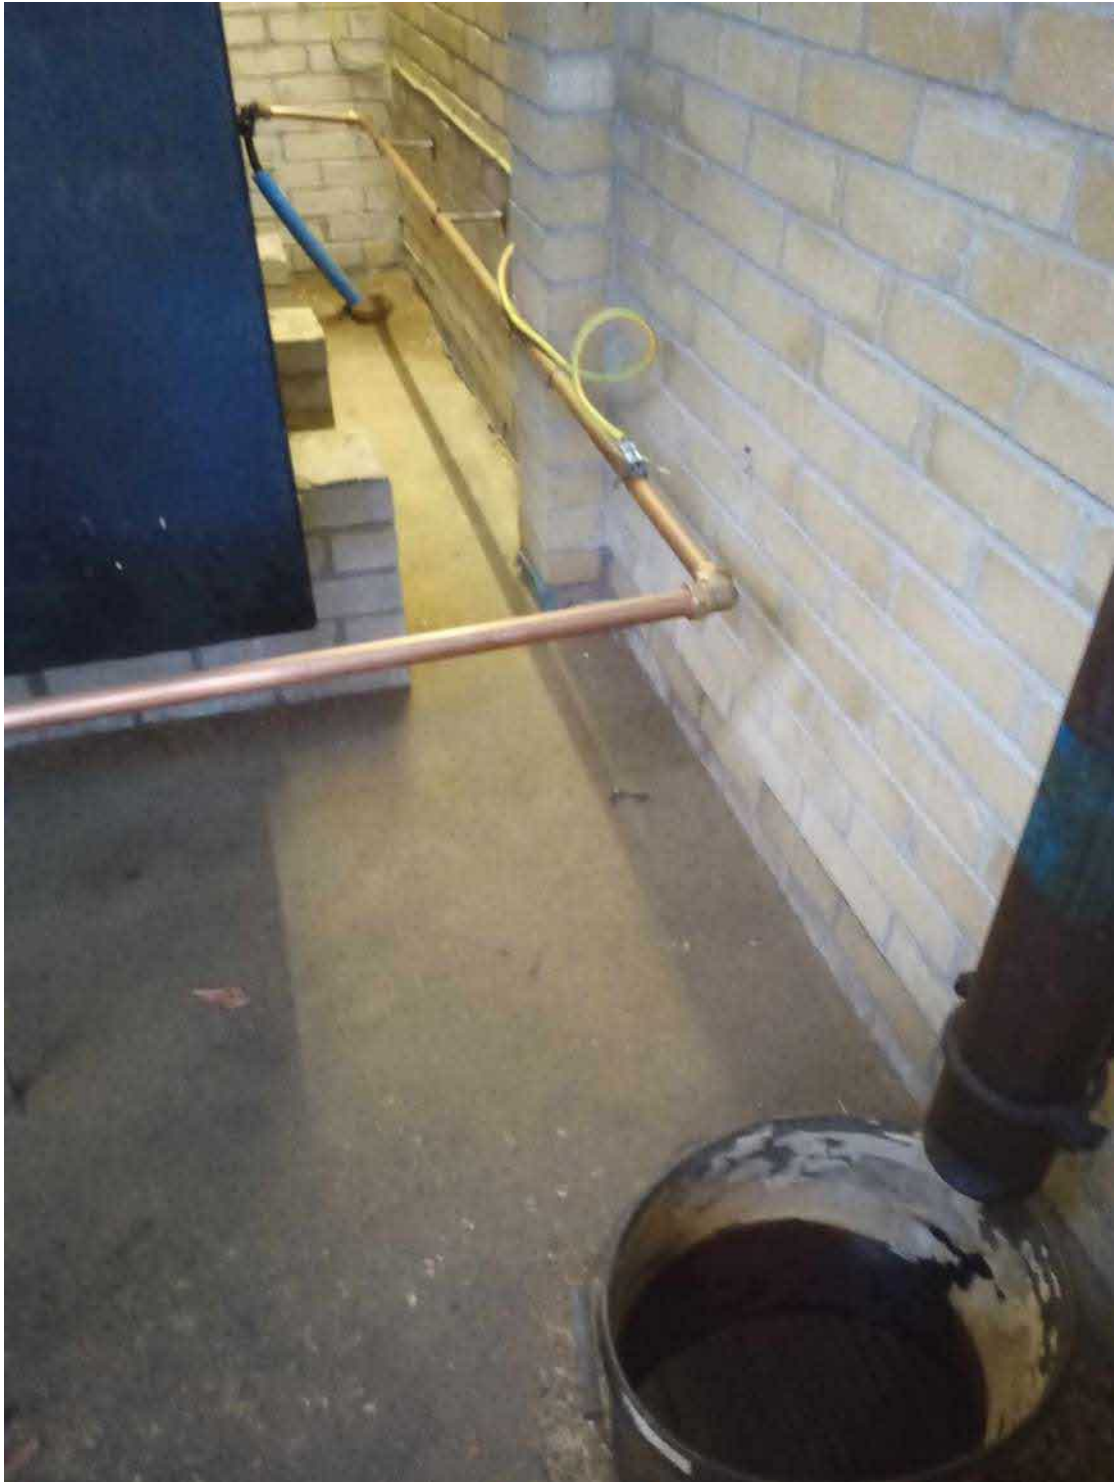
Location 03 facing South - Oil Tank (3)

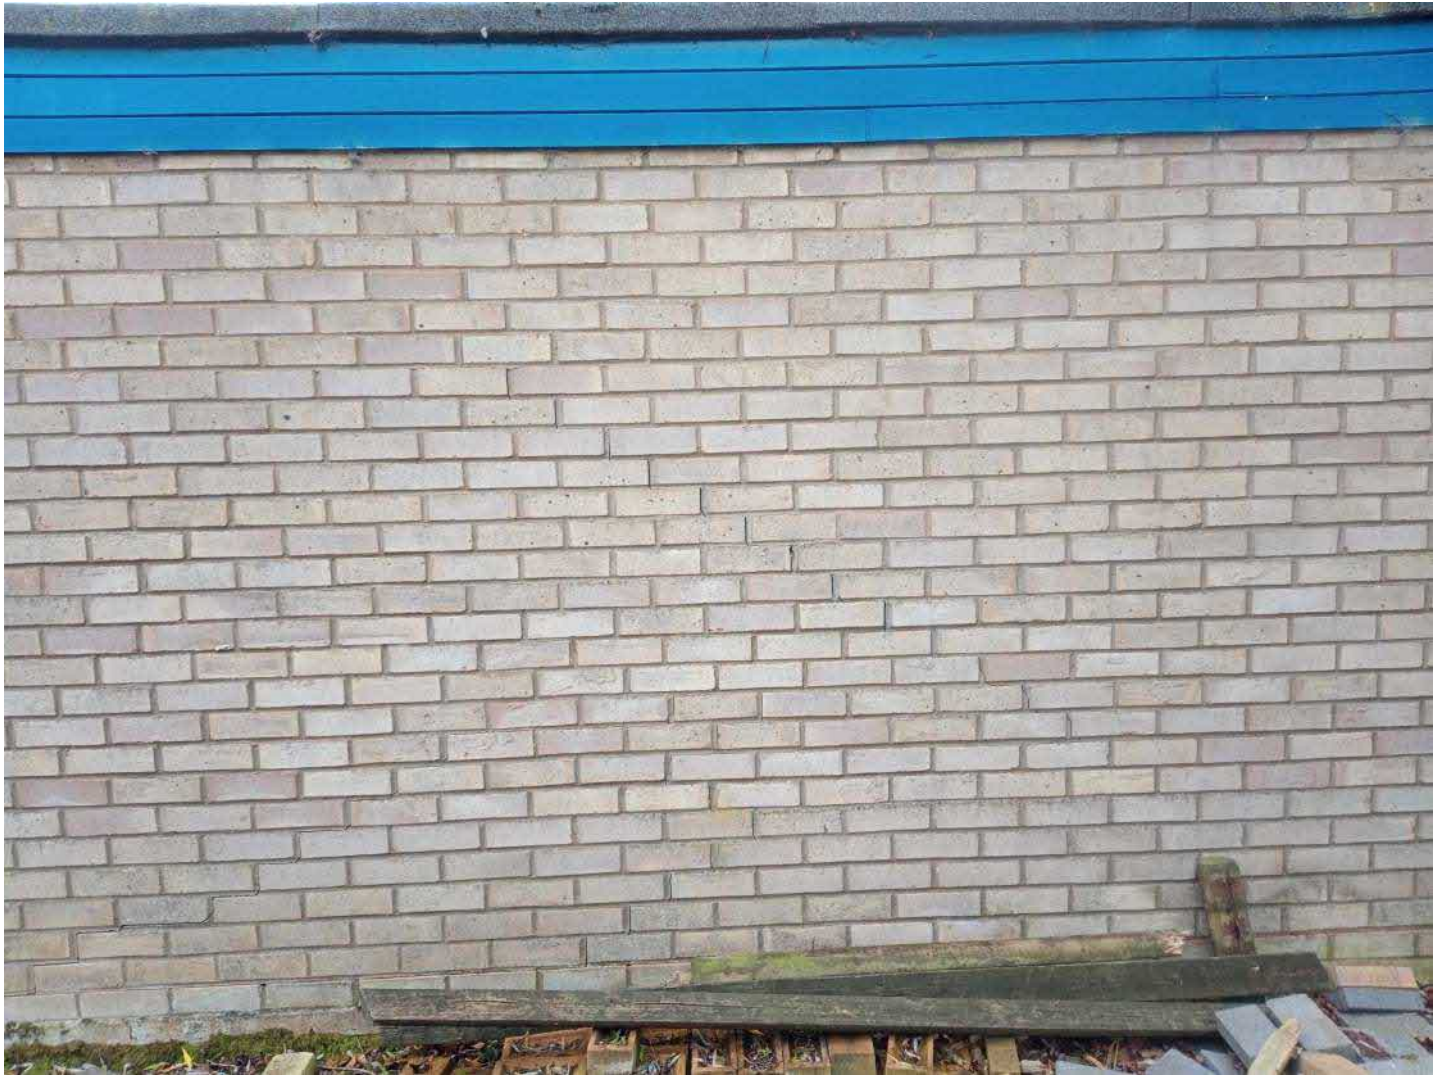
Location 06 facing South - Cracking on northern wall of ANC1 (1)

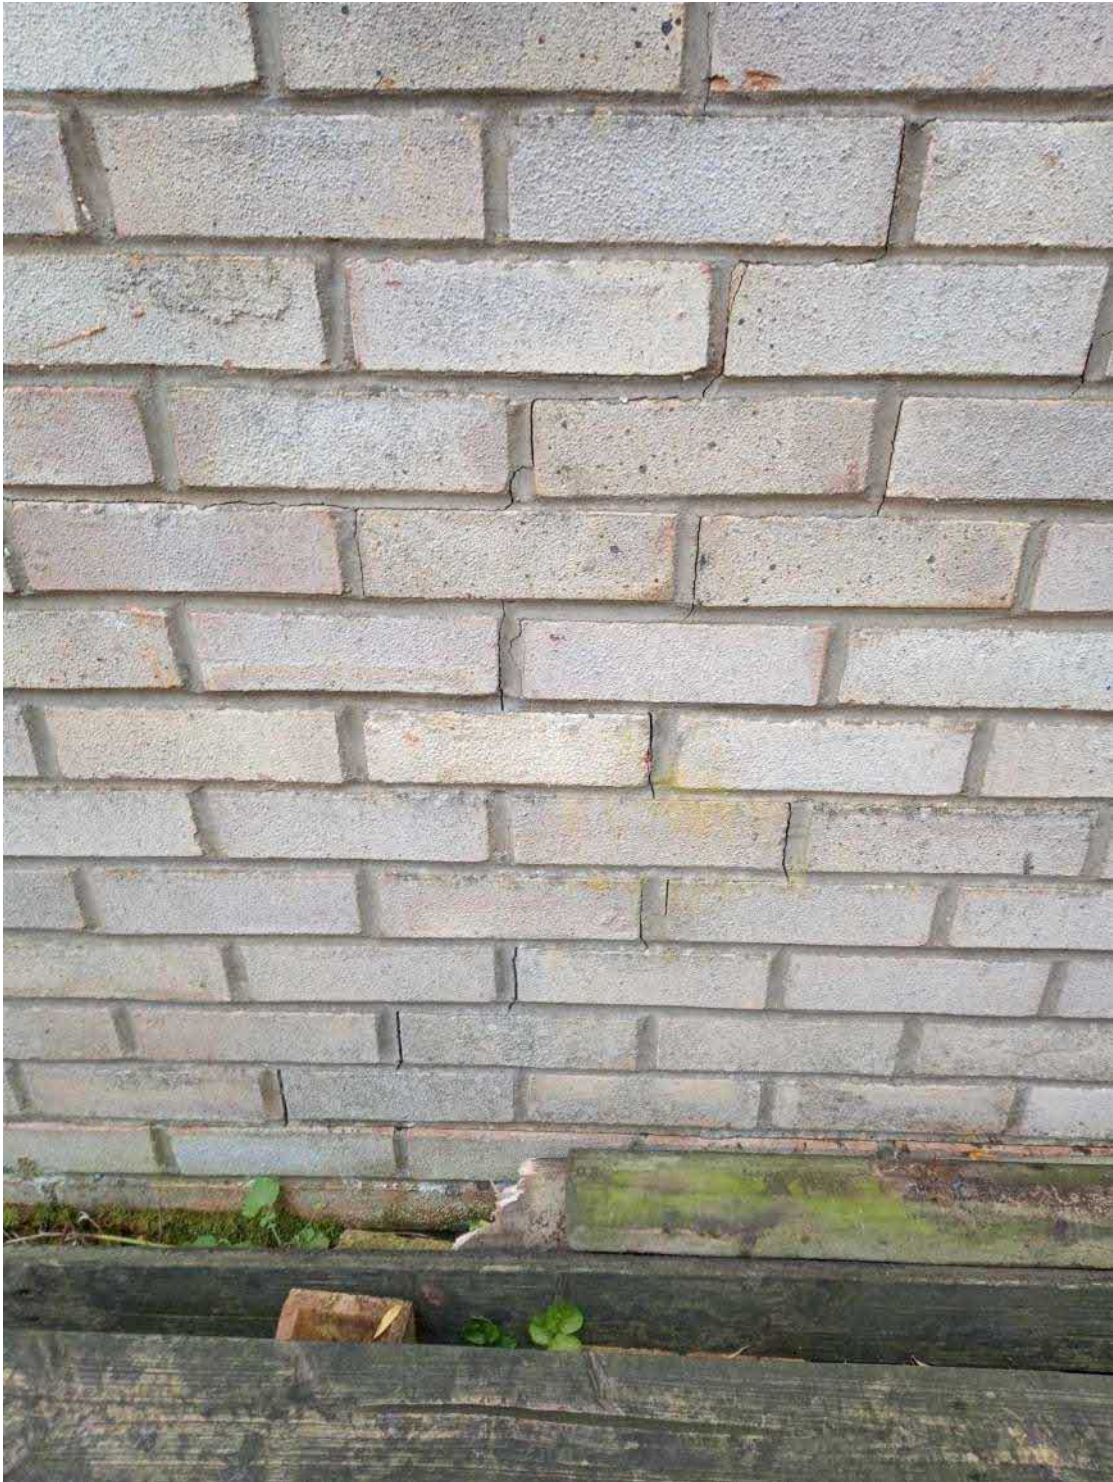
Location 06 facing South - Cracking on northern wall of ANC1 (2)

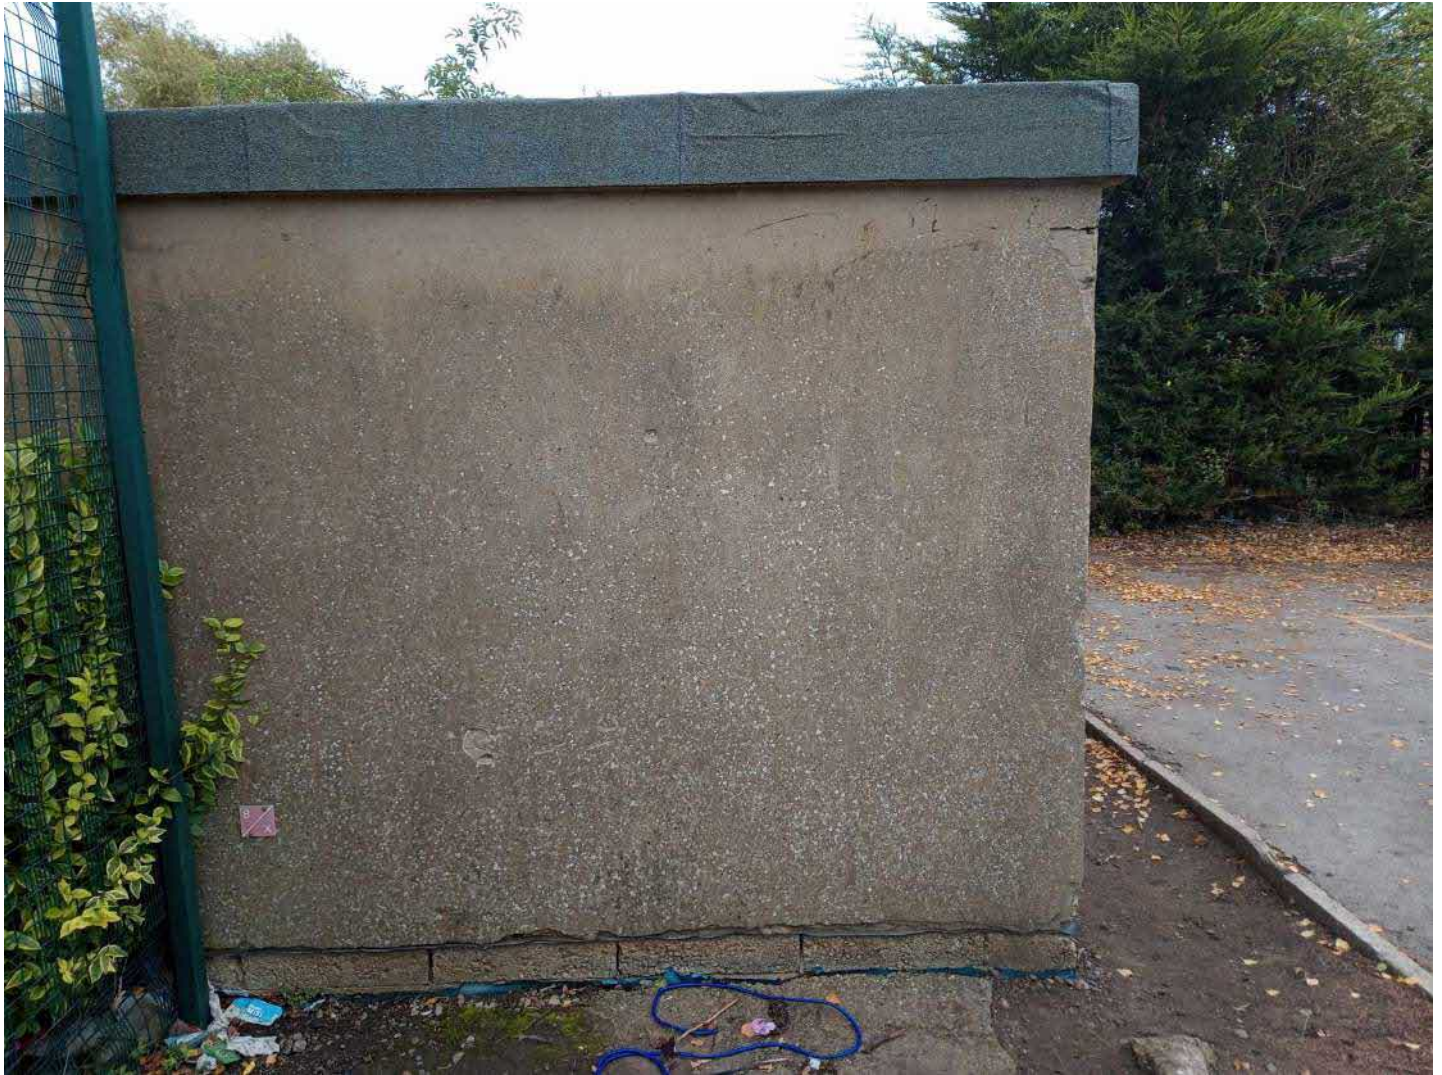
Location 11 facing South East - Shed

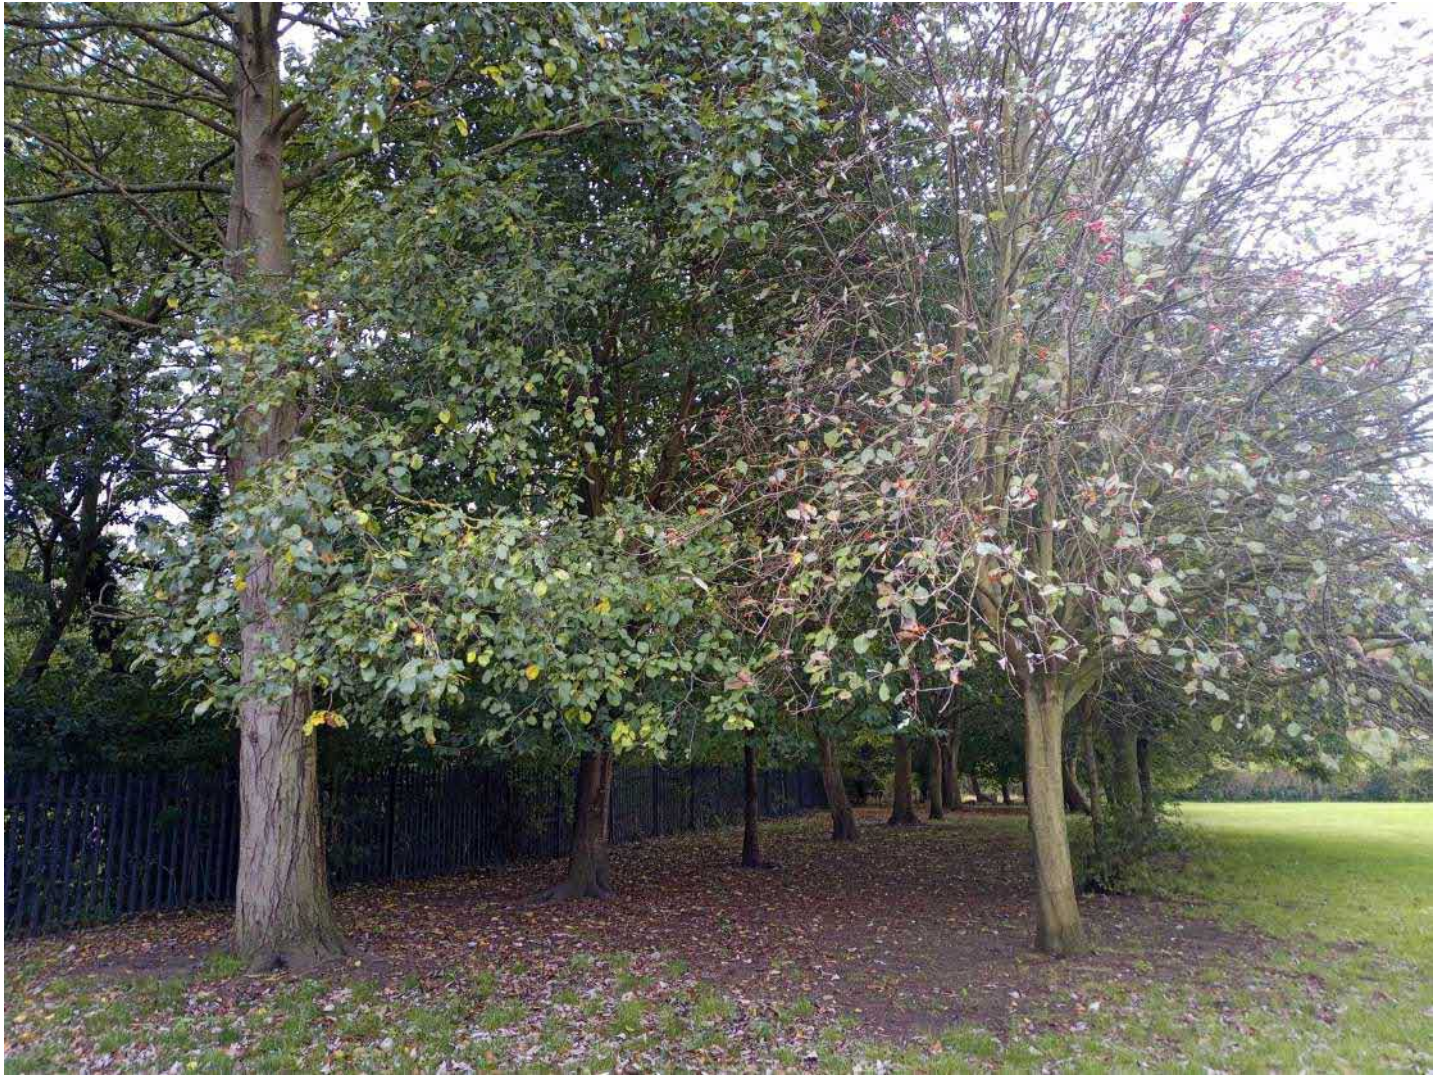
Location 12 facing South West - Trees along southern boundary

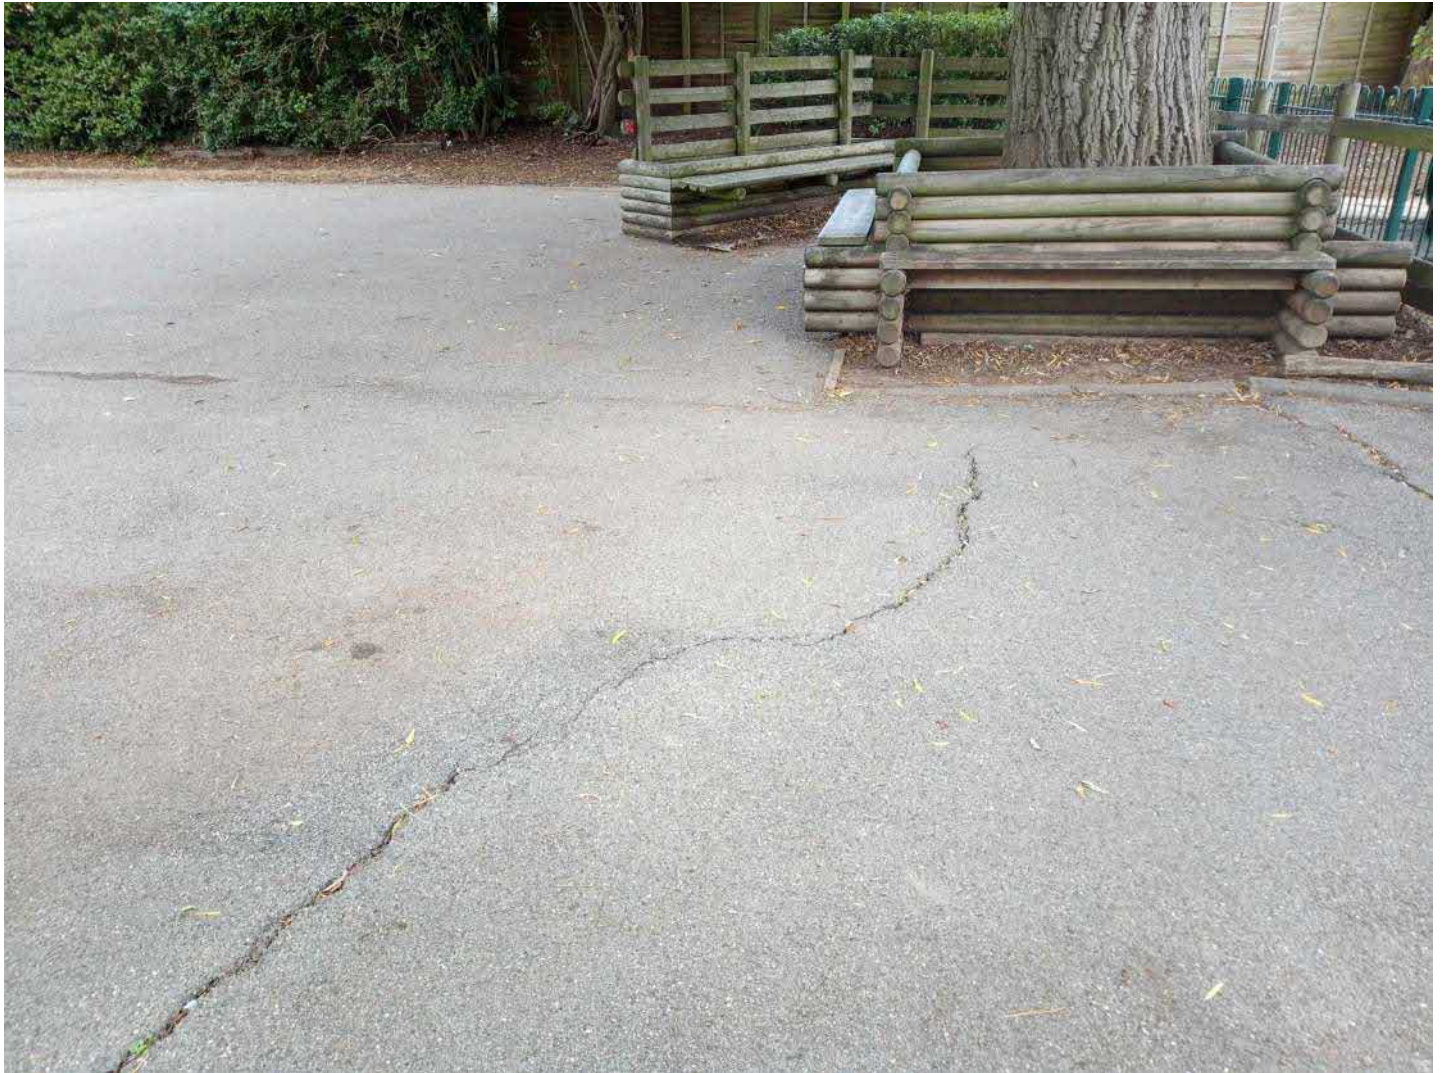
Location 16 facing North - Tarmac cracking radiating from tree

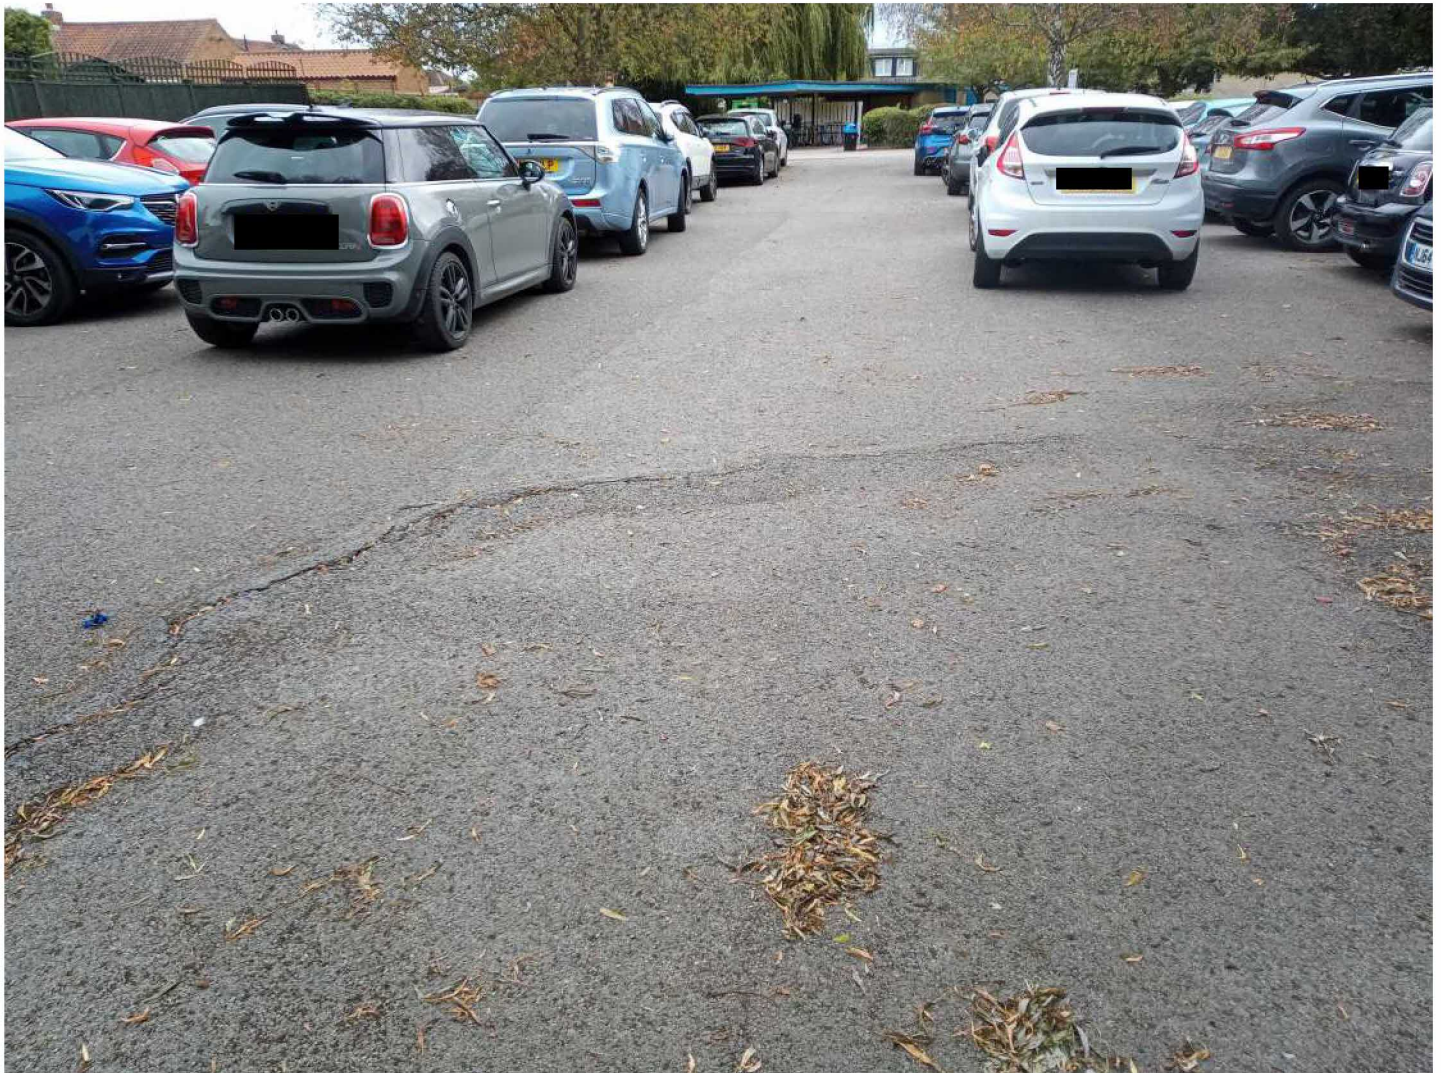
Location 17 facing North East - Staff car park and surface cracking
