Tree Condition Report

& Management Recommendations

at
The Red Lion
Akemnon Street
Hertfordshire
HP23 6AF

Dated
6th June 2022

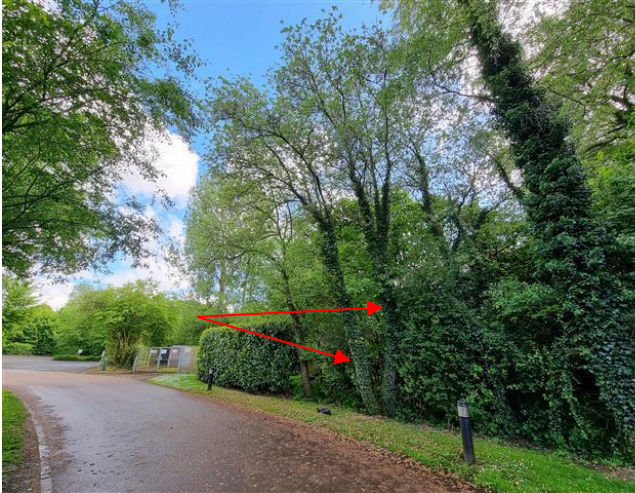
- 4.1.1. T1 is adjacent to the pub's driveway and has major included bark at its base (photographs 1-3). We recommend this tree is removed due to the risk of the stems failing at this point.

Photo 1. Location and form of T1 (arrowed)

Position: 00728. Form: Twin-stemmed at ground level with a balanced crown. History: No evidence of significant pruning. Defects: Major included bark at base.	Remove.		Moderate	Low		
								Moderate	N/A	Fair	<10	3	
T2	Early-Mature Silver Birch Betula pendula.	21	5	35	5 5 5

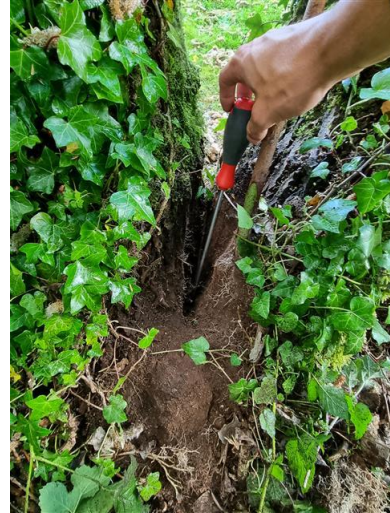
Photo 2. The extent of the poor union at the base of T1

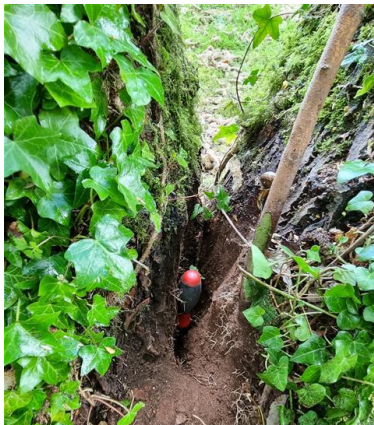
Photo 3. The extent of the poor union at the base of T1

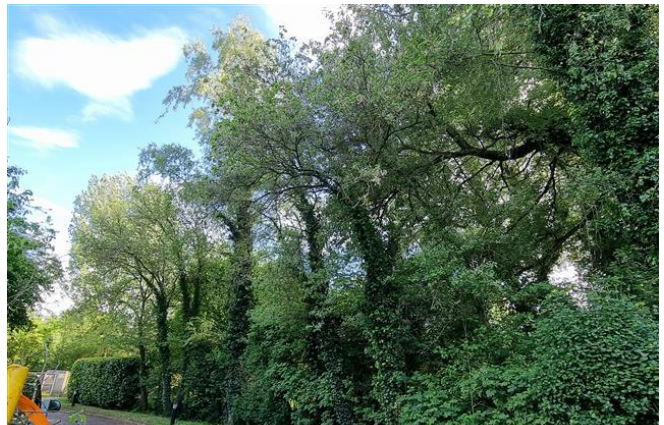
- 4.1.11. Trees T2, G3, T4 and T5 are all covered in ivy (photograph 4), which can conceal major defects on their stems and limbs. Therefore, the condition of these trees cannot be fully assessed until the ivy has been severed and removed. Given their location adjacent to the car park and driveway, their reinspection has been given a moderate priority.

Photo 4. Dense ivy on the stems of T2-T5

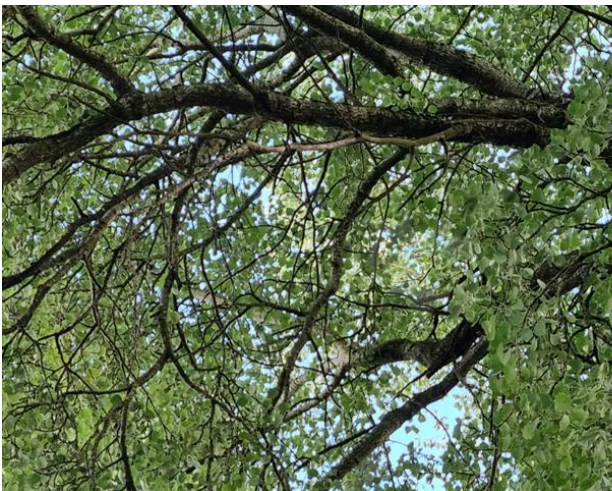
Photo 5. Example deadwood in T5

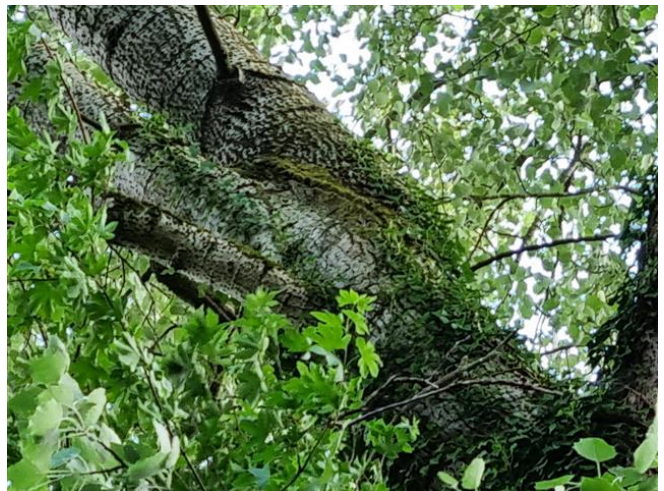
- 4.1.9. The Poplar situated on third party land (T7) has several included bark unions between scaffold limbs (photograph 6). It is therefore recommended that the crown is reduced by 2-3 meters to lessen the forces acting on the weakened unions.

Photo 6. Example included bark union in T7

The crown reduction pruning should be undertaken sympathetically and to BS 3998 guidelines. Reductions should be undertaken by drop-crotching, i.e. pruning back to a branch junction (leaving no branch stubs) and retaining sufficient foliage to keep the retained branch alive. This means that some pruning cuts will inevitably be inside of the overall dimensions stated.

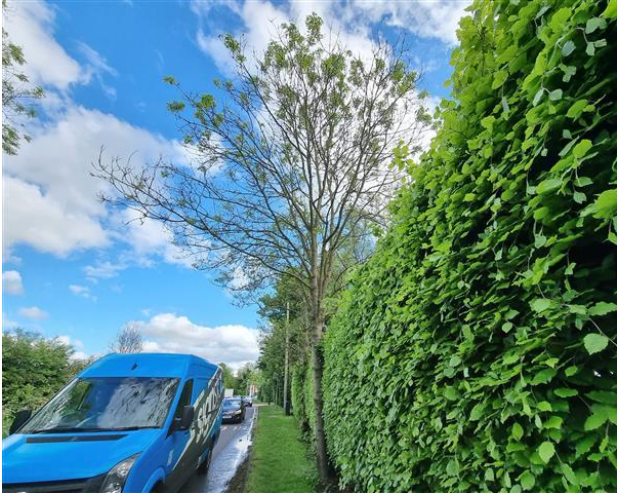
- 4.1.3. T8 is infected with ash dieback and is in decline, with small diameter deadwood over the road (photograph 7). As the condition of this tree deteriorates over time, larger diameter deadwood will die and become hazardous to road users. Consequently, we recommend this tree is removed before it becomes hazardous. If retention of this tree is preferred, it is recommended the deadwood is removed as a matter of very high priority and the tree monitored with an annual inspection frequency.

Photo 7. Location and sparse canopy of T8

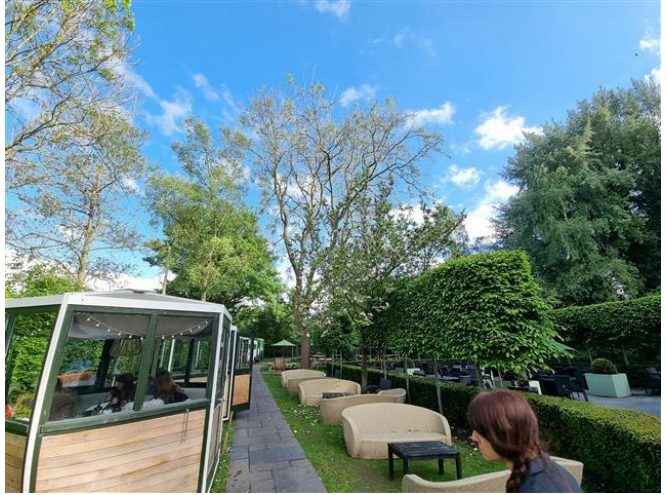
- 4.1.4. T9 is situated in the beer garden adjacent to several seating areas. It is heavily infected with ash dieback with significant deadwood over the seating areas (see photographs 8 & 9). These branches are a hazard to people using the outdoor area, and the tree's condition will continue to decline. Therefore, it is recommended this tree is removed as a matter of very high priority.

Photo 8. Location and sparse canopy of T9

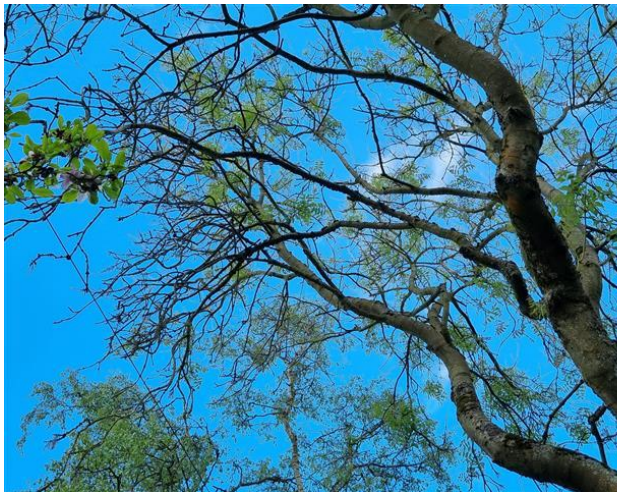
Photo 9. Deadwood in T9

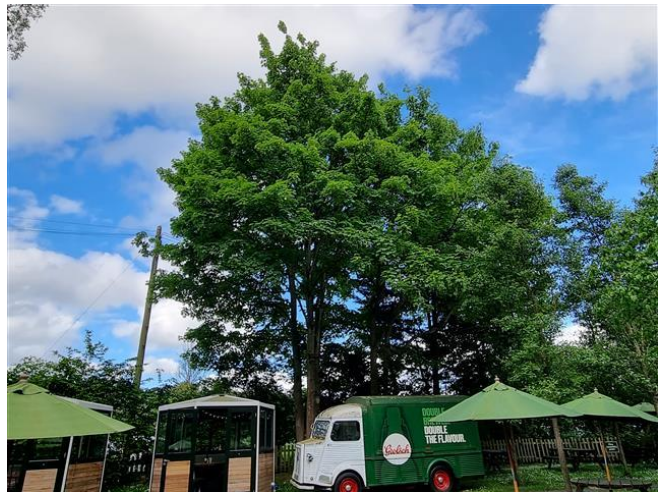
- 4.1.12. T10 is a multiple-stemmed sycamore in the beer garden adjacent to the main road (photograph 10). There are significant included bark unions between the tree's stems (see photographs 11 & 12). Therefore, to prevent failure at these points, we recommend installing a cable brace between stems that share such unions. When installing a cable brace, a sympathetic system such as the CobraTM system should be utilised. Such systems utilise a padded sleeve to prevent damage to the bark and are flexible enough to allow the tree to flex in windy conditions. Bracing systems will need to be maintained and adjusted periodically (circa every five years). They should be installed approximately halfway between the weak fork and the top of the tree.

Photo 10. Form and location of T10

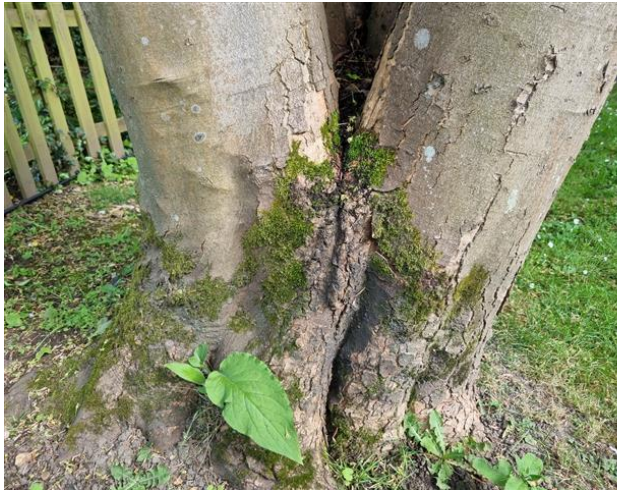
Photo 11. Poor union at the base of T10

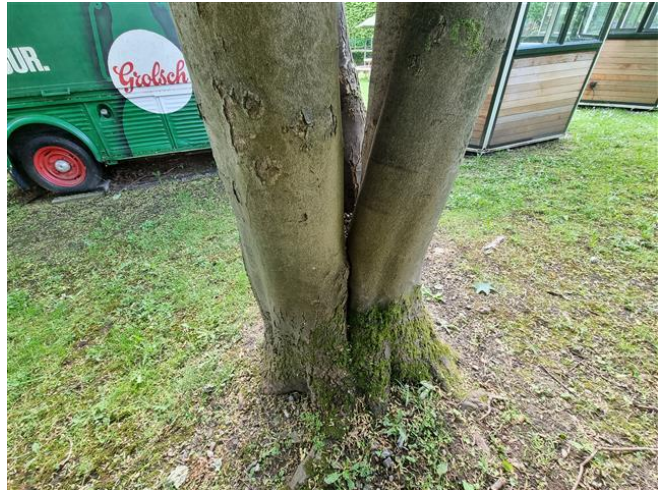
Photo 12. Poor union at the base of T10

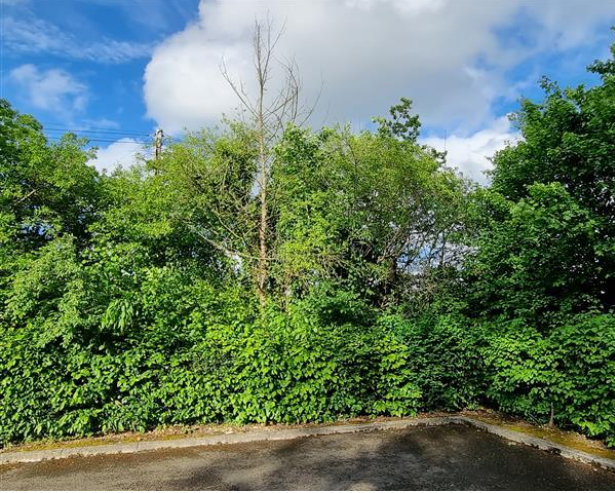
- 4.1.5. There are several small dead trees (G12 – T13) around the edge of the southern car park (photographs 13 & 14). It is recommended these trees are removed as a moderate priority.

Photo 13. Dead trees (G12)

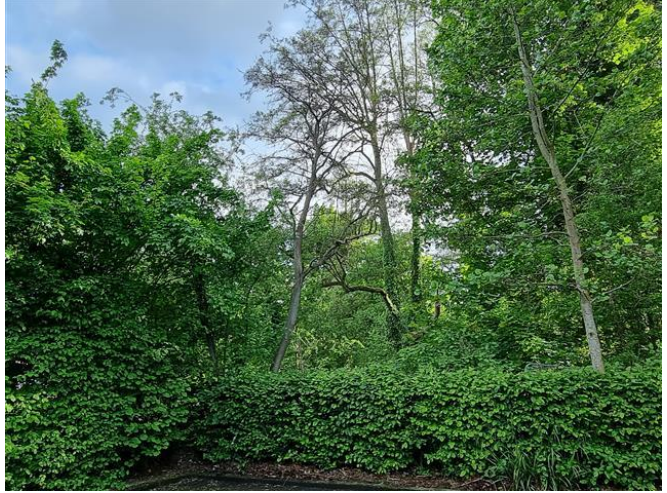
Photo 14. Dead tree (T13)

T13	Semi-Mature Dead Tree	5	3	15	2	1	1		Position: Carpark boundary. Defects: Dead tree.	Remove. Moderate N/A	Dead Dead Dead	Dead Dead 4
