Site Visit Report

Project No: 0000
Project: **Horton Court - wall stability to
out building.**
Engineer: JWS
Date of visit: 17.07.23
Present: Kath Campbell Hards

Report No: **0000SVR-JWS-01**

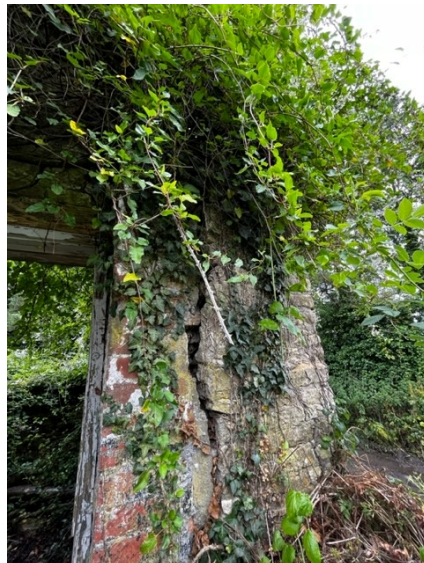
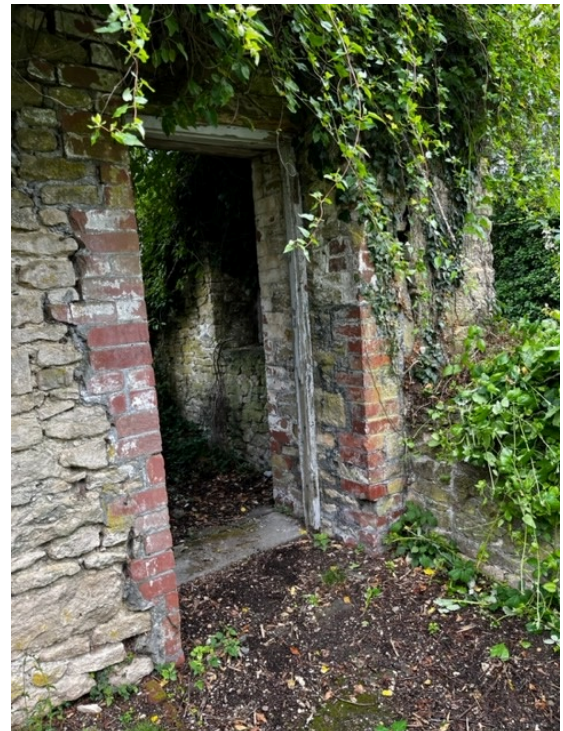
1. Stripping vegetation from the coursed, rubble stone outbuilding, adjacent the Cotswold Way to the west of the estate, has exposed fractures within the wall that appear to signify movement towards the road.

2. On close inspection, the fractures appear to be old but have increased in width over time. The fractures and the core have weathered due to water ingress and woody growth vegetation and the core work has been washed to the extent that binder loss has resulted in the core work being voided with stone-on-stone jointing.

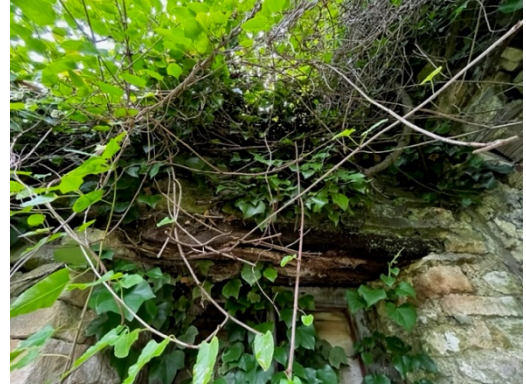
3. The failures have occurred near door openings on both the north and east elevations which creates a weakness in this corner of the building. The timber lintels to the north door are decaying and deflecting, causing the wall over to settle whilst the timbers over the east door have been replaced relatively recently, say within the last 10-15 years.

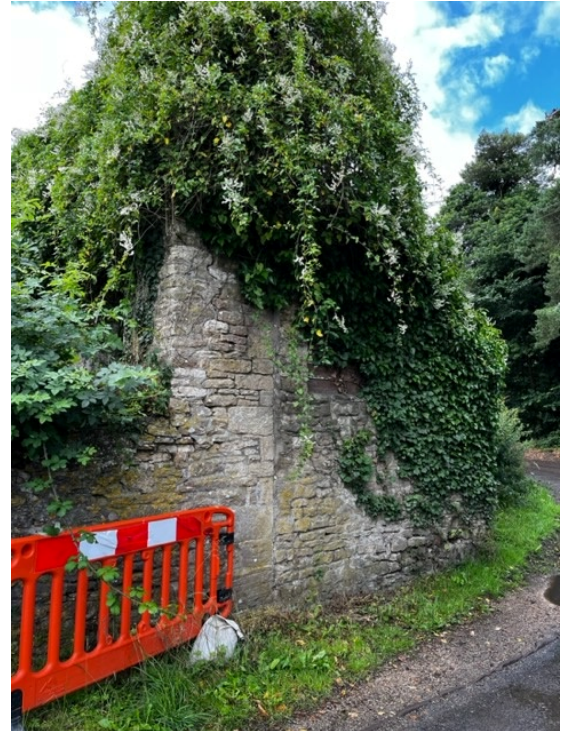
4. At a high level over the east door, the rubble stone wall has dislodged and is being held in place by vegetation. This area is dangerous as falls of stone from high level are likely over the door position.
5. The wall in its current state would be difficult to repair as the mortar loss is substantial and any stitching would have little to hold on to. Any attempt to repair is likely to require the wall to be taken down and re-built.
6. The structure is in an unpredictable state. The wall requires immediate attention which should involve the taking down of the east wall up to the south reveal and the north wall down to the decayed lintels over the door and possibly the later door infill. As vegetation is cleared and the wall removal has started, it may be come clear that more wall needs to be removed and the point of effective consolidation will be found.
