Historic Impact Assessment

IMPLEMENT SHED, HORTON COURT

PARTIAL DISMANTLING AND BOUNDARY WALL REPAIRS

Horton Court, Horton, Chipping Sodbury, Glos BS37 6QR

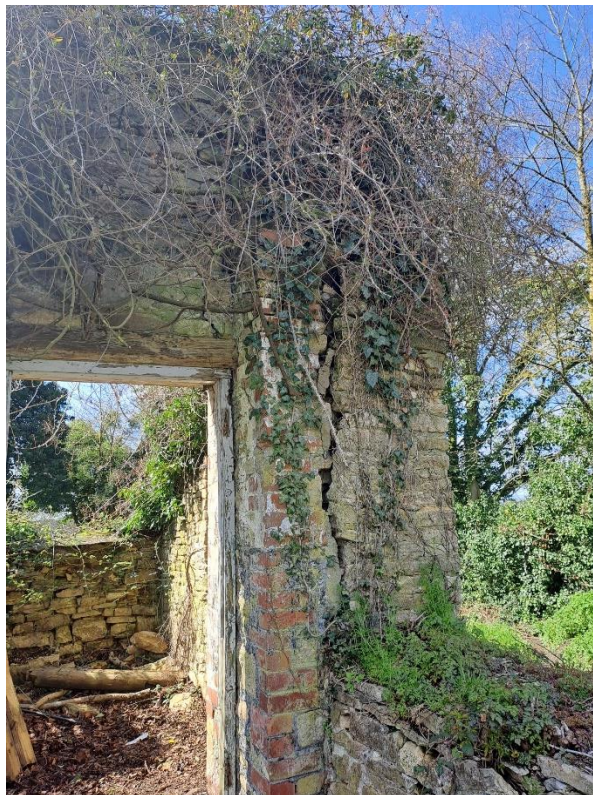
The northern extension has roughly coursed rubble limestone walls, with a brick lined doorway in the east elevation and a timber window in the north elevation. Vegetation growth has steadily been taking over the extension to the point where until recently it was difficult to see any of the structure. Once some of this vegetation was cut back, a significant crack was revealed in the masonry and loose high-level stones became apparent.

Northern extension after initial vegetation clearance showing large crack

Some urgent works have already been carried out to make the northern extension safe, particularly in relation to its proximity to road and pedestrian traffic. This involved the careful removal of vegetation that was growing in and around the north-east corner and the dismantling of unstable high-level masonry. The eastern wall has been left with a raked wall head and the northern wall has been taken down to a roughly horizontal level in line with the top of the window. The 3 no. decayed timber lintels above the window have been removed.

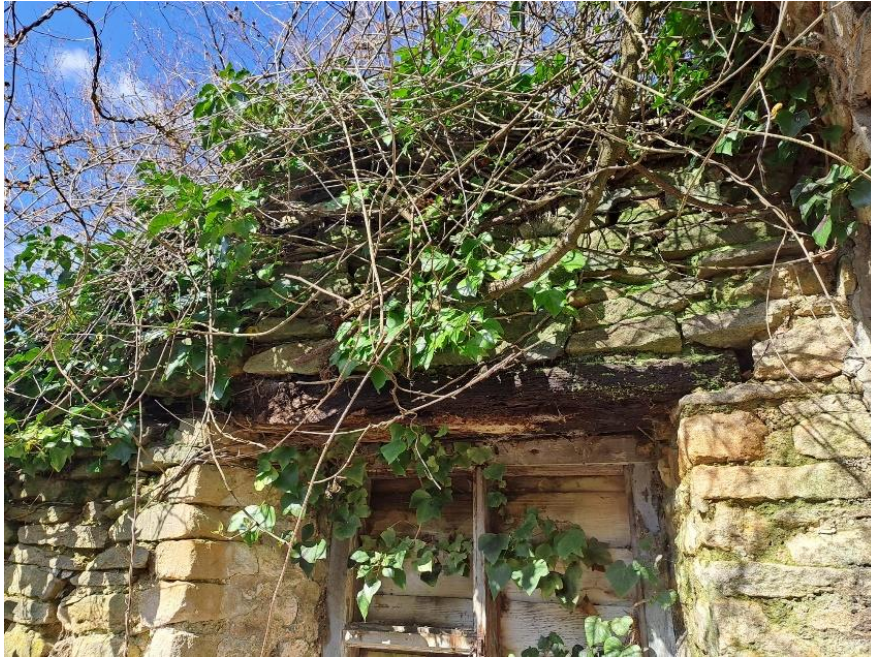
North wall (internal) showing unstable masonry and decayed window lintels

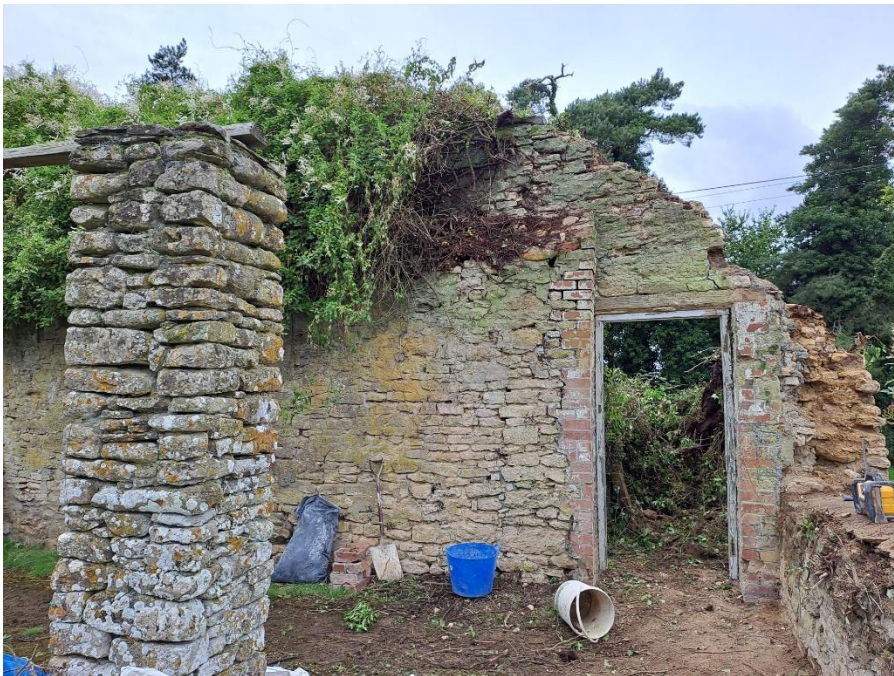
East wall after vegetation clearance and dismantling

The exposed wall heads have been temporarily protected for the Autumn/Winter, pending the outcome of this application for consent to install a longer-term wall capping. For durability, it is recommended that a relatively coarse mortar is used for this and the proposed mix is as follows:

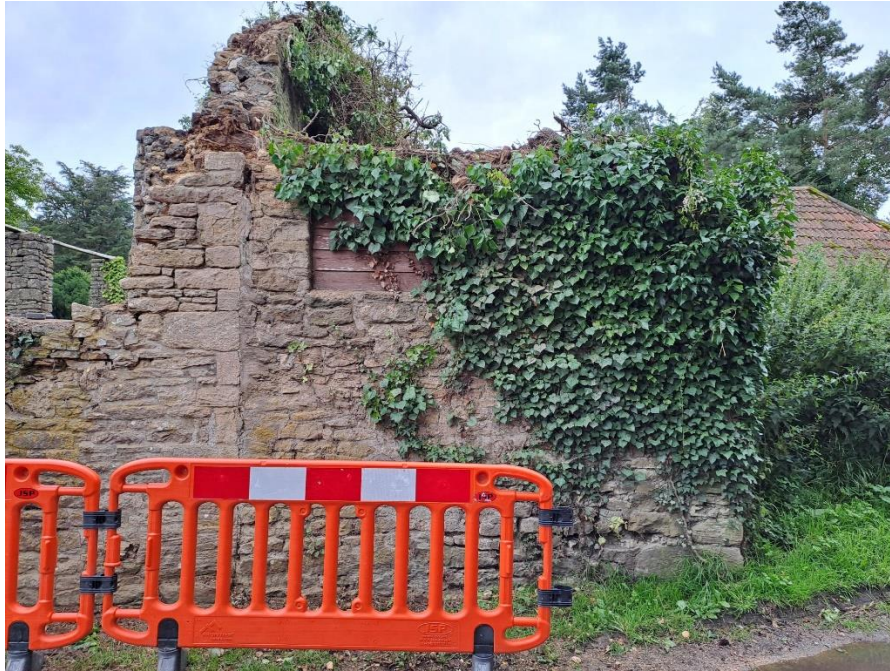
North wall after dismantling

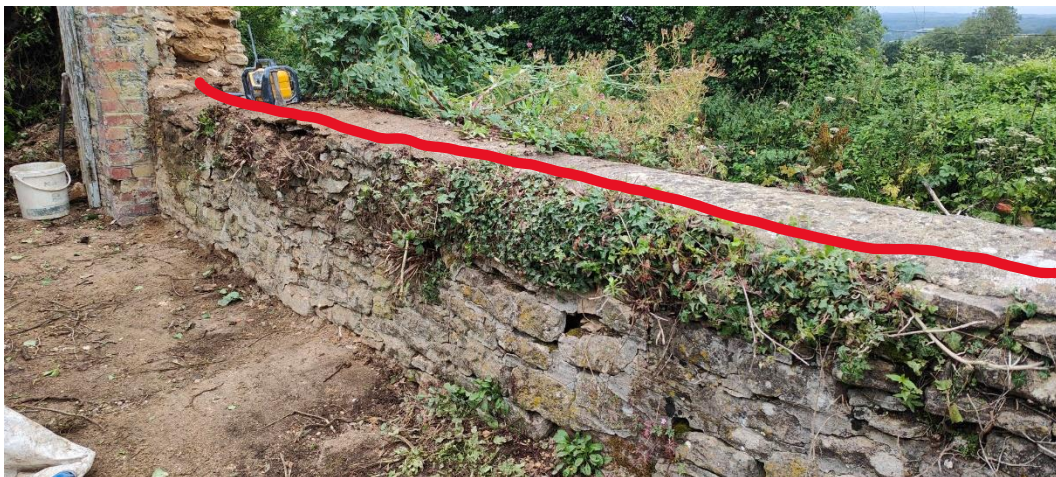
The boundary wall between the northern extension and the Church has a retaining function (approx. 850mm high on the garden side and 175mm high on the roadside). It has been affected by the growth of woody vegetation. Mortar has been washed out and the wall is now bulging in the section closest to the Implement Shed.

6m section of boundary wall that needs rebuilding (garden view)

The adjacent boundary wall also requires repair and this will involve partially dismantling and re-building approximately 6m of the wall. New weep holes will be included at the base of the wall on the roadside to facilitate drainage of water from behind the wall. Woody vegetation that is growing into the wall will be removed. Existing cement mortar will also be removed where possible and replaced with lime mortar. The proposed replacement bedding and pointing mix is as follows:

The boundary wall currently has a cement mortar capping and this will be replaced with a new lime mortar capping using the same mix as for the Implement Shed wall capping consolidation.

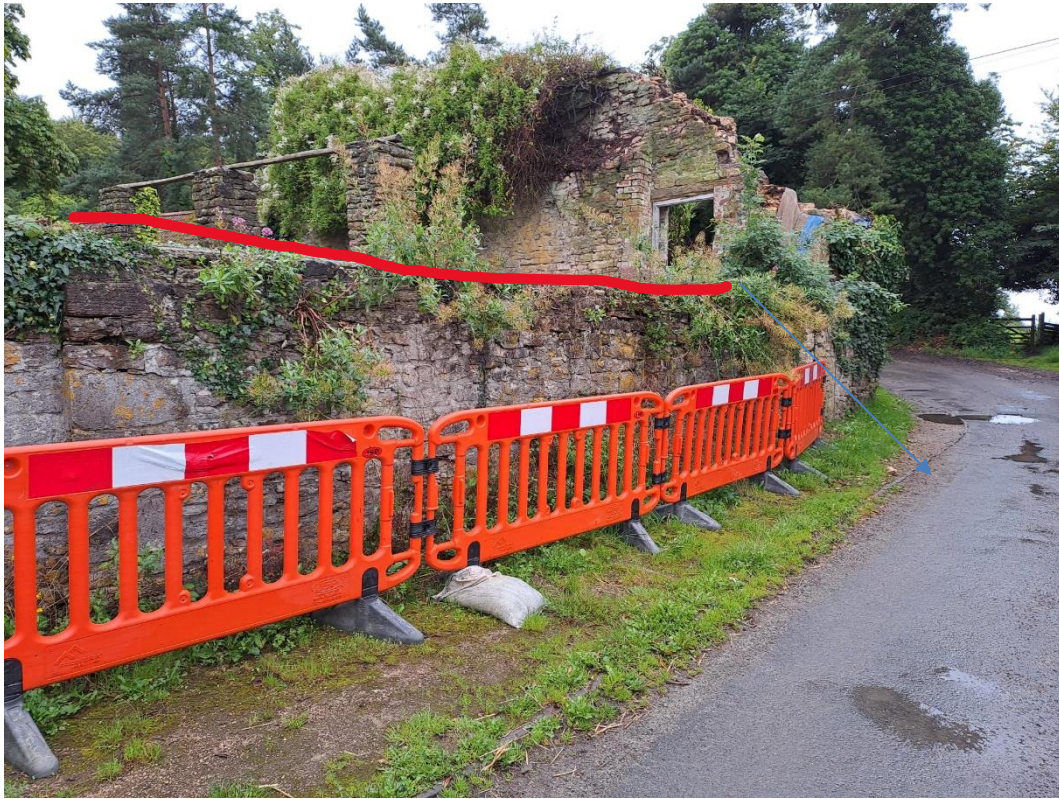
6m section of boundary wall that needs rebuilding (roadside view)

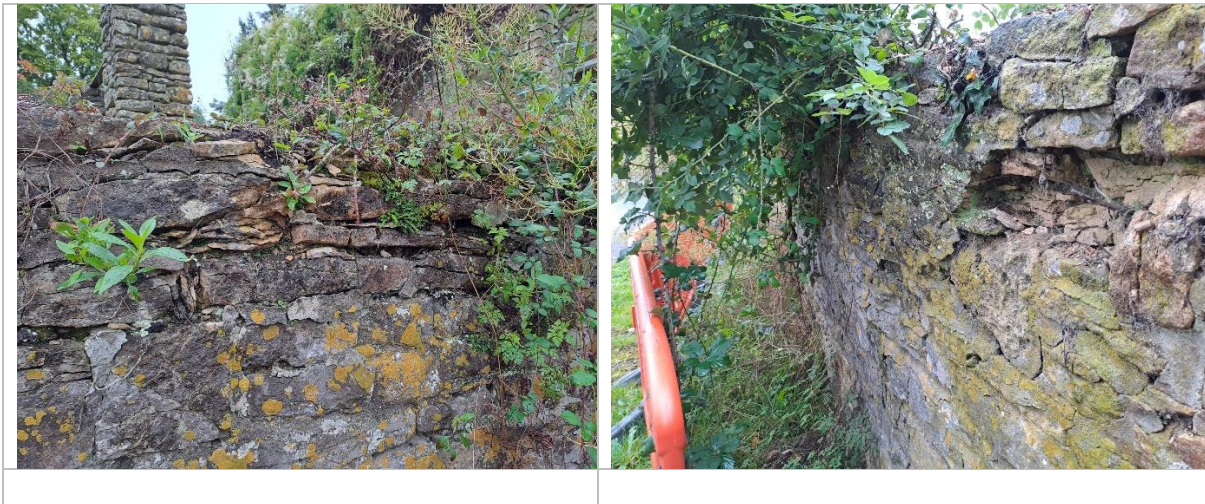
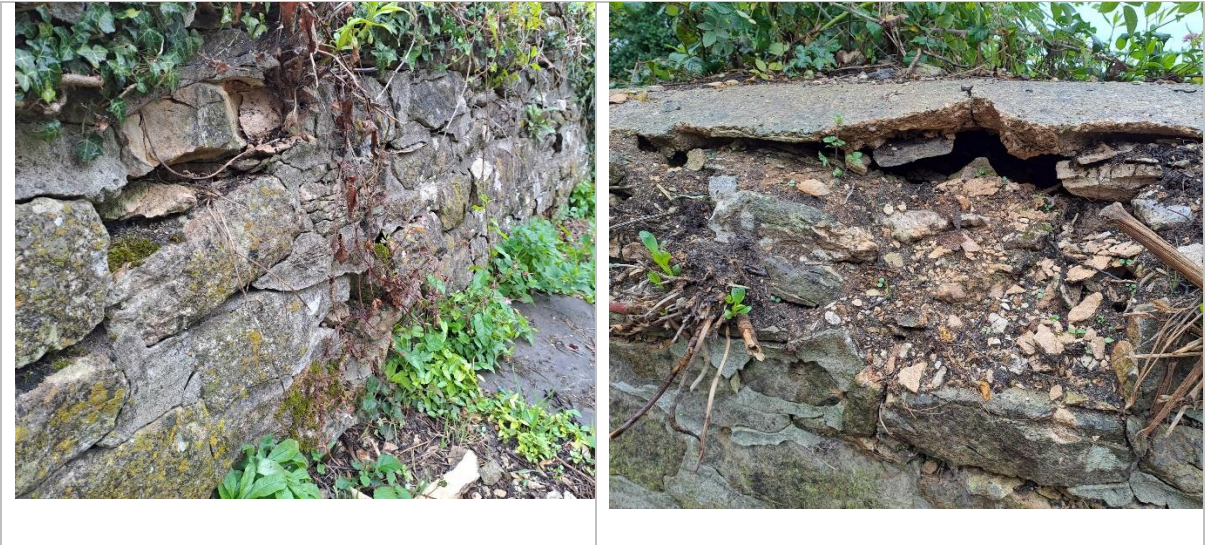
Close-up views of boundary wall showing current condition of 6m section that required re-building
