Arboricultural Survey
Land off Main Street
Aunsby
Lincolnshire
NGR TF04871 38960

Survey by
Christopher Barker CEnv dipHort ACIEEM

Report prepared by: C Barker	Date Issued: 17 January 2023 Report Version: V1
Reviewed by: KLB	C B E Consulting Highbank, 5 Grantham Road, Navenby Lincoln. LN5 0JJ. Telephone (01522) 810086. www.cbeconsulting.co.uk
Report ref: P2697 /0123 /01

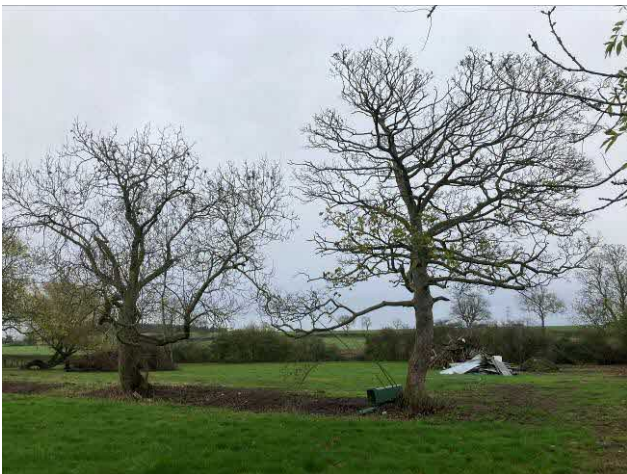
Trees T2 – T3

Tree No	Species	Ht (m)	Stem Diam mm@ 1.5m	Canopy Spread (m)	Height of Crown Clearance	Age Class	Est yrs	Overall Condition	Structural condition	Recommendations	BS 5837 Category	RPA Radius (m)
T1	Ash <i>Fraxinus excelsior</i>	7	170 x 7	N-4 S-3 E-3 W-3	0	SM	20	F	Merging Ash with a young Sycamore at the northern end. Dense broad crown. No structural faults visible from ground level	Would benefit from thinning out	B2	4.6
T2	Sycamore <i>Acer pseudoplatanus</i>	8	430	N-5 S-5 E-4 W-4	3	M	10	P	Irregular open crown. Major wound with deep decay and woodworm damage in the heartwood. Significant dead wood in the lower canopy. Appears to be in decline.	Removal recommended. If retained, monitor decay and decline. If removed replace with a new native tree.	C2	5.1
T3	Ash <i>Fraxinus excelsior</i>	8	545	N-5 S-4 E-5 W-6	2	M	10	P	Irregular open crown with significant dead wood throughout and internal regeneration. Tree appears to be in serious decline and may have Ash Die-back.	If Ash Die-back is confirmed it would be prudent to consider removing this tree and replacing this with a new specimen tree.	C2	6.5

Ref	Tree	Category	Recommendations
1	Ash	B2	Cutback the Sycamore on the north side into the hedgerow to thin out the canopy density.
2	Sycamore	C2	Removal recommended.
3	Ash	C2	If Ash Die-back is confirmed it would be prudent to consider removing this tree and replacing this with a new specimen tree.
4	Ash	U	Removal and replacement is recommended
5	Ash	U	Removal and replacement is recommended.
6	Ash	C2	No work required at this time but monitor decline. If disease is confirmed this tree will need to be replaced with a new specimen.
7	Willow	C2	No work required at this time. Monitor stability.
8	Ash	C2	Monitor decline. If disease is confirmed this tree will need to be replaced with a new specimen.
9	Ash	B2	No works required at this time.
10	Ash	B2	No works required at this time.
11	Ash	B2	No works required at this time.
12	Ash	U	Removal and replacement recommended.
13	2 x Ash	U	Removal and replacement recommended.

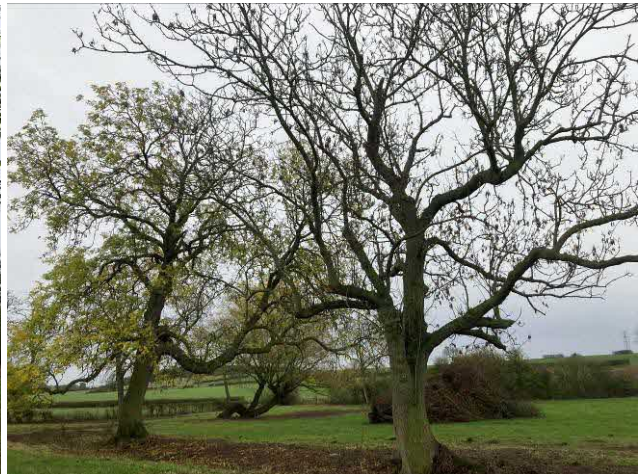
Trees T4 – T5

T4	Ash <i>Fraxinus excelsior</i>	10	640	N-5 S-4 E-4 W-5	2	M	<10	P	Very open and irregular crown with significant dead wood throughout. Internal regeneration. Tree appears to be in serious decline and may have Ash Die-back.	Removal and replacement is recommended	U	7.6

Tree No	Species	Ht (m)	Stem Diam mm@ 1.5m	Canopy Spread (m)	Height of Crown Clearance	Age Class	Est yrs	Overall Condition	Structural condition	Recommendations	BS 5837 Category	RPA Radius (m)
T5	Ash <i>Fraxinus excelsior</i>	5	745	N-4 S-7 E-5 W-6	3	M	<10	P	Very irregular crown extending south. Large fungal brackets on trunk. Significant dead wood throughout. Tree appears to be in serious decline and may have Ash Die-back in addition to another fungal infection.	Removal and replacement is recommended.	U	8.9
T6	Ash <i>Fraxinus excelsior</i>	10	485	N-3 S-6 E-4 W-5	4	M	10	P	Trunk leans east. Irregular crown extending south. Fungal brackets present and significant dead wood within the canopy. Appears in decline and may have Ash Die-back.	No work required at this time. Monitor decline. If disease is confirmed this tree will need to be replaced with a new specimen.	C2	5.8
T7	Willow <i>Salix alba</i>	10	600 560	N-0 S-8 E-6 W-8	4	OM	10	P	Trunk leans severely south and divides into two trunks. Re-rooted at ground contact point with an irregular unbalanced crown extending south.	No work required at this time. Monitor stability.	C2	9.8

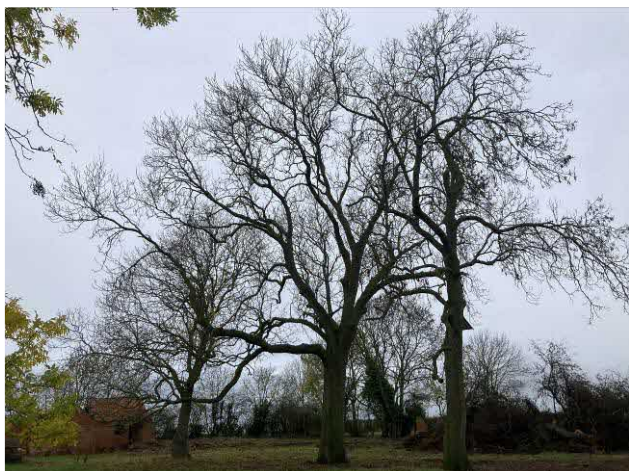
Trees T8 – T10

T8	Ash <i>Fraxinus excelsior</i>	14	660	N-3 S-5 E-4 W-4	4	M	10	F	Owl box at 5magl. Open irregular crown with significant dead wood at canopy extremities. Appears in decline and may have Ash Die-back.	Monitor decline. If disease is confirmed this tree will need to be replaced with a new specimen.	C2	7.9
T9	Ash <i>Fraxinus excelsior</i>	16	810	N-8 S-4 E-8 W-7	4	M	20+	G	Broad open crown extending to the north east. Woodpecker holes at 7magl. No structural faults visible from ground level	No works required at this time.	B2	9.7
T10	Ash <i>Fraxinus excelsior</i>	14	635	N-5 S-5 E-5 W-5	3	M	20	F	Broad irregular crown with some minor dead wood present. No structural faults visible from ground level	No works required at this time.	B2	7.6
T11	Ash <i>Fraxinus excelsior</i>	11	400	N-2 S-4 E-4 W-5	4	M	20	F	Upright crown with minor dead wood in lower canopy. No structural faults visible from ground level	No works required at this time.	B2	4.8

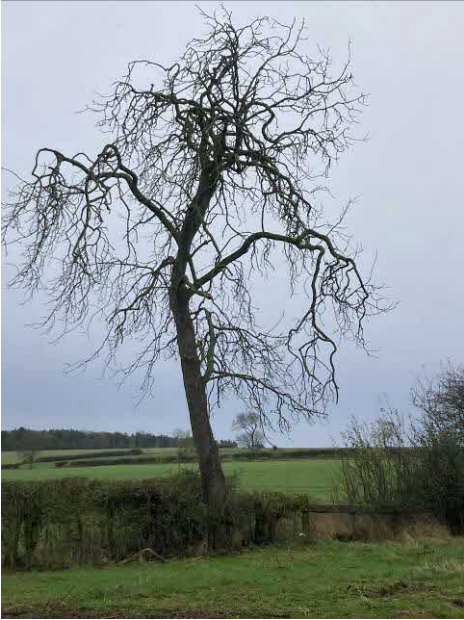
Tree T12

T12	Ash <i>Fraxinus excelsior</i>	10	420	N-4 S-4 E-3 W-3	4	M	<10	P	Appears to be in severe decline with significant dead wood throughout and decay present in the bole. Likely to have Ash Die-back.	Removal and replacement recommended.	U	5.0

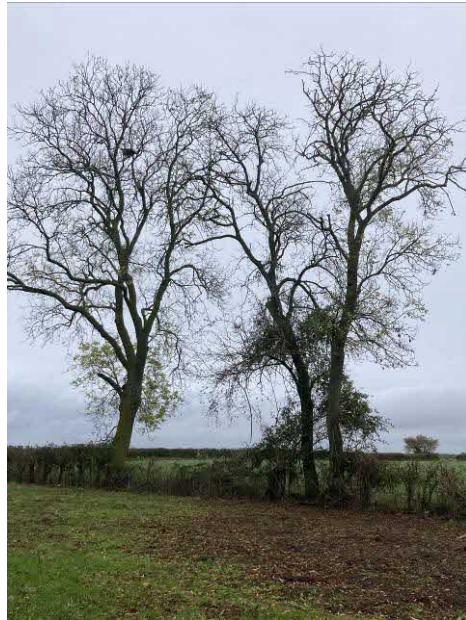
Trees T13 – T14

Tree No	Species	Ht (m)	Stem Diam mm@ 1.5m	Canopy Spread (m)	Height of Crown Clearance	Age Class	Est yrs	Overall Condition	Structural condition	Recommendations	BS 5837 Category	RPA Radius (m)
T13	2 x Ash <i>Fraxinus excelsior</i>	18	360 340	N-3 S-4 E-3 W-3	5	M	<10	P	Two trees merging to form one irregular round open canopy. Significant dead wood throughout with both appearing to be in decline. Both trees likely to have Ash Die-back.	Removal and replacement recommended.	U	5.9
T14	Ash <i>Fraxinus excelsior</i>	18	590	N-5 S-4 E-5 W-6	5	M	20	F	High broad crown with minor dead wood in open crown. Nest present. No structural faults visible from ground level but may have early signs of decline.	No works required at this time. Monitor for decline.	B2	7.0
T15	Ash <i>Fraxinus excelsior</i>	6	200 180	N-1 S-4 E-3 W-0	2	SM	10	F	Irregular crown extending south and east. Crowded by T16 with limited space for further growth on the north side. No structural faults visible from ground level	No works required at this time.	C2	3.2

14	Ash	B2	No works required at this time. Monitor for decline.
15	Ash	C2	No works required at this time.
16	Hawthorn	U	Removal and replacement recommended.
17	Ash	C2	No work required at this time. Monitor condition and watch for ADB infection.
18	Ash	U	Removal and replacement recommended.
19	Ash	B2	No works required at this time.
20	Ash	C2	Monitor condition and watch for ADB infection.
21	Ash	C2	No works required at this time.
22	Ash	C2	Removal of ivy growth recommended.
23	Ash	C2	No works required at this time.
G24	5 x Ash	U	Removal and replacement recommended.

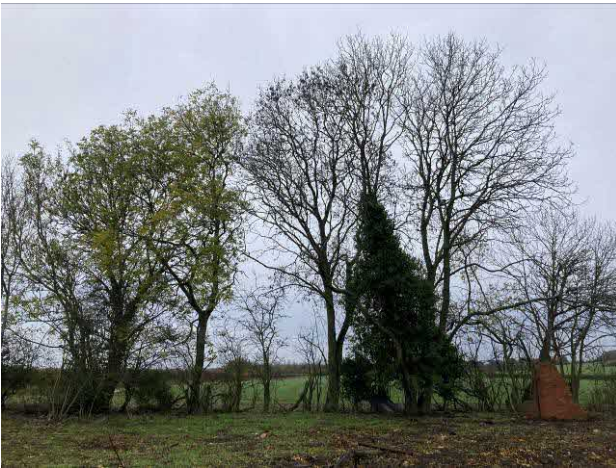
Trees T15 – T21

T16	Hawthorn <i>Crataegus monogyna</i>	5	245	N-0 S-5 E-1 W-1	2	M	<10	P	Leans south and appears to be in severe decline with significant dead wood throughout. No structural faults visible from ground level	Removal and replacement recommended.	U	2.9
T17	Ash <i>Fraxinus excelsior</i>	10	130 320 140 310 200 320	N-4 S-6 E-5 W-5	1	M	10	F	Broad crown with ivy climbing the trunks. Minor dead wood present in canopy extremities. No structural faults visible from ground level but may have early signs of Ash Die-back.	No work required at this time. Monitor condition and watch for ADB infection.	C2	6.9
T18	Ash <i>Fraxinus excelsior</i>	11	380	N-3 S-3 E-5 W-3	3	SM	<10	P	Irregular crown with significant dead wood throughout and evidence of decline. Likely to have Ash Die-back based on the decline noted.	Removal and replacement recommended.	U	4.5
T19	Ash <i>Fraxinus excelsior</i>	10	245	N-4 S-2 E-3 W-5	4	SM	20	F	Irregular crown extending north and west. No structural faults visible from ground level	No works required at this time.	B2	2.9

T20	Ash <i>Fraxinus excelsior</i>	8	510gl	N-5 S-4 E-4 W-4	1	M	10	F	Irregular crown extending to the north. Minor ivy present on trunk. Some minor dead wood around the canopy extremities. No structural faults visible from ground level but may have early signs of Ash Die-back.	Monitor condition and watch for ADB infection.	C2	6.1

Tree No	Species	Ht (m)	Stem Diam mm@ 1.5m	Canopy Spread (m)	Height of Crown Clearance	Age Class	Est yrs	Overall Condition	Structural condition	Recommendations	BS 5837 Category	RPA Radius (m)
T21	Ash <i>Fraxinus excelsior</i>	7	155	N-2 S-2 E-1 W-2	2	Y	10	F	Ascending crown extending to the west due to crowding. No structural faults visible from ground level	No works required at this time.	C2	1.8
T22	Ash <i>Fraxinus excelsior</i>	7	230	N-3 S-3 E-4 W-2	2	SM	10	F	Irregular crown extending east. Dense ivy on the trunk. No structural faults visible from ground level	Removal of ivy growth recommended.	C2	2.7
T23	Ash <i>Fraxinus excelsior</i>	8	235	N-3 S-2 E-3 W-2	3	SM	10	F	Broadly ascending crown with some minor dead wood at canopy extremities. No structural faults visible from ground level	No works required at this time.	C2	2.8
G24	5 x Ash <i>Fraxinus excelsior</i>	6-8	<300	N-3 S-3 E-4 W-3	3	SM	<10	P	Line of crowded Ash.in hedgerow with significant die back present. Lile to have Ash Die-back infection based on the decline.	Removal and replacement recommended.	U	3.6
