Dilapidation Survey
Field Farm Barn, Main Street
Aunsby, Lincs.

June 2023

Stump Cross Associates Ltd

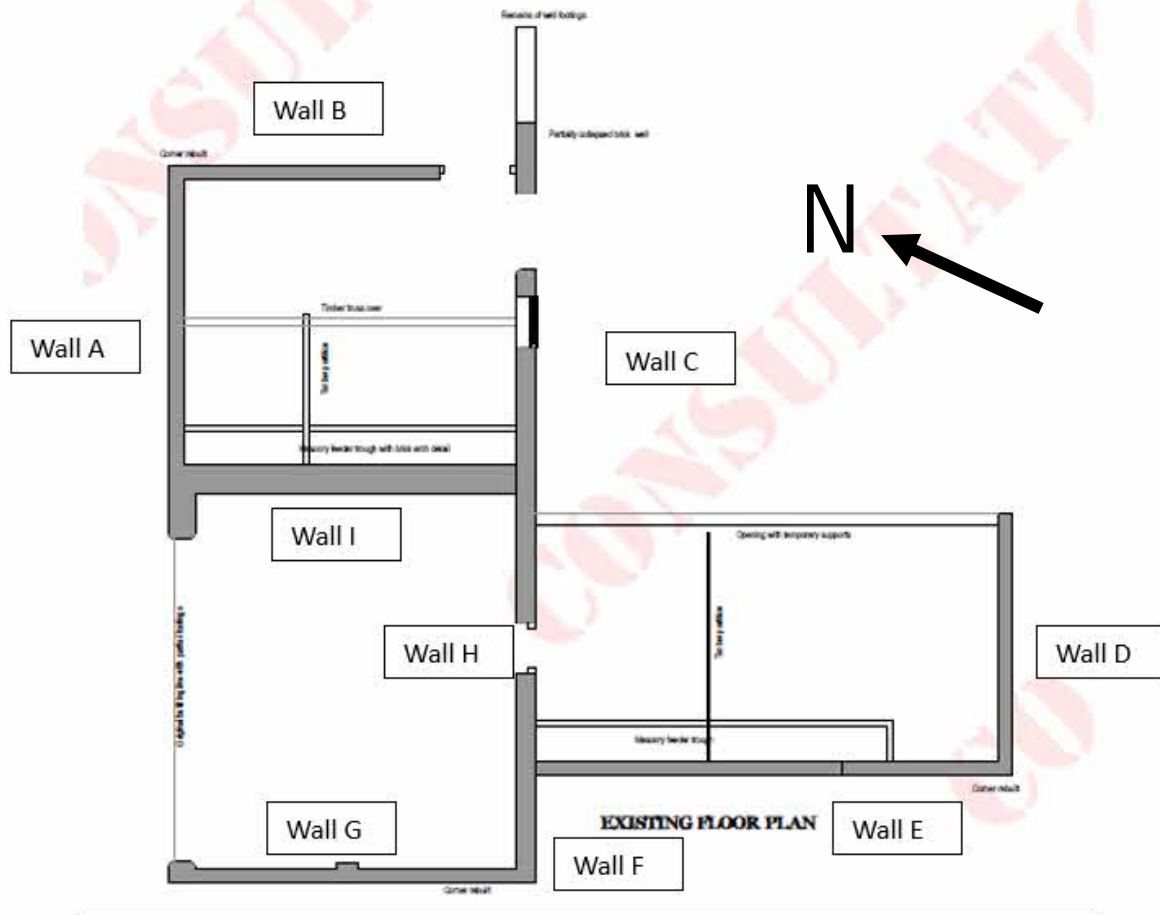
Wall Layout Reference Drg

The area bounded by Walls A, BC and I is referred to as the animal shelter

The area bounded by Walls D and E is referred to as the implement shed

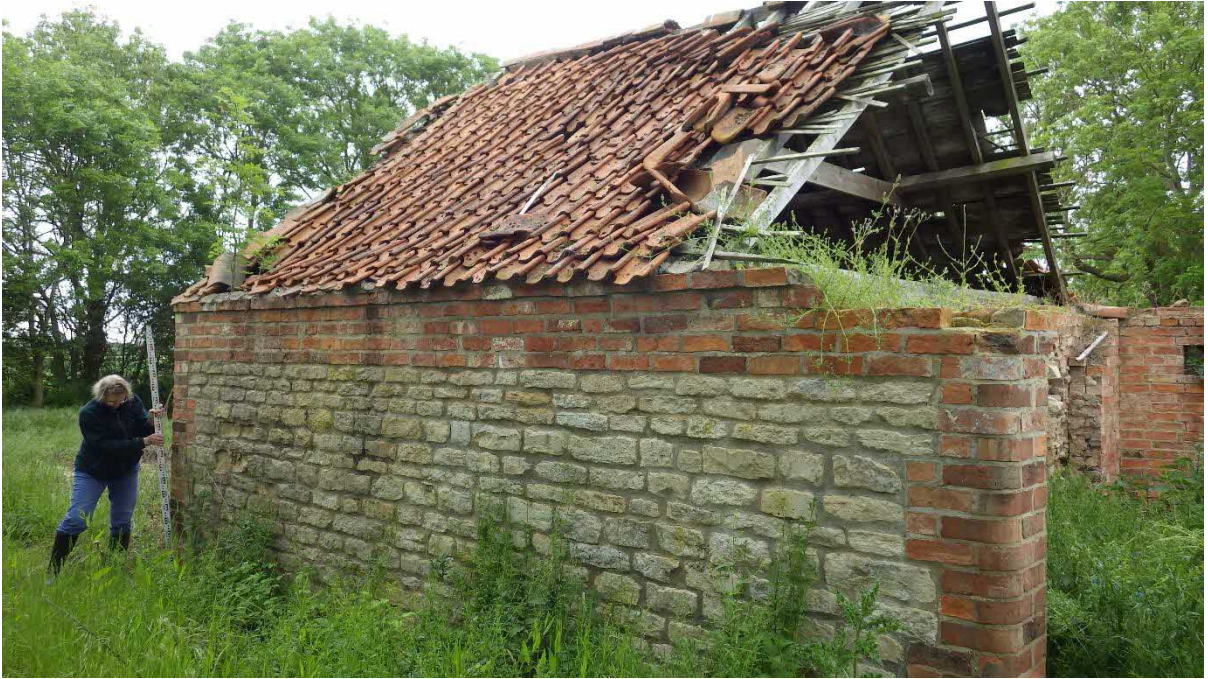
Photo 1

At the northern end, is a stone panel approximately 6.4m long, with a bullnosed brick pier to west end. Stonework approximately 1.7m high topped with 5 course brickwork. Condition is sound with recent pointing although stonework showing signs of spalling. (Photo 1)

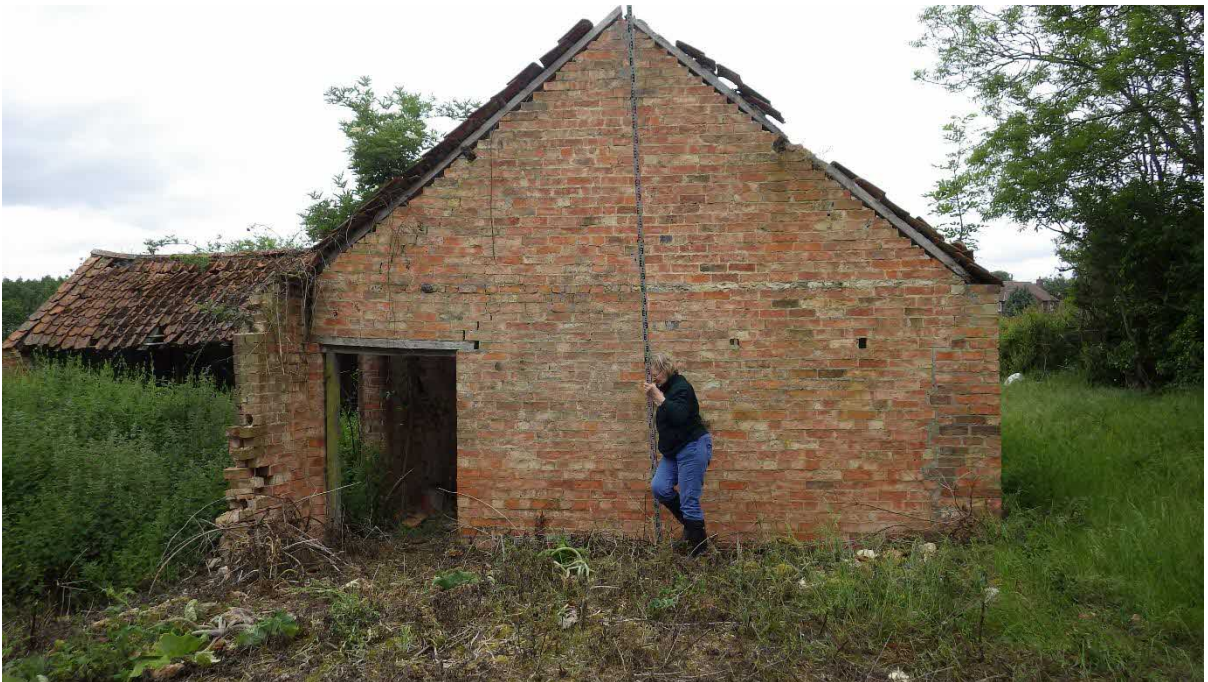
Photo 2

This gable wall is approximately 4.6m long and in poor condition. It has been rebuilt in NE corner, but is not bonded.

There is partial collapse on east corner by the opening. The opening lintol has dropped and there is cracking over door head extending high into the gable. (Photo 2 & 3)

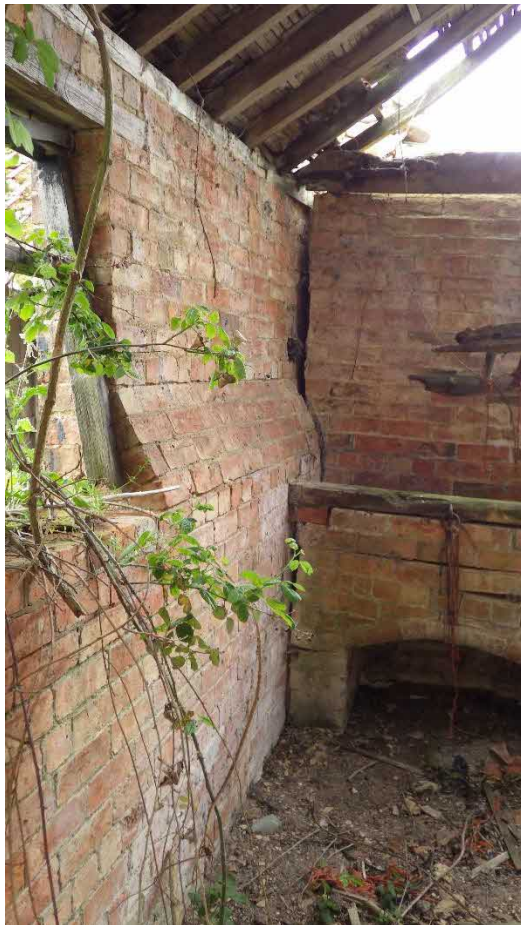
Photo 4

The wall is showing signs of rotation and is leaning outwards with loose brickwork to the head and eaves. (Photo 4)

The centre of this panel has settled and displays multiple cracking patterns and open joints. There is evidence of previous repair. (Photo 11)
Inside the animal shelter there is evidence of rotation of this wall (Photo 4 – taken viewing towards H beyond wall I)

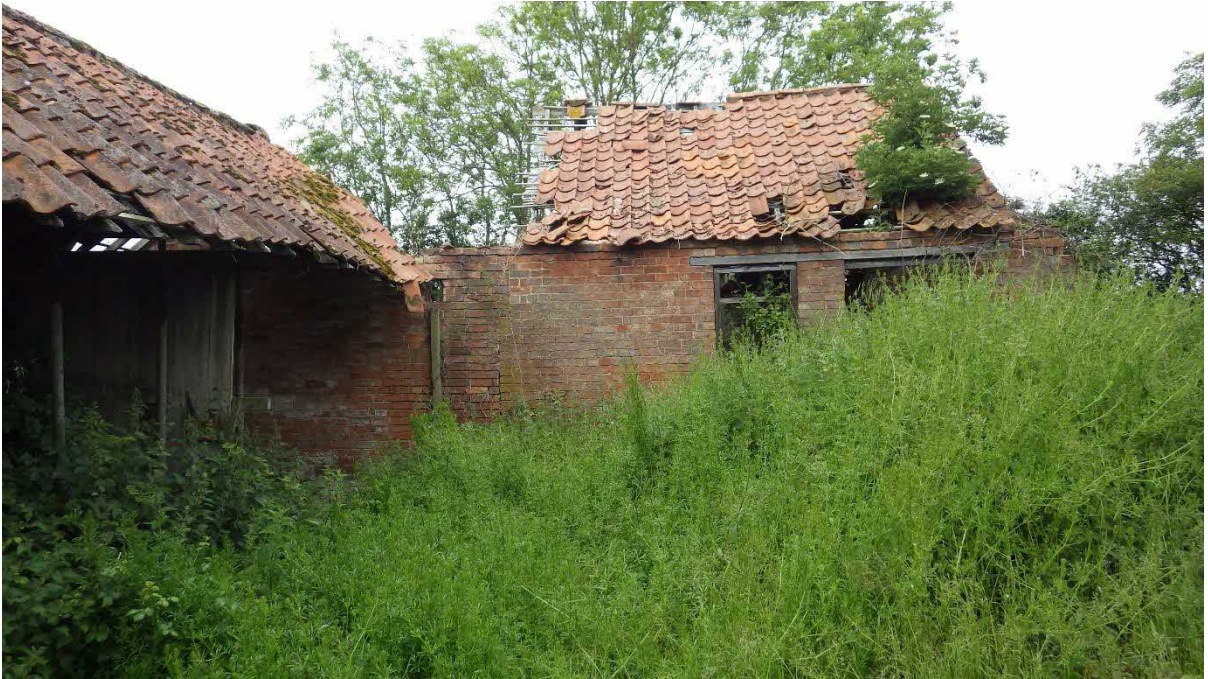
Photo 5

There is a small central panel brickwork which appears sound but has a straight joint abutting the older brickwork. (Photo 5)

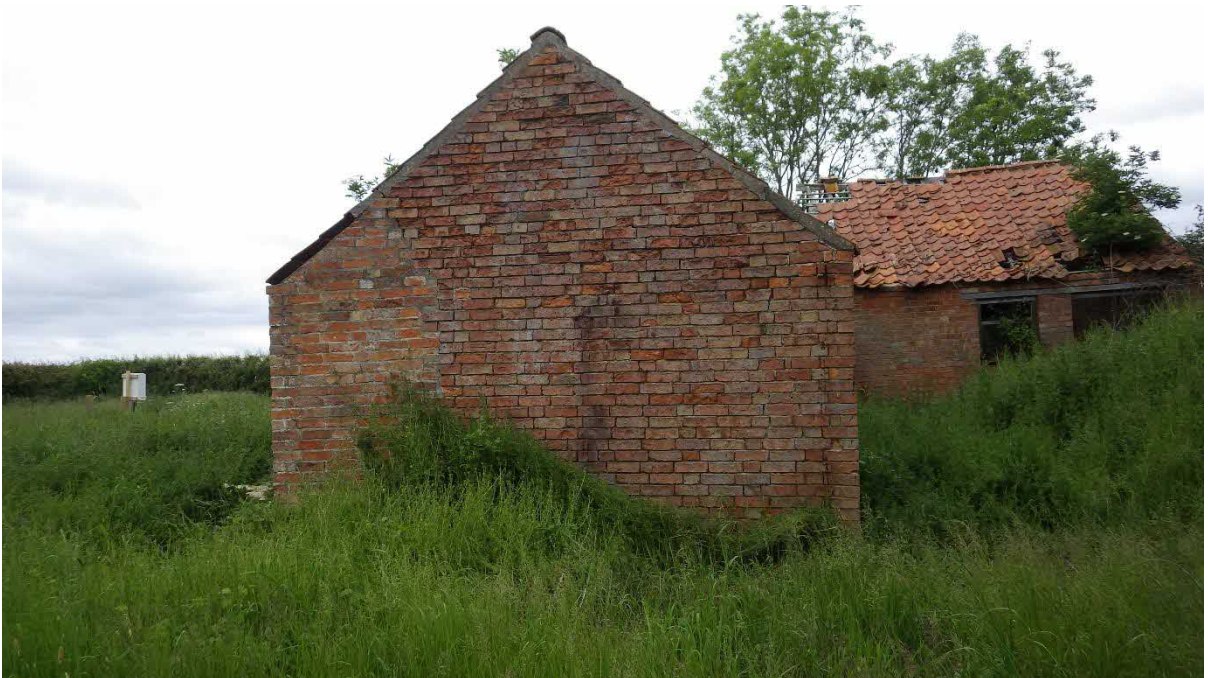
Photo 6

This is the gable wall to the implement store. The brickwork in poor condition with major spalling and frost damage across the panel. (Photo 6)

There is evidence of settlement cracks which have been repointed and are now opening further.

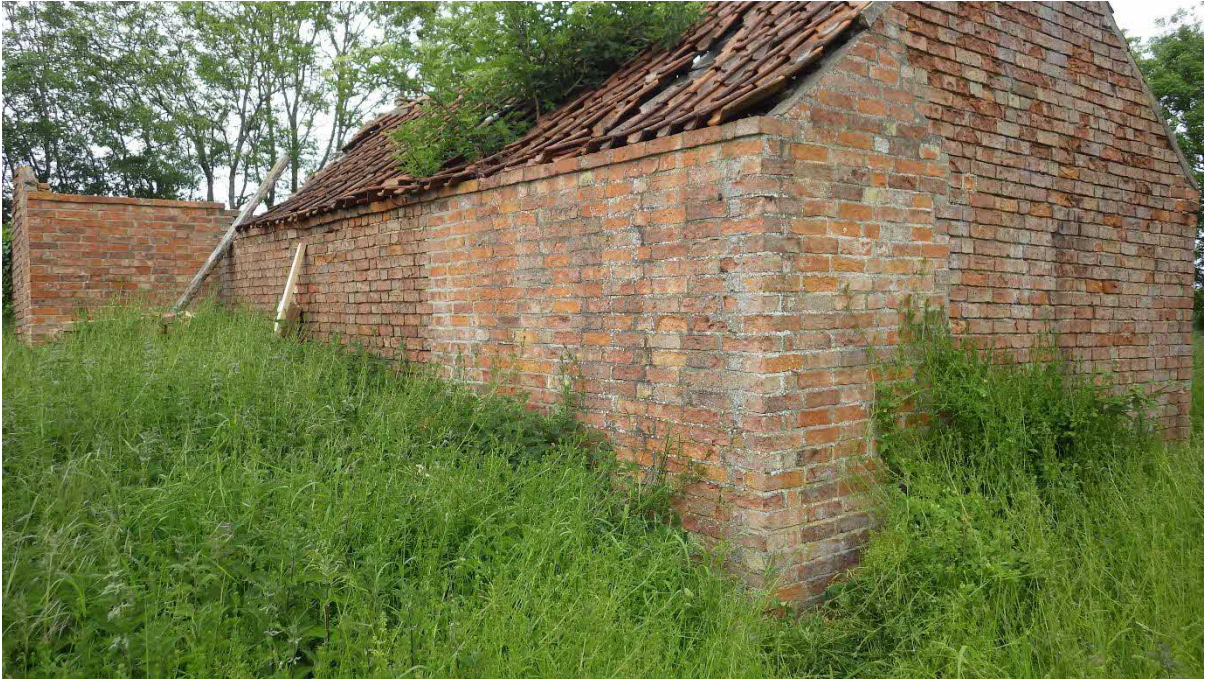
Photo 7

The west end of the gable has significant settlement. There has been a major rebuild which is poorly jointed, unbonded and horizontally out of true level. (Photo 7)

The rear face of implement shed is approximately 7.7m long. The south corner has been rebuilt, but brickwork in very poor condition, spalling and significant evidence of repointing with several mortar mix/colours visible. (Photo 7 & 8)

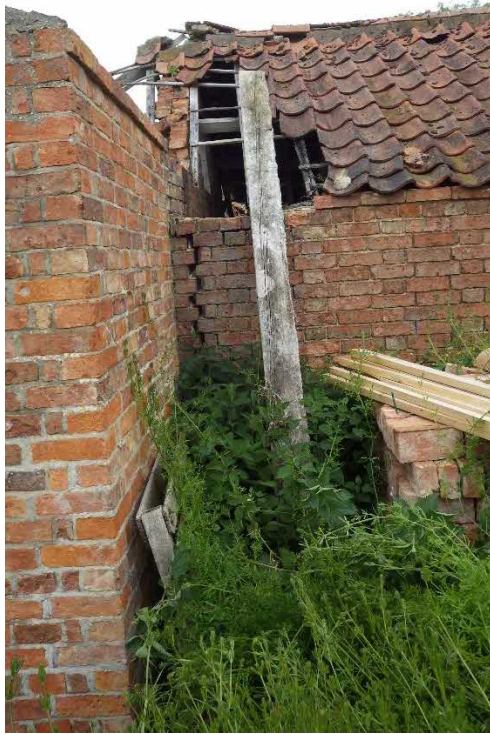
Photo 9

The western end of this wall is straight jointed to the perpendicular wall and shows signs of further settlement in the corner with significant joint opening – circa 20-25mm. (Photo 9)

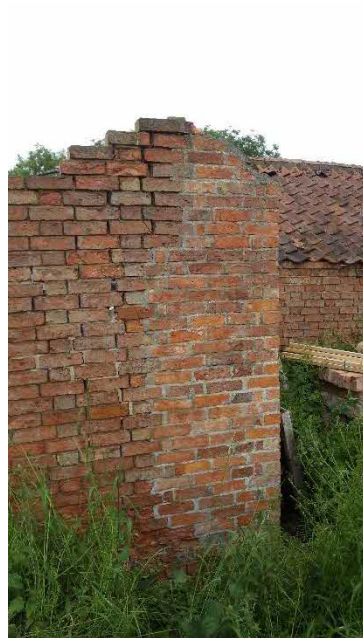
Photo 10

The northern return of this panel from the return has been rebuilt but again shows settlement and out of level brick coursing. (Photo 10)

The area further to the north side is of poor quality brickwork, with spalling, and it is partially collapsed across the panel until it meets the northern return. (Photo 10)

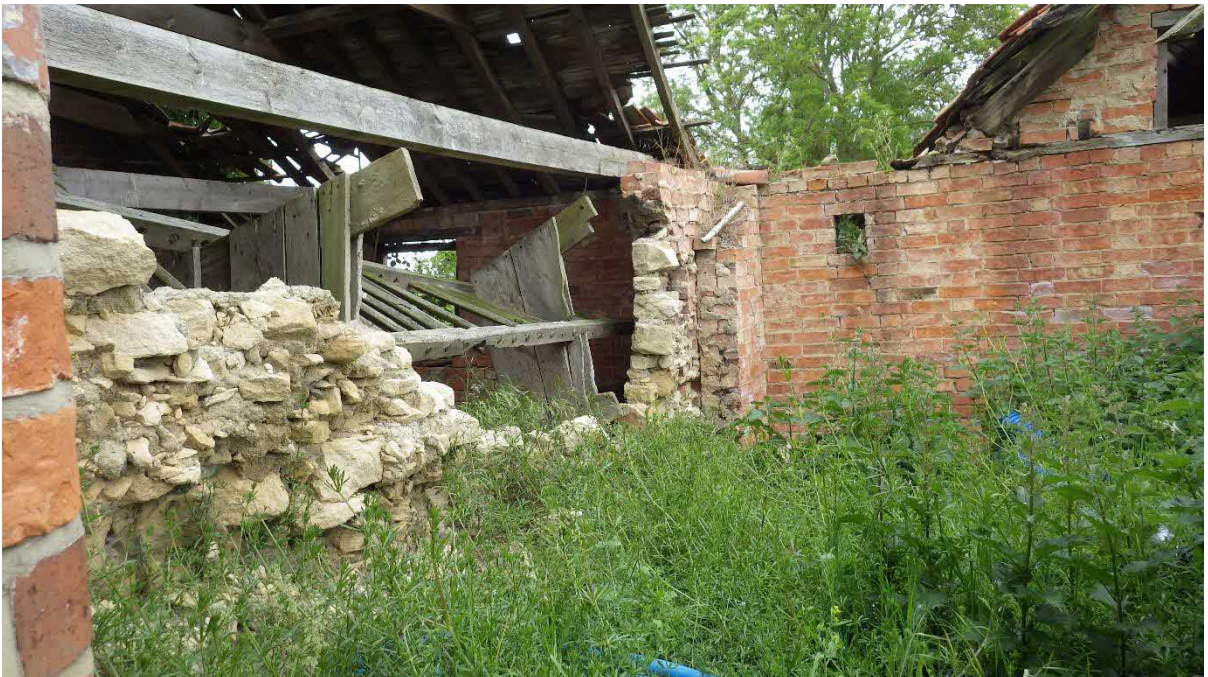
Photo 12

This internal return wall is partially collapsed stonework. (Photo 12)
Inside there are brick stalls showing major joint movement.

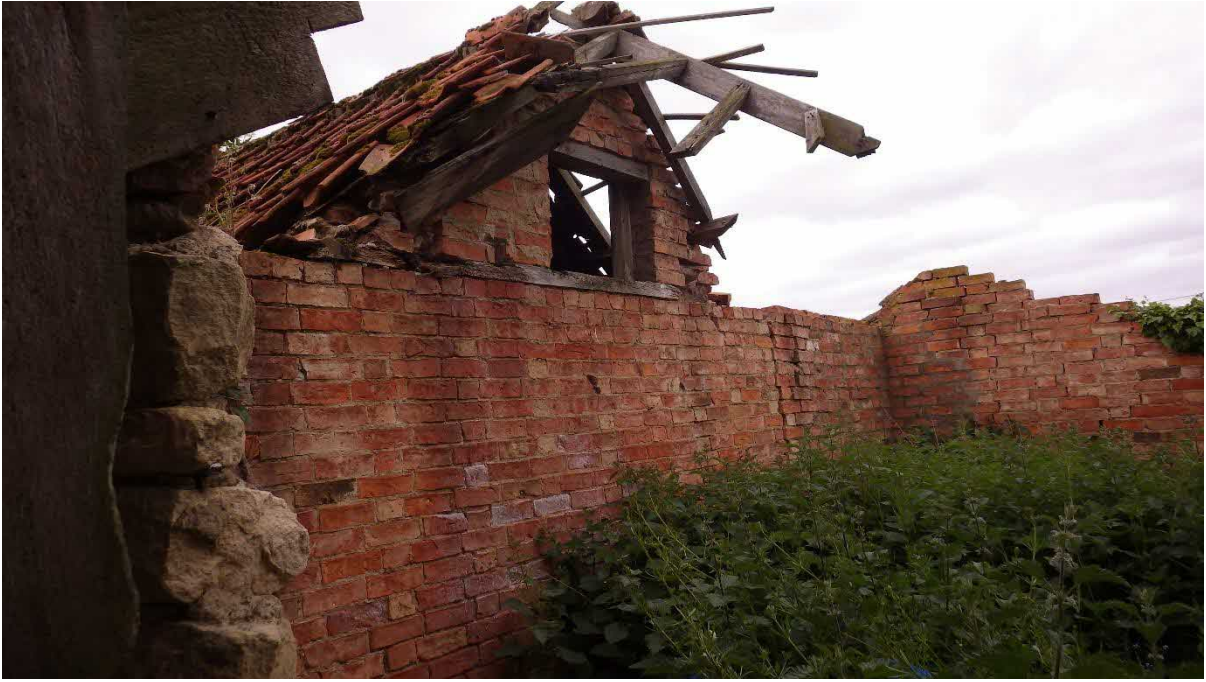
Photo 13

5.1 The roof structure is in extremely poor condition and generally unsafe.

It has partially collapsed over the animal shelter

The implement store is open fronted but the roof is only been prevented from collapse by the acrow props strategically placed internally. These are now leaning due to further settlement.

Timber work is generally weathered and rotted having been exposed to the elements for some considerable time. (Photo 13)

Main timbers and lintols additionally show signs of infestation.

The roof is clearly beyond repair and will require full refurbishment. It may be possible to reuse some of the clay pantiles although it is unclear if there would be sufficient number for economic reuse.

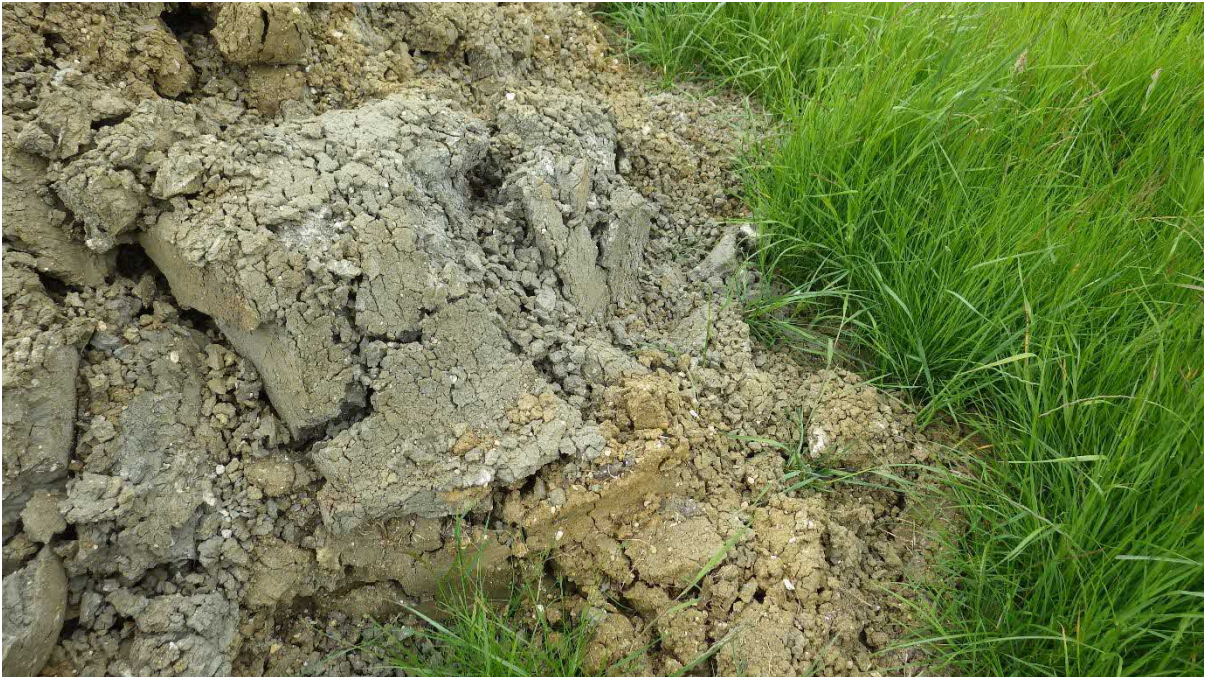
Photo 14

6.1 A trial hole has been excavated to the west of the site and is left open. This shows the following: (Photo 14)

The arisings from the trial hole show stiff grey clay below the top soil.

The ground conditions are stiff grey clay which can desiccate in dry weather and soften when saturated.
