Site Investigation Report

145038.1.USI

Client	Crawford & Co
Client ref	SU2203656
Visit date	06/03/2023
Report date	18/04/2023

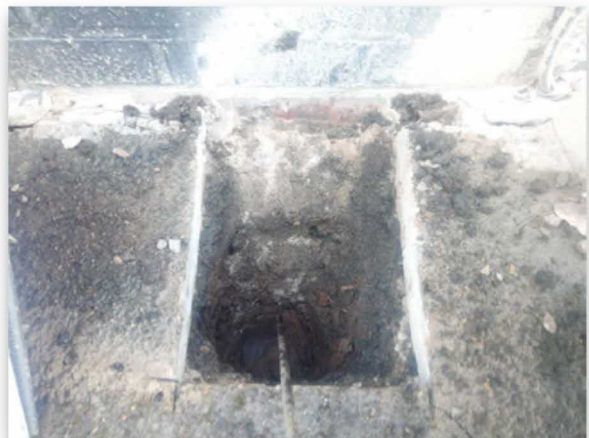
Fig 12: Trial Hole 1 Footing

Within Trial hole 1 we revealed the footing but were unable to auger to the required depth (3m) in the proposed location. This was due to a solid obstruction we encountered at 1.6m below ground level, therefore we carried out a remote borehole in the grass area closest to TH1 in which we achieved a depth of 3.0m. We took soil and root samples. These measurements are shown in Trial hole log 1 below. In TH1, water was encountered at 1.6m below ground level.

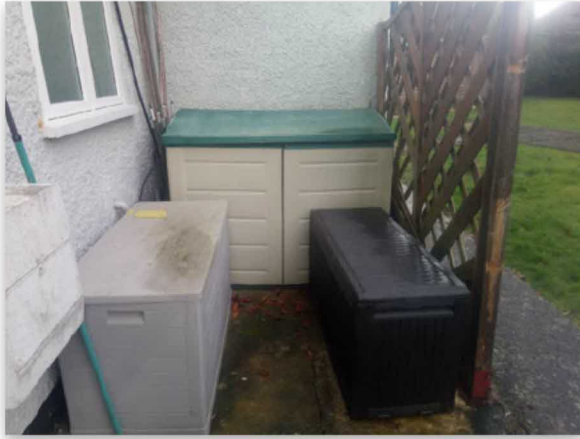
Please note: RWG1 was surveyed down to what is believed to be a manhole, however as shown in figure 3.1 we were unable to access the manhole. If the loss adjuster wishes for us to survey any drainage from the manhole it will require the customer to move these boxes. We will await the loss adjusters further instructions.

Fig 3.1: Storage boxes preventing access to MH

We will now refer the claim back to the client in order to progress the claim.
