# Arboricultural Appraisal Report

## Subsidence Damage Investigation at:

15 Rowan Avenue  
York  
YO32 4AT

CLIENT:	Crawford & Company
CLIENT REF:	SU2203656
MWA REF:	SUB230504-12983
MWA CONSULTANT:	Mark Johnson (FdSc; MArborA)
REPORT DATE:	22/05/2023

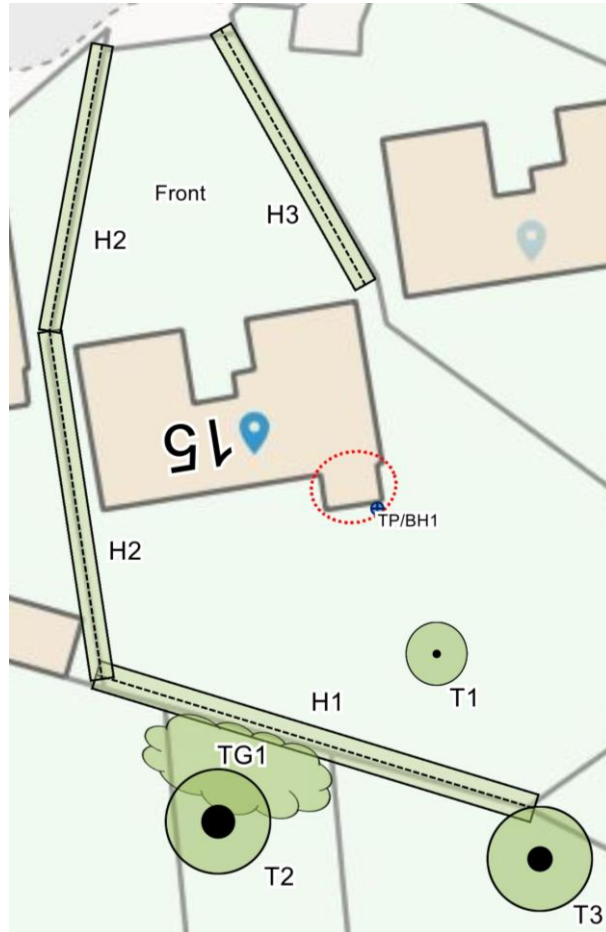
Site Plan

Approximate areas of damage

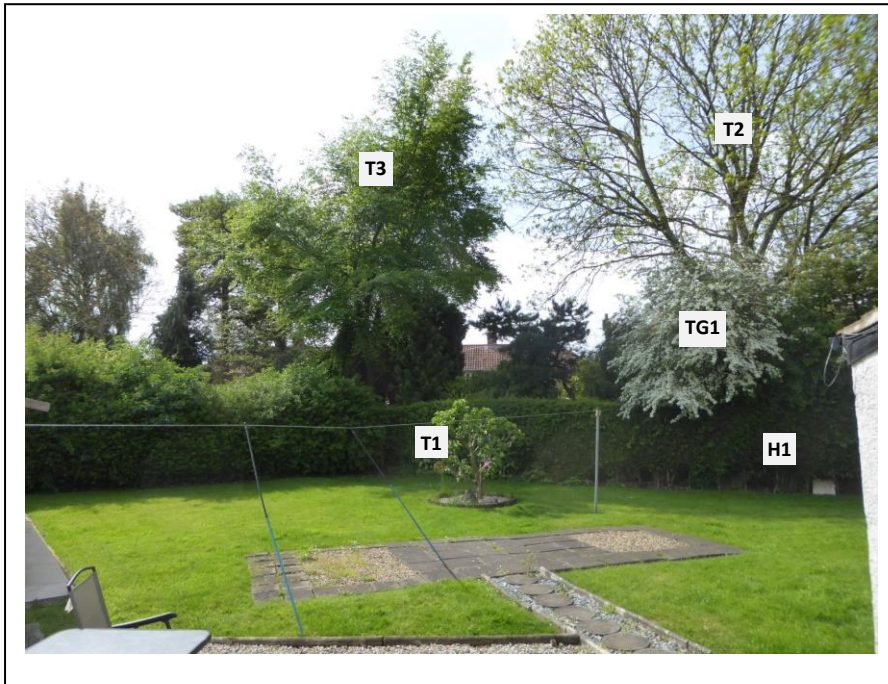
Roots were observed to a depth of 1000mm bgl in TP/BH1 and recovered samples have been positively identified (using anatomical analysis) as *Fraxinus* spp., the origin of which will be T2 (Ash) confirming its influence on the soils below the foundations.

Based on the technical reports currently available, engineering opinion and our own site assessment we conclude the damage is consistent with shrinkage of the clay subsoil related to moisture abstraction by vegetation. Having considered the information currently available, it is our opinion that T2 is the principal cause of the current subsidence damage.

View of T3, T1, TG1, T2 and H1

If an arboricultural solution is to be implemented to mitigate the influence of the implicated trees/vegetation we recommend that T2 is removed. Other vegetation recorded presents a potential future risk to building stability and management is therefore recommended.

Tree No.	Species	Ht (m)	Dia (mm)	Crown Spread (m)	Dist. to building (m)	Age Classification	Ownership
T2	Ash	16 *	450 *	14 *	15 *	Younger than Property	Policy Holder located at 5 Cherry Tree Avenue YO32 4AR
Management history		No significant recent management noted.					
Recommendation		Remove (fell) to near ground level and treat stump to inhibit regrowth.

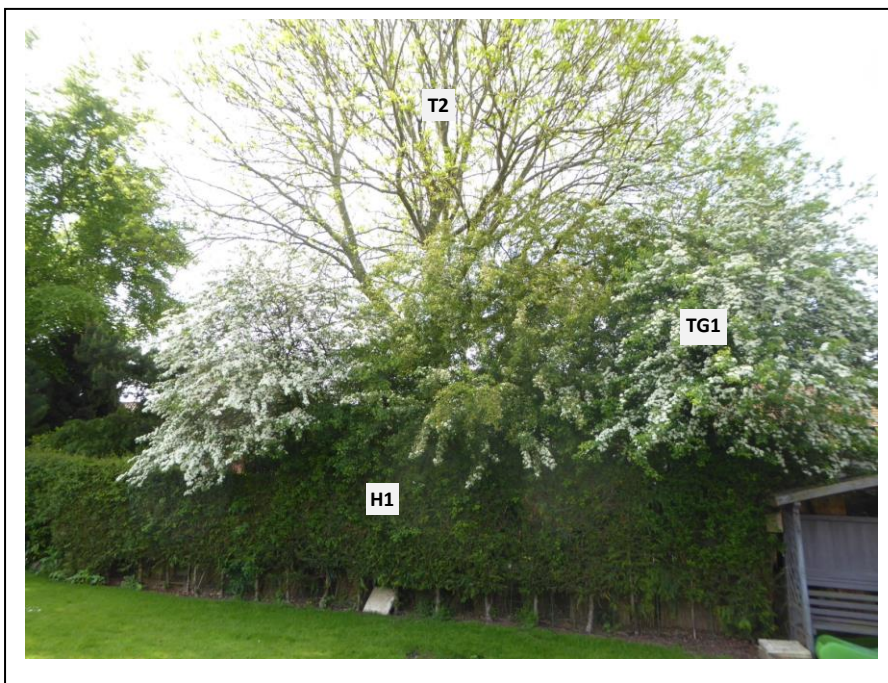
View of H1, T2, and TG1

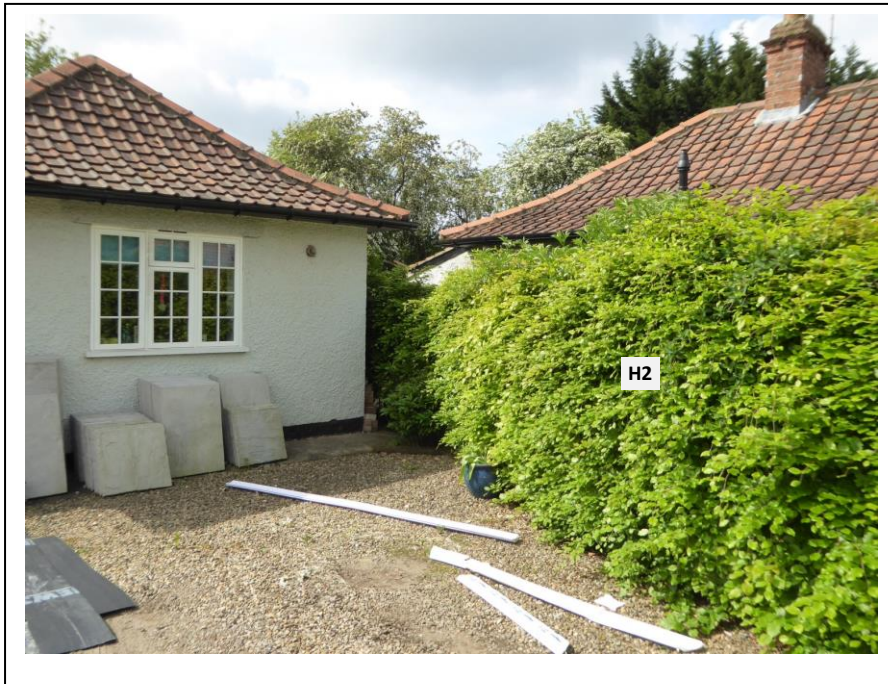
Tree No.	Species	Ht (m)	Dia (mm)	Crown Spread (m)	Dist. to building (m)	Age Classification	Ownership
H2	Privet, Elder, Lilac, Beech	2.5	Ms	40 *	2	Younger than Property	Policy Holder located at Policy Holder and/or 17 Rowan Avenue YO32 4AT
Management history		Subject to past management/pruning - appears regularly trimmed.					
Recommendation		Maintain broadly at no more than current dimensions by periodic pruning.					
H3	Privet, Elder, Beech	2	Ms	14 *	1.5	Younger than Property	Policy Holder
Management history		Subject to past management/pruning - appears regularly trimmed.					
Recommendation		Maintain broadly at no more than current dimensions by periodic pruning.

View of H2
