2021 8589

The Grain Store, Boggarts House Farm

Structural Report

Date of Report: 13/07/2022

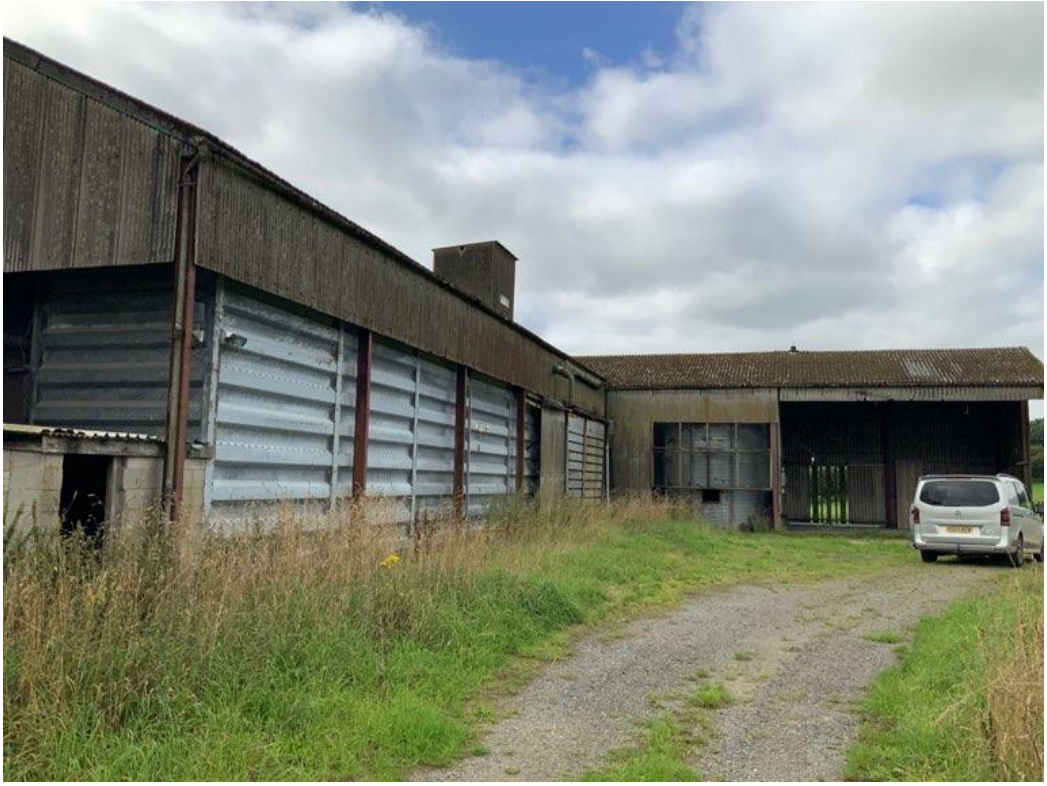
No	6.1
Location	Front Elevation
Description	General view front of building. The building is L-shaped on plan and the elevations are referenced to the left or right wing of the plan shape.
Photograph

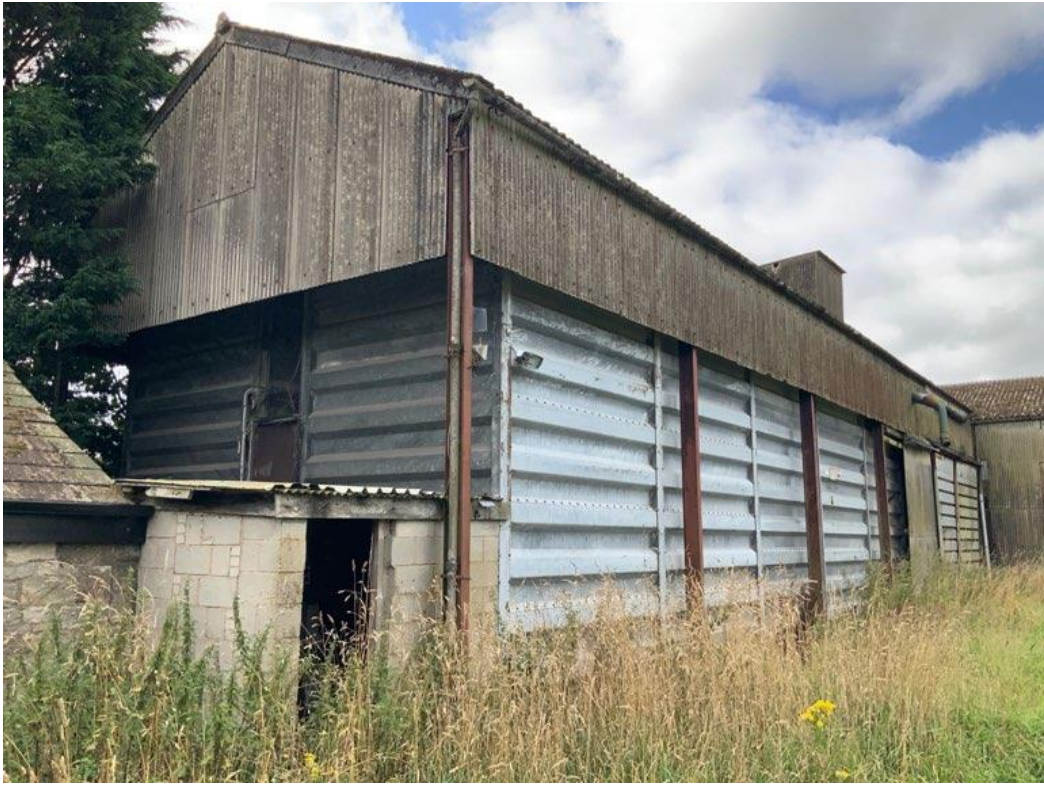
No	6.2
Location	Left Wing
Description	<p>Left wing of building consists of a steel frame with columns supporting steel trusses. The elevations to the front and left of the left wing are partially clad.</p> <p>The cladding appears likely to be asbestos-based cement panels.</p> <p>The steel grain silos within the building are independent of the steel frame and do not form part of the building structure.</p>
Photograph

It is assumed that the existing cement based profile sheet is likely to be replaced as it is likely to contain asbestos.

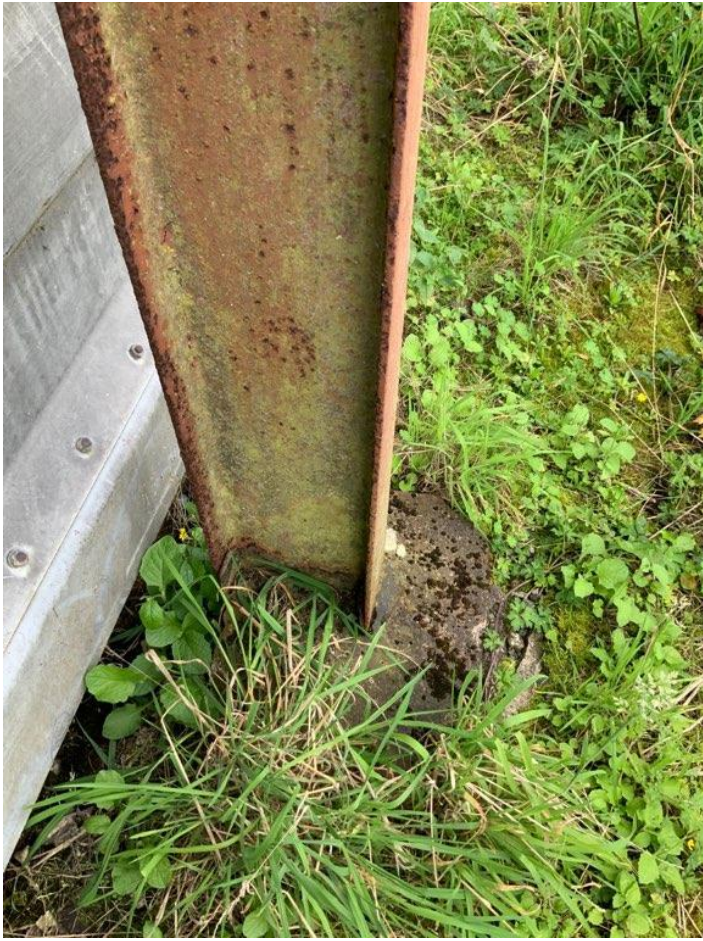
No	6.3
Location	Left Wing
Description	<p>The steel columns to the left wing have minor surface corrosion. The columns generally appear to be in reasonable condition.</p> <p>At the column bases the corrosion is more advanced to a number of the columns.</p> <p>The base of the columns has been encased in concrete.</p>
Photograph

There is more advanced and significant corrosion to the lower sections of a number of the existing columns and localised repairs will be required to these columns

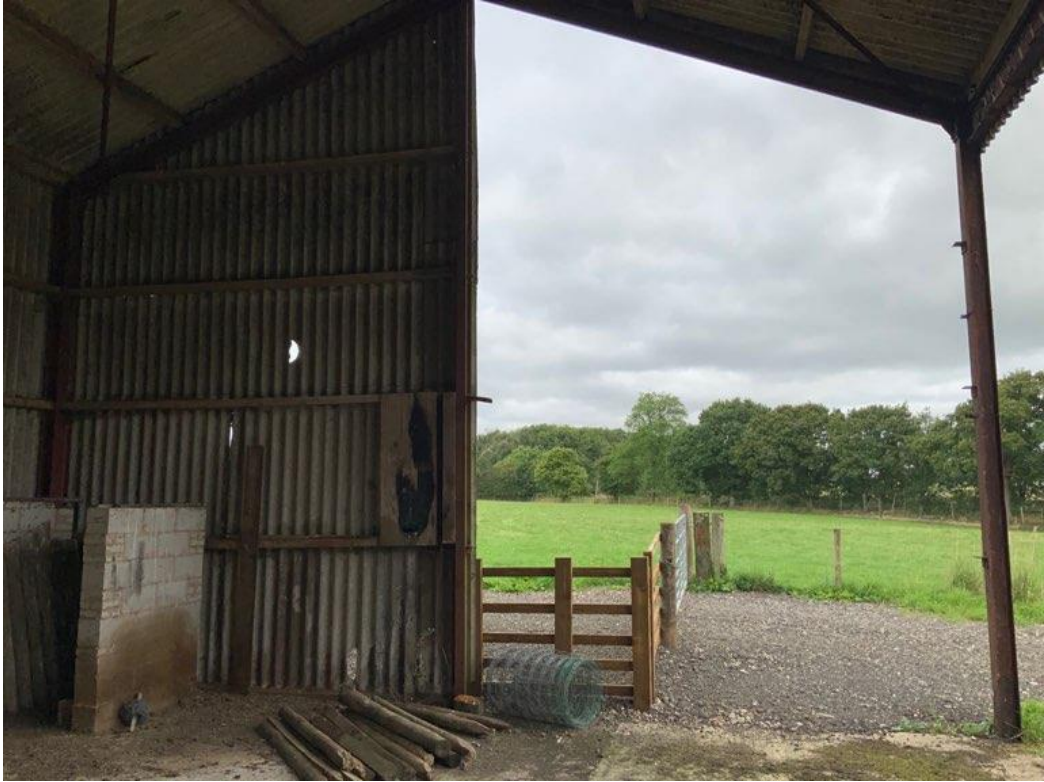
No	6.4
Location	Right Wing
Description	<p>The right wing of the building is an open steel frame.</p> <p>The structure formed with a gable frame supporting long span roof ridge beam and front elevation eaves beam.</p> <p>This differs in arrangement to the left wing as there are no steel roof trusses.</p>
Photograph

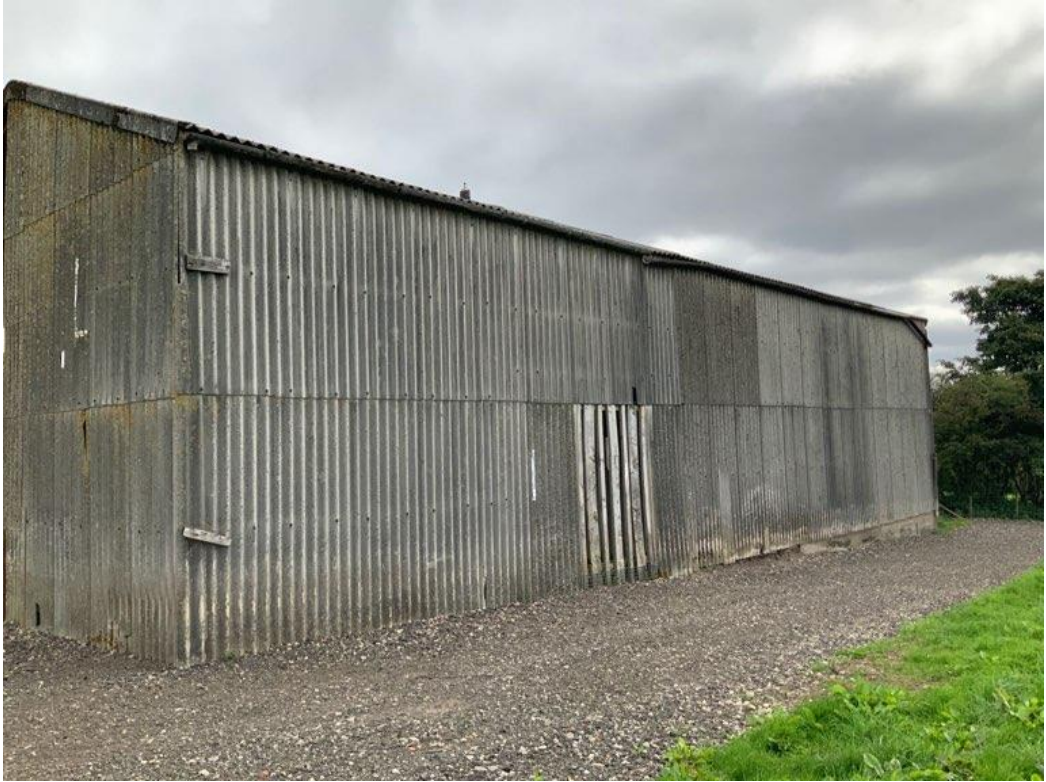
No	6.5
Location	Right wing rear elevation
Description	<p>General view of the rear elevation of right wing.</p> <p>The elevation is fully clad.</p> <p>Note the external ground level reduces to the rear left corner of the building.</p>
Photograph

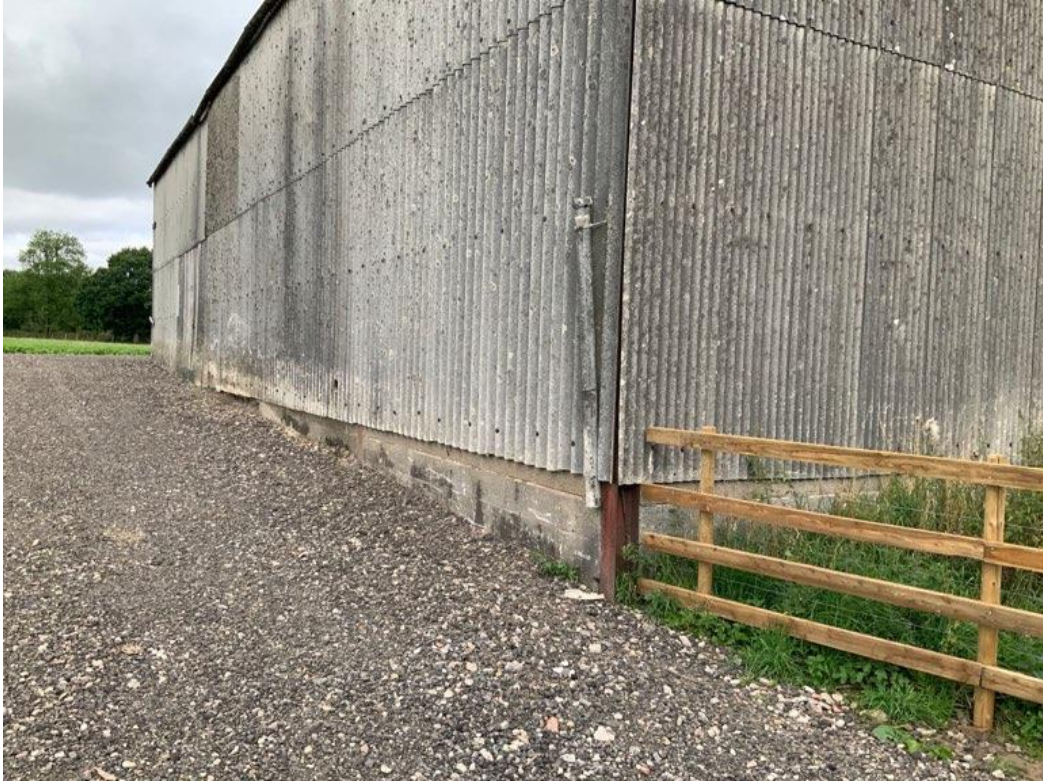
No	6.6
Location	Right wing rear elevation
Description	<p>To be left end of the building at the junction of the right and left wing rear elevations the external ground level is around 450mm to 600mm lower than the internal floor level.</p> <p>The visible low level block work appears likely to act as a retaining wall to the hardcore/substrate below the floor slab.</p>
Photograph

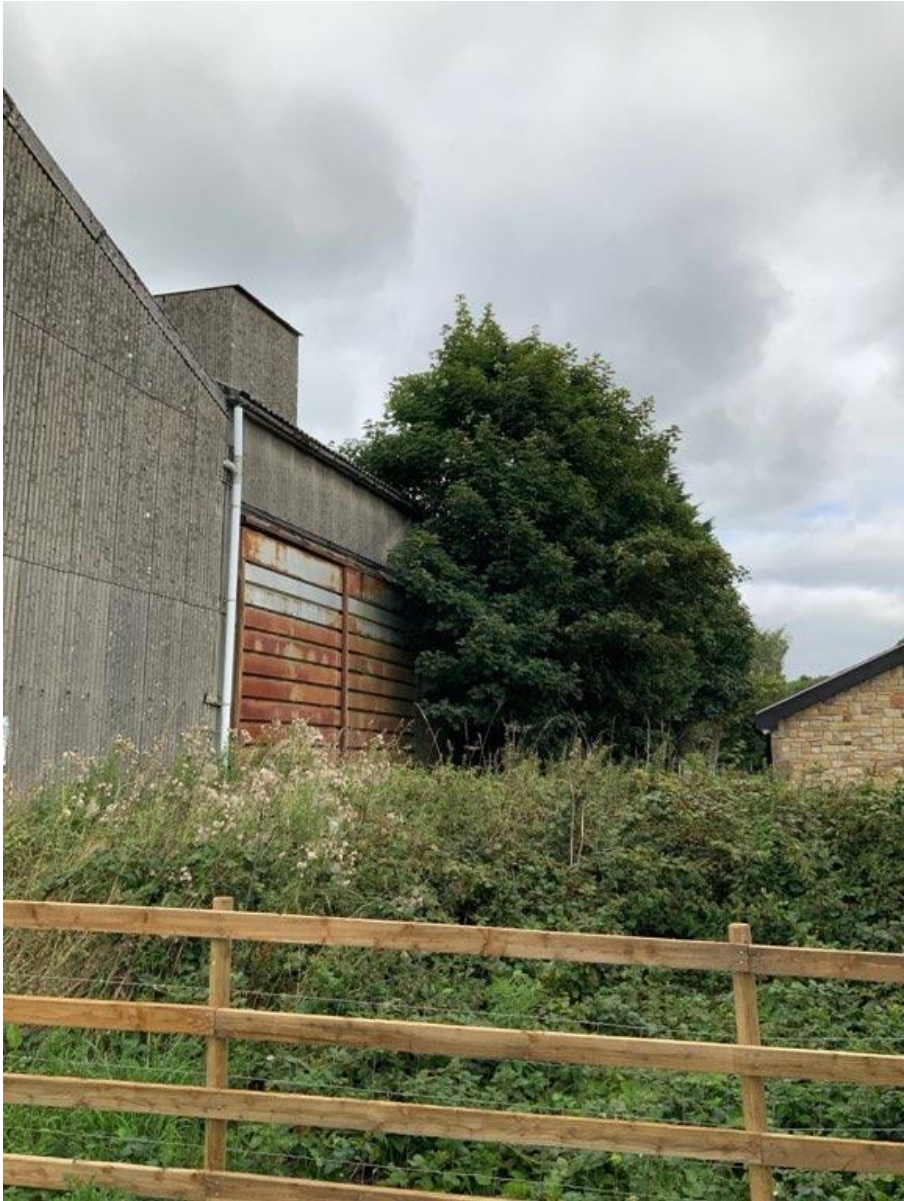
No	6.7
Location	Left wing rear elevation
Description	<p>The rear elevation of the left wing is partially clad to the left end and fully clad where the elevation adjoins the right wing.</p> <p>There are a number of trees in close proximity to the elevation.</p>
Photograph

There is a likelihood that clay may exist on site and if present an assessment of risk due to seasonal clay volume change will be required. This will also need to consider the impact of vegetation and trees.

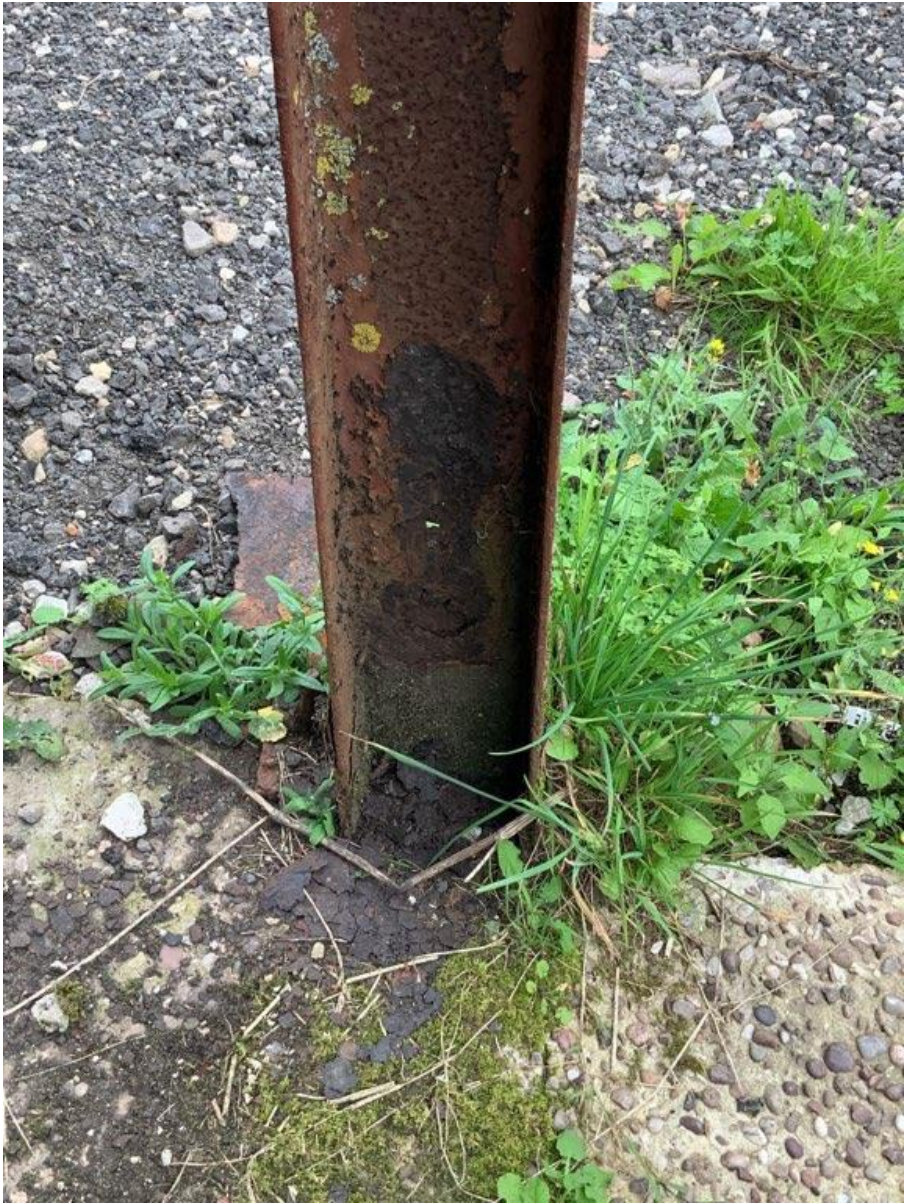
No	6.8
Location	Right wing front elevation
Description	There is significant corrosion evident to the to the column to the right front corner. Corrosion has affected the full thickness of the column web.
Photograph

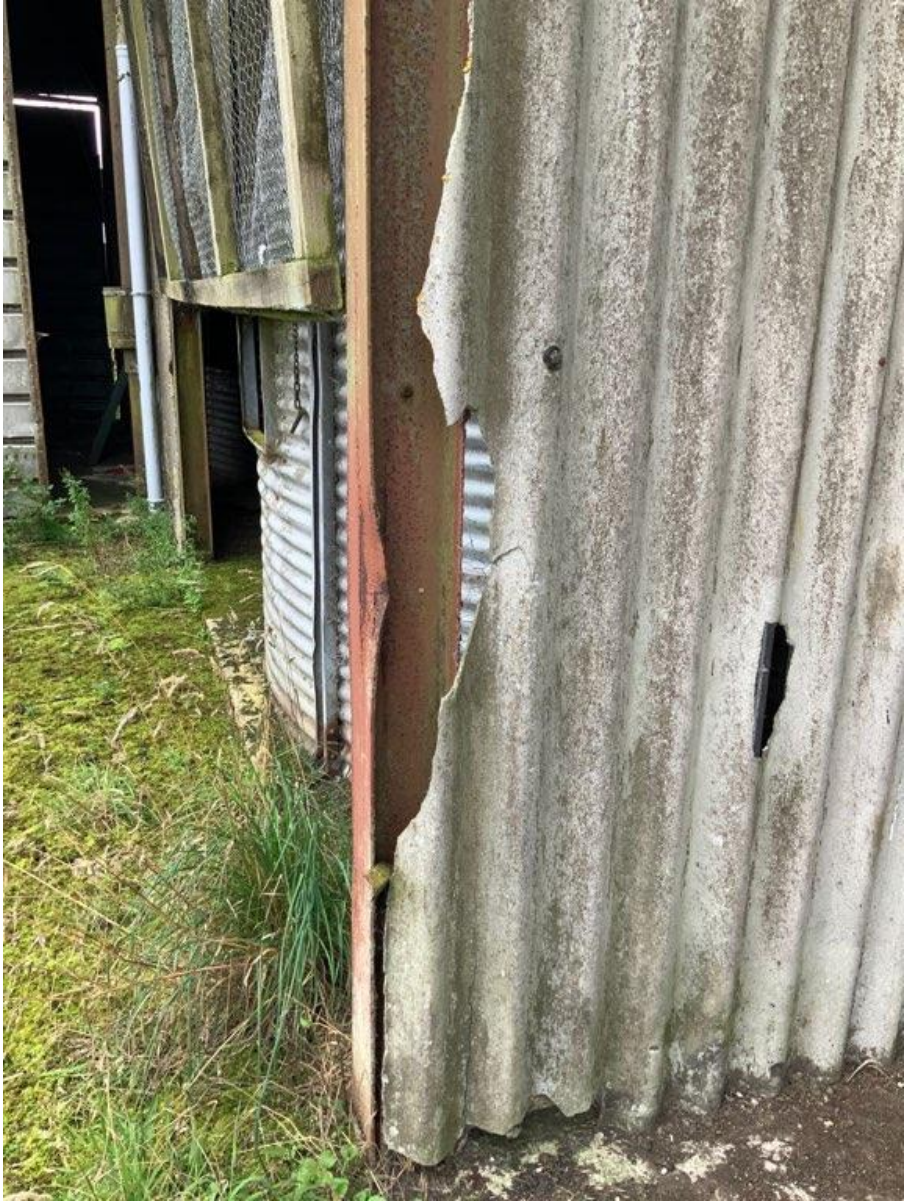
No	6.9
Location	Right wing front elevation
Description	Minor impact damage to the column midway along the right wing front elevation.
Photograph

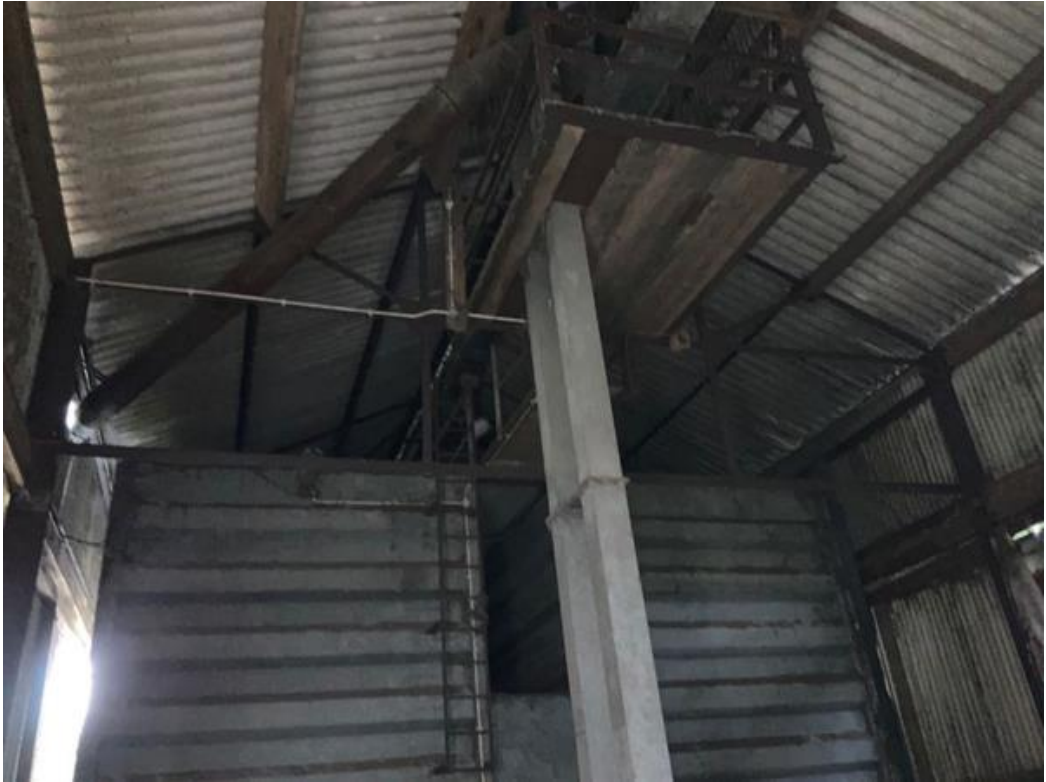
No	6.10
Location	Left wing ground floor
Description	Typical internal view showing steel roof truss supporting timber roof purlins
Photograph
