JF/B2089

1st November 2022

**RE: BARN 2, MINNIS FARM, OFF MINNIS WAY, WORTH, DEAL, KENT CT14
0DQ - STRUCTURAL REPORT FOLLOWING INSPECTION OF BUILDING**

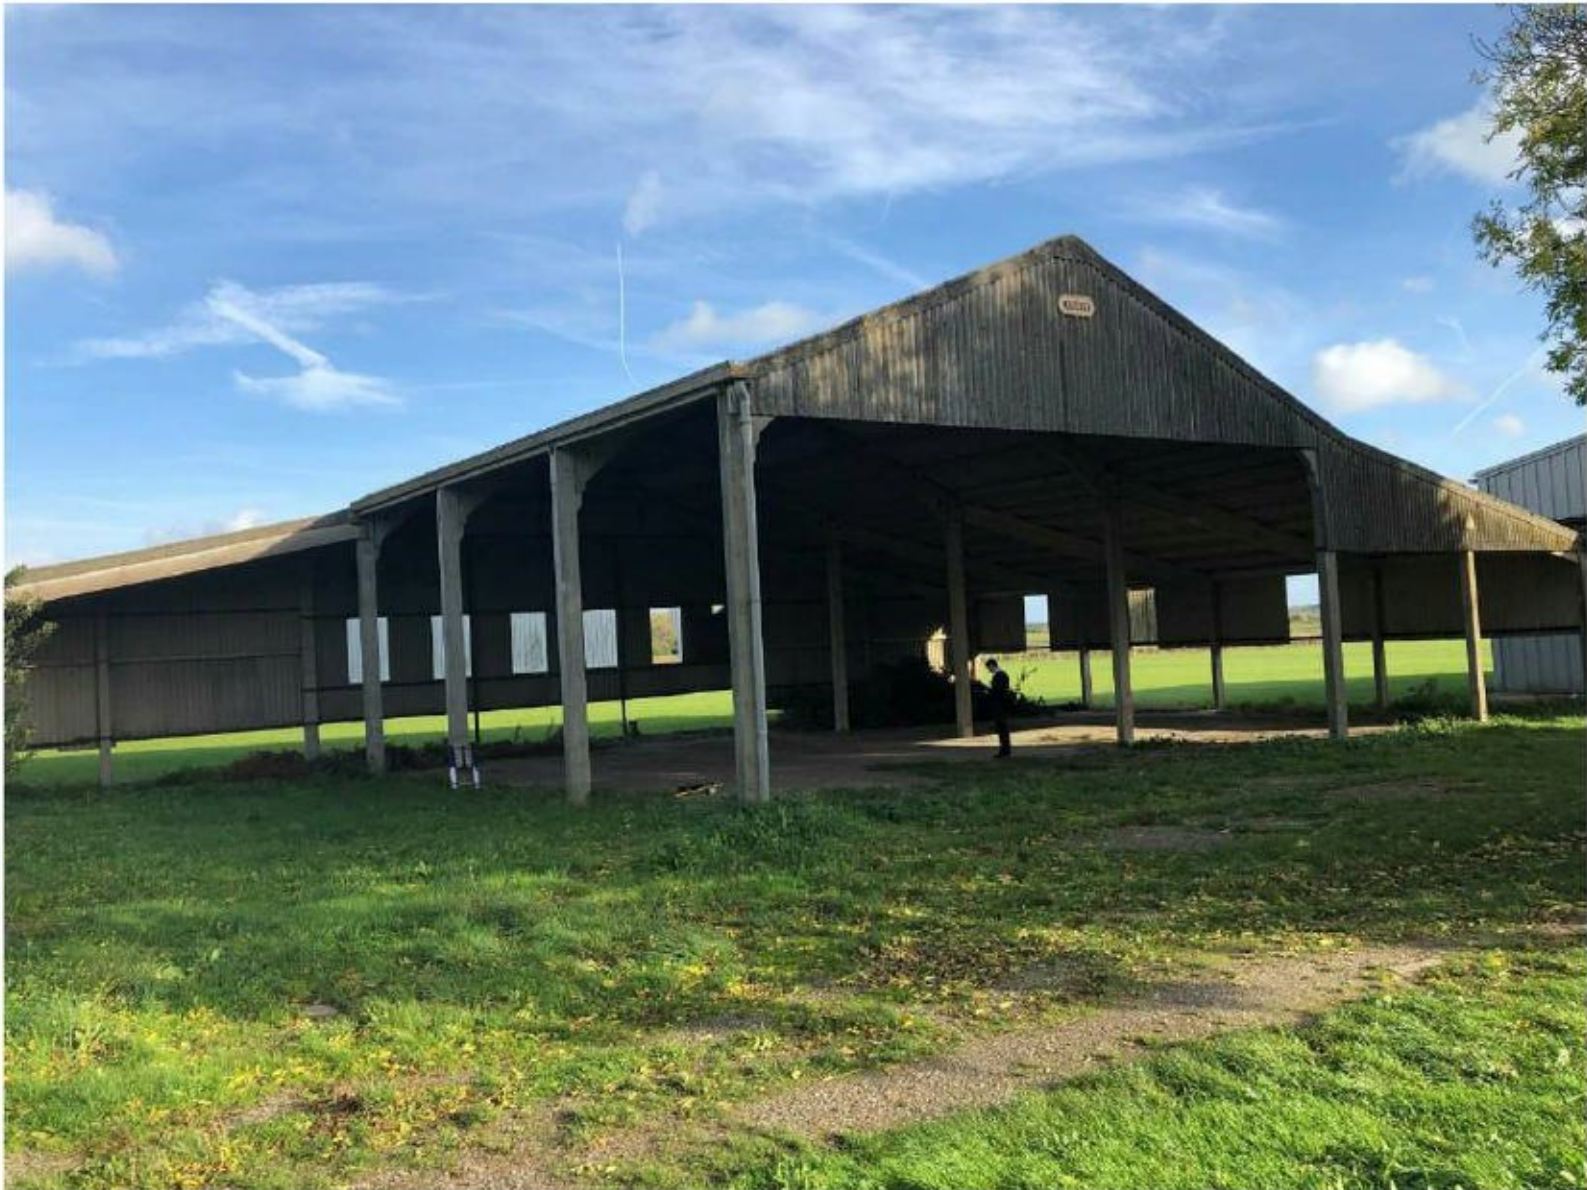
View on front of barn from north west

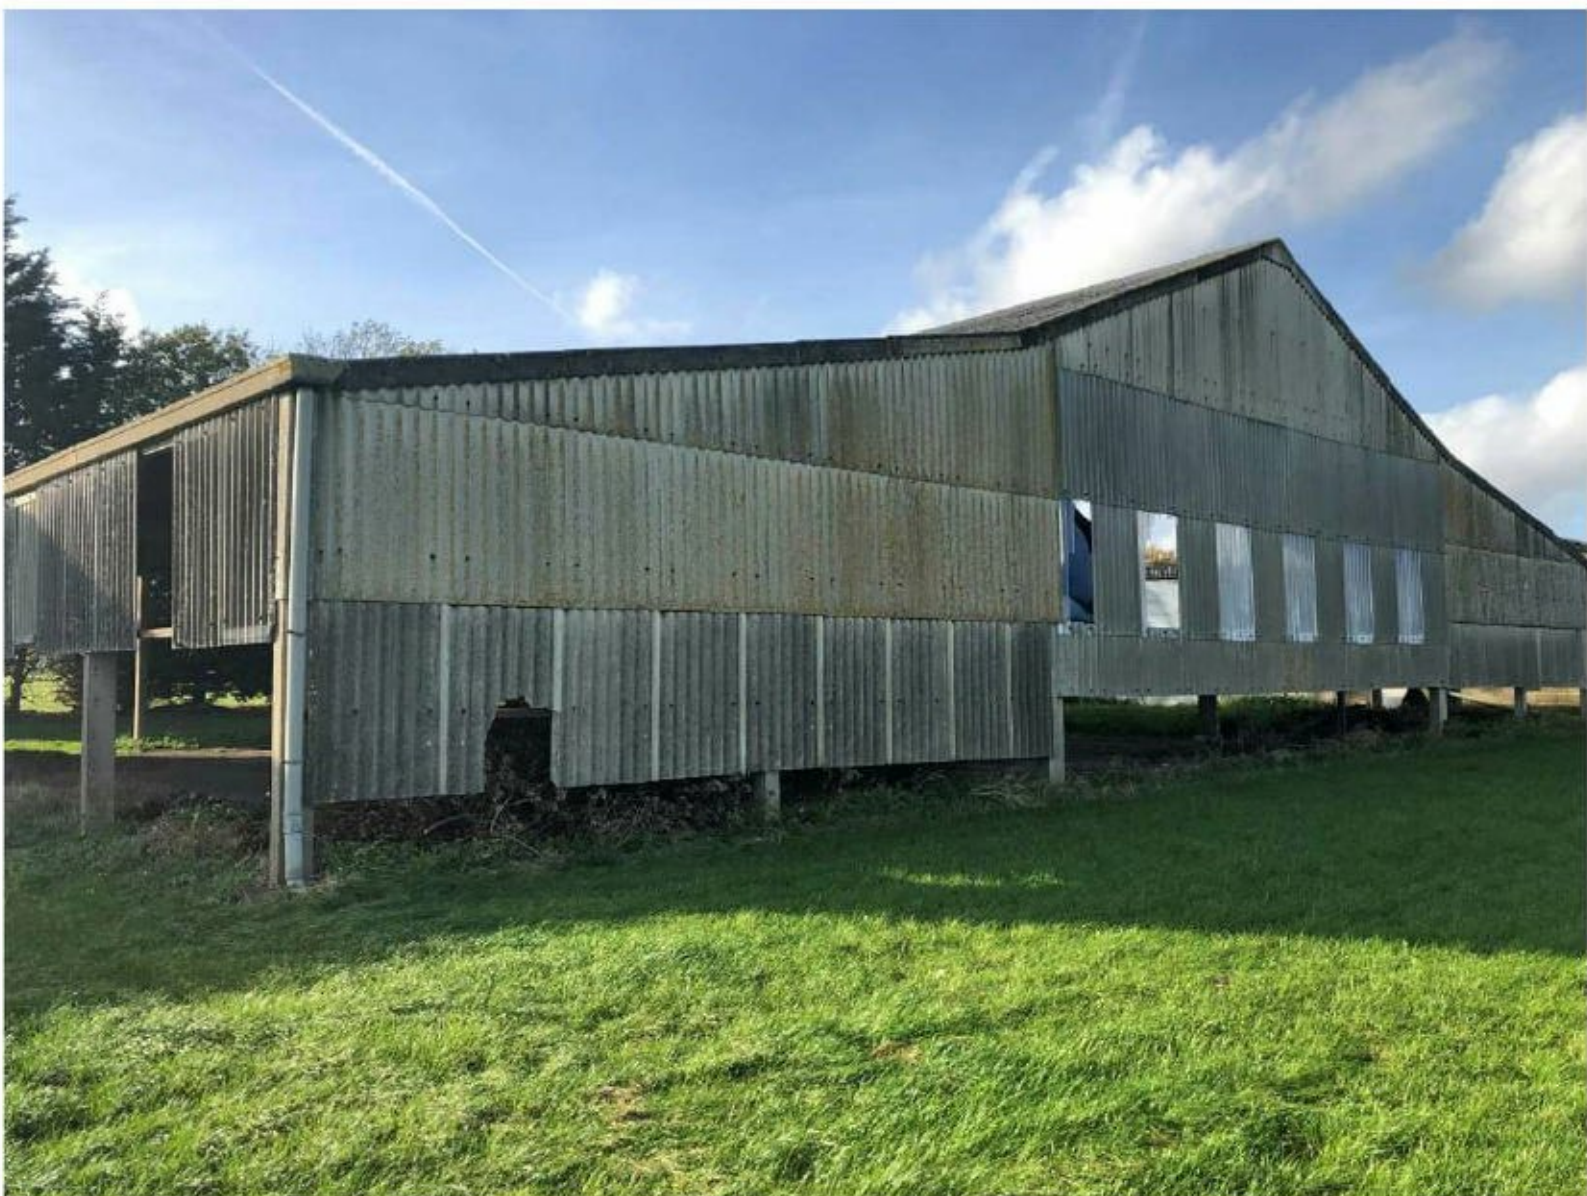
View on rear of barn from south east

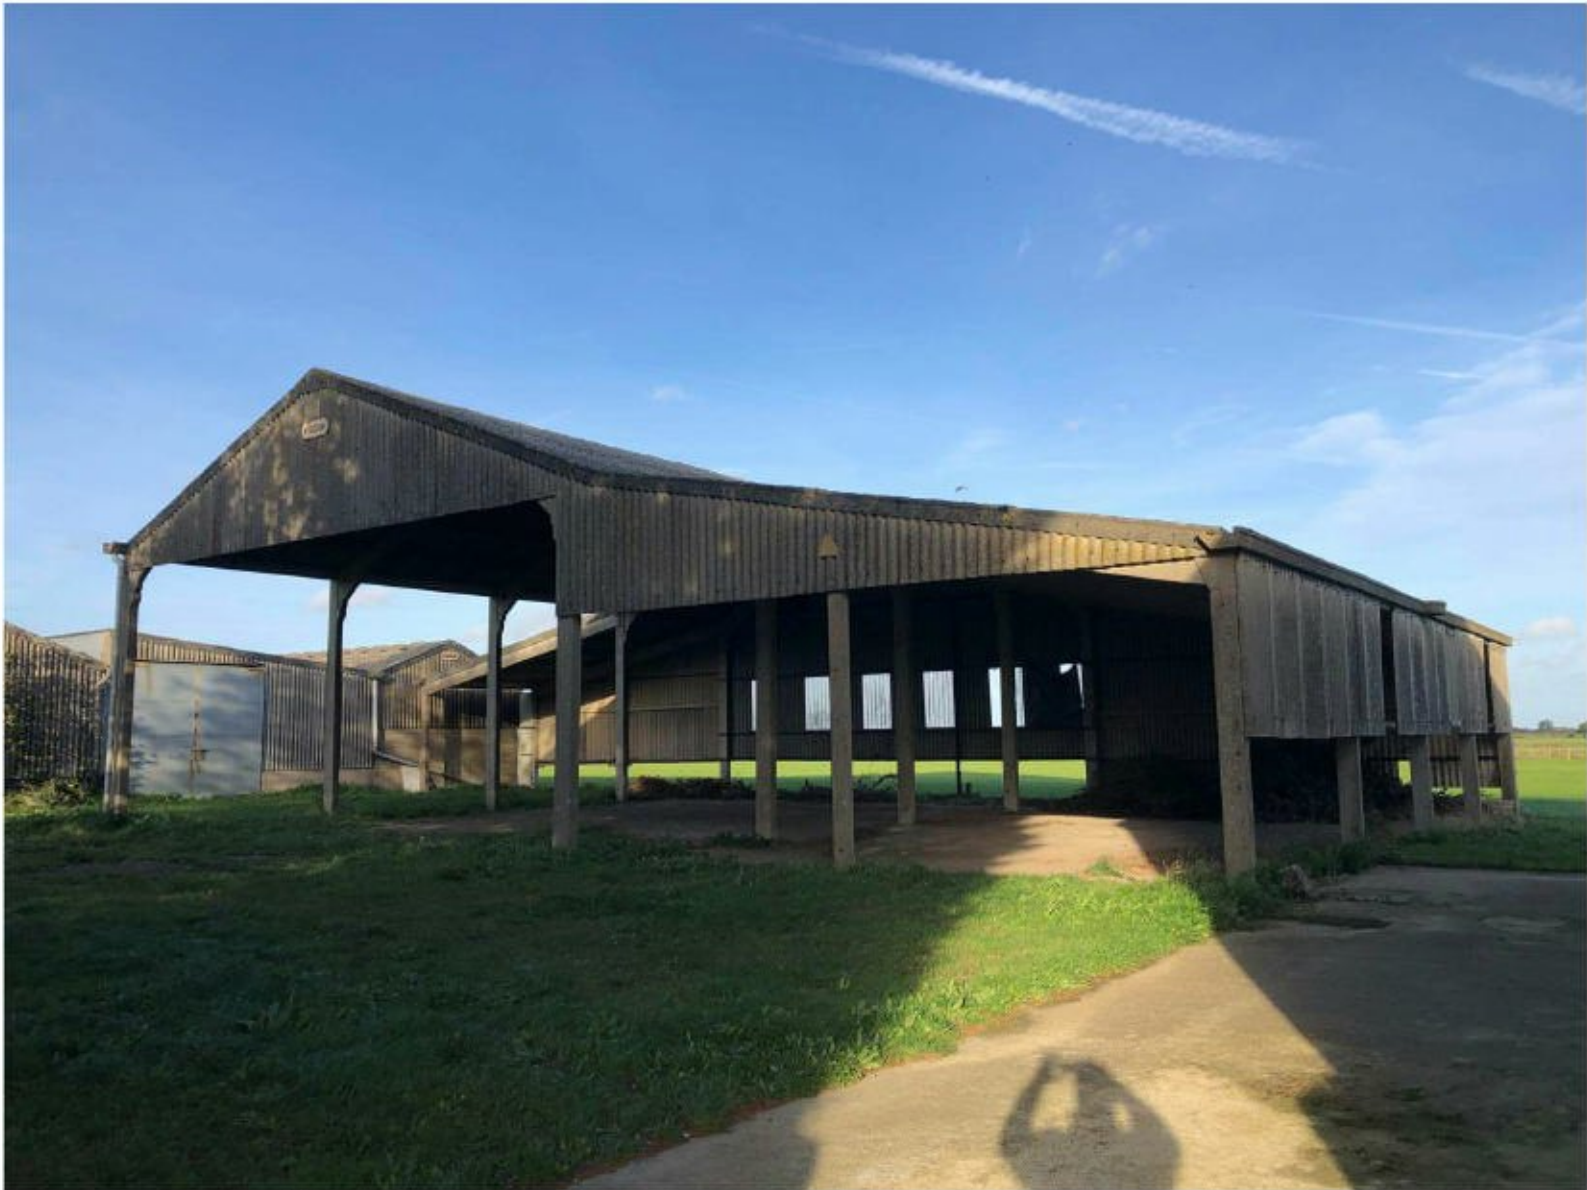
View on front of barn from south west

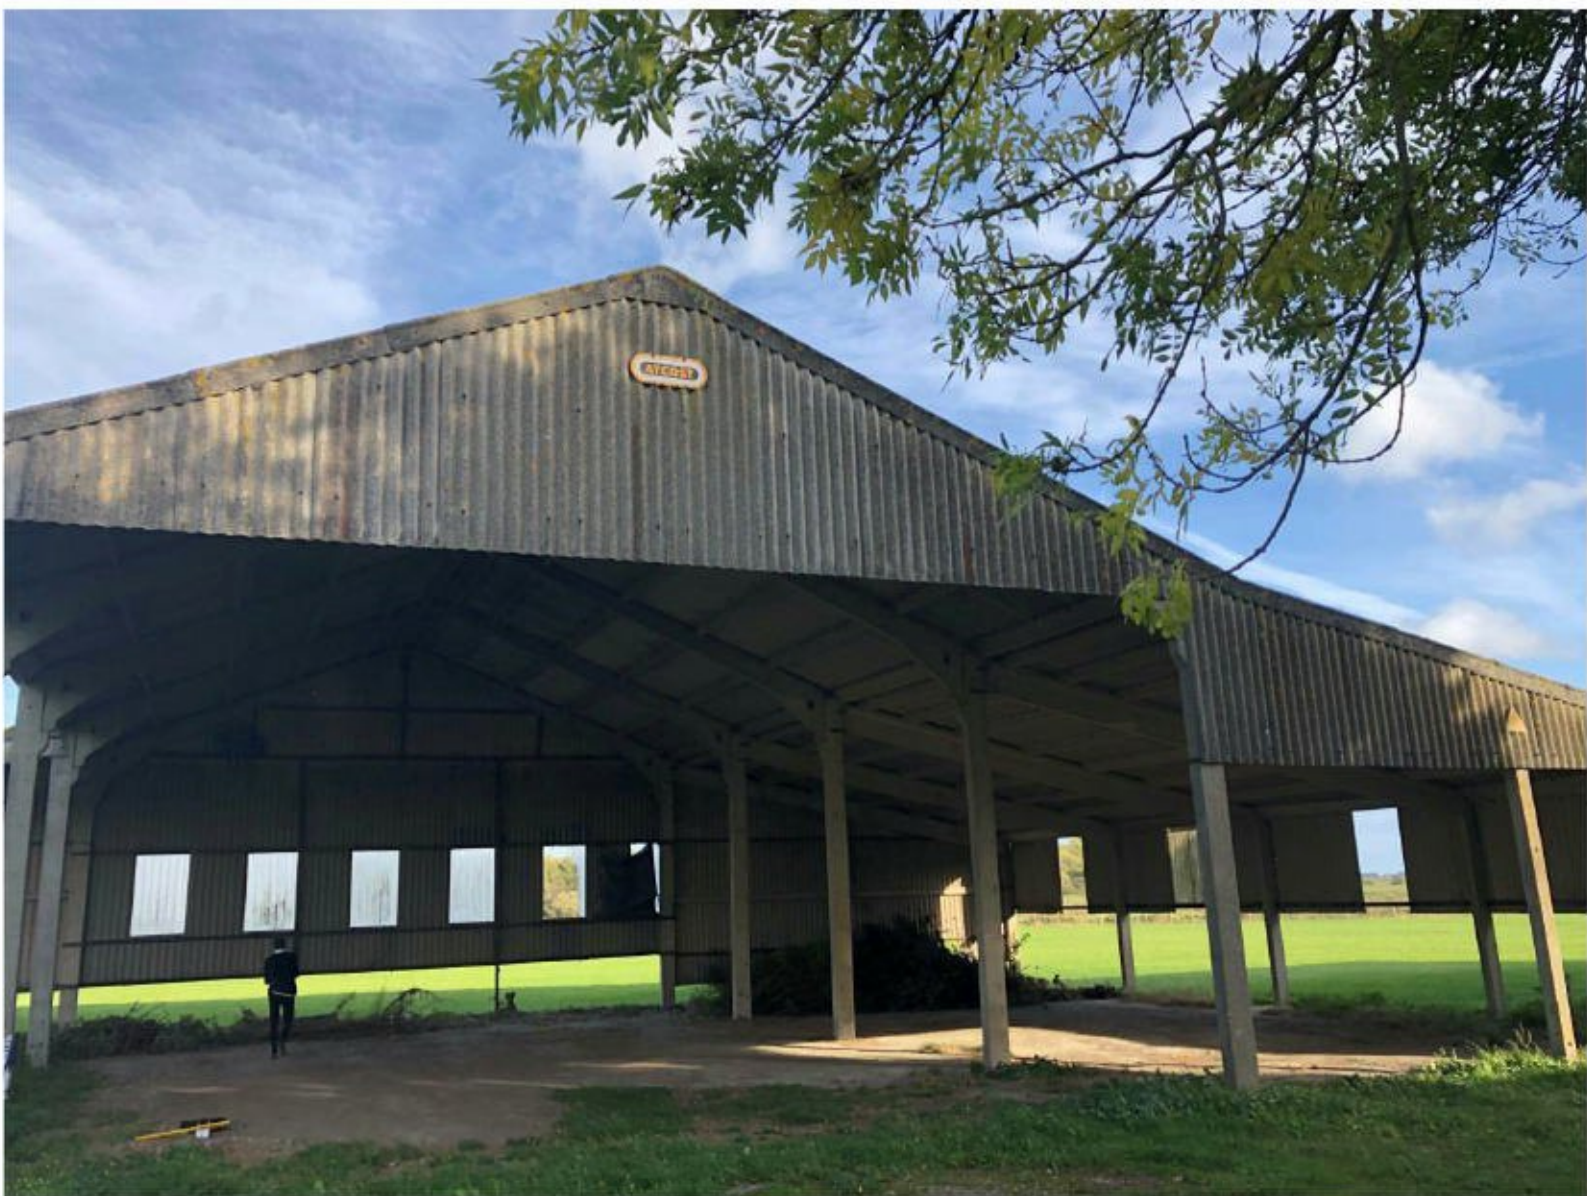
View on bean showing concrete frame structure

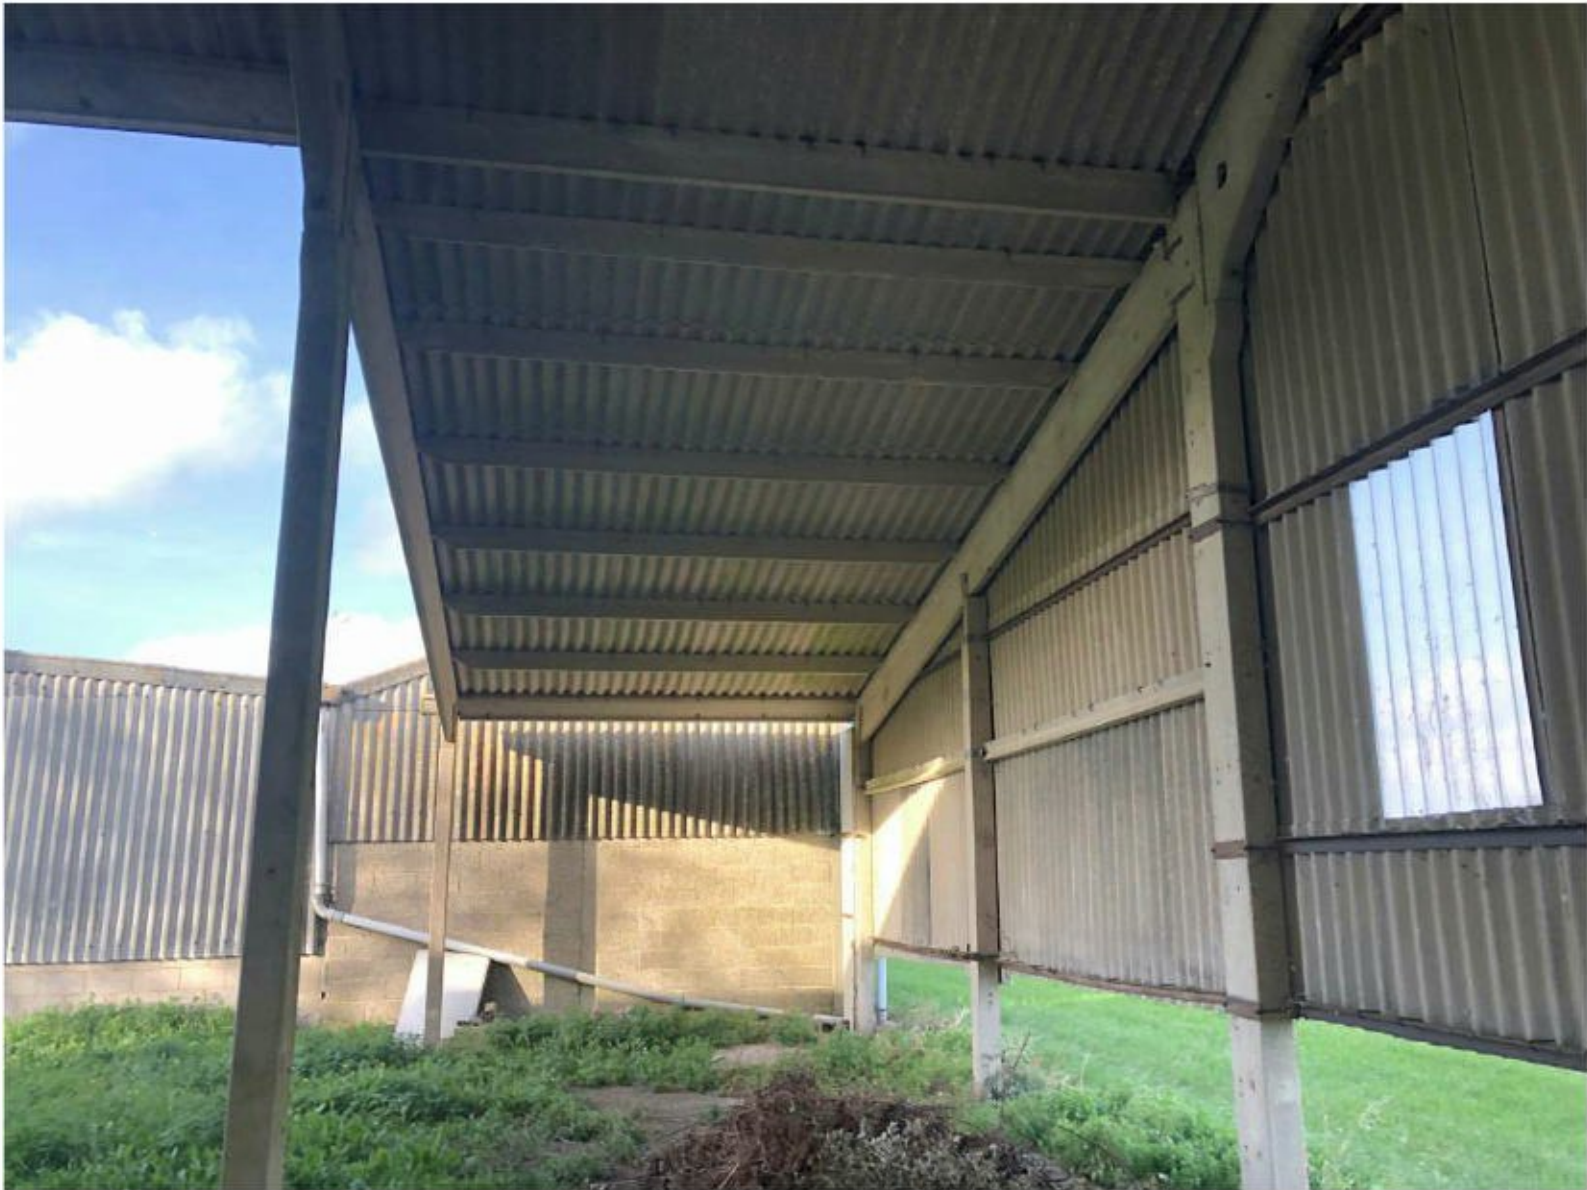
View on lean-to to north side of barn showing structure

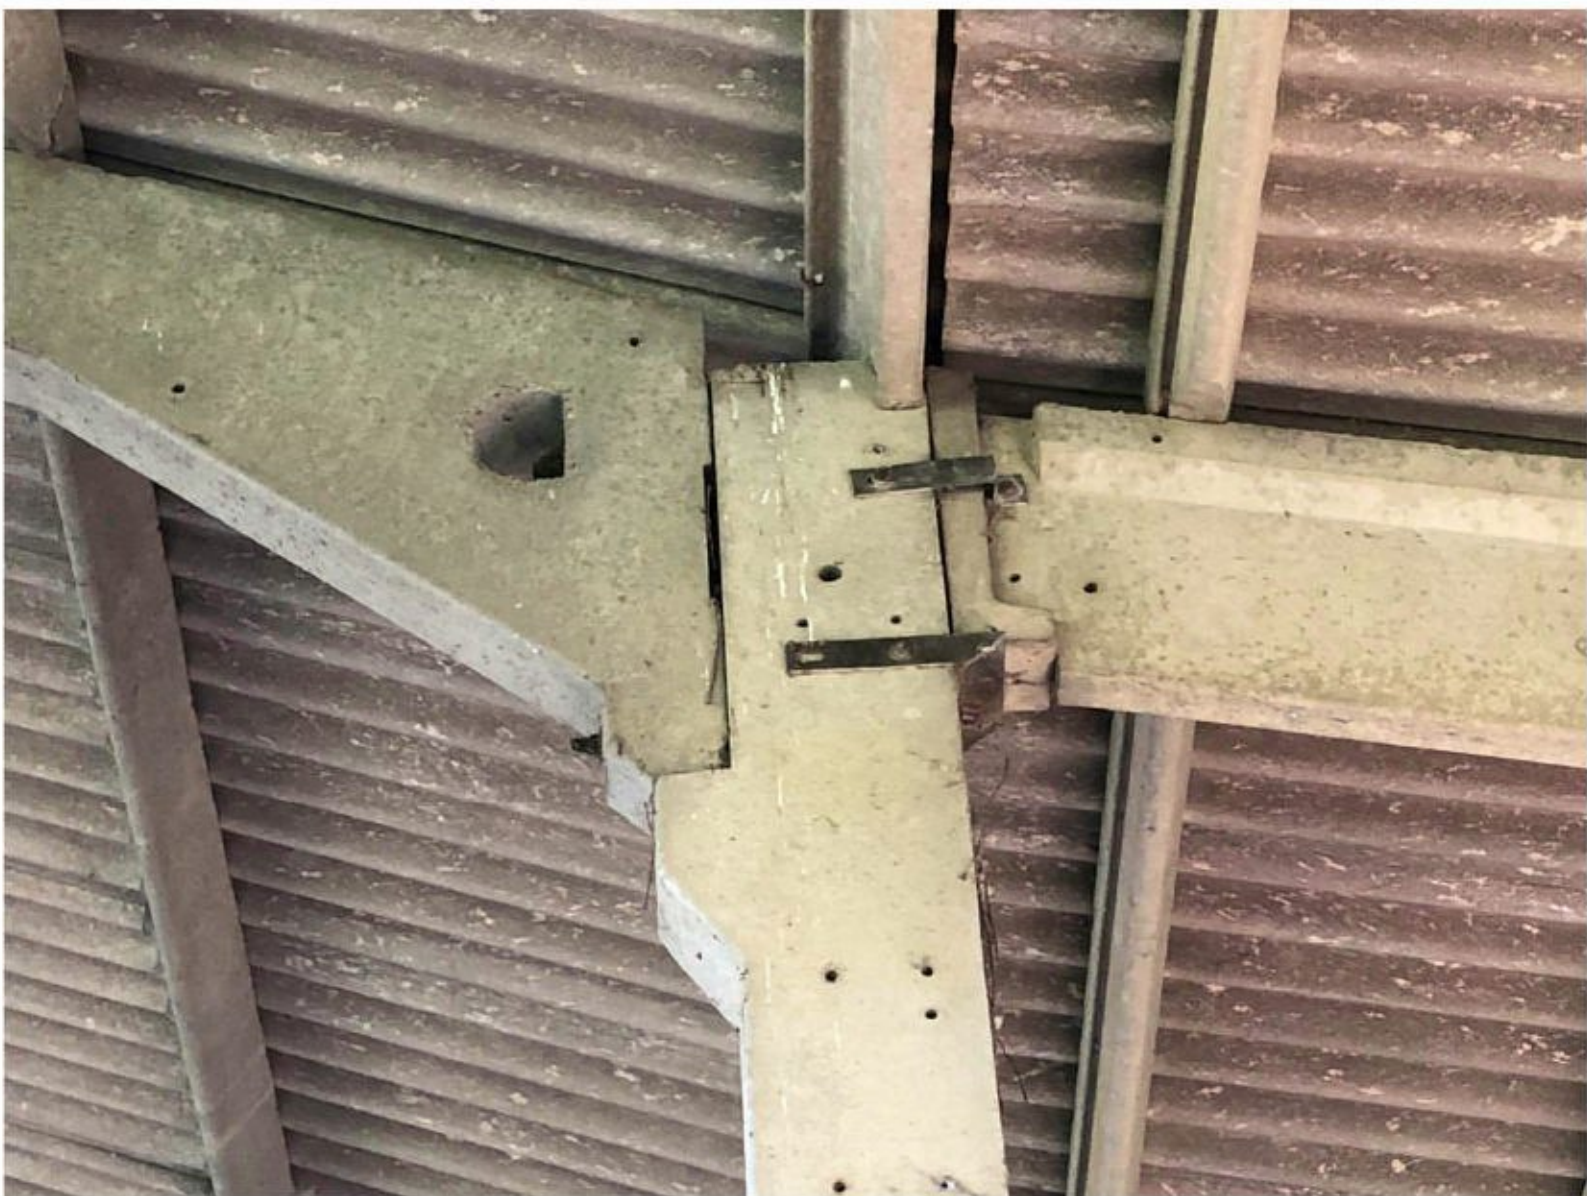
Detailed view on connection of post to portal rafter and lean-to rafter
