Professional Arboricultural Care Management Report

18th August 2023

JOB REF No. 3196

25 High St, Skellingthorpe, Lincoln LN6 5TS

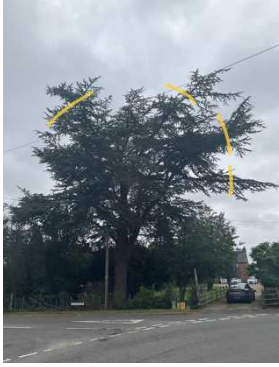
Reference G=Group H=Hedge T=Tree	Age & Species	Height (m)	Crown Ht (m)	Diameter (cm)	Crown spread (m)	Notes	Recommendations		Life expectancy
						All measurements are for our guidance purposes only	Priority	Inspect Frequency (yrs)	
T=Tree	T1 mature Cedar	17	5	90	N = 7m E = 10m S = 8m W = 8m	<p>TPO Application will be made by ourselves if quote accepted, and application for prunus removal will be made by ourselves if it falls within a conservation area.</p>

<p>Inspect failure point at 10m in height, removal of remaining limb may be required depending on the severity of the failure site. Selectively Reduce the south eastern aspect of the canopy by 4-5m to bring within the natural canopy line. All remaining aspects to be selectively reduced by a maximum of 3m. All arisings removed from site. remove all the hung up branches and any deadwood over 30mm diameter throughout the tree. Medium 3</p>
