## **Structural Report**

**The Lodge  
Over Norton Park  
Chipping Norton**

May, 2023

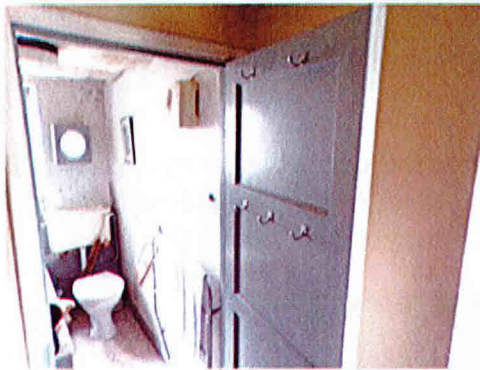
Photograph No.7

The second area is on the first floor underneath the truss where there is a plan to remove the wall between the toilet and the bedroom which is shown on both sides on photographs No. 7 and 8. What can be seen is that there is a downstand beam within the bedroom which supports the attic floor, however this does not correlate to the truss above and is a separate entity.

On the first floor underneath this area, the partition is considered to be non-loadbearing between the bathroom and the bedroom and does not extend to the ground floor below and therefore it is felt this can be removed. Prior to this being carried out, a check on the first floor will be made and if necessary, the new tie beam can be utilised to provide additional support.

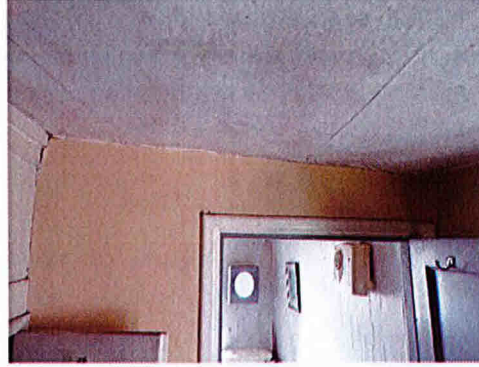
Photograph No.9

There is generally a bow to the ceiling in the corridor space outside of the bathroom, as shown on photograph No. 9, and potentially the introduction of the new tie beam to the truss can also be utilised to provide additional support to the floor joists. What should also be noted is that the plasterwork is all in the deformed shape of the ceiling, however prior to works being carried out, then the attic floor will be exposed to fully check out the floor joists and determine the detail with the new beam.

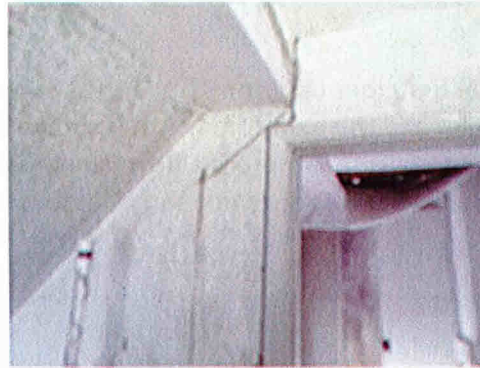
Photograph No.10

The proposal is to move the wall between the end bedroom next to the gable and the bathroom. The roof in this area is relatively straightforward being supported by a cased purlin which will span over the wall to be removed as shown on photograph No. 10.

At the southern extension, the proposal is that the wall within the first-floor bedroom is moved as currently this cuts across the dormer. It is felt that this is a non-loadbearing partition as it does not appear on the ground floor below and the purlins are cased and are thought to span the length of this part of the building. Prior to any works being carried out, the ground floor ceiling would be partially removed as it is only plasterboard and significantly damaged, at which time the support for the partition will be checked. Similarly, the casing will be locally removed from the purlin to check that this is sufficient for the span and if necessary, strengthening works introduced.

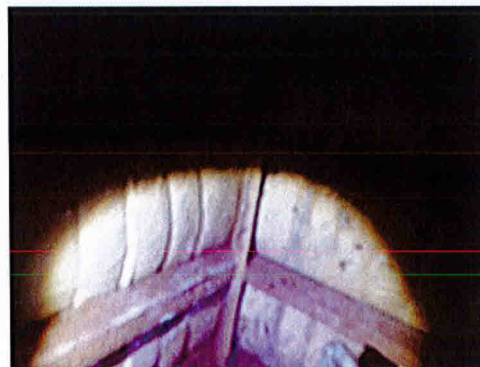
Photograph No.11

The wall in itself is clearly a later intervention as this would appear to cut across the window and halfway across the dormer. There is a very small loft hatch and from what could be seen there are modern rafters and ridge board as shown on photograph No. 11.

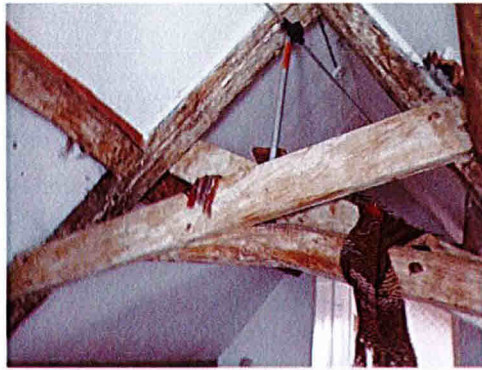
Photograph No.5

When viewing internally from the attic storey, the dip in the roof is quite apparent and there is an A-framed truss which has failed where the southern principal rafter has fractured. This has now been supplemented with additional horizontal tie beams above the floor level, a post under the failed principal rafter and then two cross braces to supplement the collar.

The truss supports two purlins to each pitch over which are rafters. A general view of the roof looking towards the north-west is shown on photograph No. 3, the fractured south-western purlin on photograph No. 4, the later cross bracing on photograph No. 5 and then the relationship of the new tie beam with the floor on photograph No. 6.

Based on the external condition of the stone tiles and the fact that there is such a distinct bow, then it is considered that the roof does need to be re-covered and at this time, this is the ideal opportunity to repair the truss by letting in a new principal rafter and attaching the new tie beam

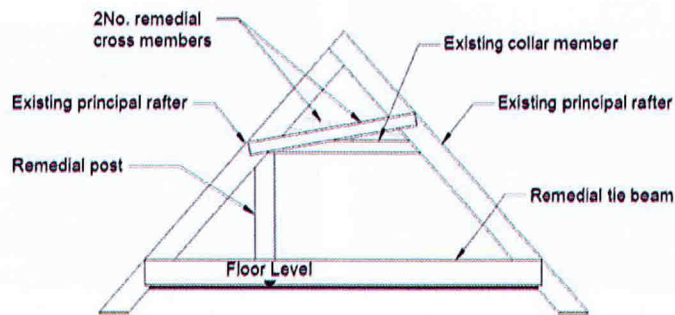
A general layout of the truss, as existing, is shown on the sketch below.

The truss has clearly failed and this will be due to the spreading of the principal rafters as there is a distinct lack of horizontal tie at floor level, therefore the rafter will bend about the collar due to the weight of the stone tiled roof. This has therefore caused a fracture at this position which has subsequently been propped.

An analysis shows that the principal rafter will fail under the current configuration but is satisfactory if a tie beam is inserted. Placing the new tie above the attic floor as currently found, means that the room is basically not useable. The proposal therefore is that a tie beam is inserted within the floor depth which will be jointed into the ends of the principal rafter and in this way, this will hold the feet in position, prevent further spread and ensure that the truss works satisfactorily.

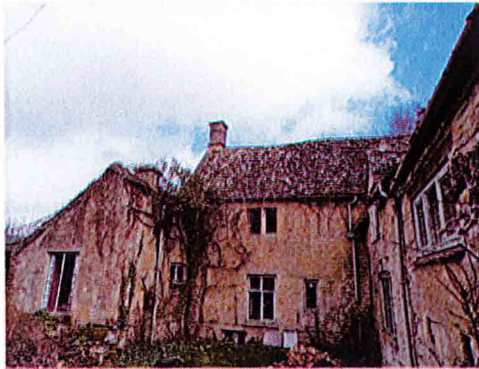
Photograph No.1

The first area of inspection was the north-western end, as shown on photograph No. 1, where there is a distinct dip in the roof as can be seen on photograph No. 2.

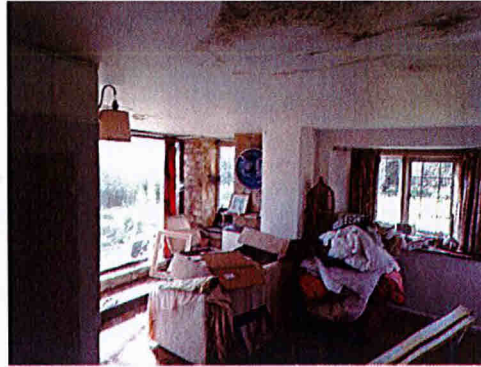
Photograph No.12

On the ground floor, the first-floor wall above is not present as this is one open space, as shown on photograph No. 12, and therefore it is felt that the purlin spans the length of this part of the building.

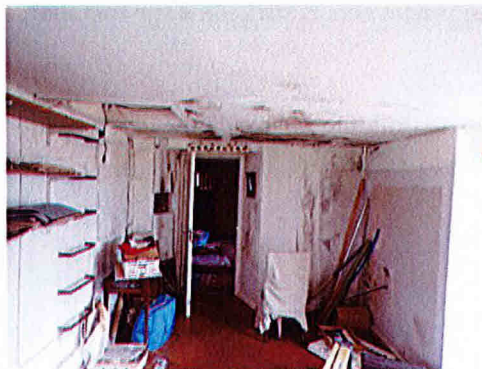
Photograph No.13

Prior to construction, then the cased purlin will be partially exposed to check the span and also a small area of the plasterboard ceiling in the sitting room. It is noted that this is severely damaged, as shown on photograph No. 13 and in more detail on photograph No. 14. The trial investigation will check that there is no beam within the floor depth under the wall, however based on the measurements, this is thought unlikely. The existing construction will also be checked to ensure it is suitable to support the proposed partition between the proposed dressing room and ensuite .
