August : 2023

**Tree Condition Report for a Beech tree
11 Lon Pennant, Blackwood NP12 1EL
For Ceri Hughes**

AUTHOR: MARK CHESTER

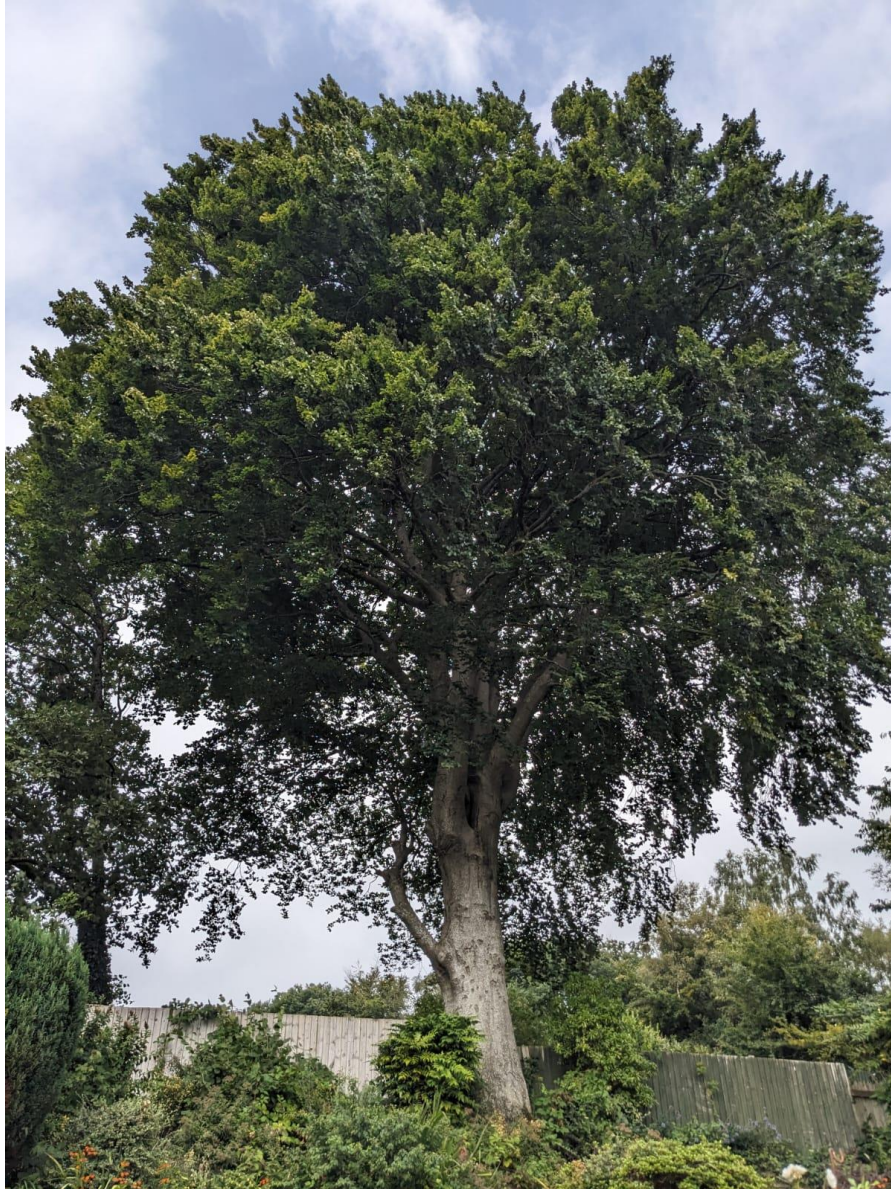
IMAGE 1 The Beech tree viewed from the bottom of the rear garden.

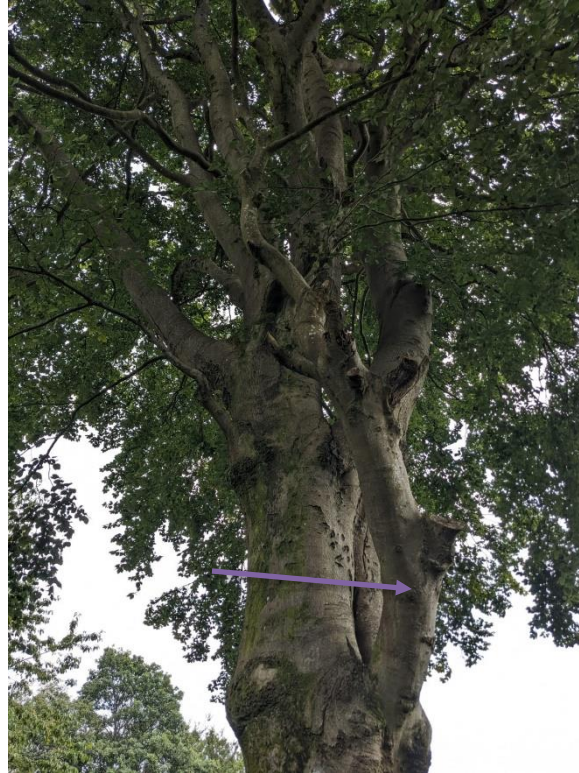
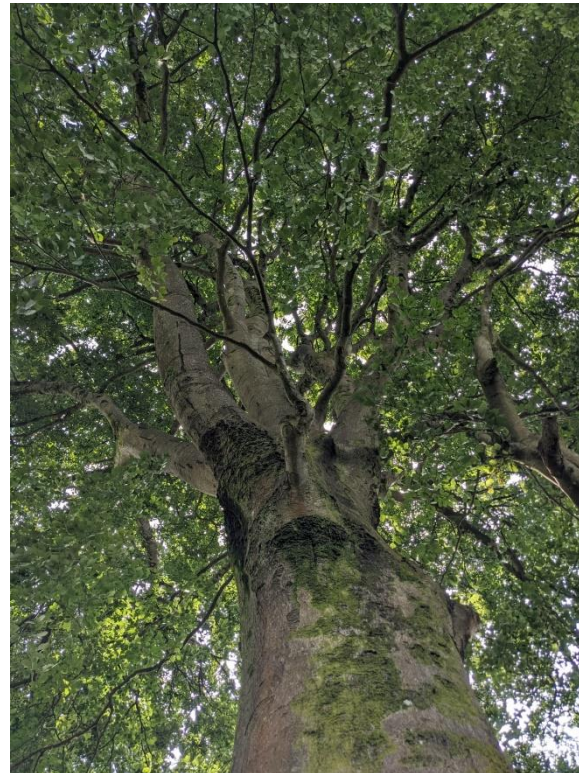
IMAGE 2 (above) and 3 (below): Two views of the trunk, showing some of the smaller branches and one larger one recommended for removal.

- 6.1 There is a mature Beech tree on the rear boundary to the property. It is in an elevated position, exposed to the prevailing wind. The ground within the rear garden is tiered, rising 4-5 metres to the rear boundary, where the tree is. The ground beyond is broadly level. The tree is one in a row on this boundary, with some birch and possibly willow close by. There is another beech in the neighbouring garden. The ground beyond is part of the golf course, and there is extensive open ground.
- 6.2 The tree was inspected when in full leaf. It is in good vigour. There is no evidence of decay via the presence of fungal fruiting bodies. There are some smaller branches and their removal would be beneficial.
