DJC/DS/6405

21 December 2021

### **BARN A AND B, OAK TREE FARM, KENTON – STRUCTURAL INSPECTION REPORT**

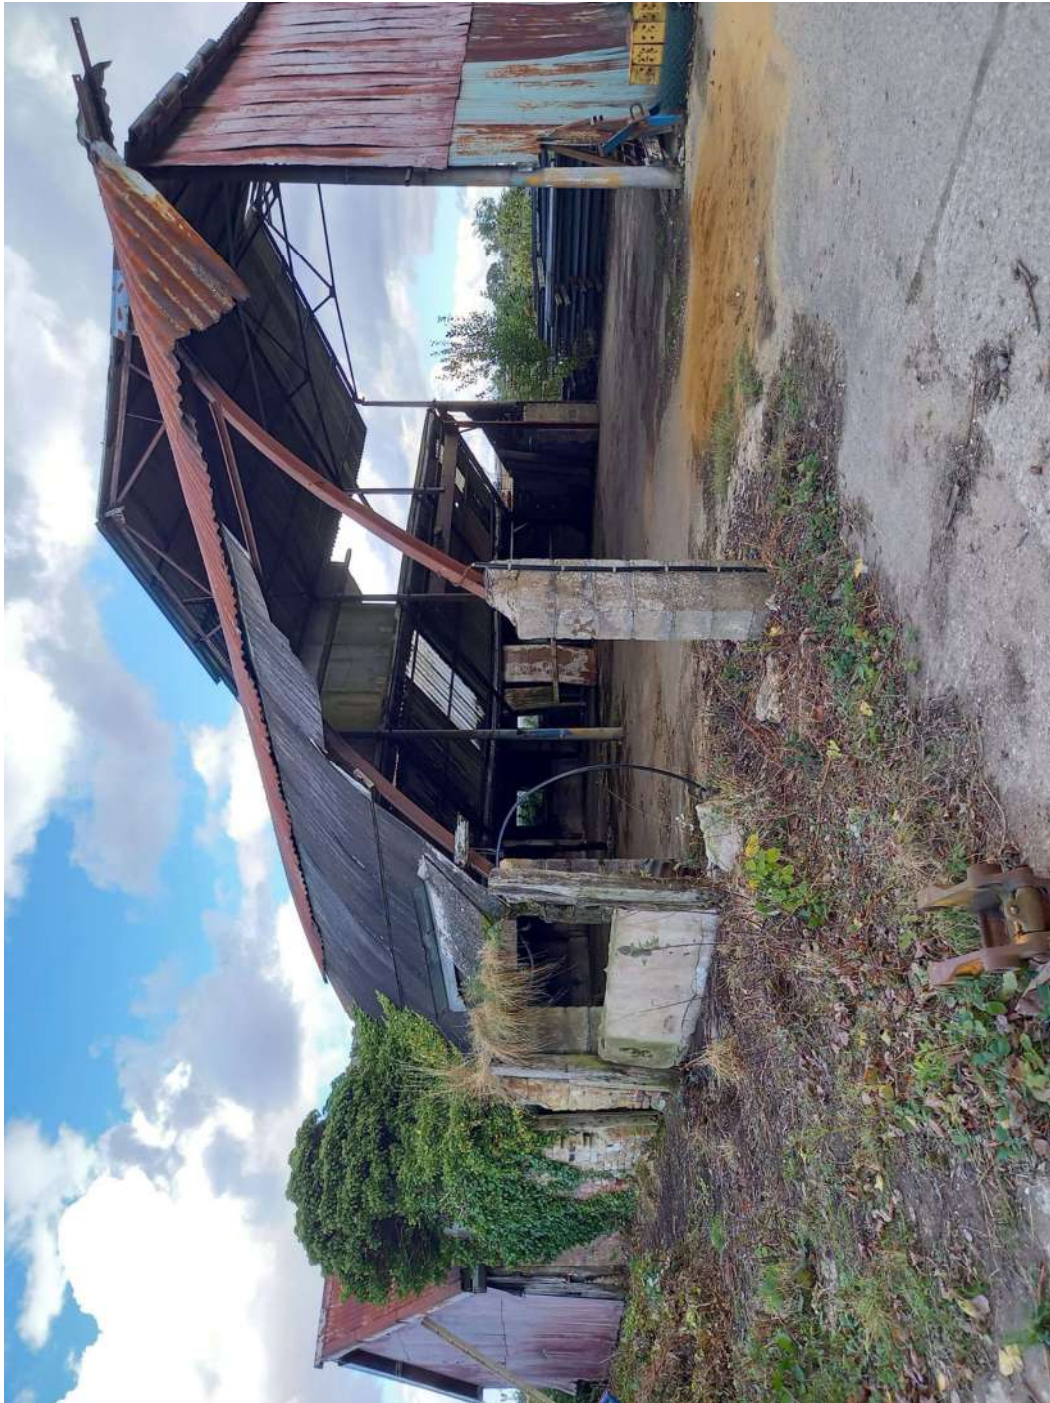
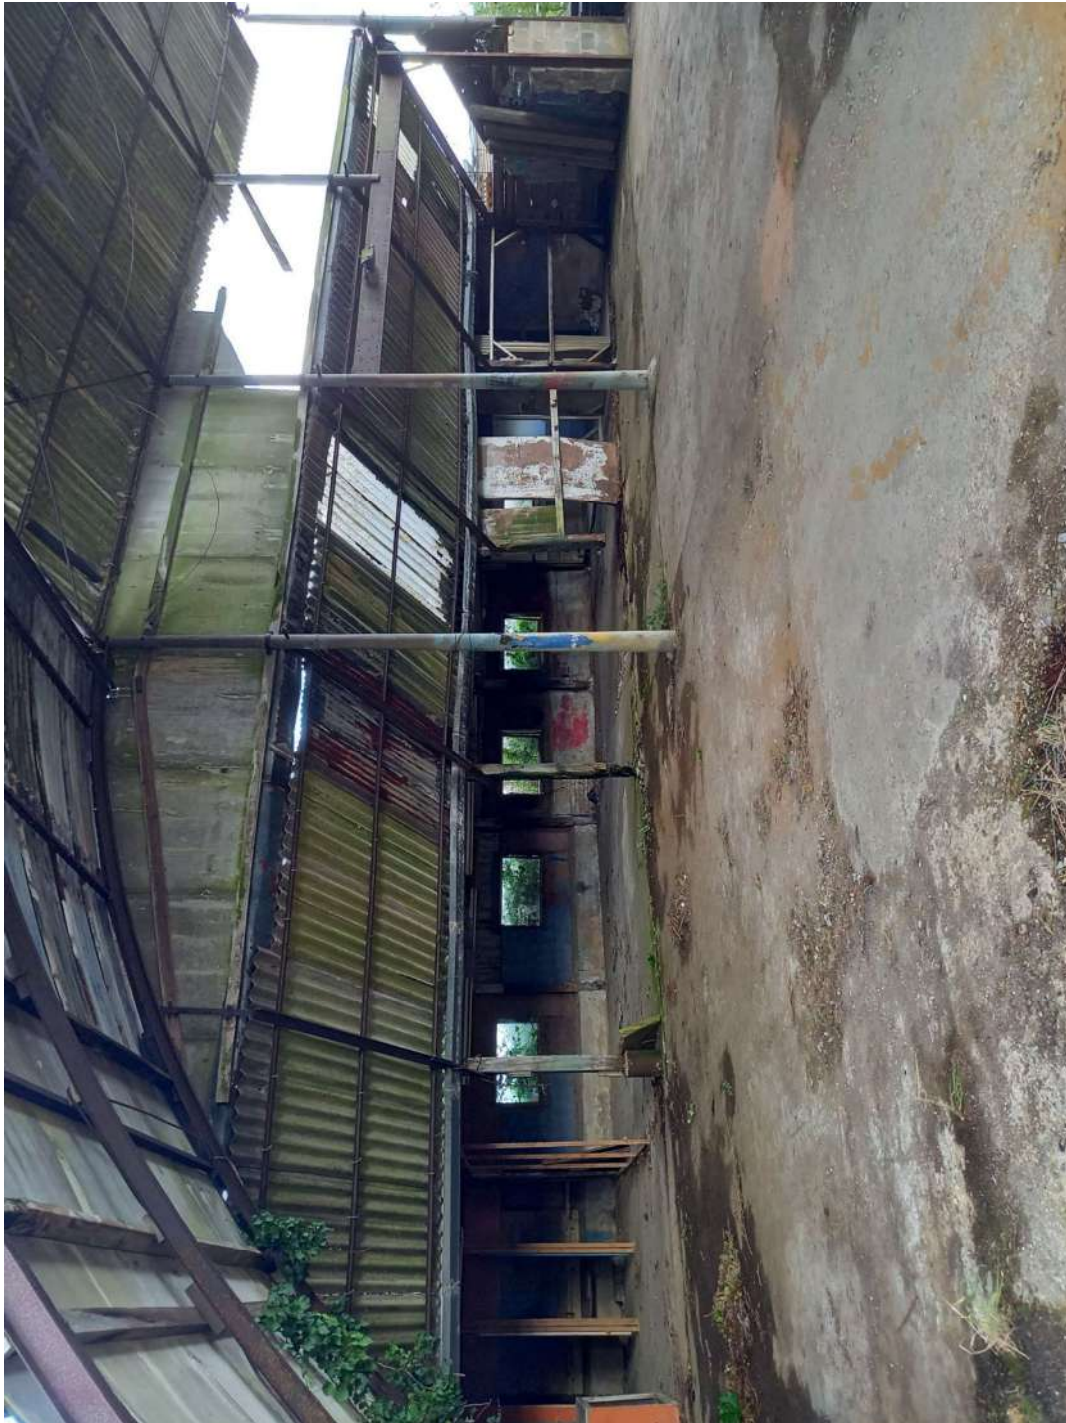
Barn A is a single storey agricultural building constructed from a low level masonry plinth with principal timber trusses and posts over and infill studwork partitions. To the front of this barn, a reverse lean to pitch spans between the front elevation and circular hollow column sections supporting a significant steel frame. The front structure is due to be demolished and falls outside the scope of this report. See Photograph 1 and 2.

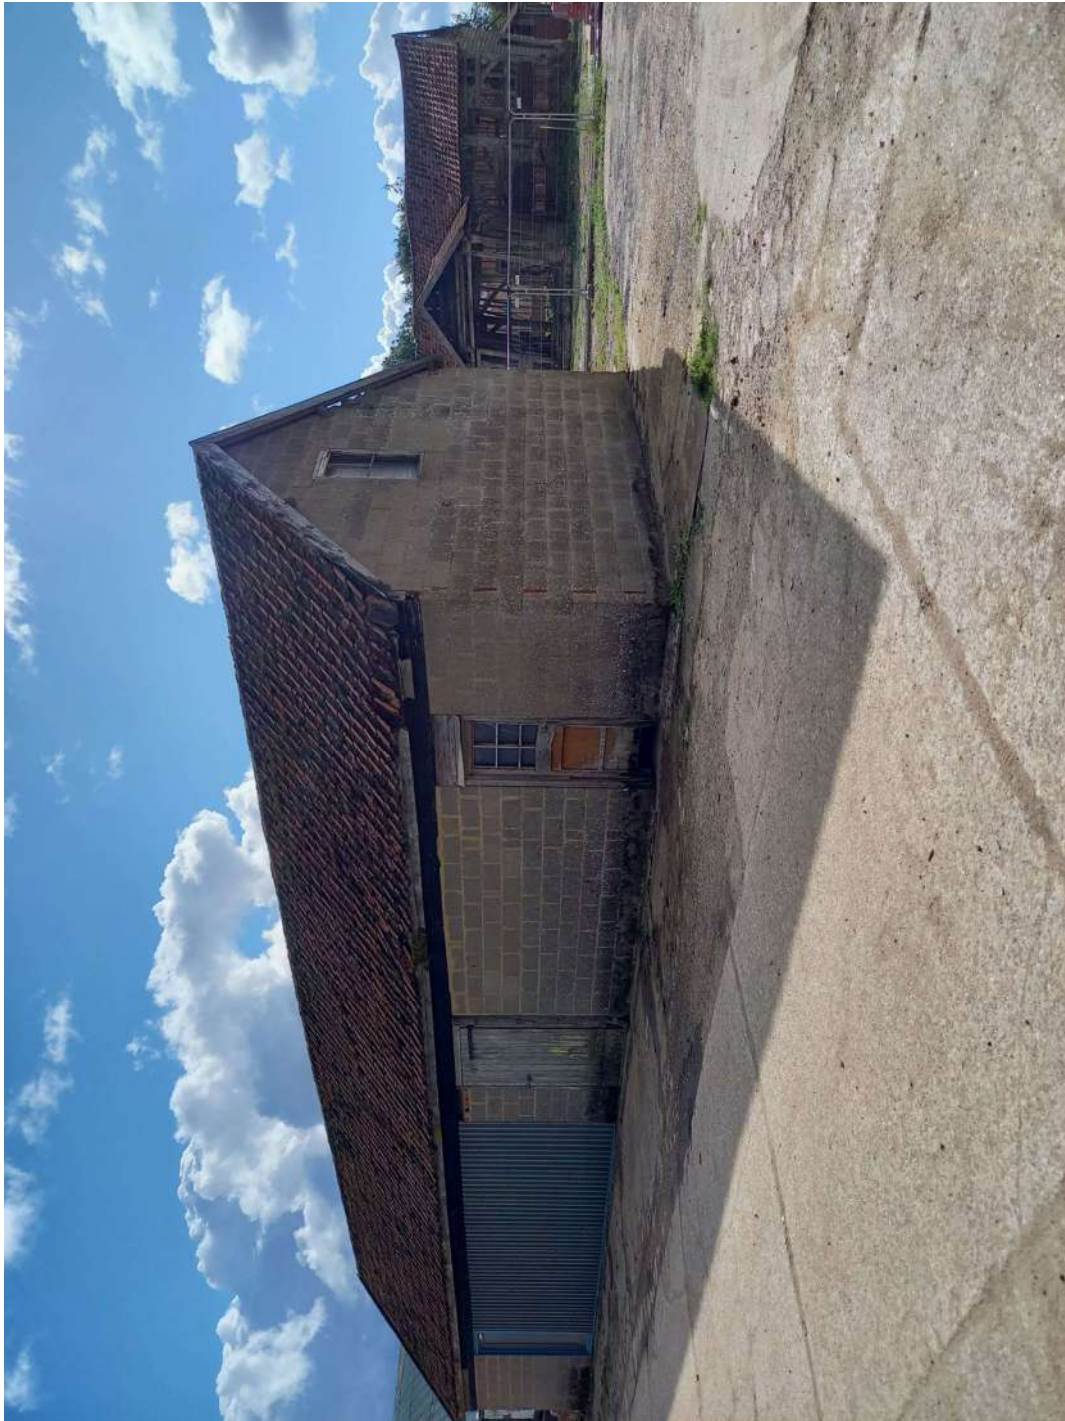
#### Photograph 3

Barn B is a single storey agricultural building constructed from solid masonry with a cut pitch roof constructed from principal rafters and purlins overclad in clay pantiles. See Photograph 3.

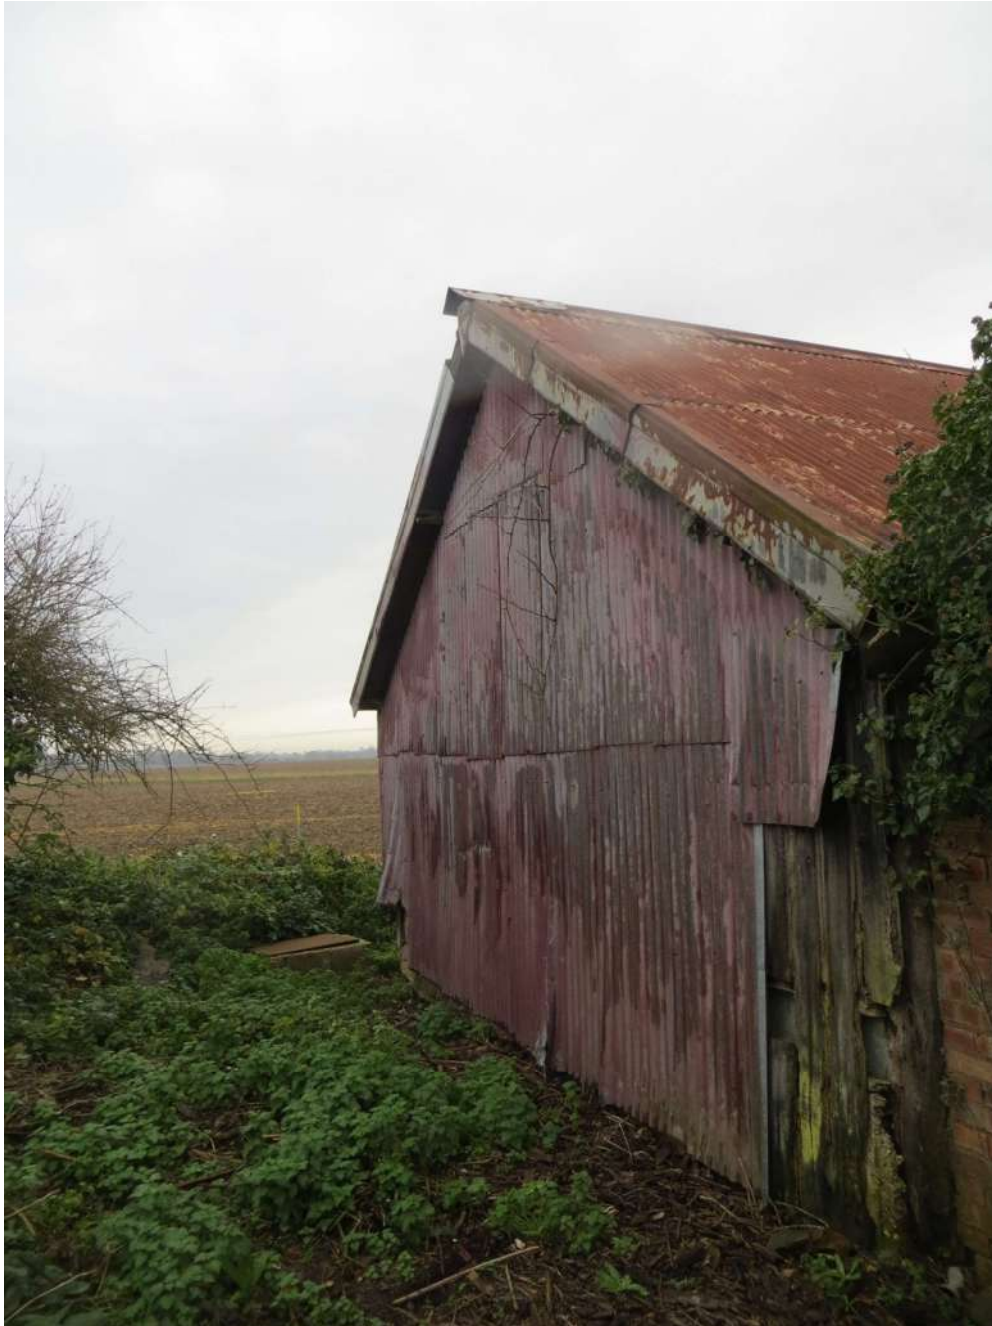
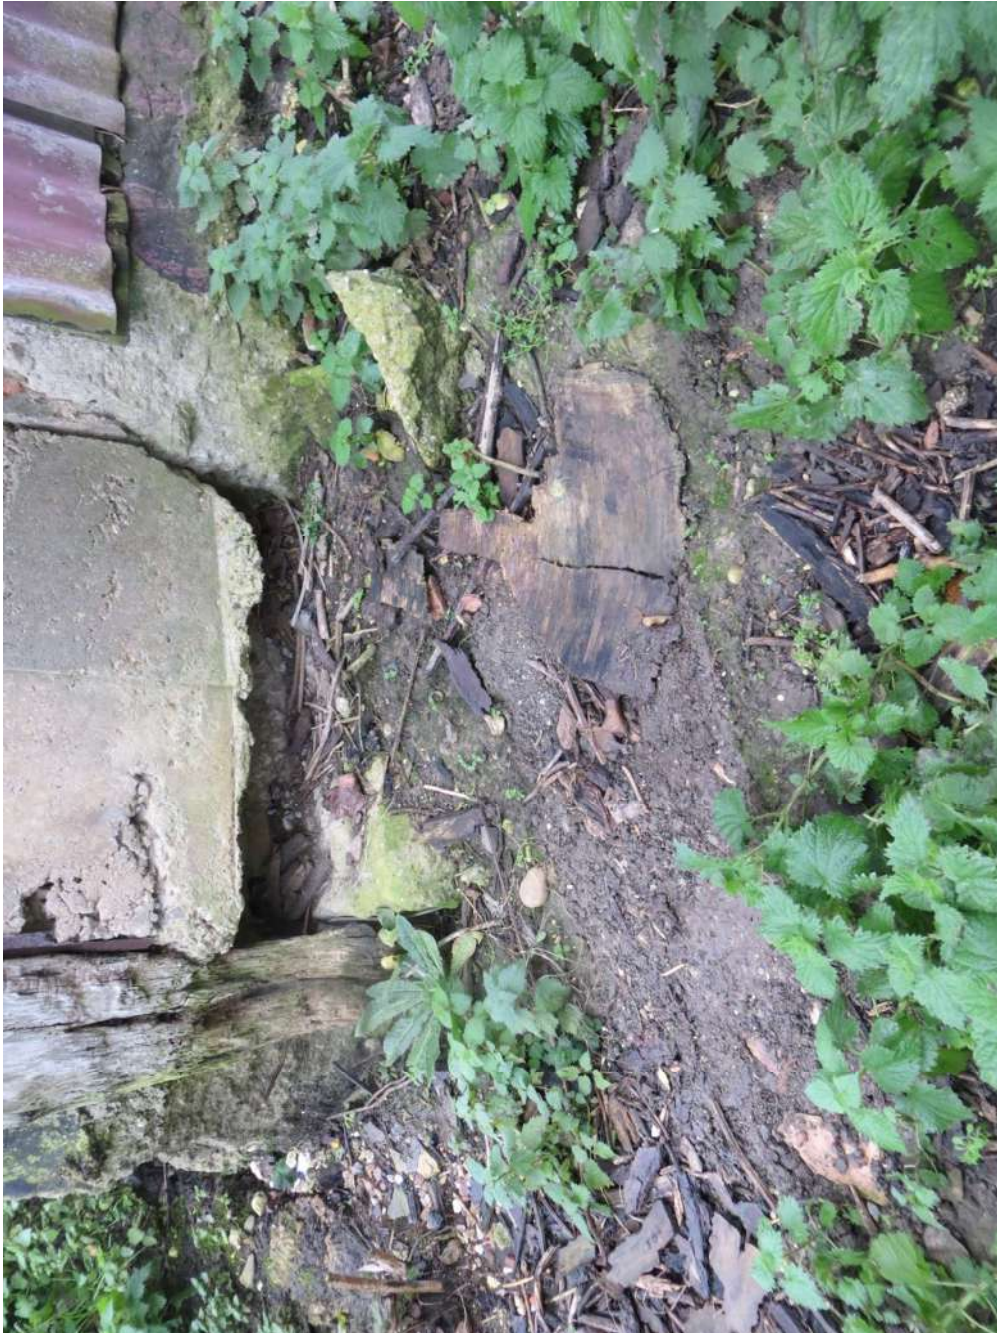
An inspection of the left gable reveals that the front timber corner post has been exposed to the elements and has deteriorated at low level. To the rear of this, a door opening appears to have been bricked up without any tying to the existing masonry and this has now subsequently started to fall out. See Photographs 4 and 5.

1. Carefully cut out the damaged timber to the post bases and reform using a sympathetic material with a waterproof detail to prevent rot.
2. Once the property is made watertight, the timber should be treated to prevent any further rot or woodworm.
3. We recommend that the build up of soil behind the rear wall is removed down to its natural level to prevent damp penetrating through the wall.
4. We recommend that where the ad-hoc adjustment of the circular hollow steel support columns has been undertaken, a review of this layout completed prior to any renovation works.

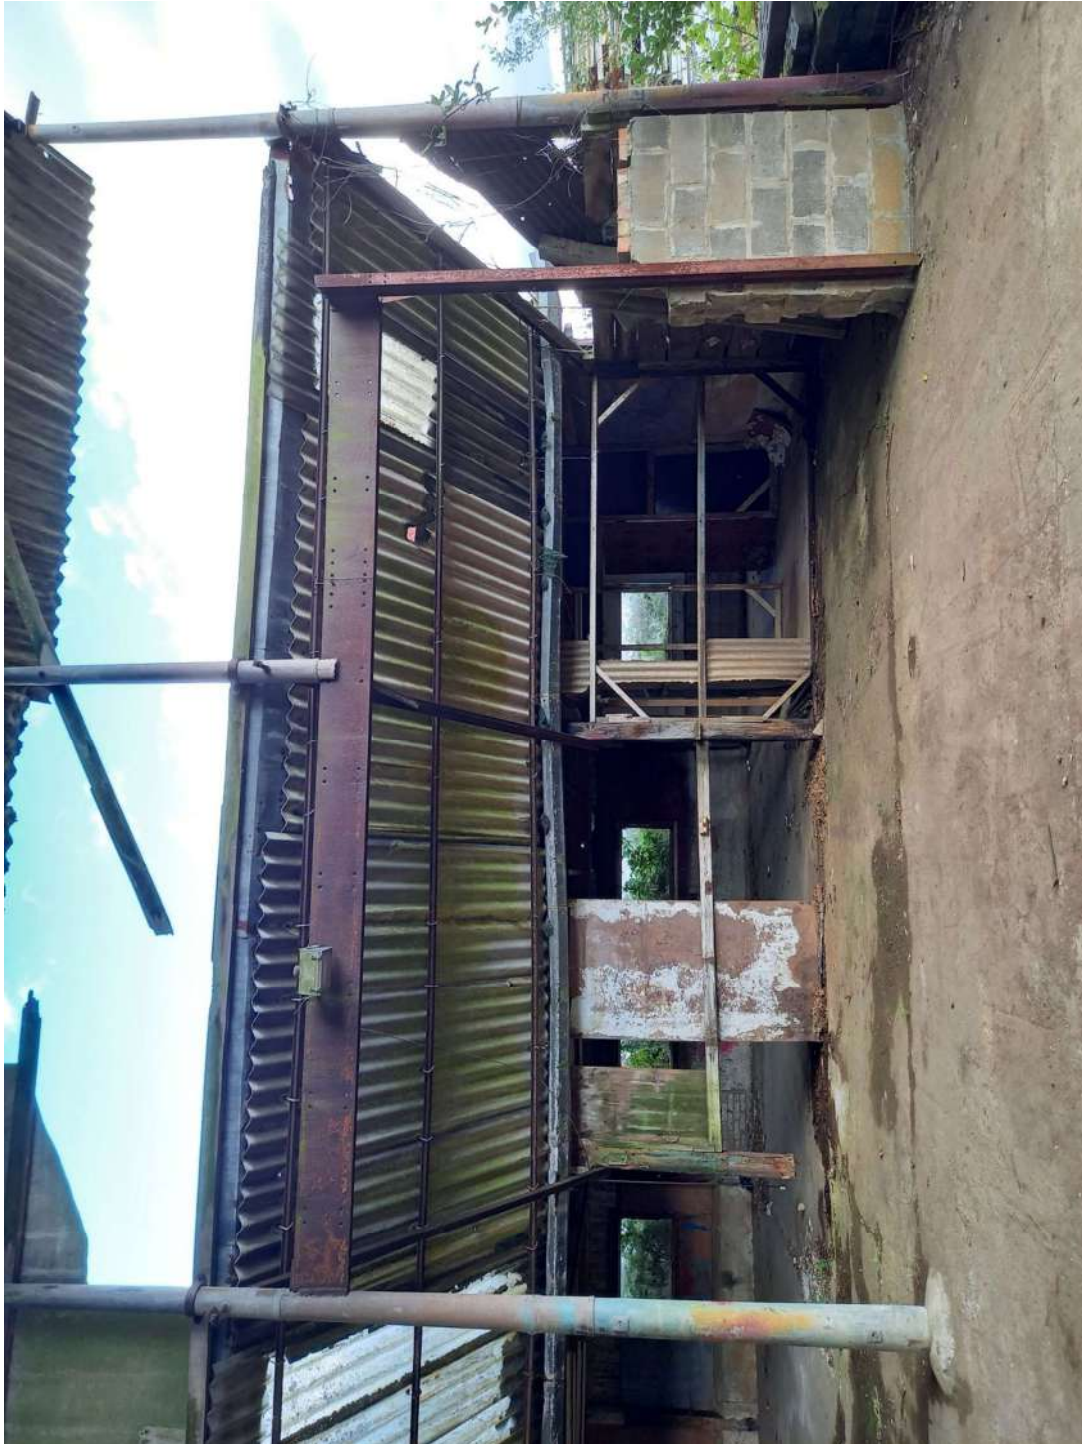
#### Photograph 6

The major steel frame in the front of the target building has circular hollow section columns supporting the roof. The lean to structure to the target building has been formed by spanning steel equal angle between the timber structure of the target building and the steel columns of the front building. The steel angles have been bolted to the posts to the rear and a combination of welding and bolting to the circular hollow sections to the front. One post has been removed at low level and a steel goal post installed to support the post at high level. See Photograph 6.

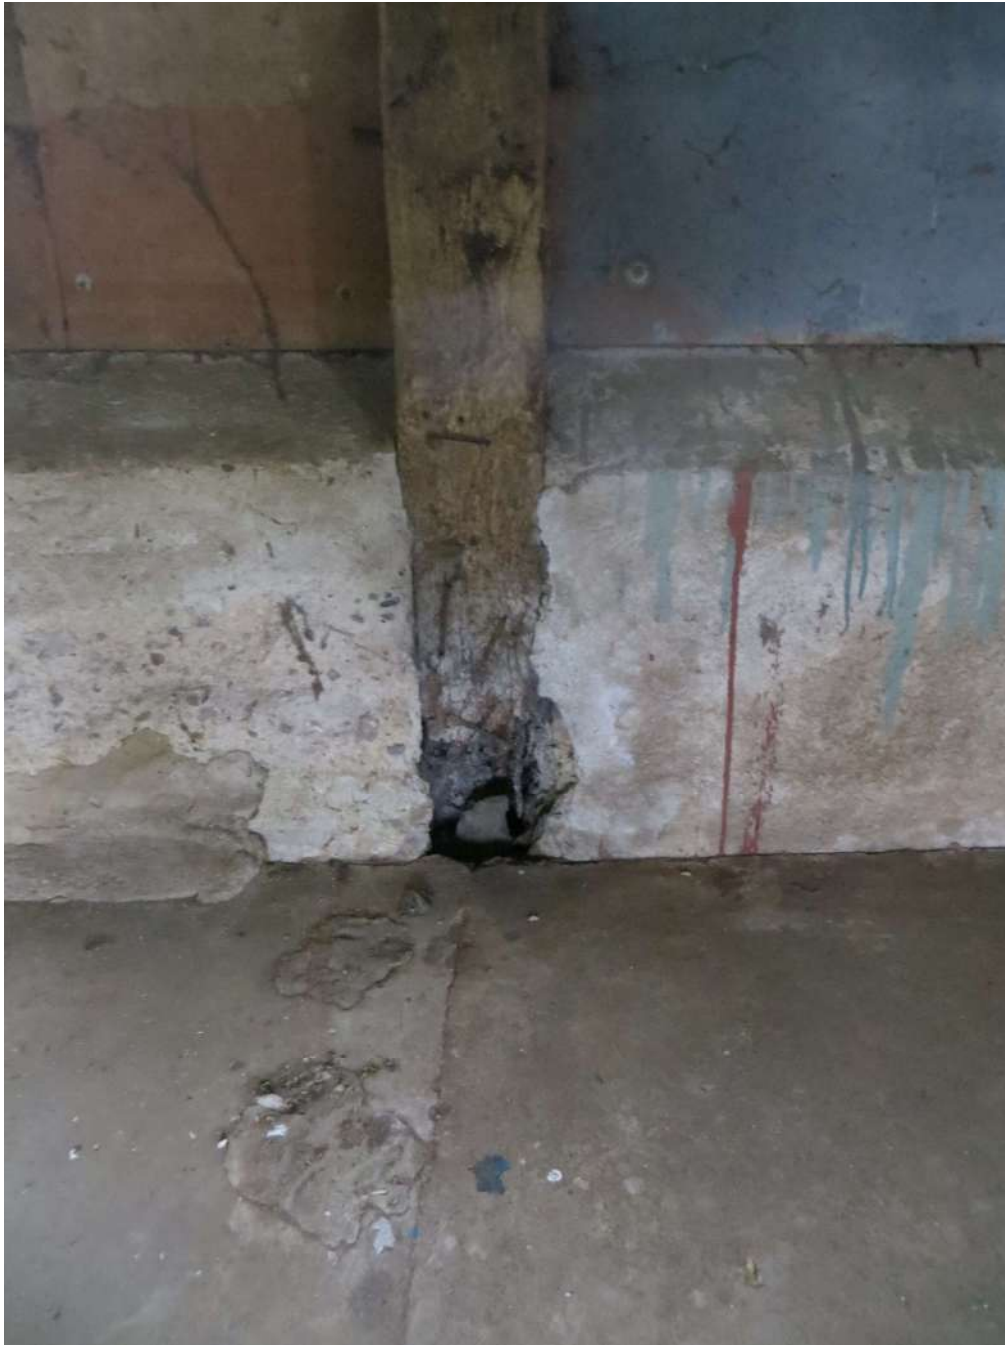
#### Photograph 7

An inspection internally reveals that, generally the principal support posts extend down to slab level with masonry infills on either side. Exposure to moisture has led to deterioration of these posts. The majority of the posts have suffered from surface rot but when penetrated the underlying material was hard, however two posts within the rear wall have totally disintegrated and one of the front timber posts has also partially disintegrated. An inspection of the low level walls throughout the property revealed no significant structural defects. See Photograph 7.

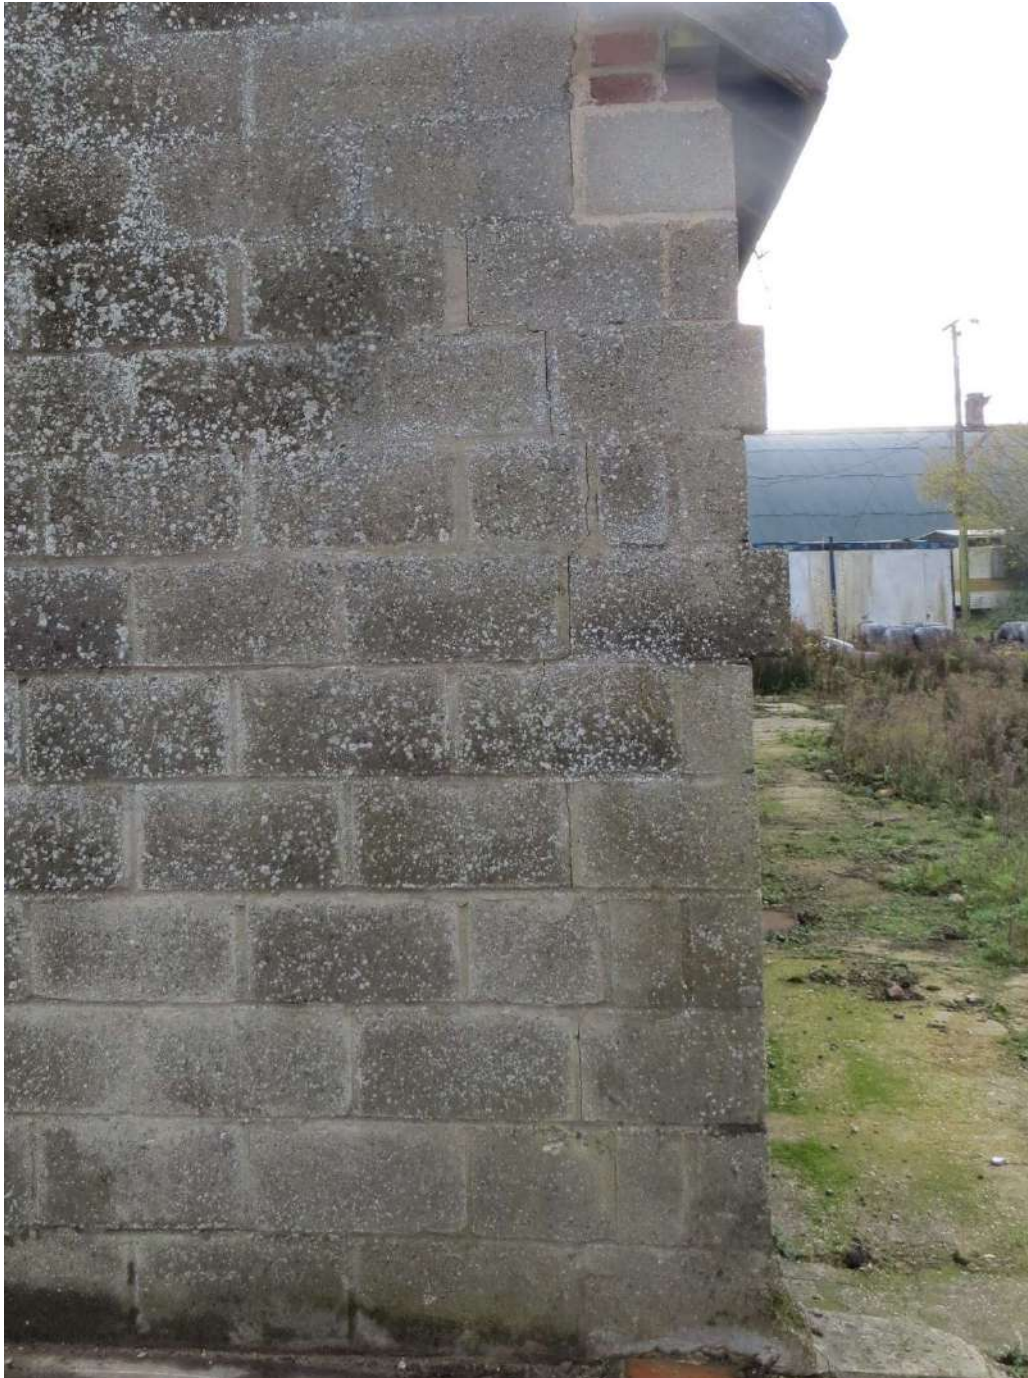
#### Photograph 8

An inspection of the right gable wall reveals that a vertical crack extends from ground level through to roof level varying in width between hairline at ground level through to 1.5mm wide at roof level. See Photograph 8.

1. Impact damage to the rear wall should be restitched using traditional methods to ensure the stability of the individual masonry elements.
2. The crack damage to the right gable wall should be repaired using traditional methods and once complete, Helibar reinforcement should be installed extending 500mm either side of the crack location at 450mm vertical centres.
3. The property should be made watertight and the timber structure treated for rot and beetle infestation.

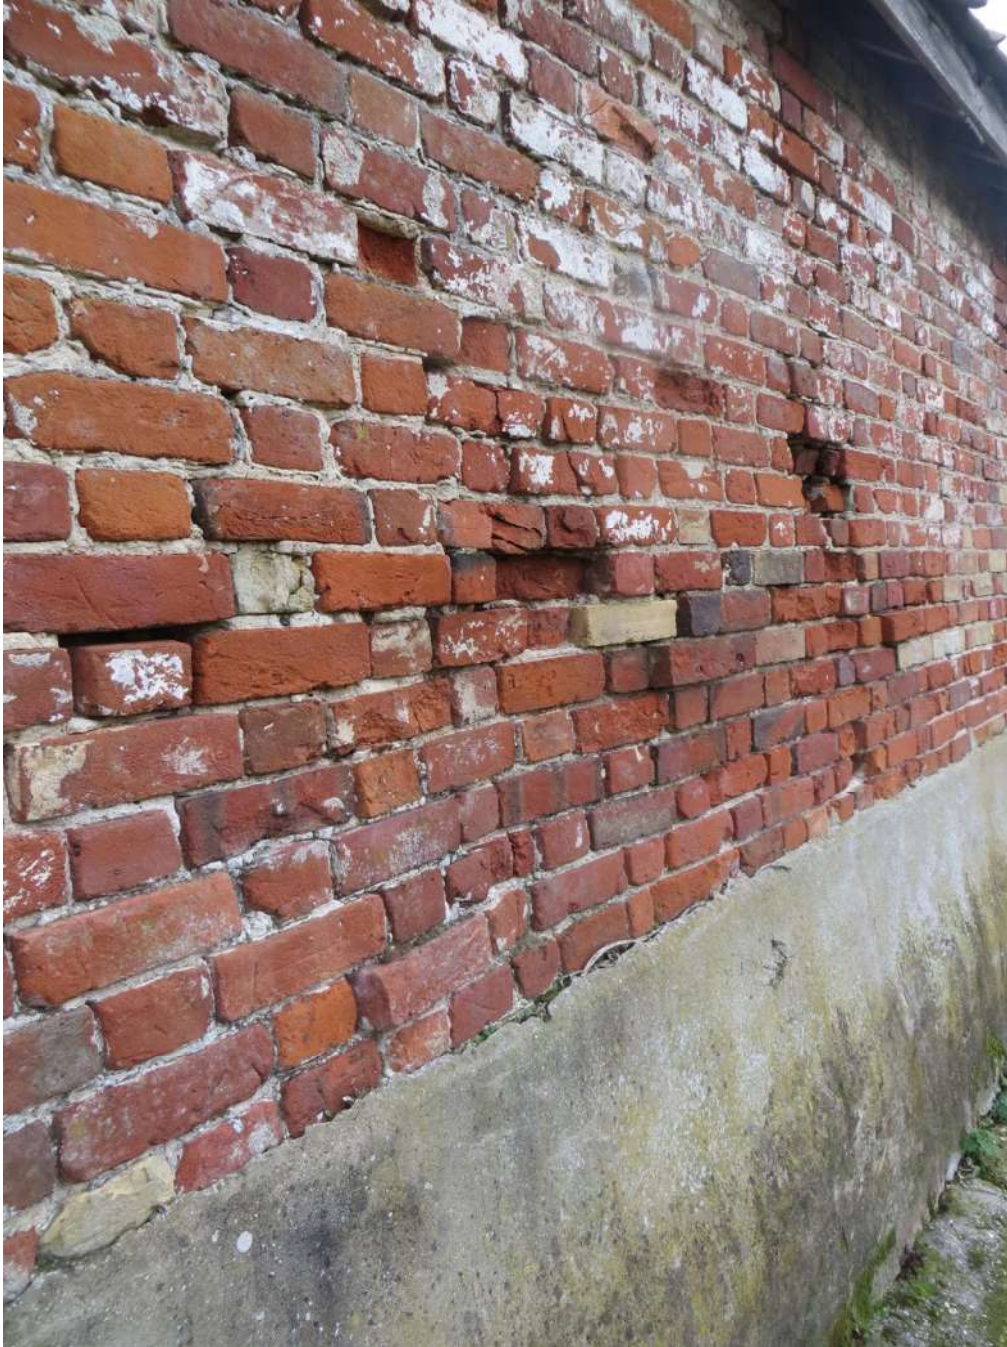
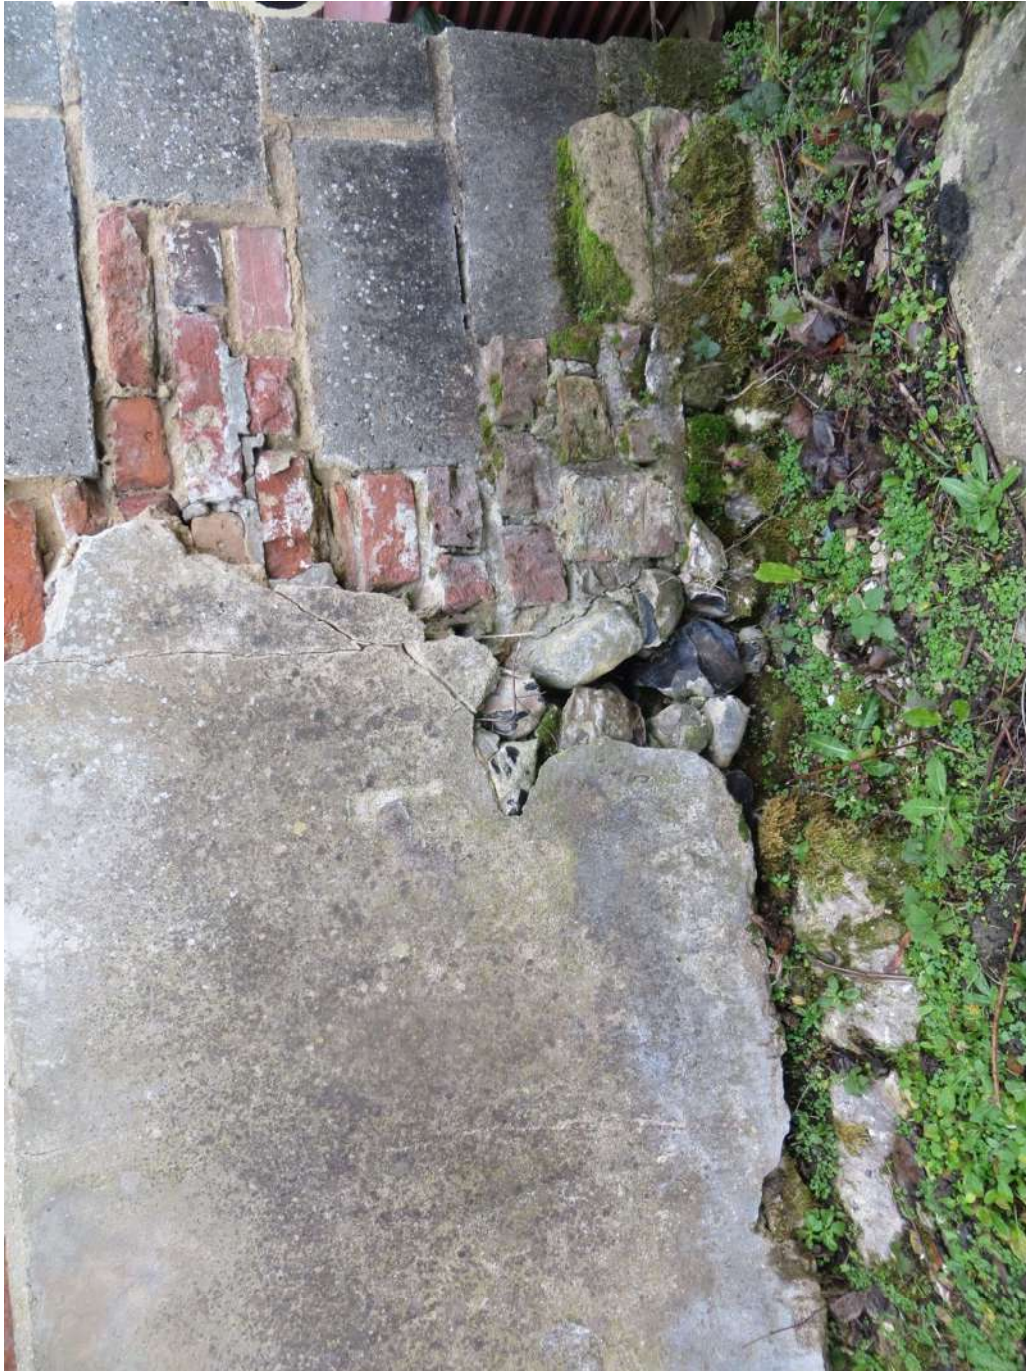
An inspection of the rear elevation reveals that there appears to have been an impact at mid height of the wall halfway along its length, leading an indentation of approximately 30mm. See Photograph 9. To the left of this location, washout of the mortar joints appears to have occurred in a 1m stretch of the masonry. Towards the left hand end of the rear elevation, the mortar plinth has been damaged exposing the flintwork beneath. The mortar joint into this flintwork has weathered leading to cutback. See Photograph 10.

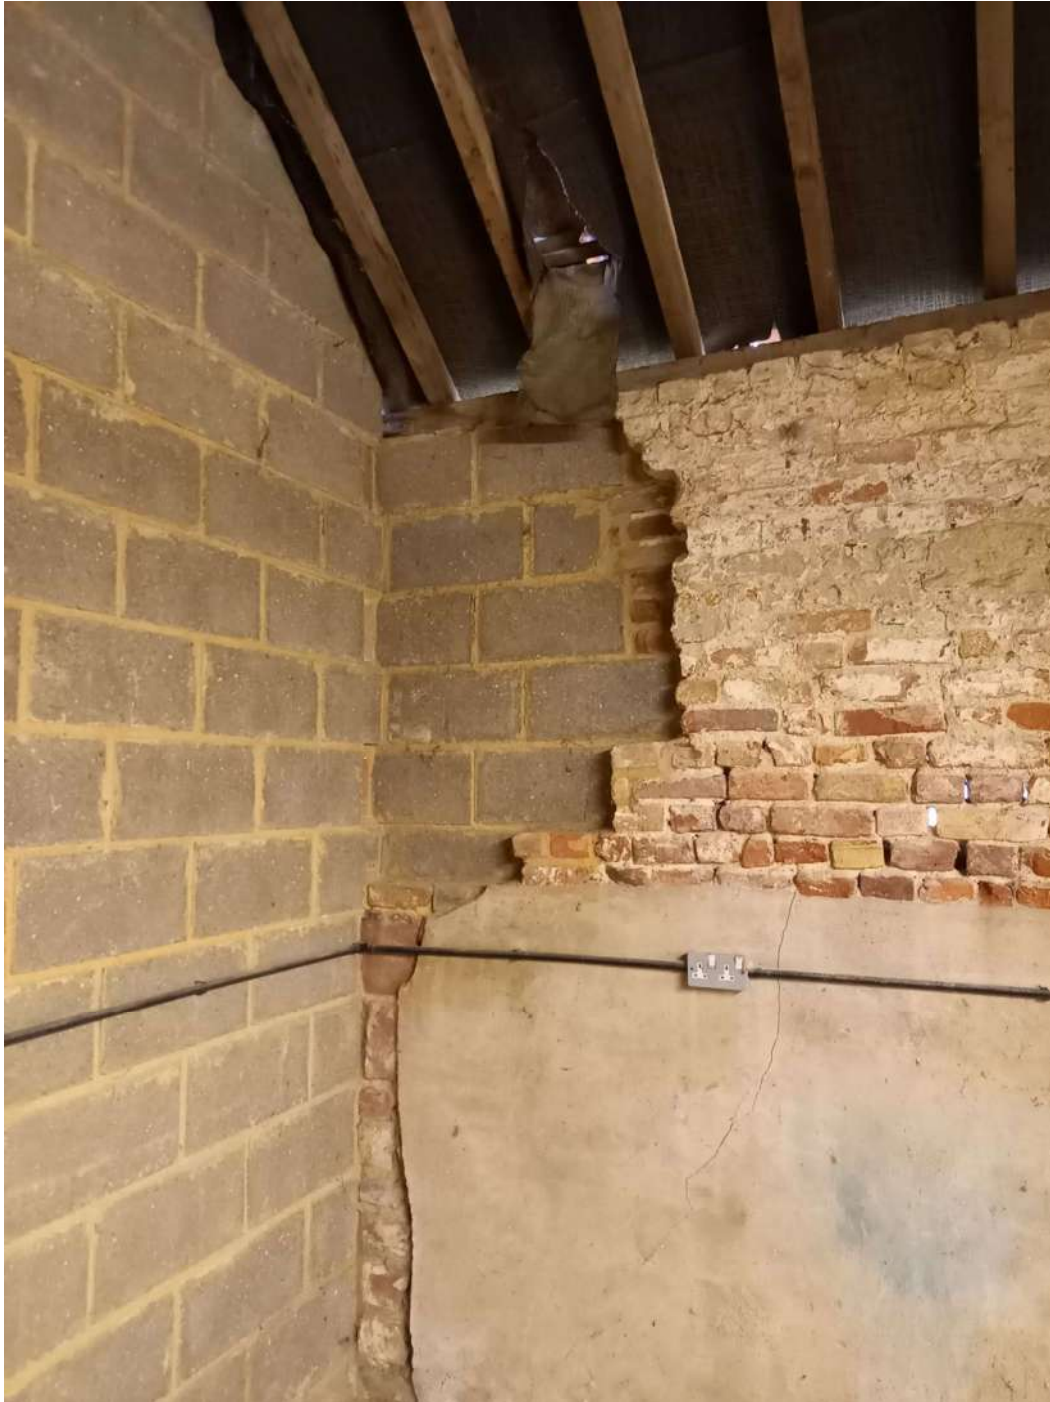
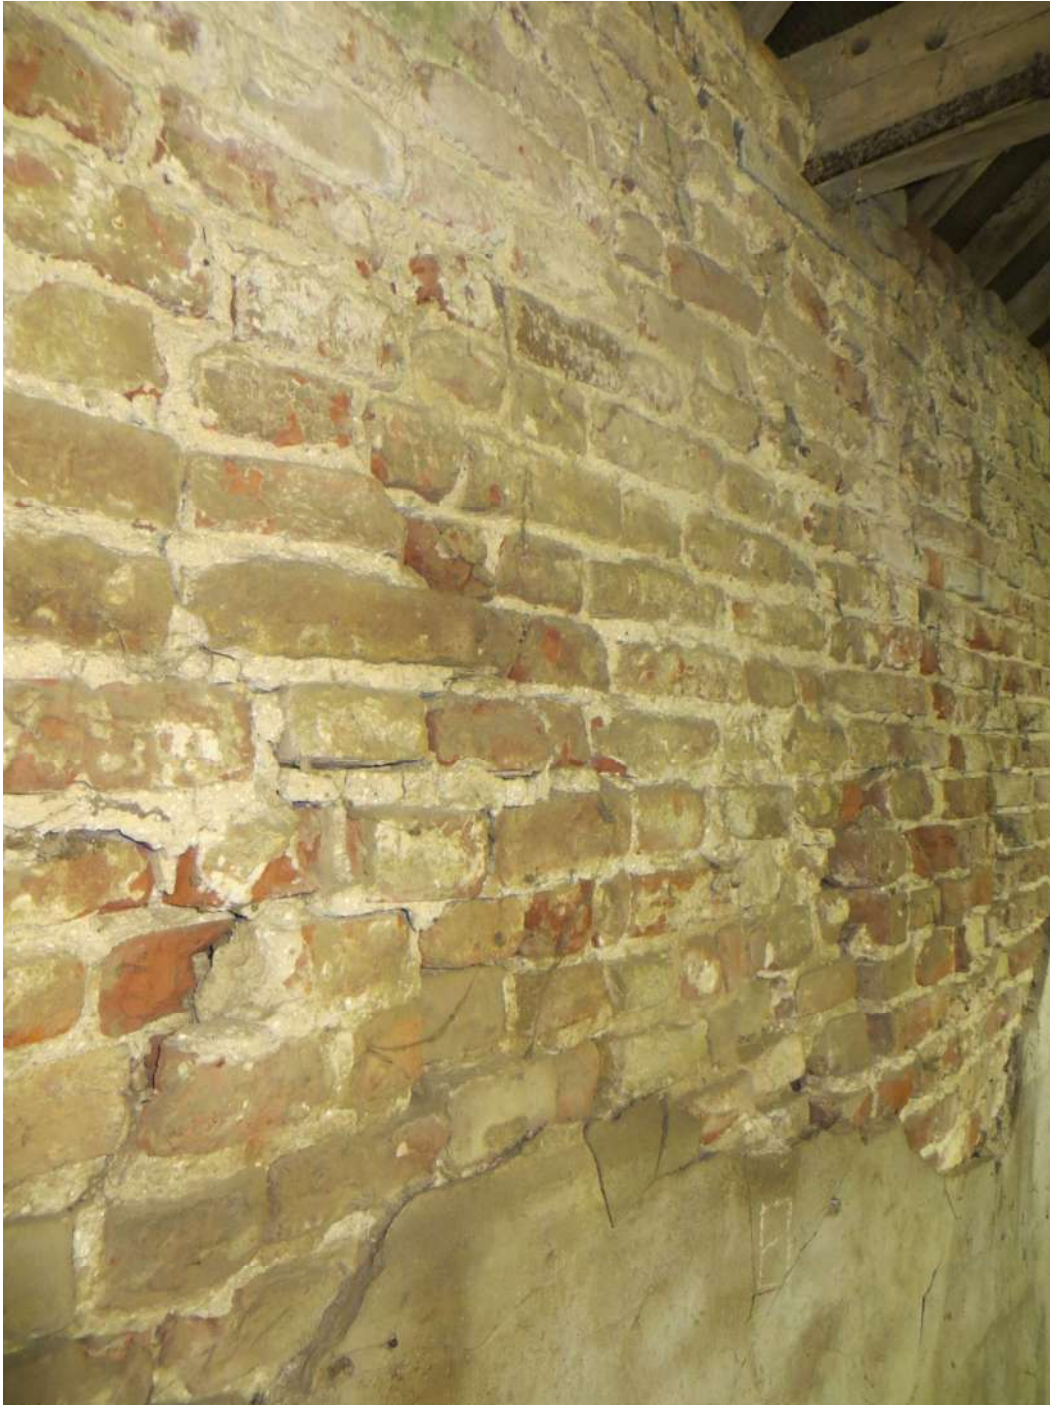
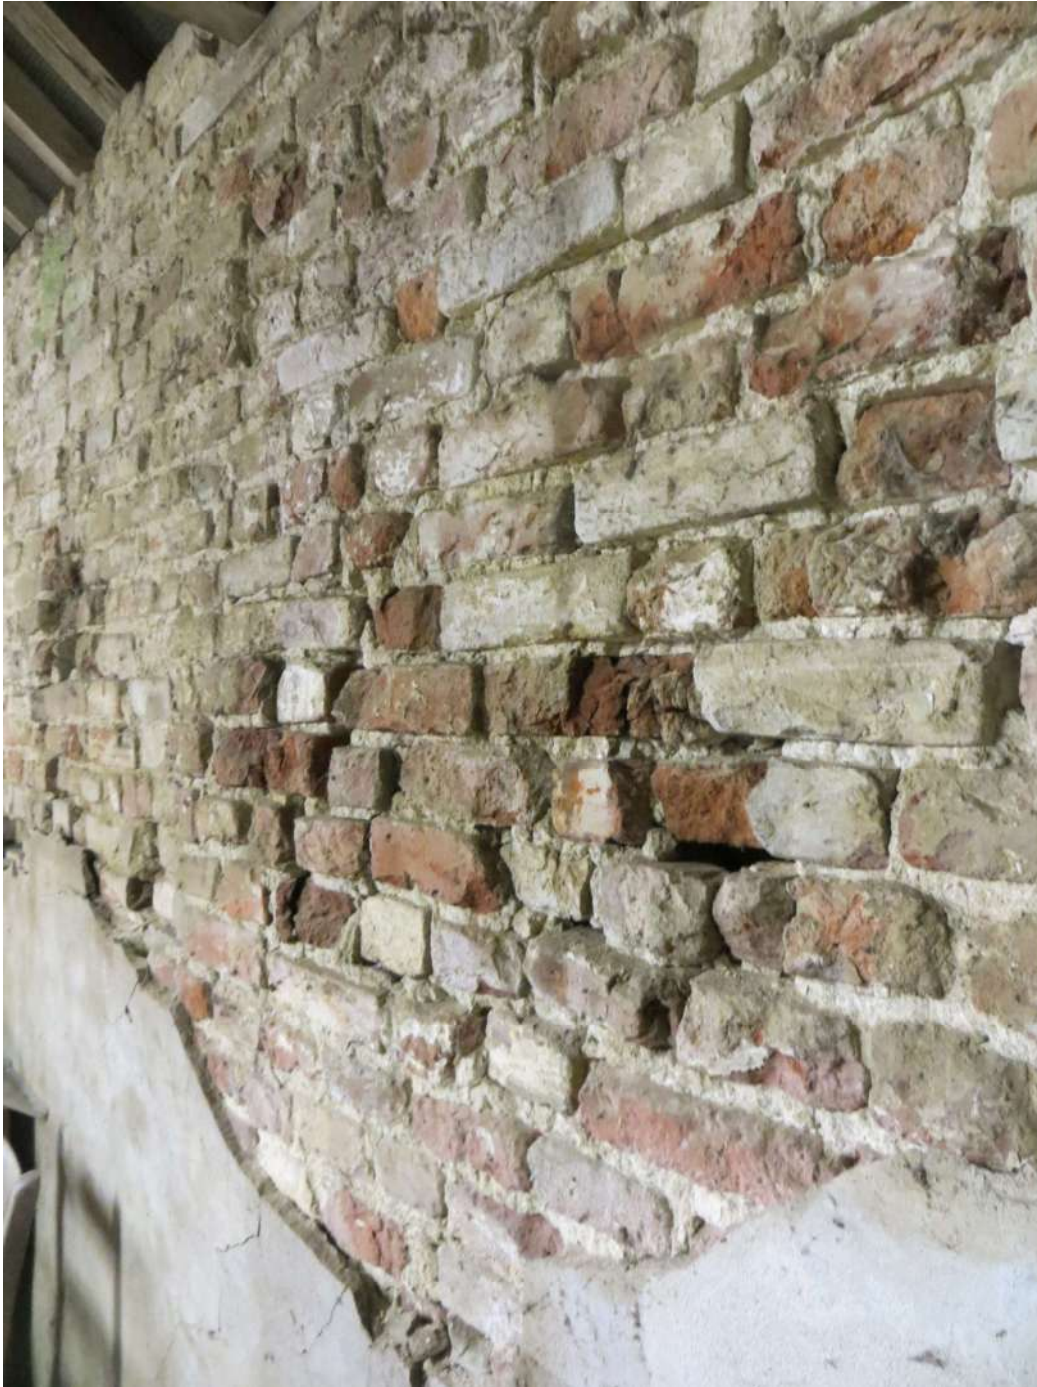
An inspection within the left room revealed that the masonry is exposed on the left gable wall and the rear elevation. Inspecting the left gable wall reveals no significant defects. Inspecting the rear elevation reveals a hairline crack at the junction between the modern blockwork and the historic masonry. See Photograph 11. Centrally within this room, the impact observed externally is present. This is evident in a 30mm bulge in the brickwork with associated cracking, varying in width between 1 – 5mm. See Photograph 12 and 13.

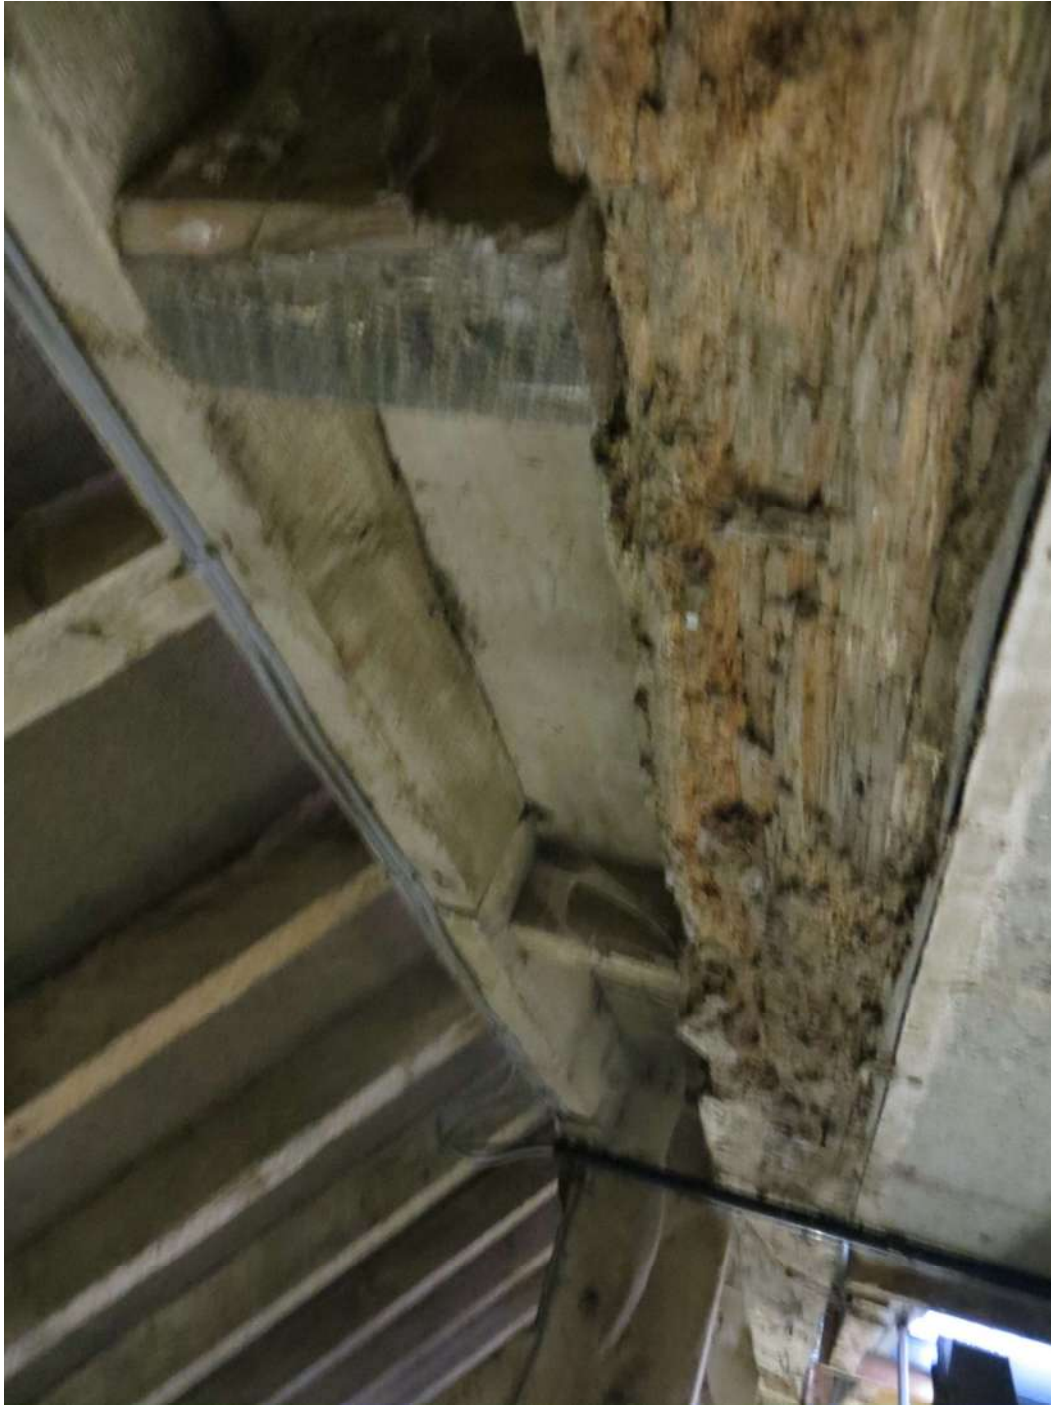
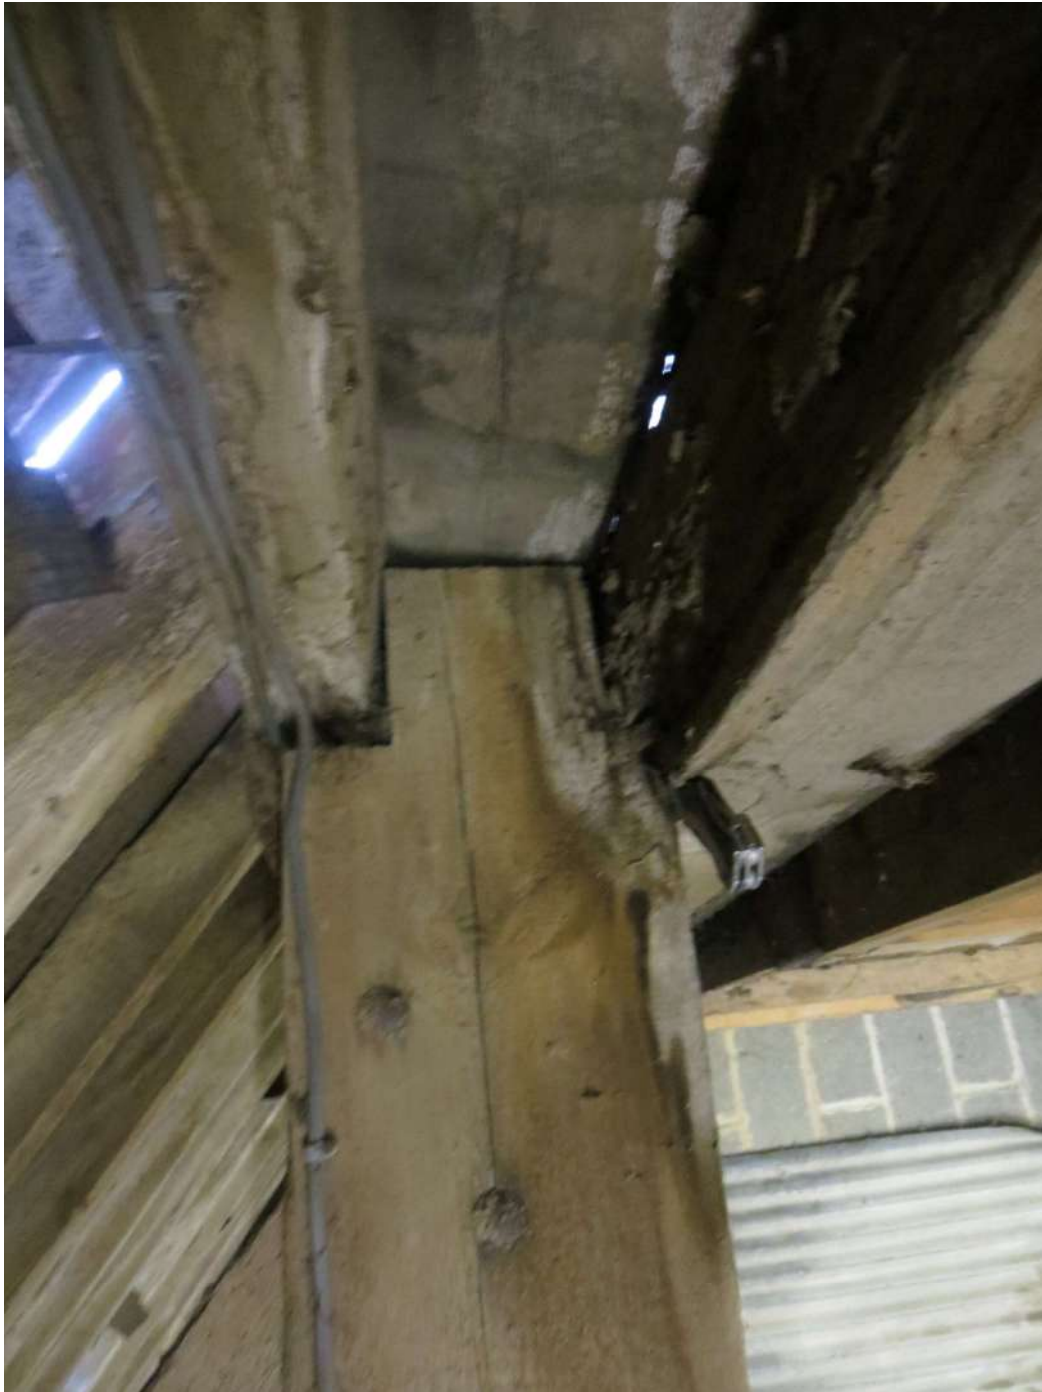
The eaves member along the front elevation shows evidence of surface rot on the top face, indicative of standing water. Staining is also present on some of the rafter feet. See Photograph 14 and 15.
