Healey Court Farm

Trial Pit Investigation and Structural
Feasibility Assessment

WBC Document Ref: 3230079-WBC-XX-XX-RP-S-20001
Revision: P01

Issue Date: 02 June 2023

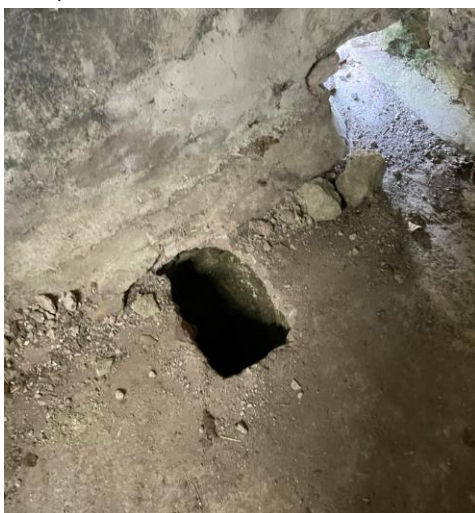
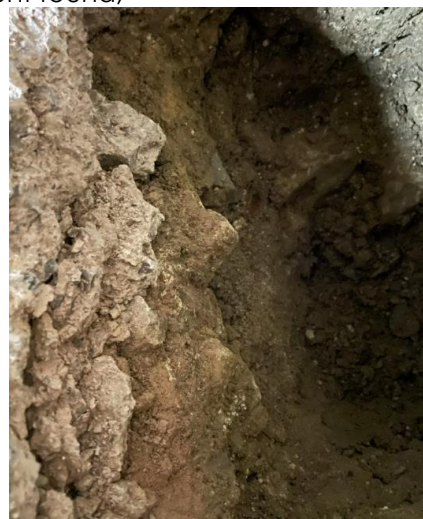
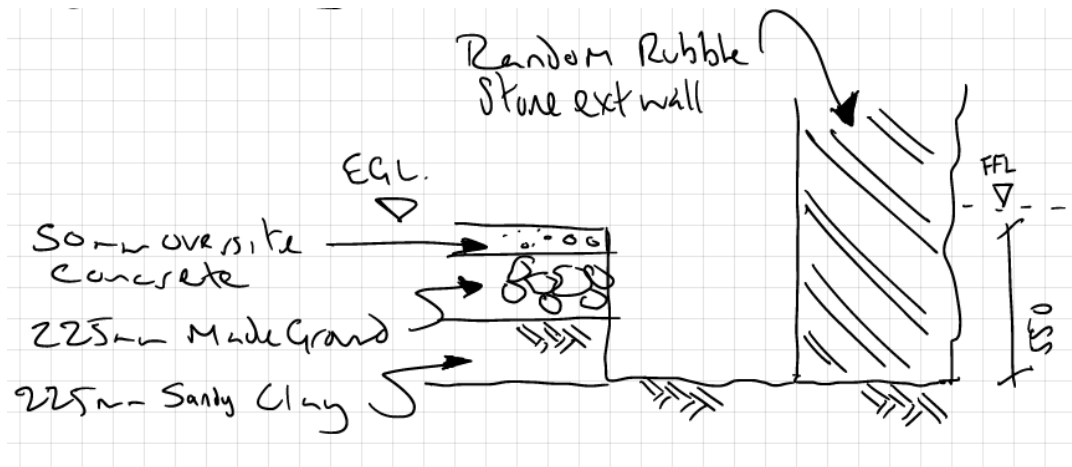
4.2.1 Trial Pit 1

Trial Pit 1 was excavated to the internal areas through the existing concrete slab. It exposed the thickness of the slab to be 50mm over 225mm made ground and 225mm thick firm sandy clay. The footing consisted of a large rubble stone laid on compacted clay formation material. Footing level approximately 400mm below ground level.

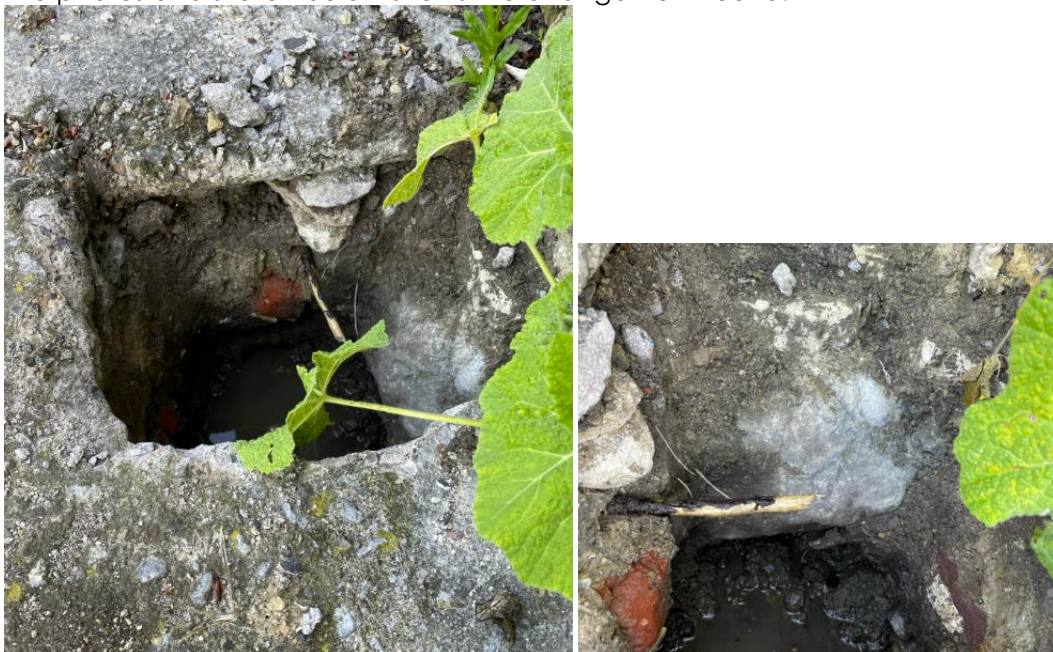
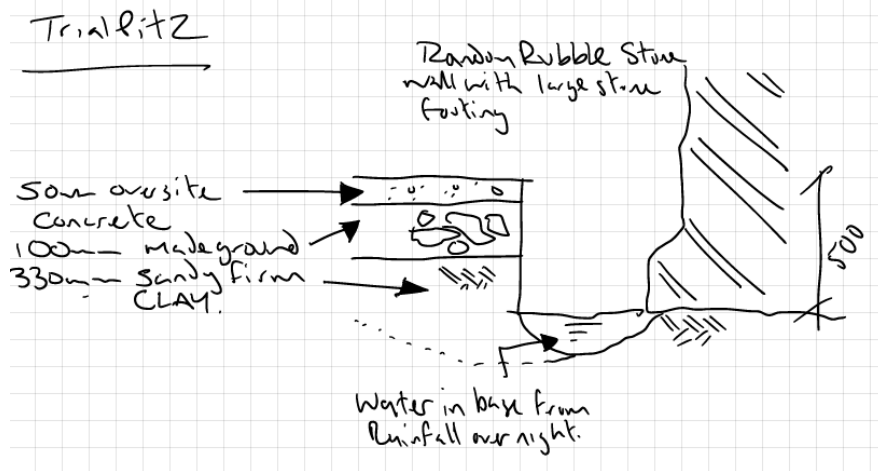
4.2.2 Trial Pit 2

Trial Pit 2 was excavated externally on the other side of the wall to TP1. This confirmed the arrangement for the external slab as 50mm also, over 100mm made ground with bricks noted over sandy clay and confirming the large rubble stone footing is full width of the wall.

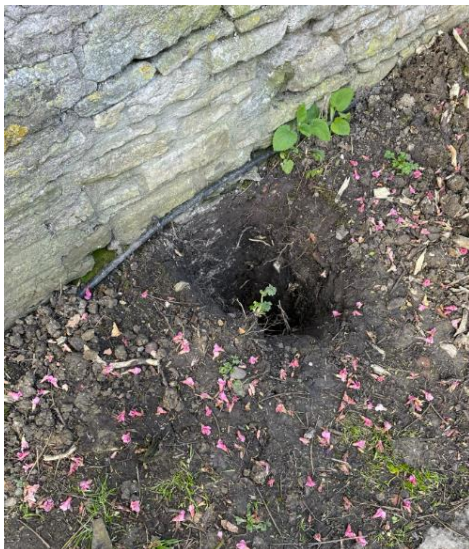
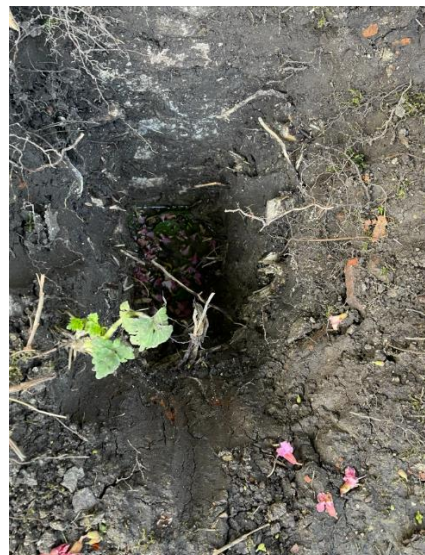
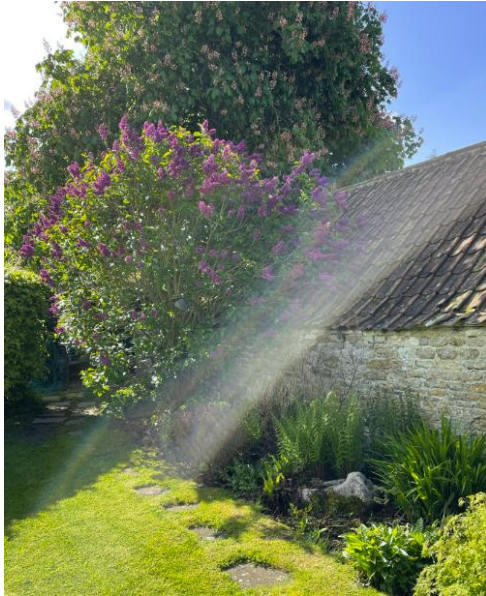
4.2.3 Trial Pit 3

Trial Pit 3 was excavated externally. It confirmed the depth of the footing to be around 700mm below ground level, with the ground raised by top soil and roots by around 500mm. The material at the base of the footing was noted as firm Sandy Clay and the wall was served by coursed rubble stone footing.

A large tree is noted around the corner to the gable end wall. The roots of the tree were abundant in the top soil of the

The presence of a large mature tree circa 500mm from the foundations should be addressed. The potential removal of the tree should be a last resort and other options should be explored fully before undertaking the removal of the tree.

On this basis, it would be essential to install a root protection system to the external face of the stone wall to reduce the impact of tree roots on the wall. The barrier ideally would be located below the footing level, circa 300mm below – reference to the manufacturers guidance would confirm this requirement.

Additionally, the new internal ground floor slab should be keyed into the existing footings via stainless steel dowels to prevent relative uplift from the roots.

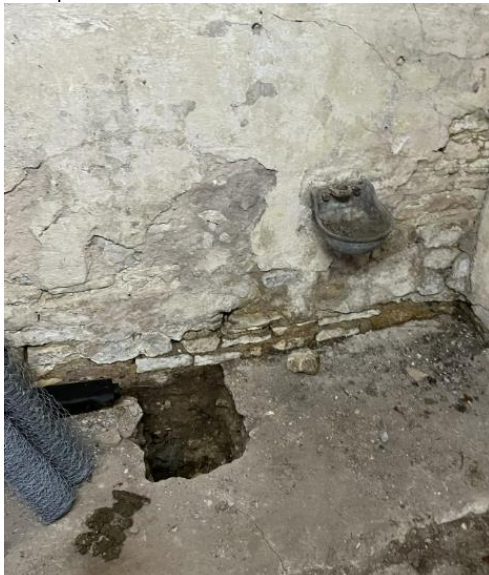
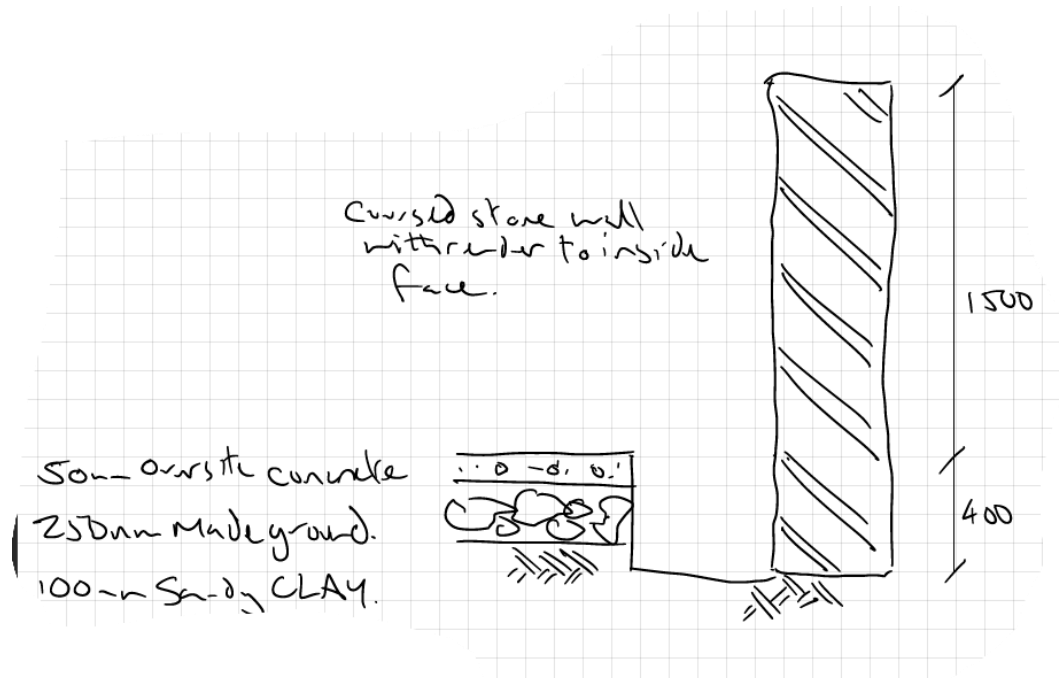
4.2.4 Trial Pit 4

Trial Pit 4 was excavated internally and exposed 50mm thick oversite concrete slab over 250mm made ground. The material below consisted of sandy Clay and the formation of the foundation consisted of coursed stone footings bearing directly to the clay at around 400mm below slab level. There was approximately 400mm level difference between internal and external areas.

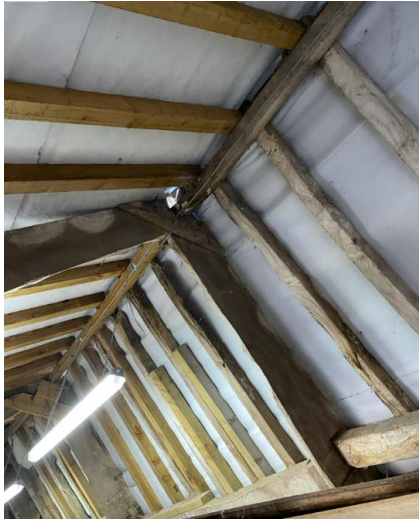
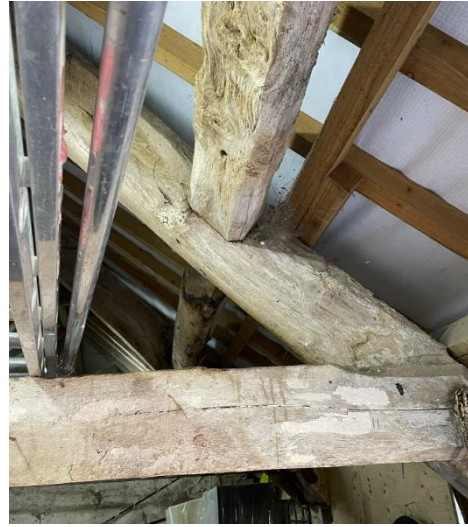
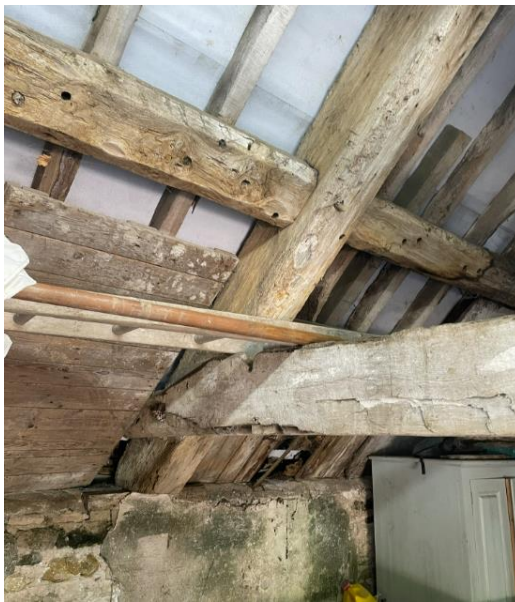
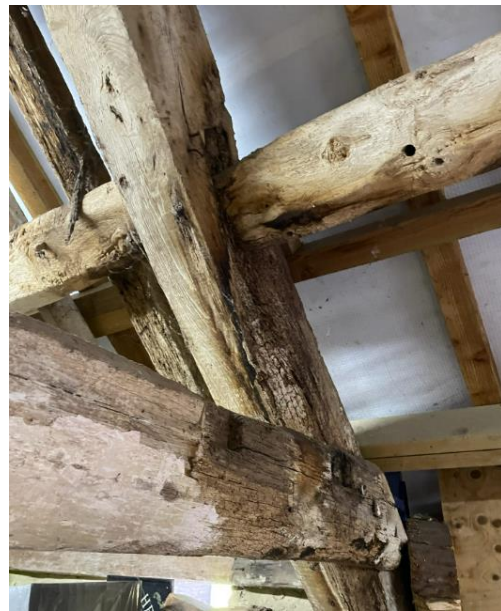
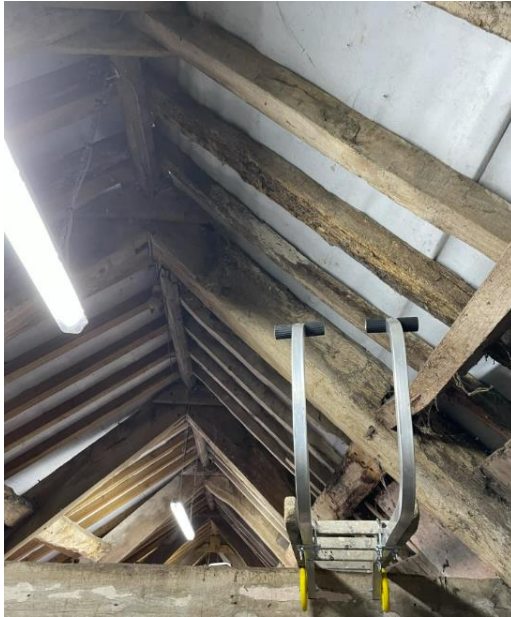
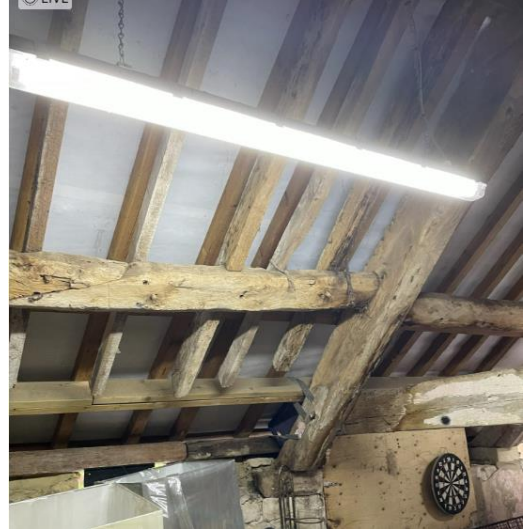
4.2.5 Roof Assessment

The existing roof arrangement consisted of large hardwood, assumed Oak, trusses supporting purlins at the mid span of the common rafters. The common rafters had severe water damage where they had not been replaced by common softwood members. The rafters currently area exposed, with breathable membrane, battens and roof tiles installed over.

The trusses form bays around 2.2m – 2.6m wide and span approximately 3.9m. The trusses are formed by varying sized timbers, commonly these consist of 330mm x 100mm inclined members and 230mm x 80mm bottom chords. The bottom chords are raised approximately 300mm above the eaves level. Purlins are typically undersized for the loads applied and several have failed along the South elevation.

The existing timber rafter arrangement consists of damaged original members and replacement members of unsuitable sizing to accommodate modern habitable load arrangements. It is recommended that all rafters are removed and replaced with arrangements of suitable depth.

The existing purlin arrangement will be removed, with the originals assessed against the minimal size as determined by the structural assessment. If the condition and size of the member is suitable these will be reinstalled, if not, these will be re-purposed for other elements within the proposed works.

The existing timber trusses will be left in place, with temporary propping installed following the removal of the other members. The collar of the trusses are to be lifted, with an assessment against the applied loading undertaken during the principal design phase.

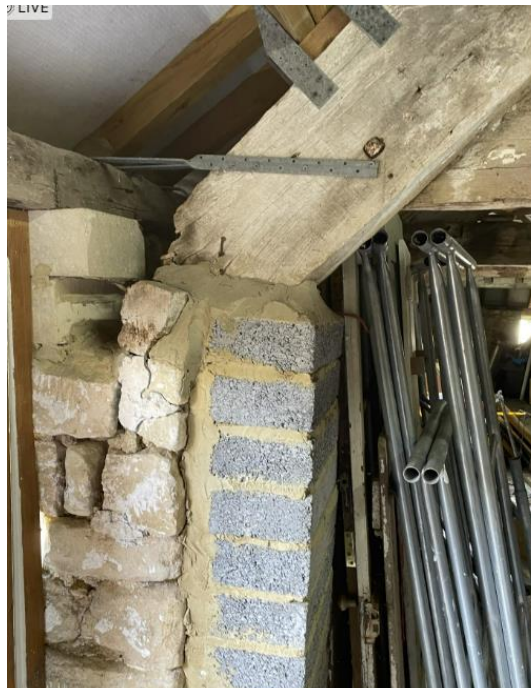
The existing masonry formation within the wall panels are generally satisfactory. There are patches where suitable works are required to be undertaken to improve and enhance the durability of the wall structure.

The openings have had remedial works to accommodate new door formations, these have been formed in blockwork and may not co-ordinate with the proposed architectural strategy. These should be reduced down and reformed using stone facing matching the external faces.

Around the wall plate level loose stones are common and should be reformed and embedded in a suitable lime mortar mix.

The internal areas were used to store livestock have had cement render finish. It is recommended to undertake removal of the render in test areas to assess the ease of removal and the extent of bonding to the stone substrate. If significant damage is caused by removal, it is recommended to remain and ensure details around do not effect the breathability of the wall panel.
