Building Survey:

Castle Farm
Wragg Castle Lane
Pitchcombe
Stroud
GL6 6LU

Date: 23/06/2022

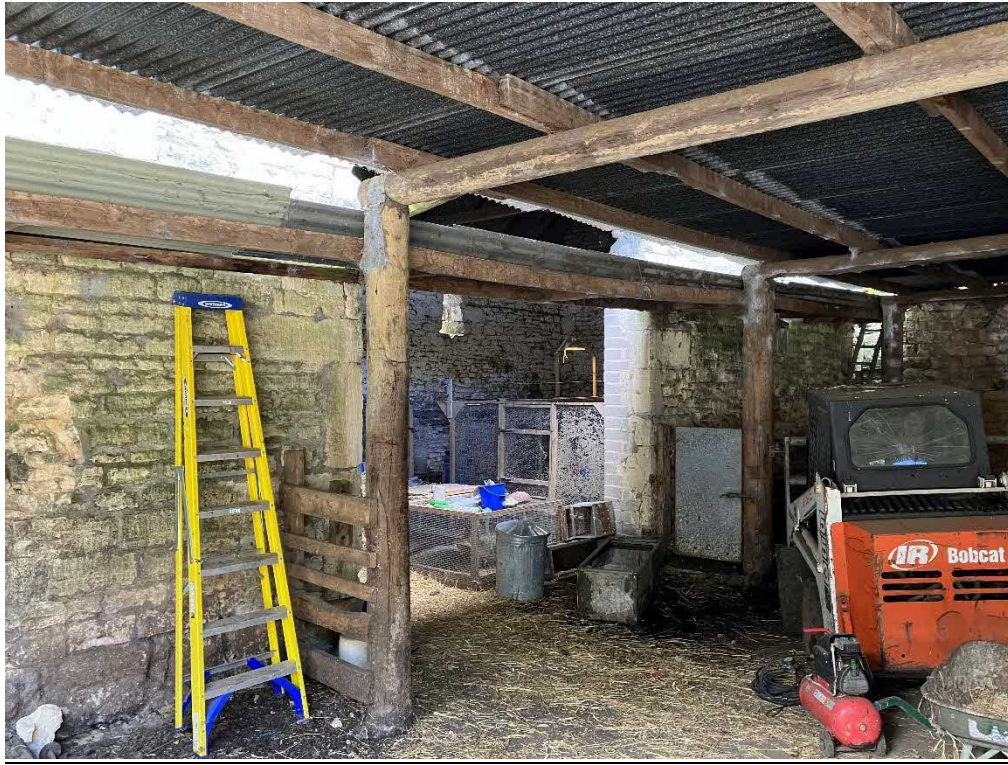
Figure 1 - Overview of barn through view of cattle store

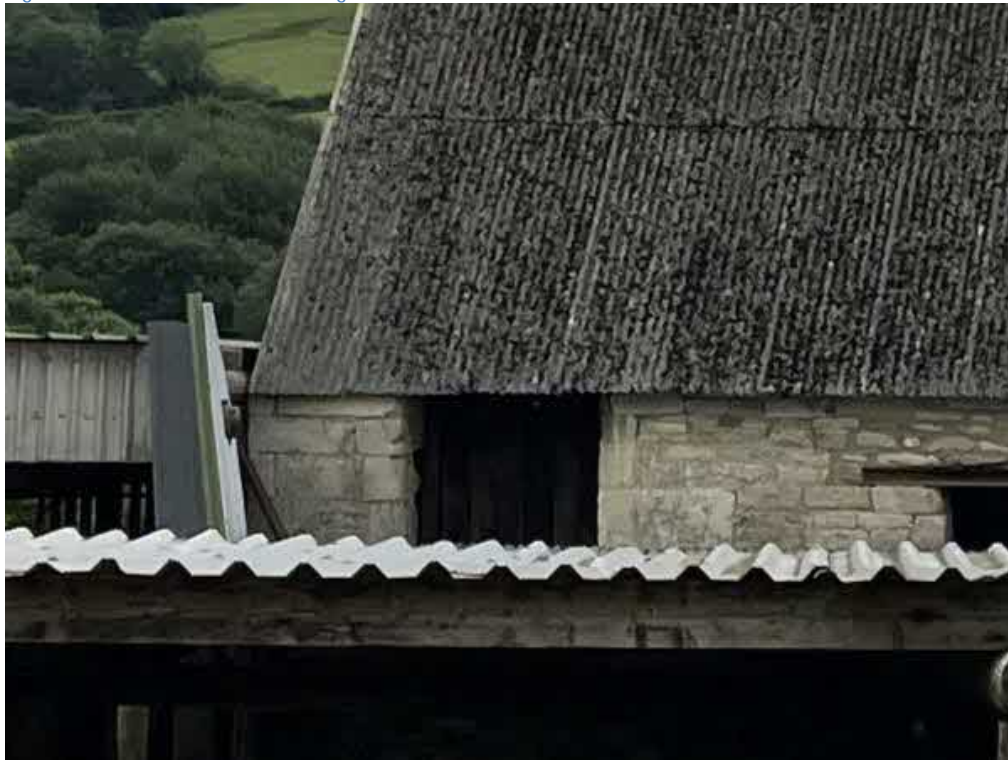
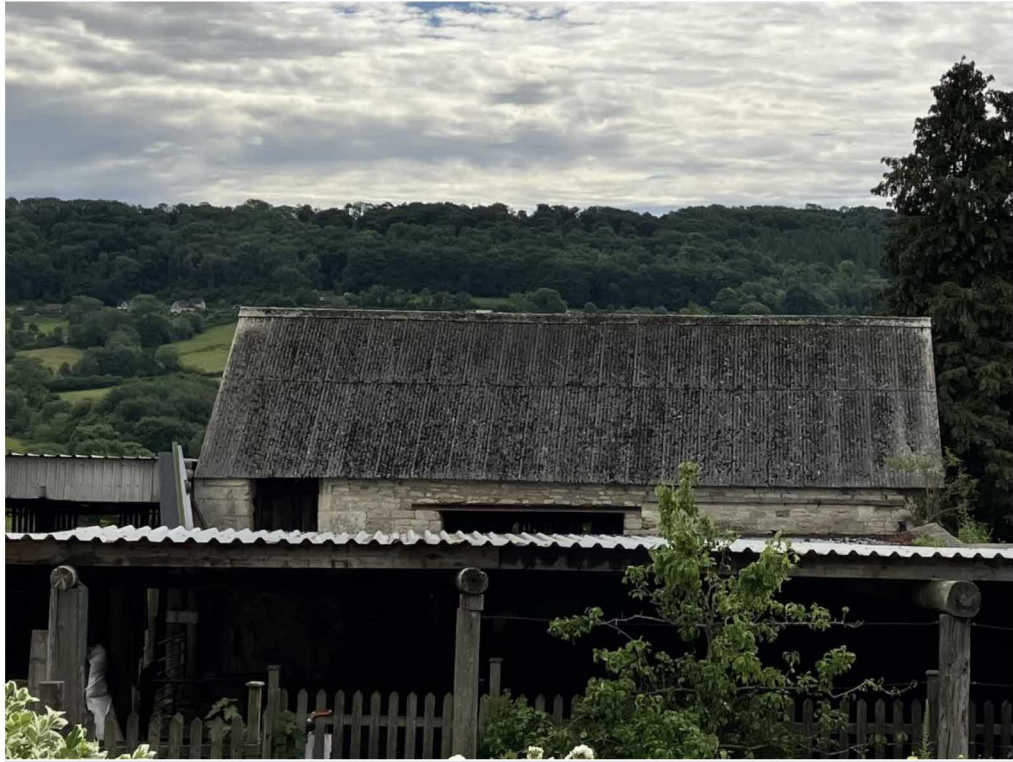
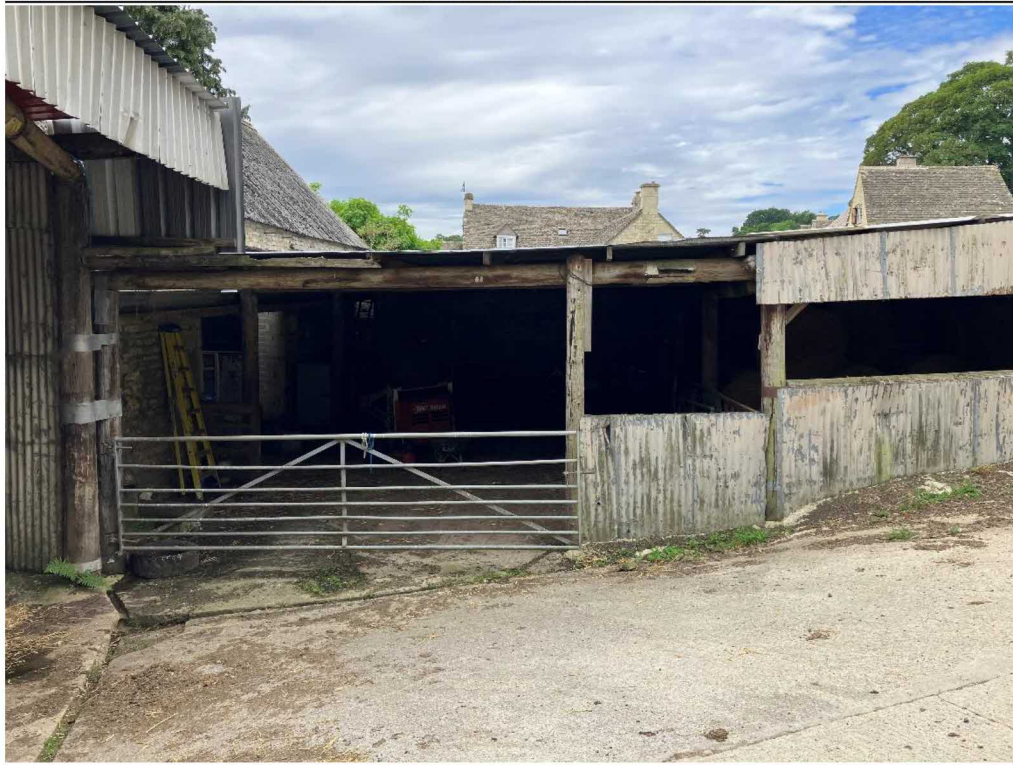
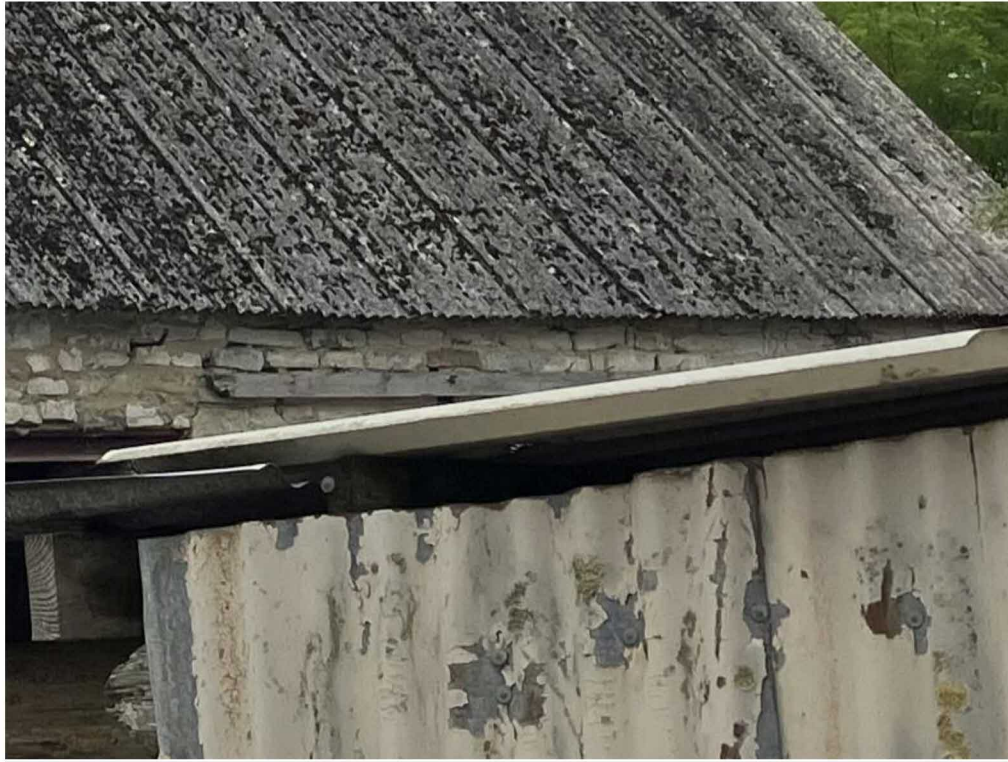
Externally the roof generally appears to be in reasonable condition although is covered with a fairly heavy build-up of moss and to the rear corner it appears that vegetation has grown up over the edge of the roof that requires cutting back prior to any conversion.

Figure 2 - Asbestos roof sheeting and external images of roof / high level wall structure

As the roofing material potentially contain asbestos which is hazardous to health, it is suggested that the opportunity to remove this finish and replace it with a lightweight covering before conversion would potentially advert any contamination to a habitable space in the future. There are several ways in which the roof structure could be converted to habitable use, the first of which is to ensure that any new roof covering has a breathable membrane, this would allow for 75mm of celotex to be installed between the rafters and underdrawn with a 50mm celotex insulation board, vapour control layer and 12.5mm plasterboard.

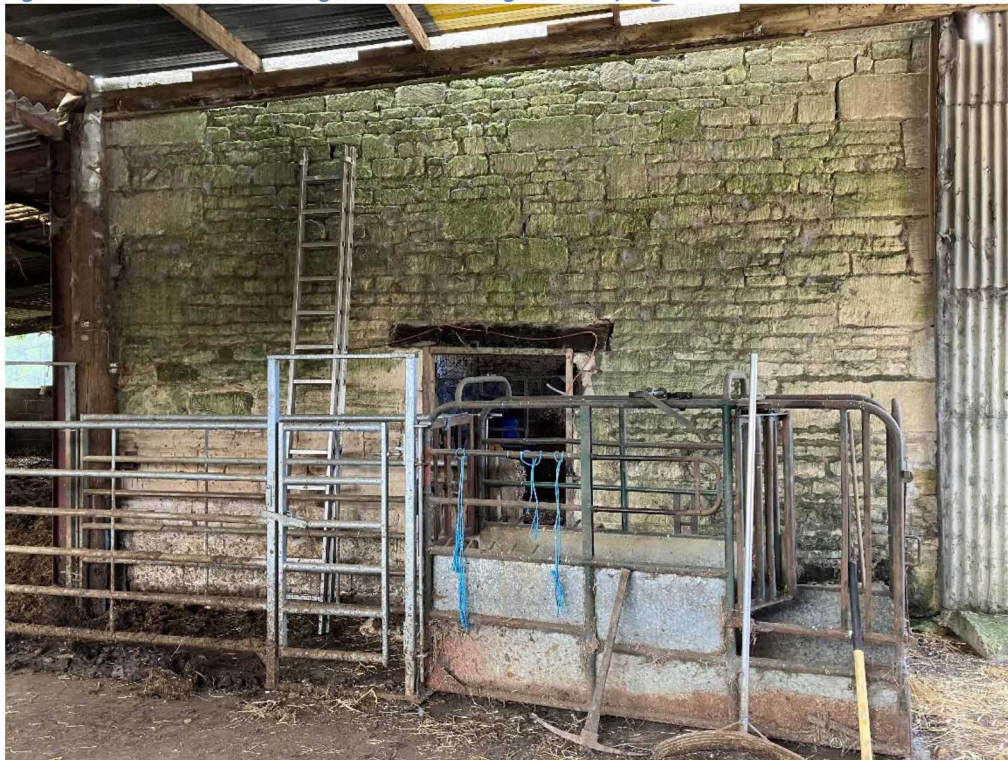
Figure 3 - Rubblestone walling

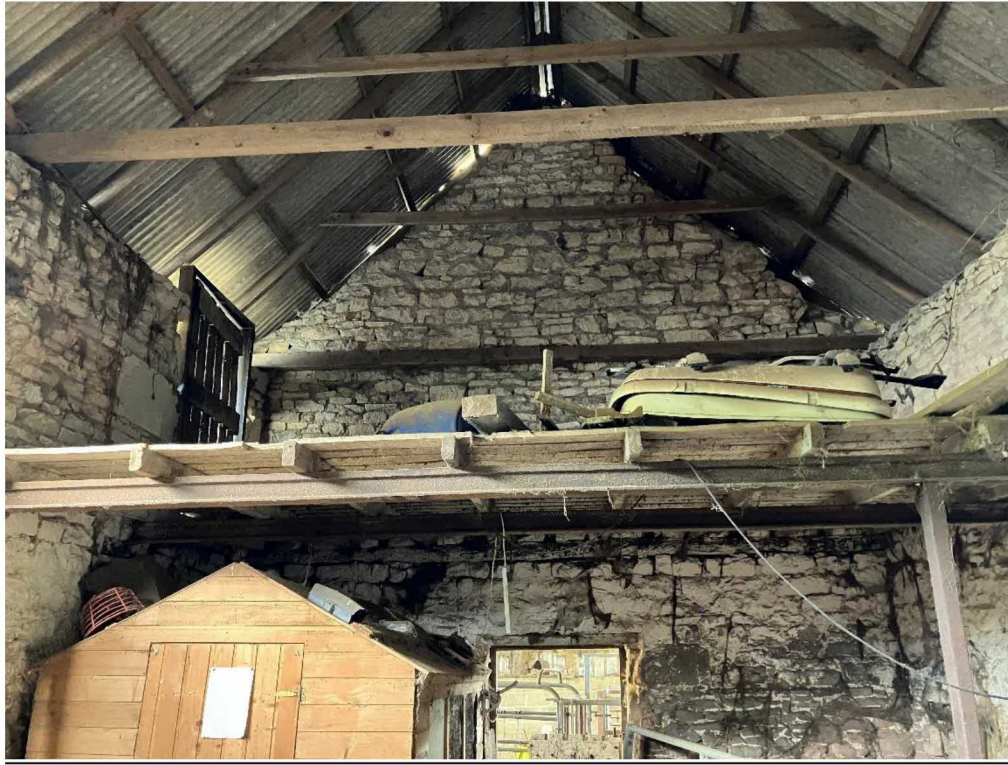
The mezzanine deck structure is timber joists at approximately 700mm centres, laid over this are painted timber floor boards all of which appear to be suffering heavily from insect attack and it is recommended that the floor covering is replaced and the retained timbers treated for insect attack. The steel work is showing signs of surface corrosion although it is likely to be structurally sound. The connection detail at slab level of the posts cannot be seen at this time and subsequent further

Figure 4 - Internal view of main barn and timber mezzanine storage area

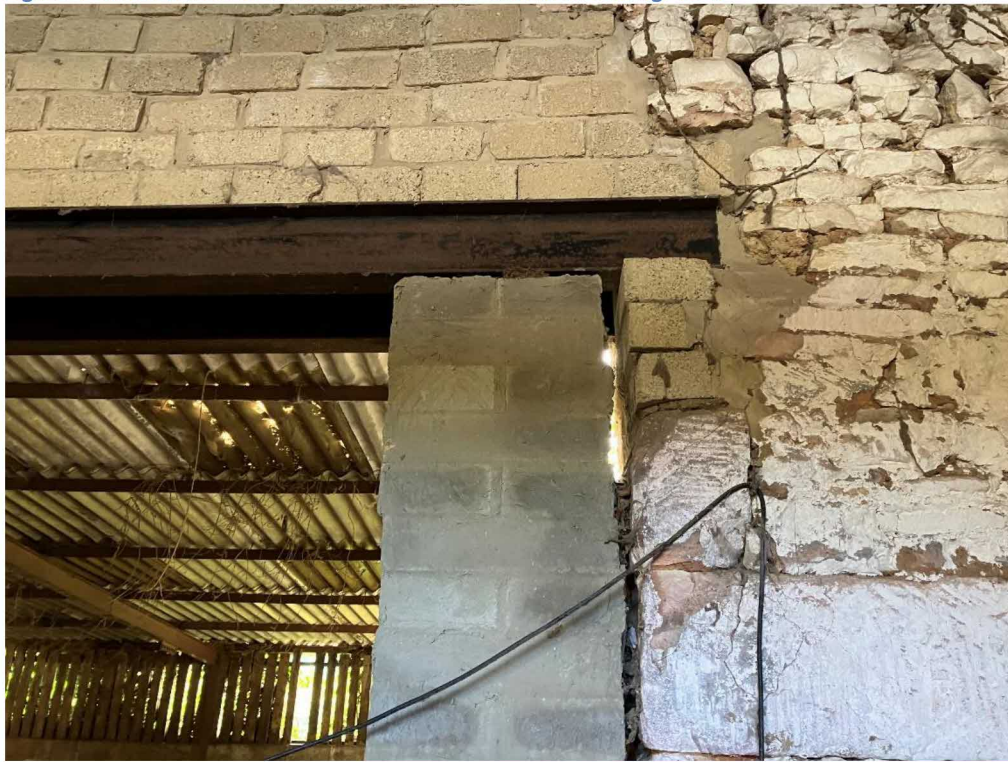
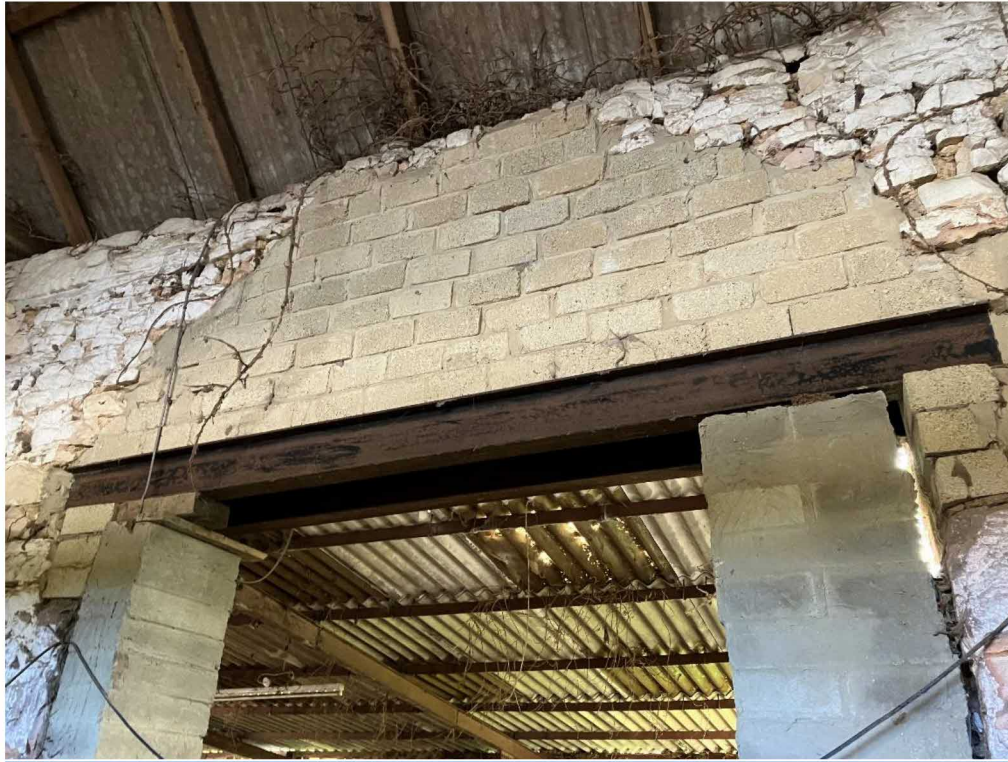
To the opposite side of the barn there is an opening through into another lean to barn area. There are two steel beams running across at high level forming this opening, these appear to be suffering from heavy surface corrosion. Above the beams it appears that the wall has been removed or collapsed previously and has been rebuilt in block work. The block work appears to either side of the opening at low level, this has also been reconstructed in blockwork and have been covered in what appears to be a Vandex tanking slurry.

Figure 5 - Historic steel beam sat on pad with more modern walling addition above

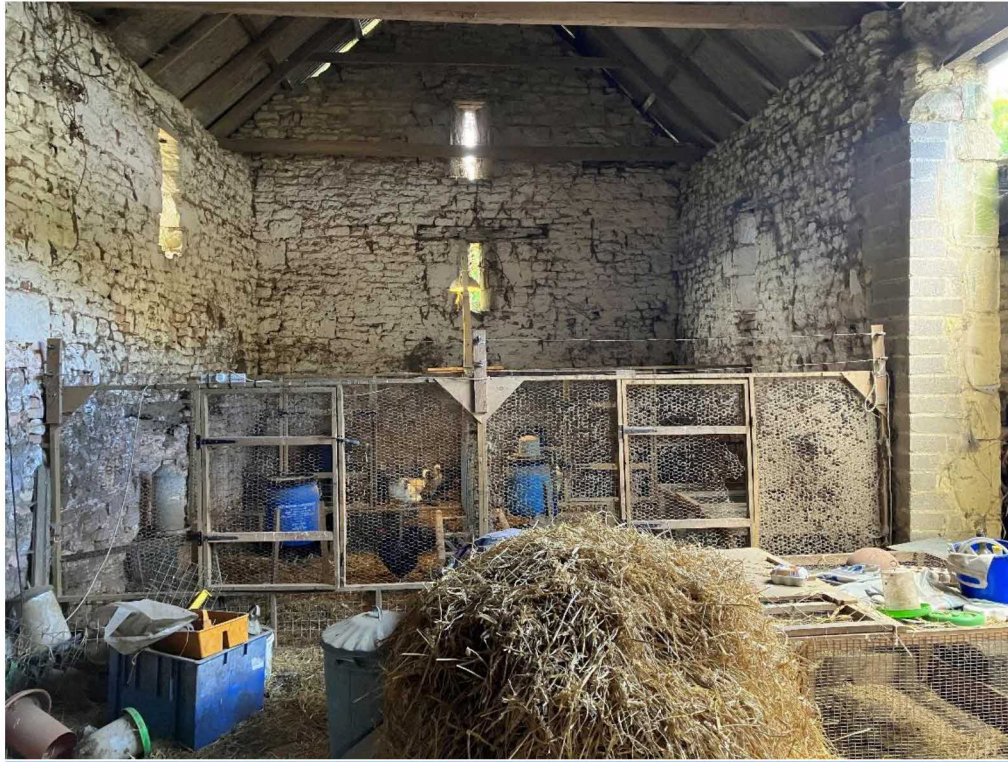
Figure 6 - Internal view of rubblestone walling in main barn

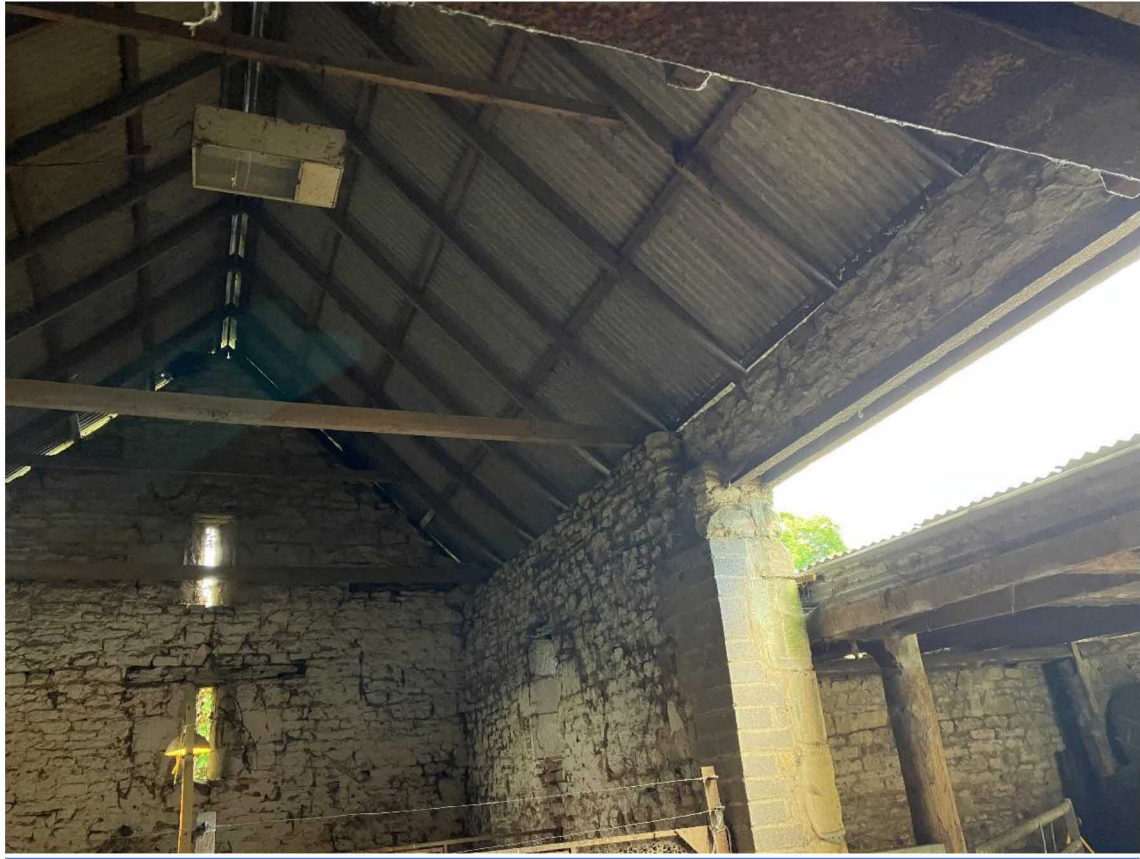
The roof is covered with an asbestos cement sheet throughout, these sheets are laid over a timber substructure and 50mm x 100mm timber rafters at approximately one meter centres over the top of these are timber binders, the binders being 75mm x 50mm laid across again approximately one meter centres. There are ceiling ties at high level on three / four of the trusses and three ceiling ties which appear to be approximately 75mm x 150mm spanning across from front to back. The roof timbers and structure appear to be in reasonable condition although it does contain slight deflection in areas and potential staining from historic water ingress however when tested this is not damp at present.

Figure 7 - Internal roof structure / timbers of main barn
