**REPORT on VISUAL STRUCTURAL INSPECTION  
BARN CONVERSION FOR PERMITTED DEVELOPMENT**

**TOWER VIEW FARM**

**RIDGEWAY**

**NUNNEY**

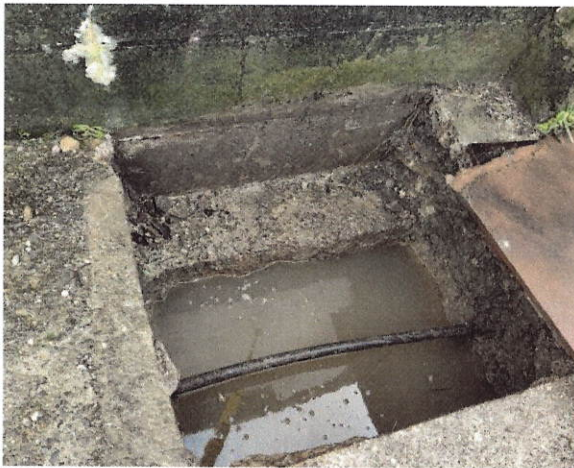
**Figure 4 – Trial pit at SW**

- 2.5 Two trial pits were excavated to allow assessment of the existing foundations and ground. One on the NW elevation, towards the north corner. The other on the SE elevations, towards the south corner.
