ARBORICULTURAL ASSESSMENT REPORT

The Limes, Queen Street, Waddesdon, Aylesbury, HP18 0JW

**PRI Ref:** 261898

**Survey Date:** 02/06/2023

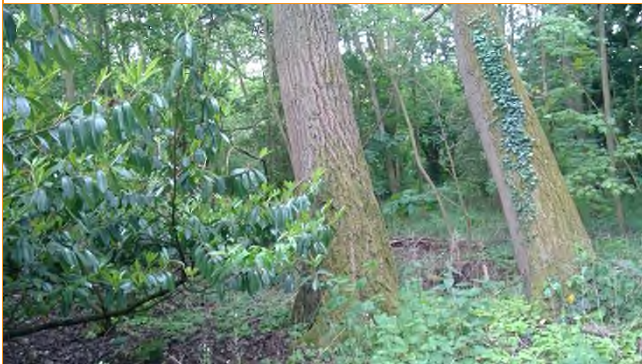
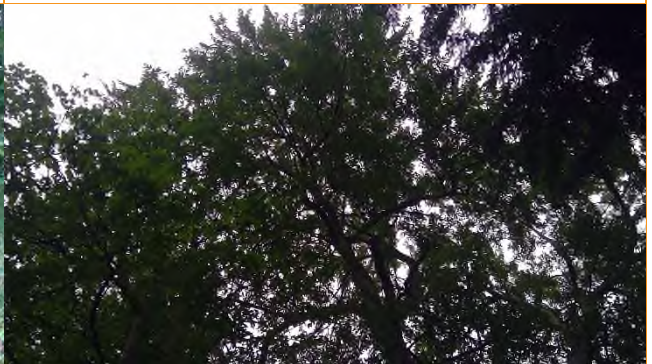
T7 - Poplar

T7	Poplar	Mature	Fair	28.5	16.0*	600*	21.17	N	Subject to past management. No significant recent management.	No work required.	Restricted access.		District Land Registry Search Required	UKN
