STRUCTURAL APPRAISAL

**The Forge
Church Street
Ropley
Hampshire SO24 0DS**

A Report on a Structural Appraisal of symptoms of distress evident to The Forge, Church Street, Ropley, Hampshire SO24 0DS by BSF Consulting Engineers Limited.

Date: May 2023

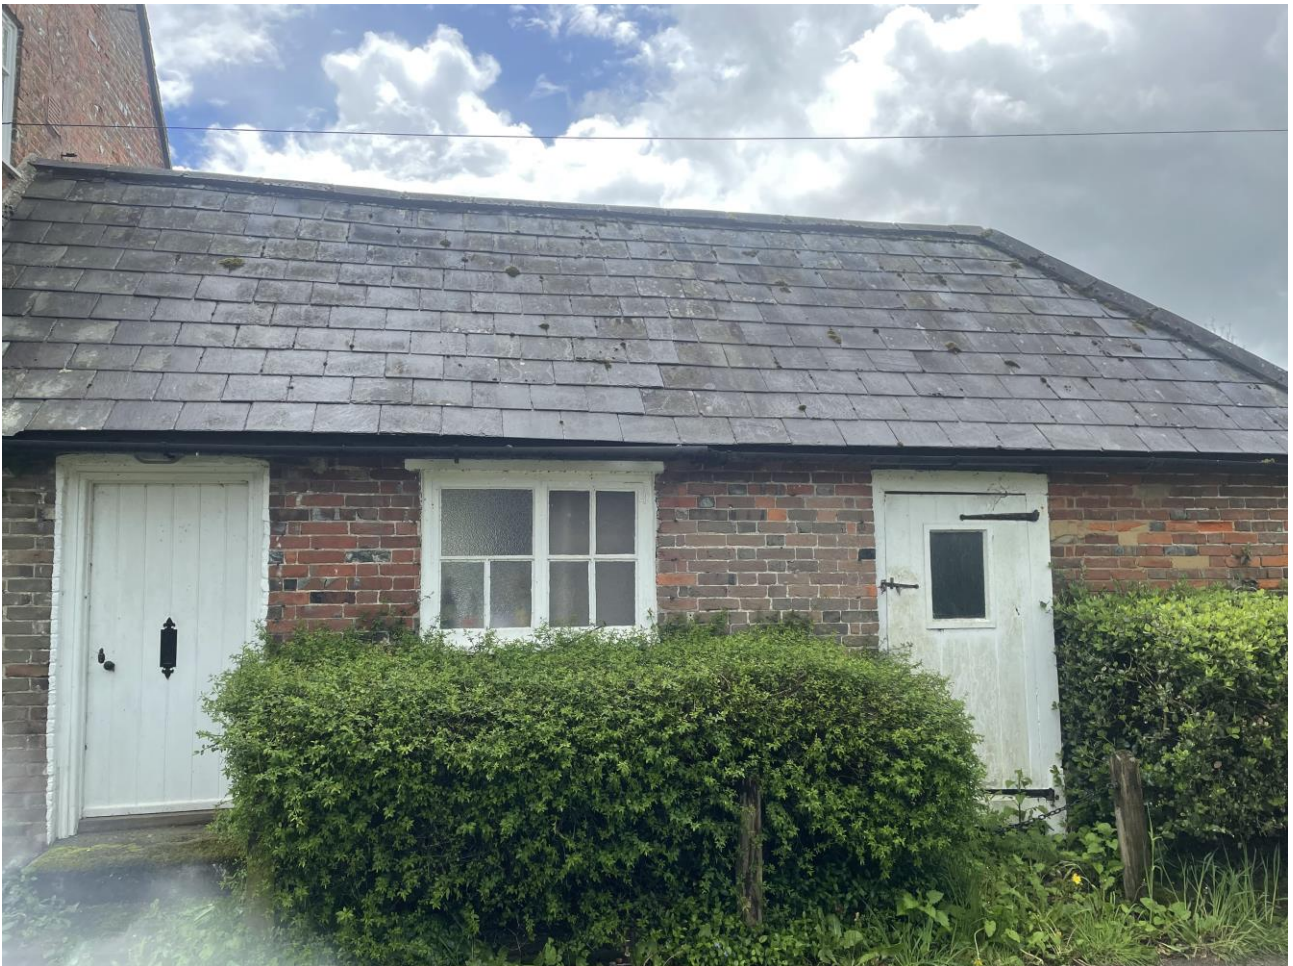
Looking at the property from the road, to the right is a converted stable block which is the same brick masonry construction, pitched front to rear with a hip end on the right hand side and is laid with slate.

The roof over this area was re-roofed during the 1990/2000 with bitumen BS747 Type 1F roofing felt. The roof to The Forge was re-roofed circa 1970/1980 with a bitumen membrane without hessian strips.

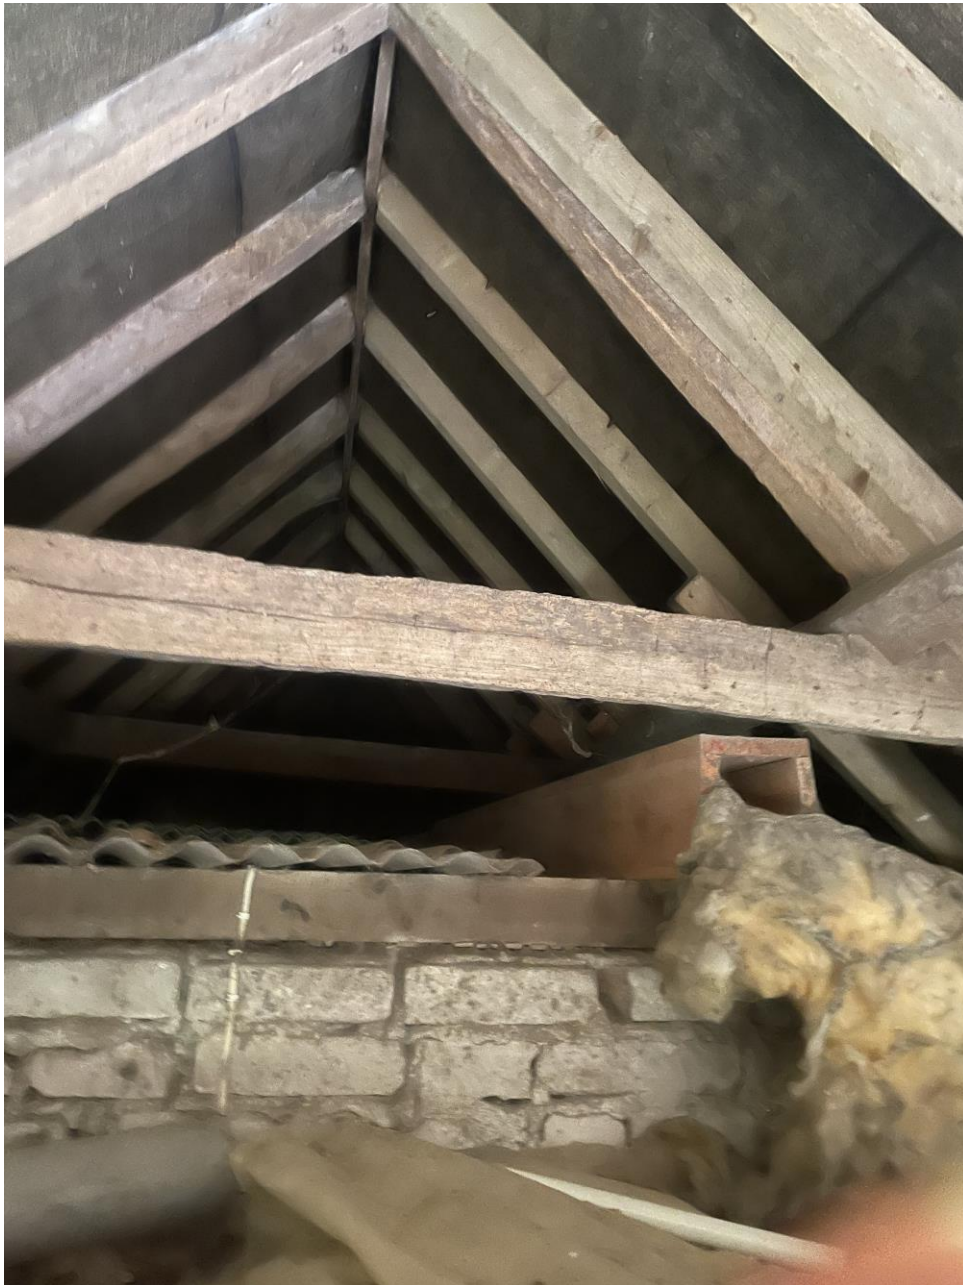
The lathes are machine cut. The lathes are $\frac{1}{2}$ " x $\frac{3}{4}$ " untreated which indicates they are from the late 1970's / early 1980's.

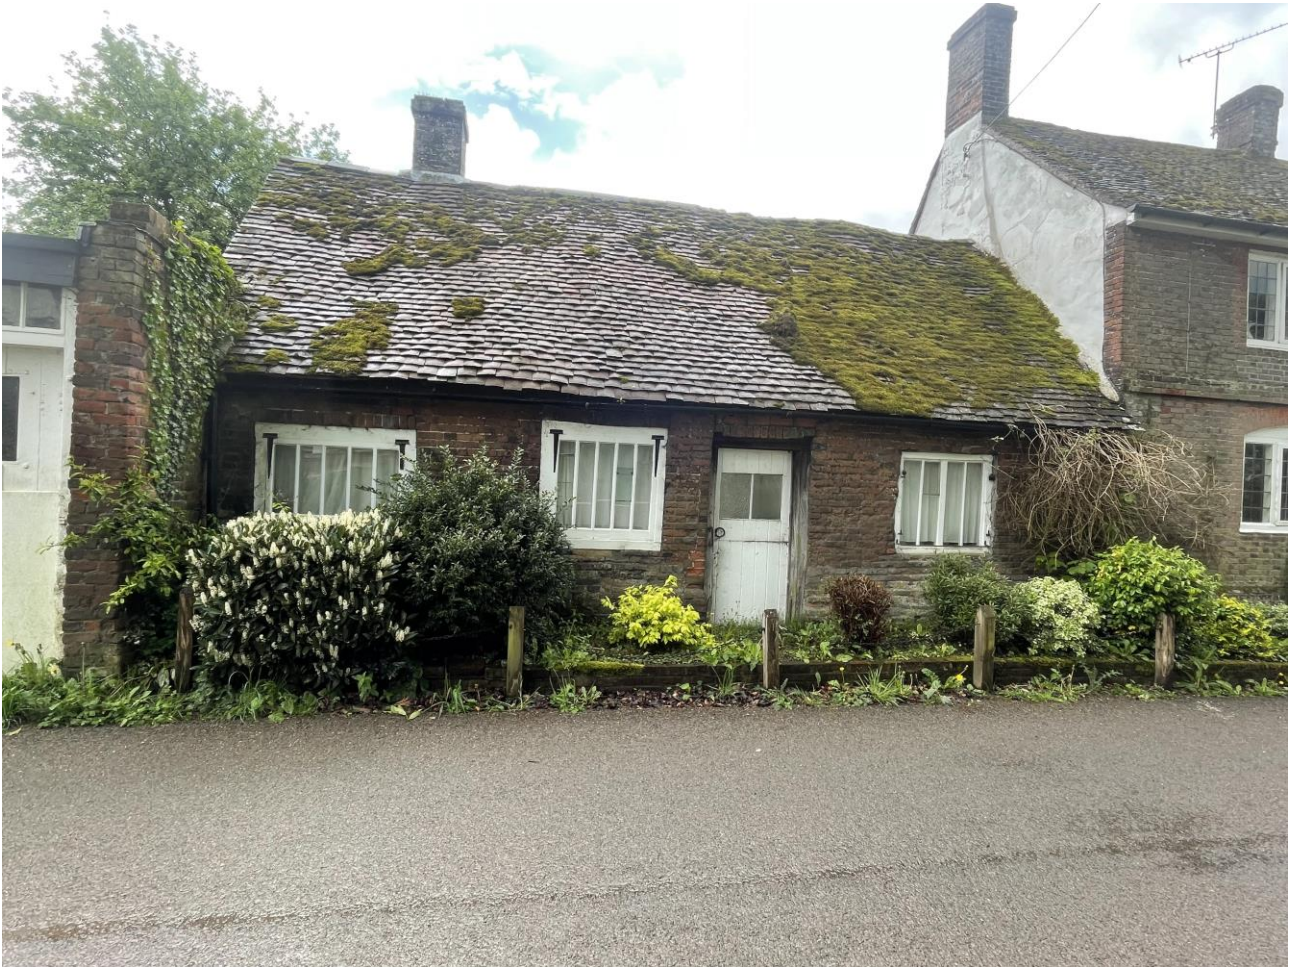
To the left hand side of the building is The Forge which is single storey, solid brick masonry construction with handmade clay plain tiles to the roof and half round Hogsback clay ridge tiles.

6. The roof of The Forge needs an overhaul. Ridge tiles needs to be checked and re-bedded where necessary, the moss needs to be carefully removed, any broken tiles replaced and the eaves to both front and back need to be replaced with a new timber fillet. The tiles should be cut so they fit vertically in the centre of the new guttering.

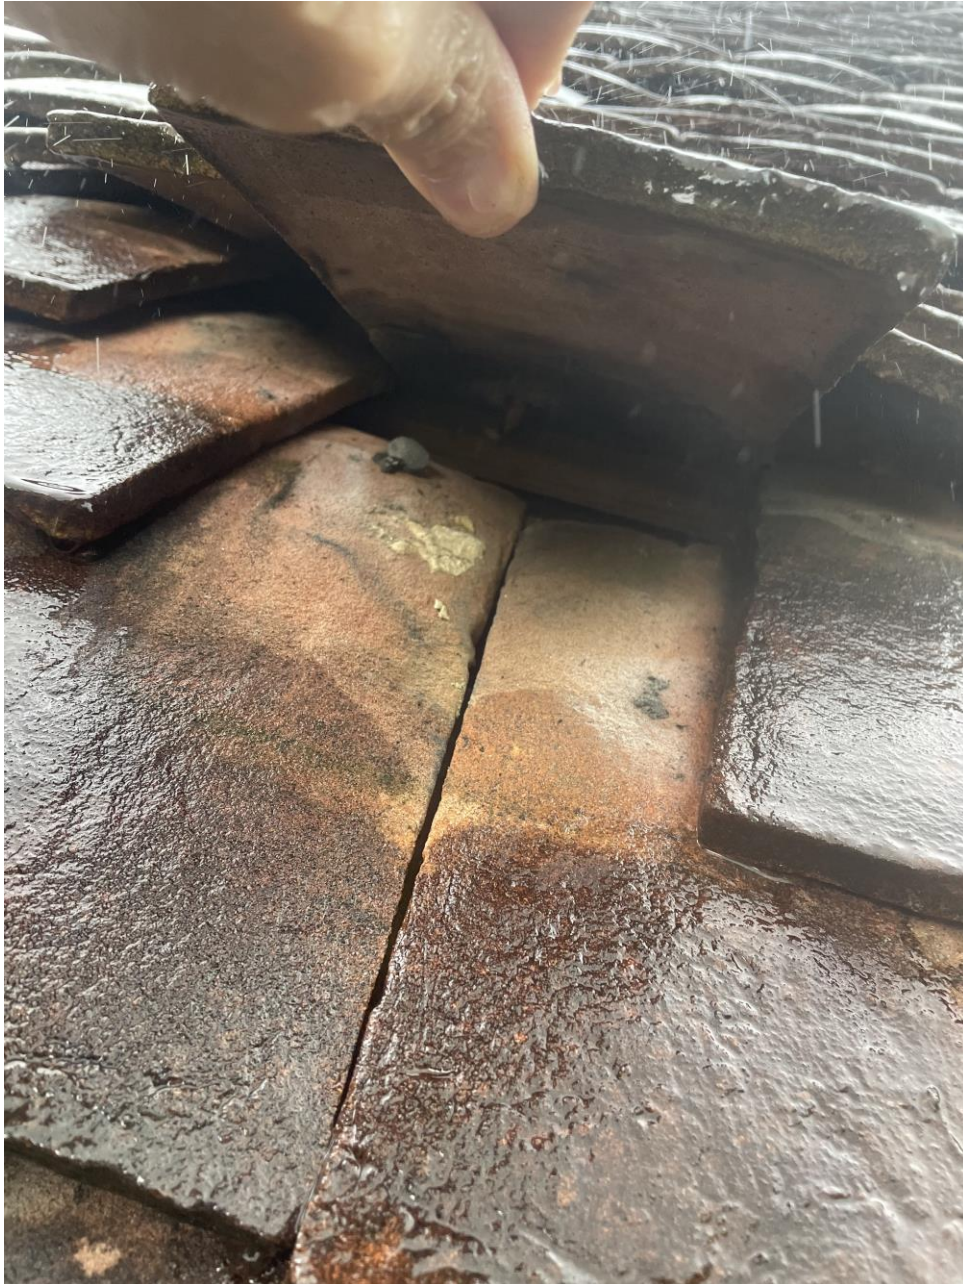
The main roof looks to be in a good condition with cement flashings around the chimney which appear to have pulled away from the chimneys.

The wooden pegs holding the tiles on have been replaced with iron peg drops.

3. The main roof requires a minor overhaul with new tile flashings around both chimneys, again with cut down lead soakers.
4. The gable wall to the main house adjacent to The Forge, requires the cement rendering to be removed and replaced with lime rendering.

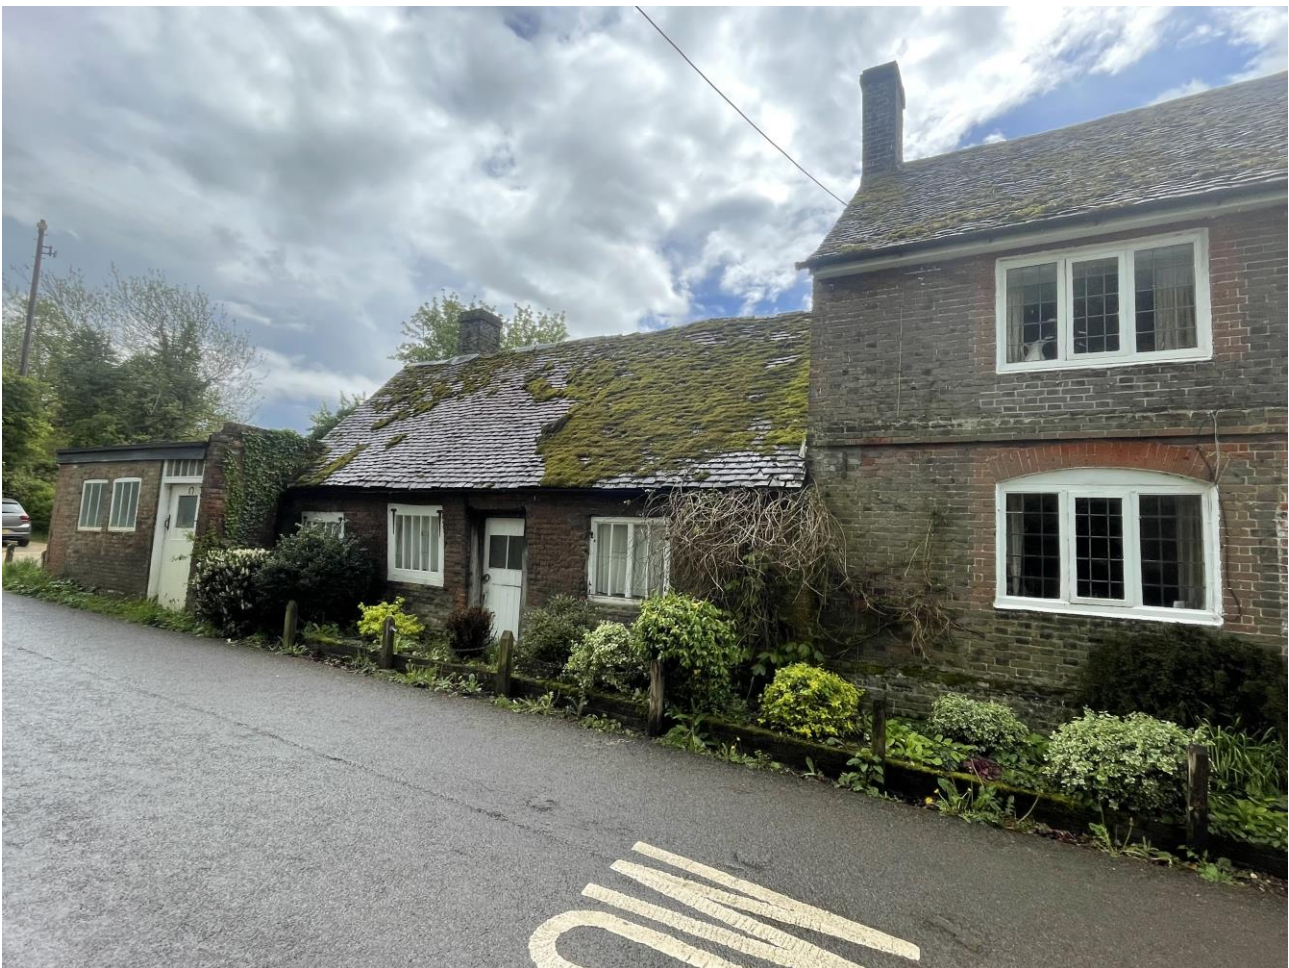
The main issue within The Forge is that the front wall has pushed out. The cause of this movement is that the front elevation of the roof having no gutter, allowing the water to discharge to ground, washing the earth away therefore undermining the wall, causing the movement.

8. The works to the internal fabric of The Forge should consist of propping to the front of the building to temporarily stop the front wall from moving, underpinning of the front of the building to arrest any further movement of the front wall and the wall plate at the rear of the property replaced.

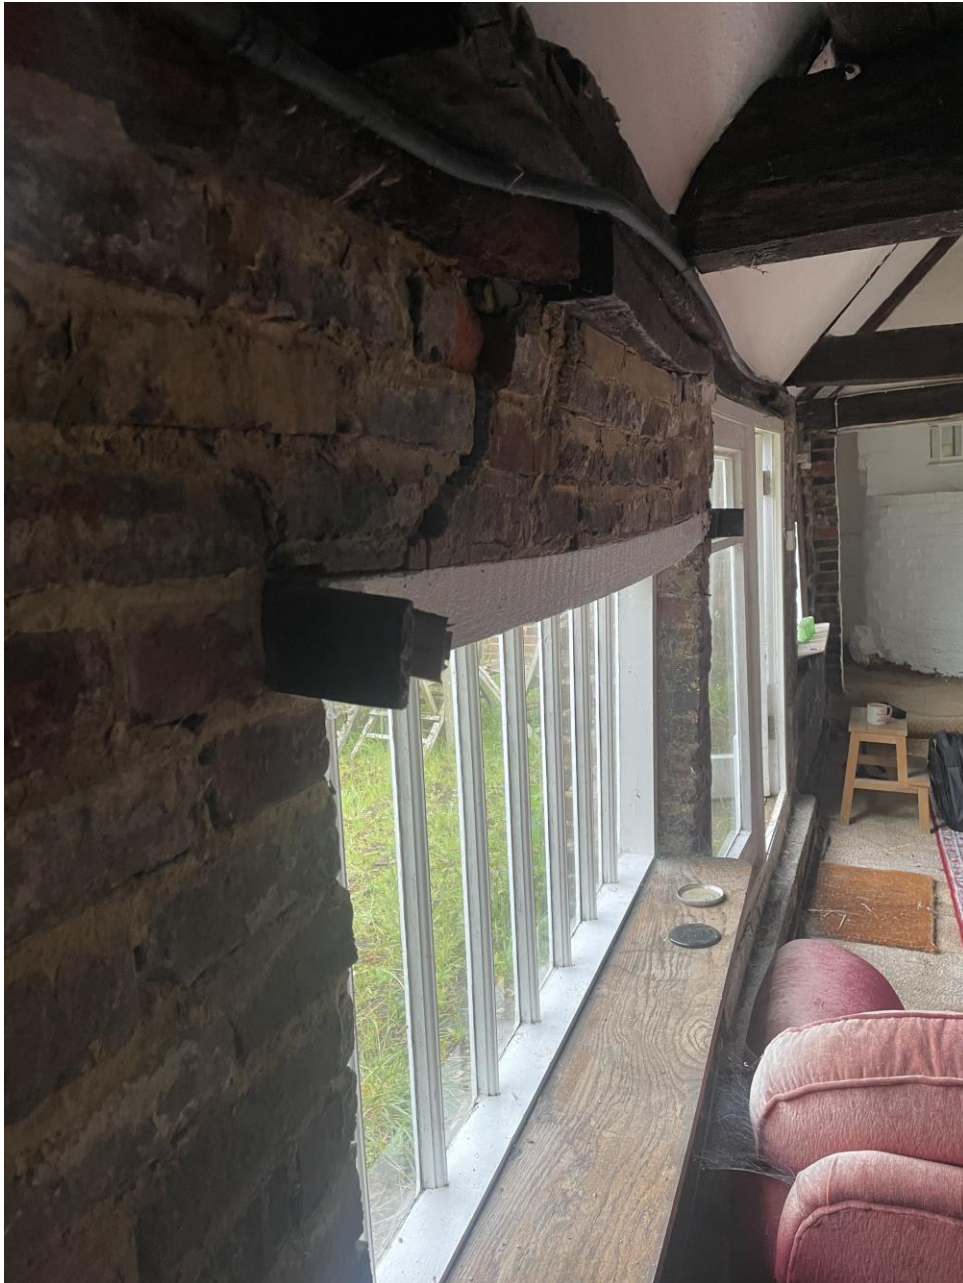
The movement has resulted in the timber tie pulling forward and putting pressure on the wall plate, which has a joint at the point of the tie bearing. The wall plate has been pulled inwards allowing the three courses of brick above the lintel over the window to also be pulled forward as evidenced by cracking.

7. The external wall plate needs to be removed and replaced with a larger plate or steel, strapped to the inner wall plate which has moved with the timber tie, strapped to arrest any further movement.

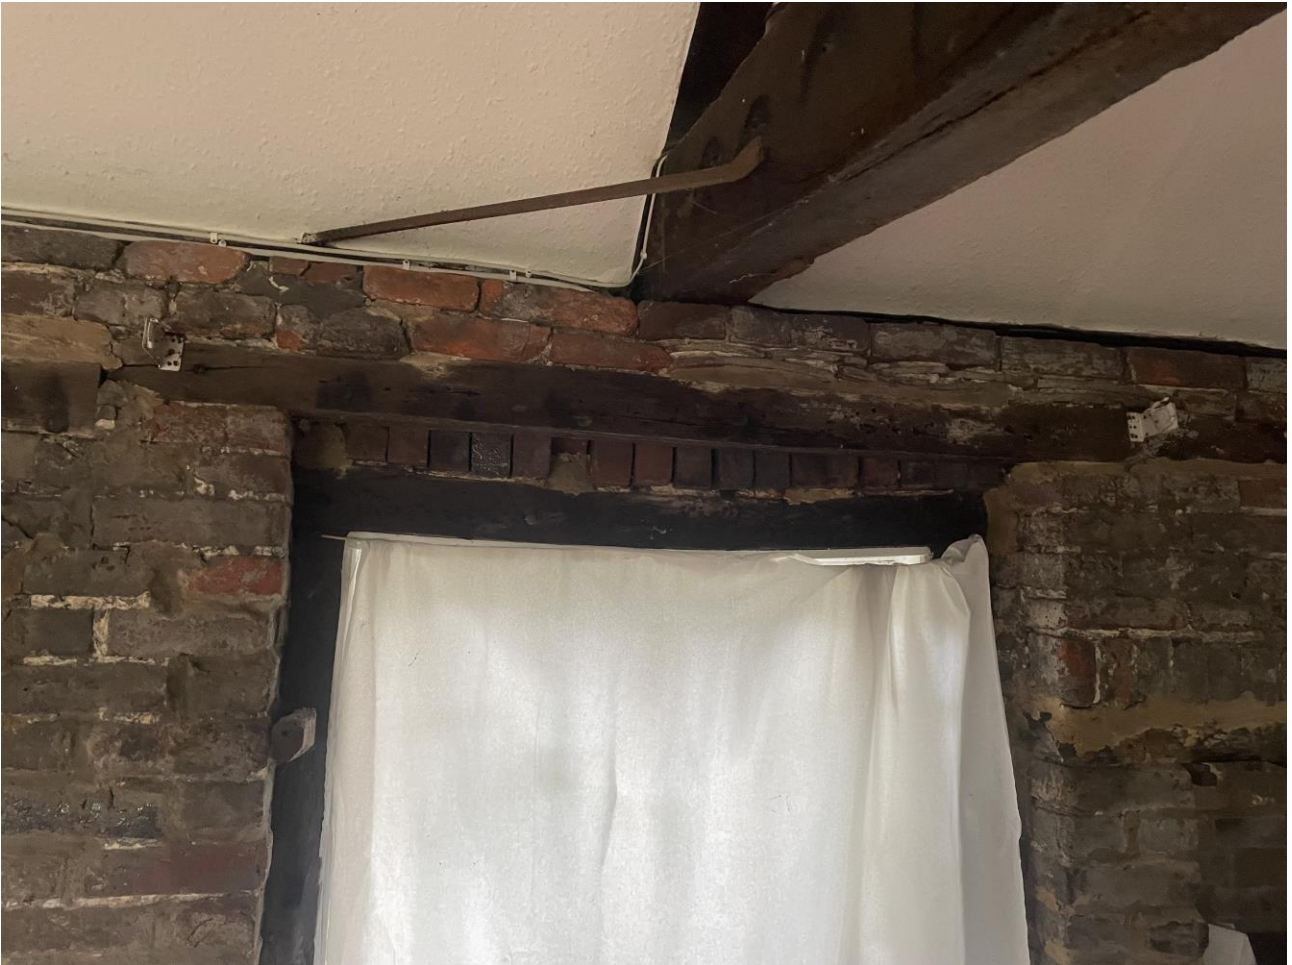
As a separate issue, the timber lintel above the window is undersized causing deflection. There is also evidence of wood boring insect infestation which has weakened the timber.

Within The Forge, several lintels have dropped.

9. The lintel above the window should be replaced with a larger piece of timber, possibly of Oak with the brickwork re-bedded using reclaimed bricks that match in colour and texture, with lime mortar.

10. The lintel on the other window should also be replaced in the same manner.

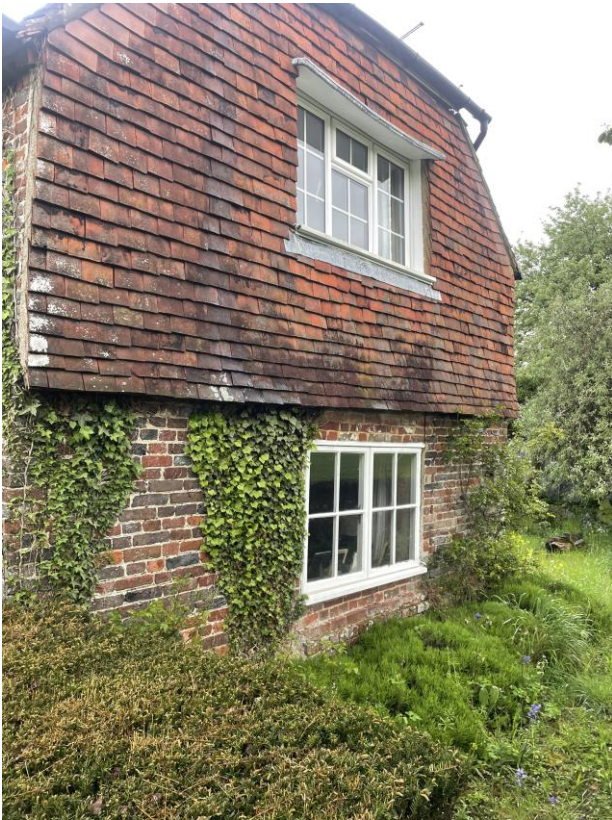
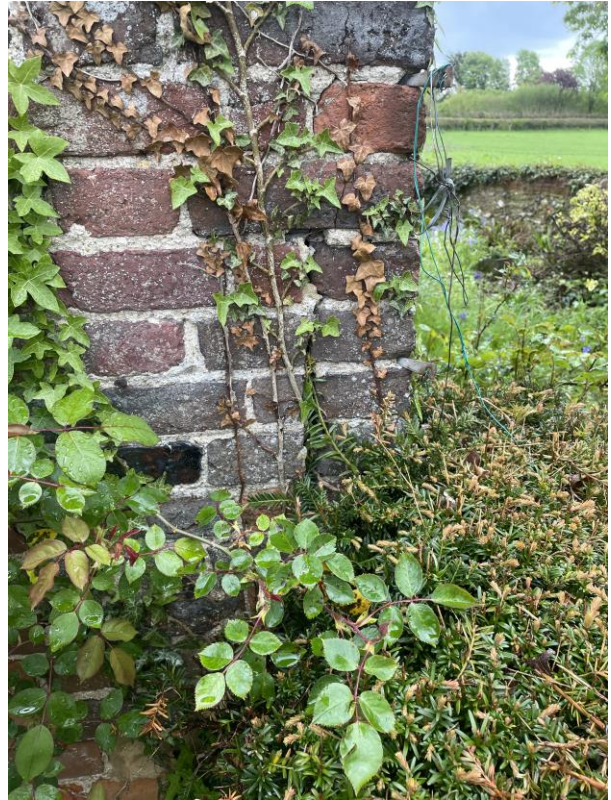
To the rear of the property is a crack in the corner which is evident within the living room which is caused by movement due to the water overflowing from the valley to the main roof.

12. The crack in the rear wall, externally, requires repointing with lime mortar. Internally, three Helifix bars to be installed across the crack at a height of approximately 500mm, 1000mm and 1500mm above floor level in the mortar joints. The guttering above requires adjustment to stop any overflow.

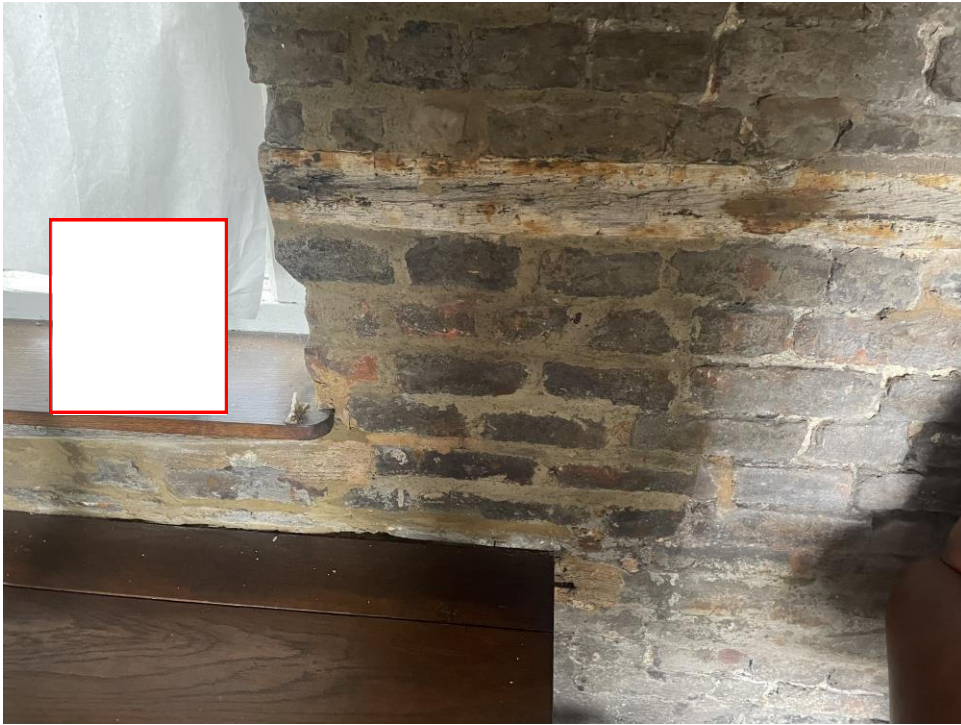
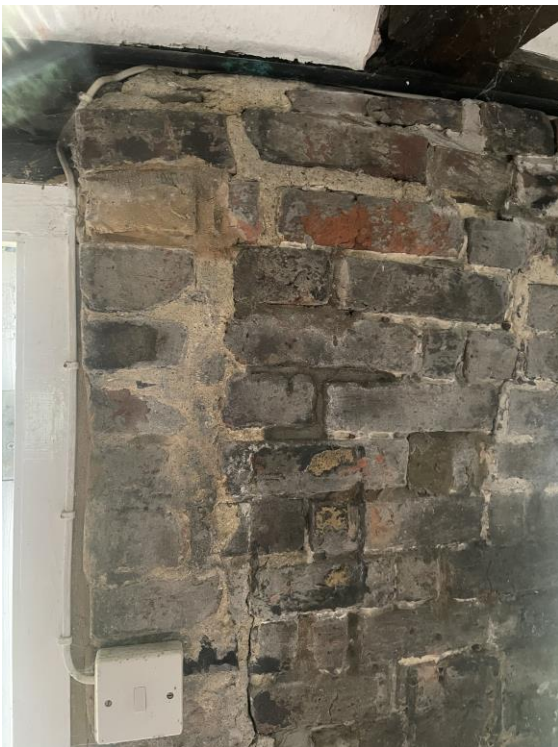
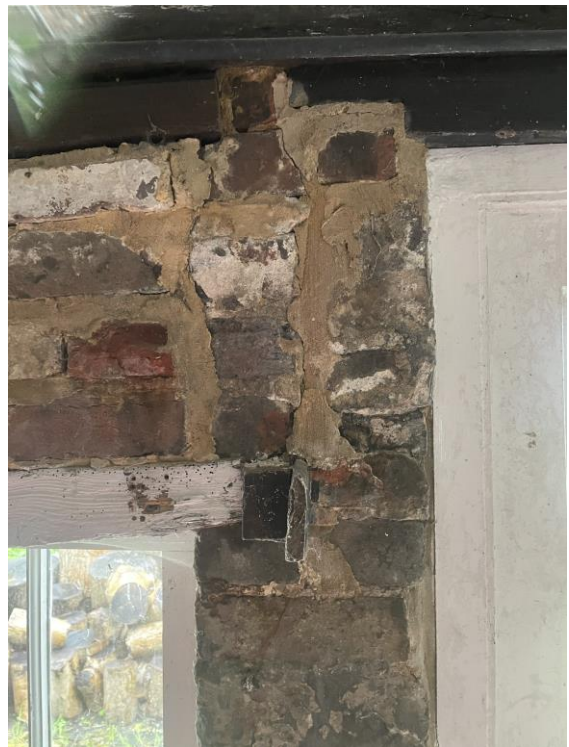
Over the years several areas of lime mortar have been replaced with sand and cement. This should be carefully removed and replaced with lime mortar.

11. Repoint with lime mortar.
