CONDITIONAL DISCHARGES

Site: The King's Head, Ivinghoe

The following Conditions are sought to be discharged following receipt of Planning approval 23/00481/ALB

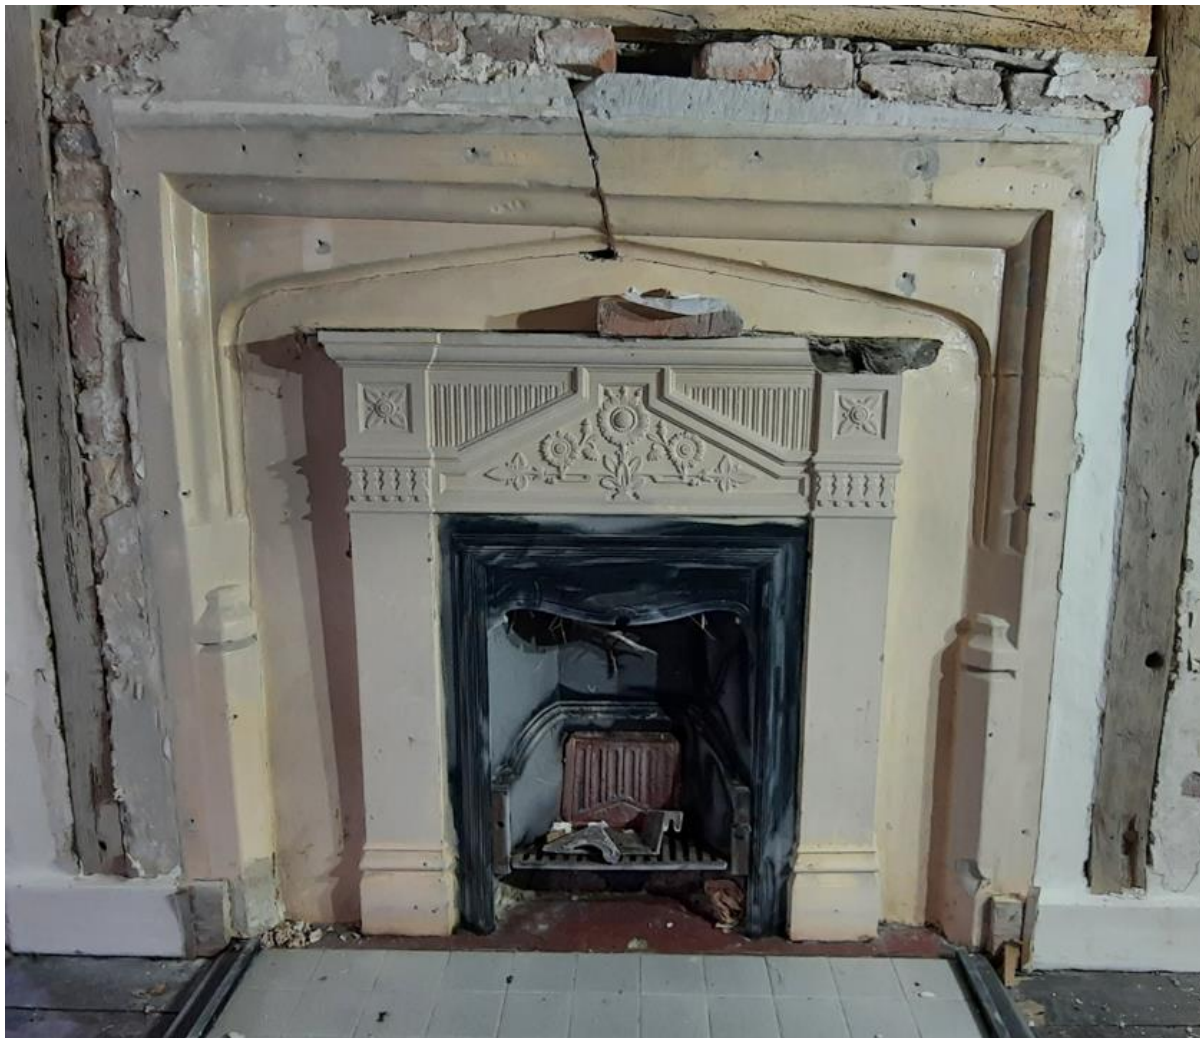
The restoration of the fireplace on the first floor has two elements; structural and conservation aesthetic.

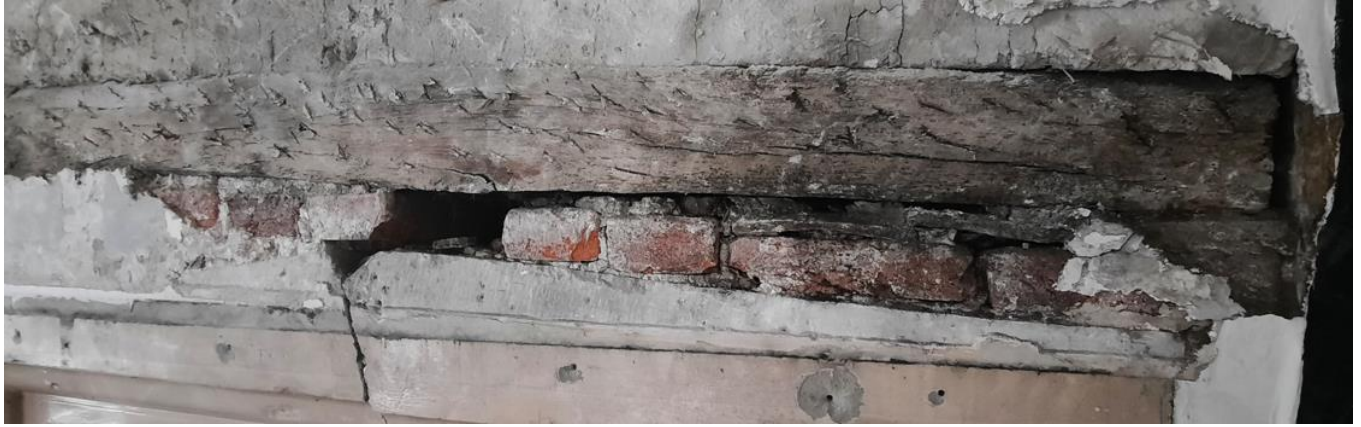
Opening up of the boarding and damaged plaster has revealed a horizontal timber beam, presumed contemporary to the installation of the fireplace. Below, the brick course is in poor condition; the bricks are loose and the mortar has degraded.

The lintel of the fireplace has a very large crack, vertically through the stone, near the centre of the arch. Above this lintel there is a horizontal wooden beam – assumed to be original when the fireplace was built. This beam is not structurally fixed into the wooden uprights to the left and right and is built into the brick courses above the stone lintel of the fireplace.

1. Insert acrow props and strong boys where required to support the weight of the wall above.
2. With the acrow props in place, remove the brick course above the stone lintel and below the wooden beam. Remove the Victorian era fireplace and the expected rubble infill from the original fire opening – constantly assessing for any movement in the stone.

3. Lift the right-hand piece of stone linel back into its original place – closing the gap as best as possible. – The stone will be lifted as much as possible to allow for the old mortar bed of the right-hand joint to be removed and a new bedding mortar to be inserted.

4. Once set into the correct position, two holes will be drilled at an angle through from the top or possibly the bottom of the stone lintel to allow for 2no 10mm stainless steel threaded rods to be inserted into an injected chemical resin.

5. Fill the crack of the stone and the disrupted right-hand side joint with suitable lime mortar made using a similar stone dust that will closely match the original stone.

6. Replace the original brick course using appropriate lime mortar.

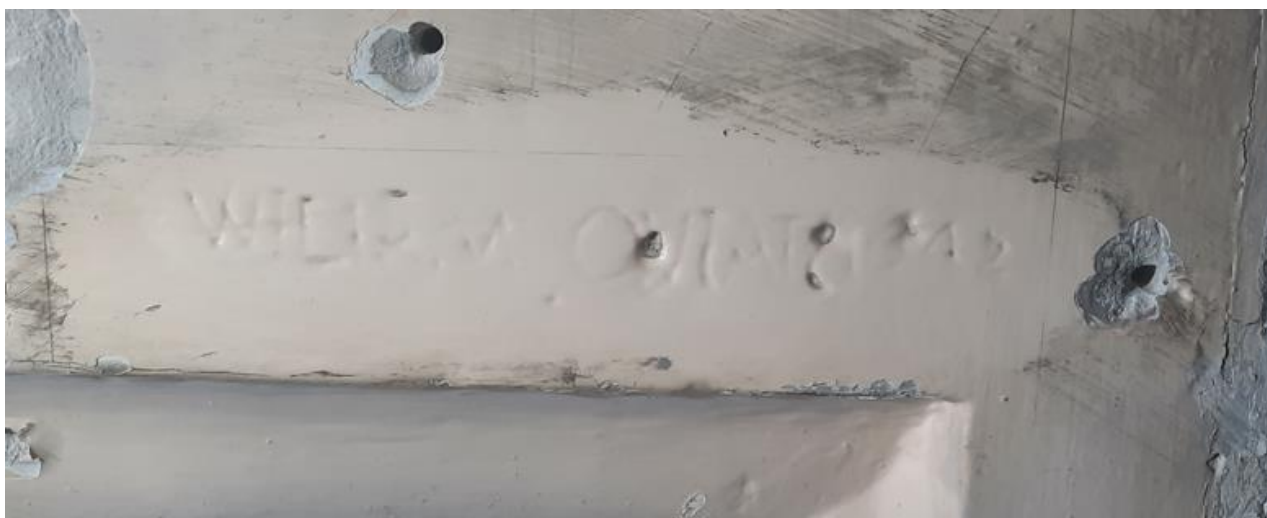
Over many years, the stone fireplace has been subjected to several coats of gloss paint. When fully exposed, an inscription beneath the paint is just visible to the upper right hand side. We understand the inscription to read *WILIAM OVIAT 1?42*. The engraving is unclear, however we believe the century number to be 6 i.e. 1642. Genealogical research from the parish register shows a marriage between William Oviott and Ann Eames, 23rd October 1645 in St Mary the Virgin Church, Ivinghoe. They later had a son called William, one of seven siblings. He was recorded as baptised in 1647.

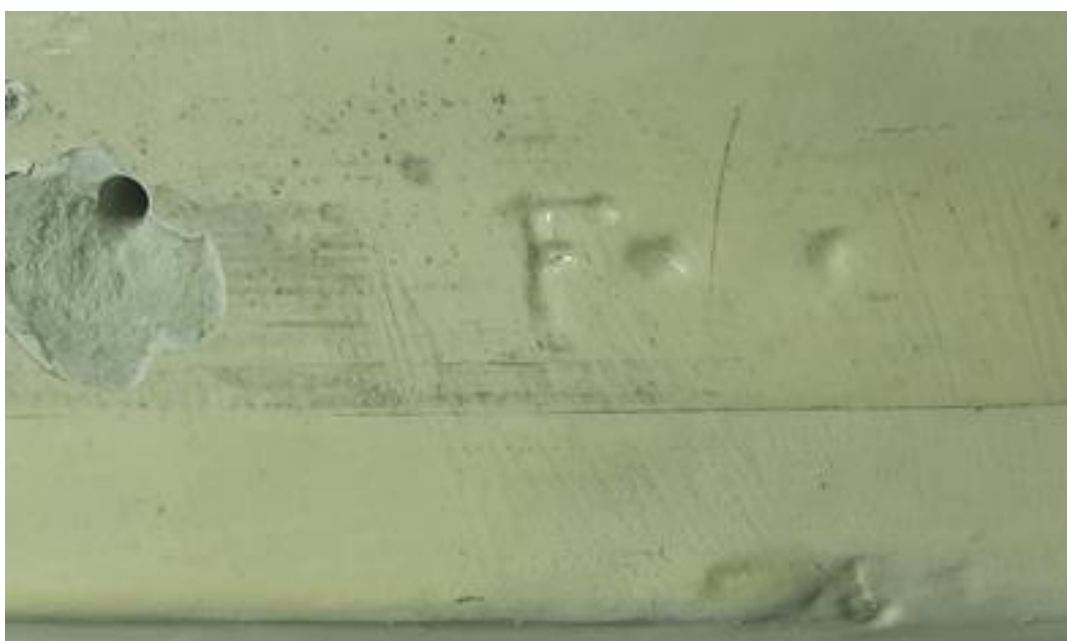
In addition, to the left of the centre head, what appears to be an F is visible, with separate dots to the right hand side.

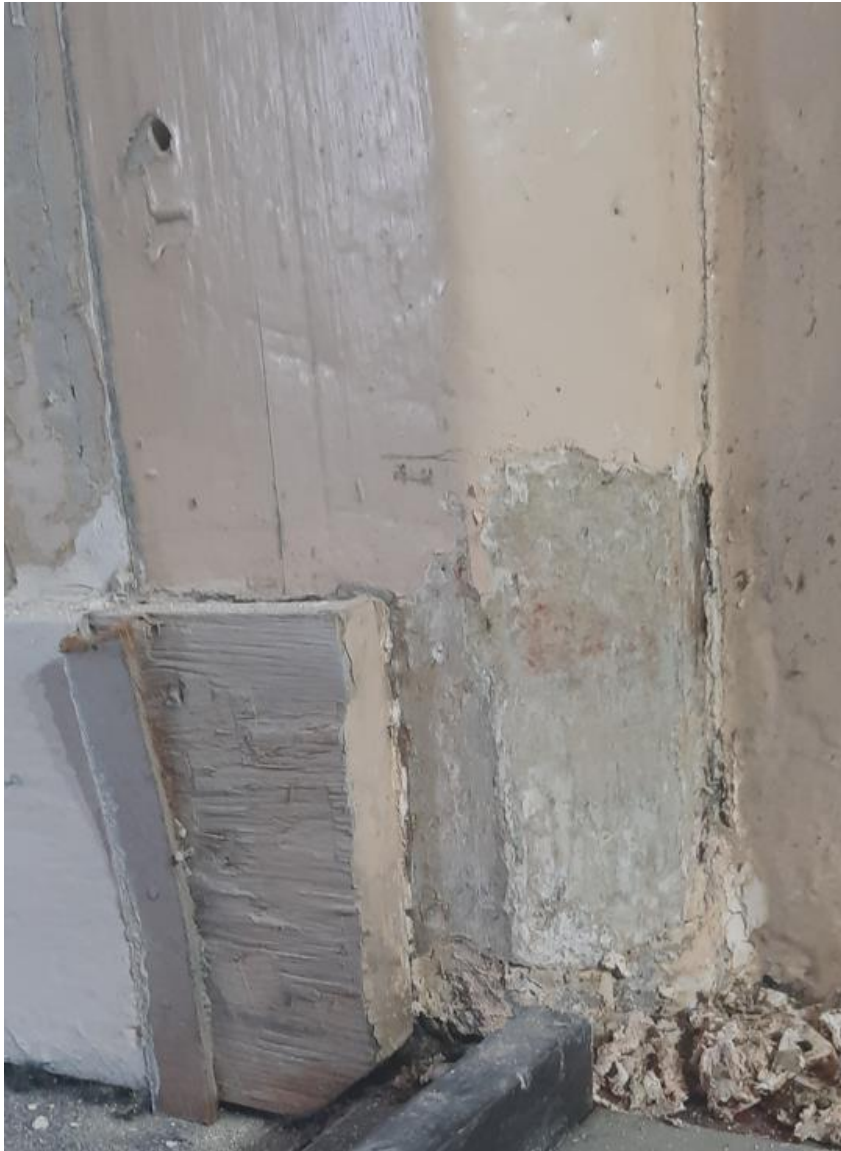
It is proposed to use Peelaway poultice paint removal system. Approved by Historic England, the poultice is suitable for a range of substrates including stone. A test patch was commissioned at the lower left 'foot' of the fireplace. This successfully removed all layers of paint with no damage to the stone surface.
